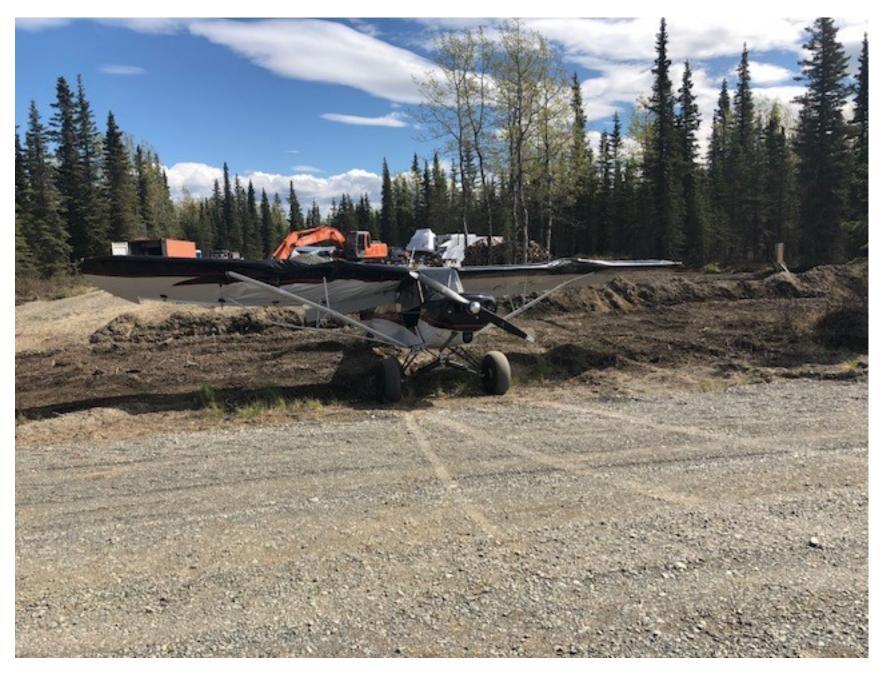
**Photo 1 – View of damaged wing lift struts (Photo courtesy of the pilot)**
