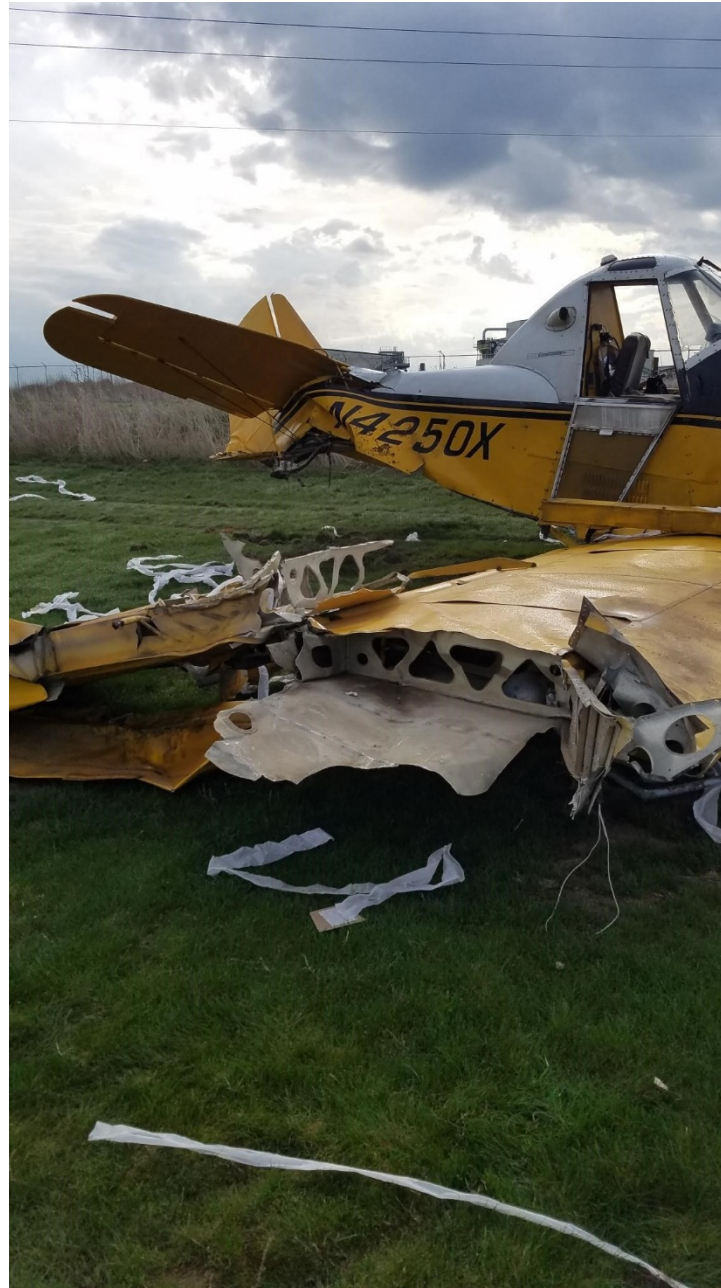
Photo 1 – View of damaged right wing and empennage (Photo courtesy of the pilot)
