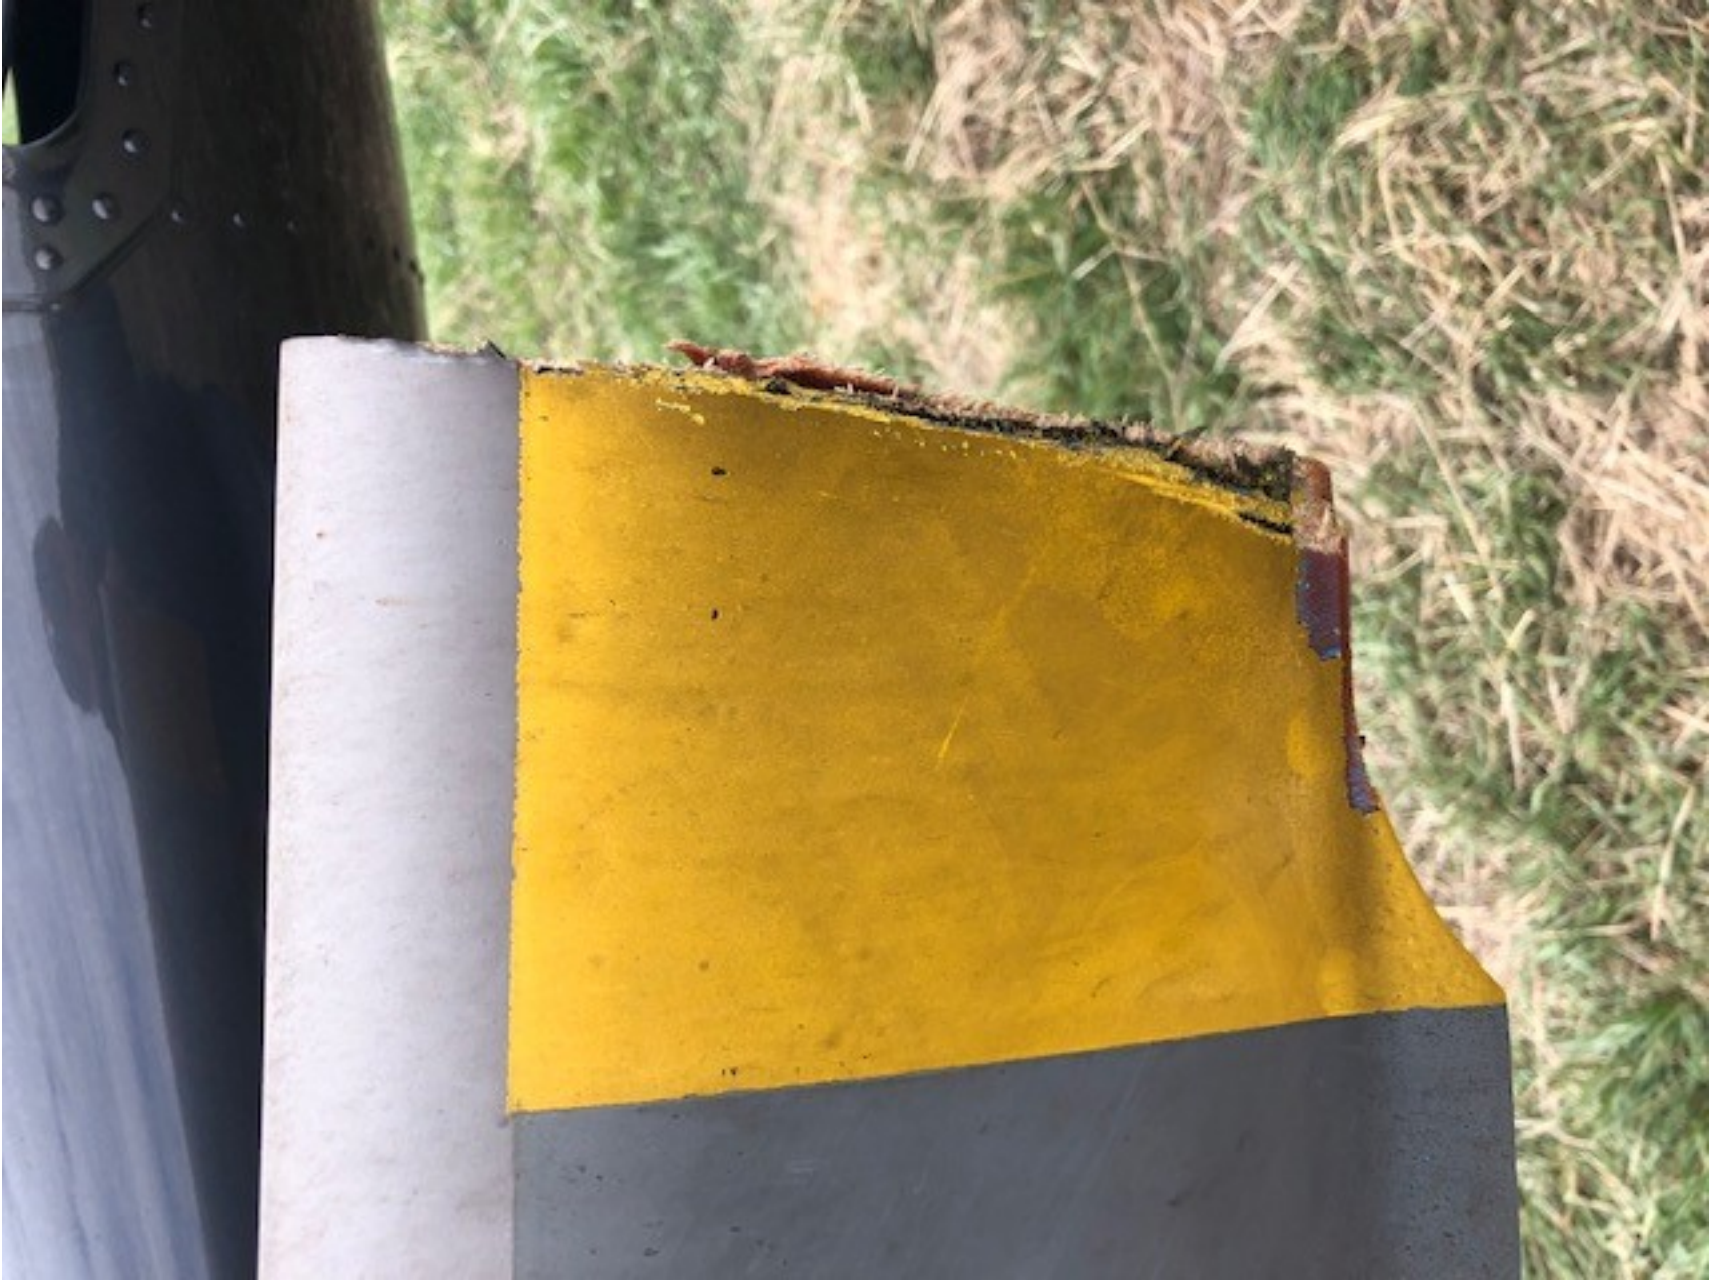
Photo 1 – View of damaged tail rotor blade (Photo courtesy of the operator)
