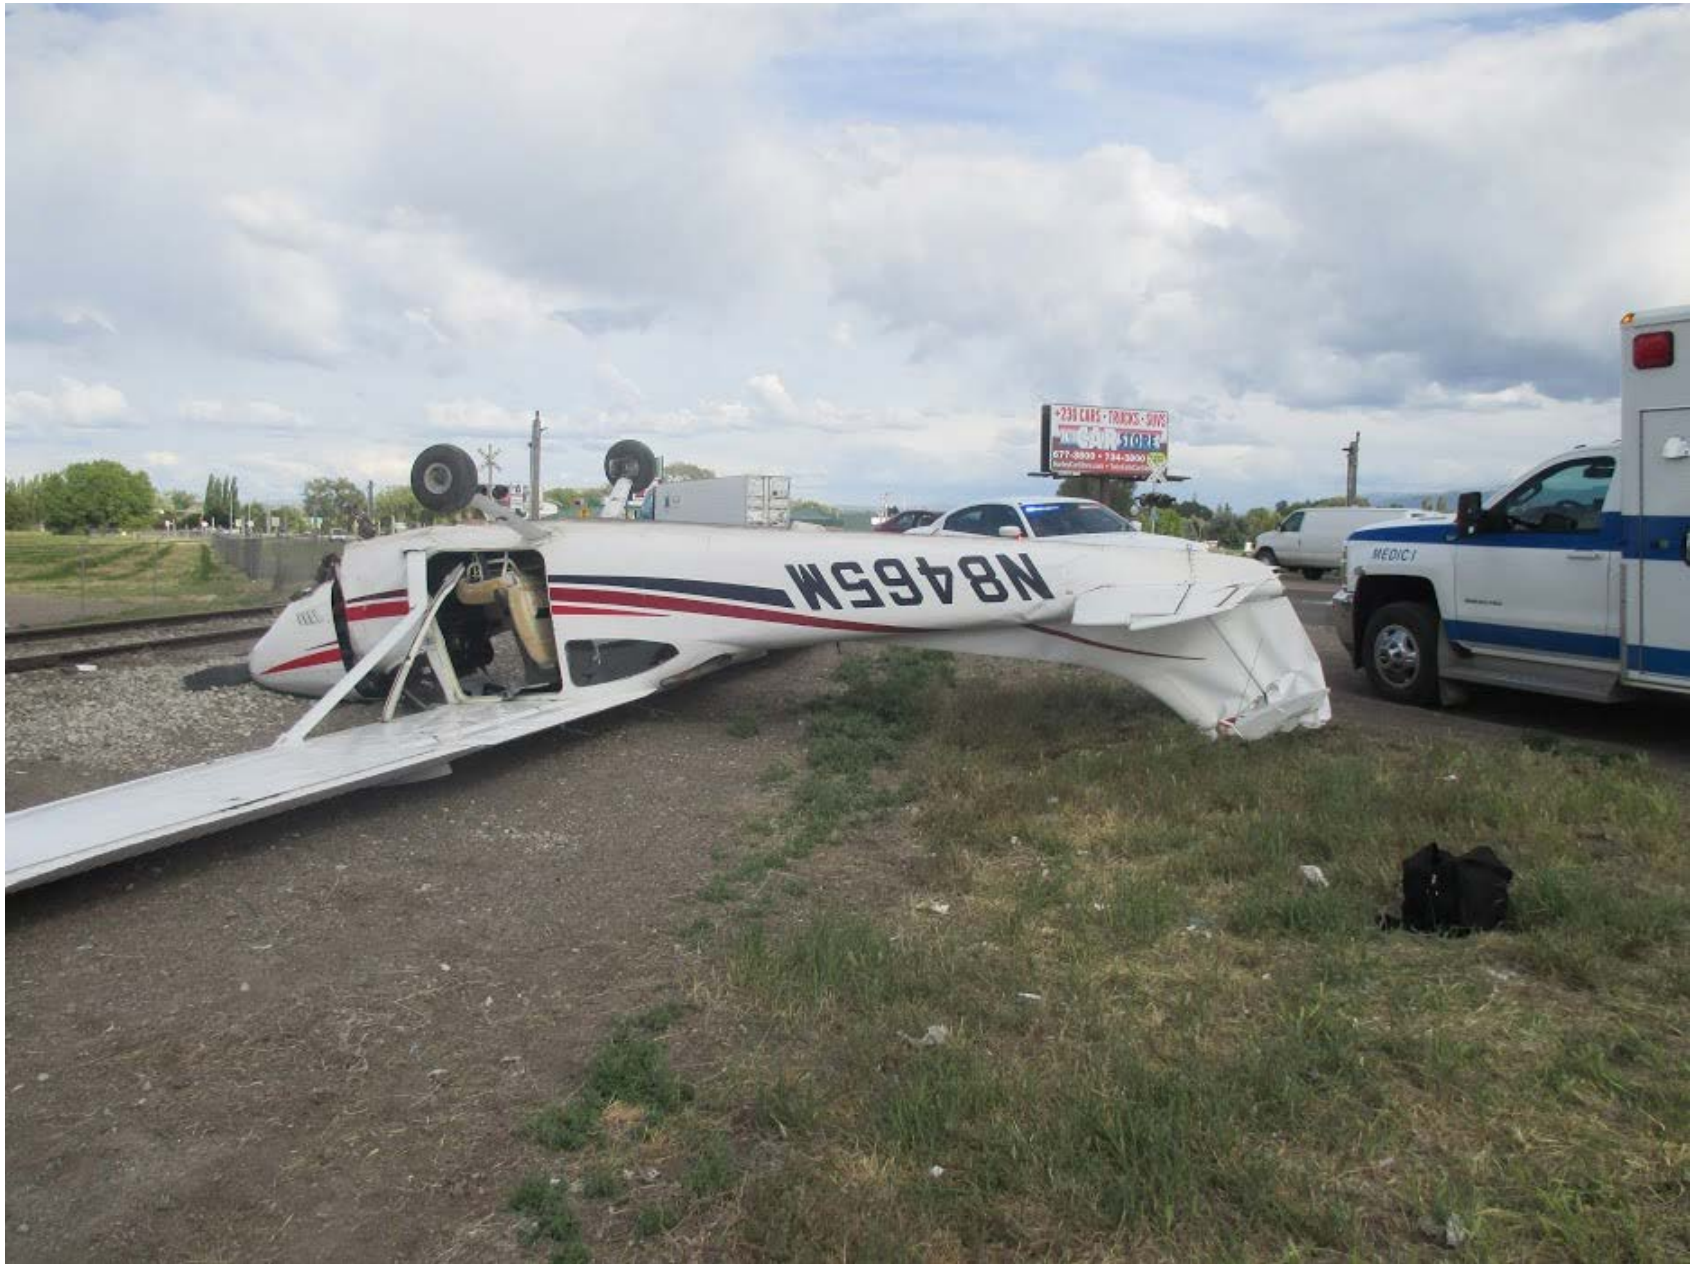
Photo 1 – View of damaged empennage and right-wing lift strut (courtesy of the FAA)
