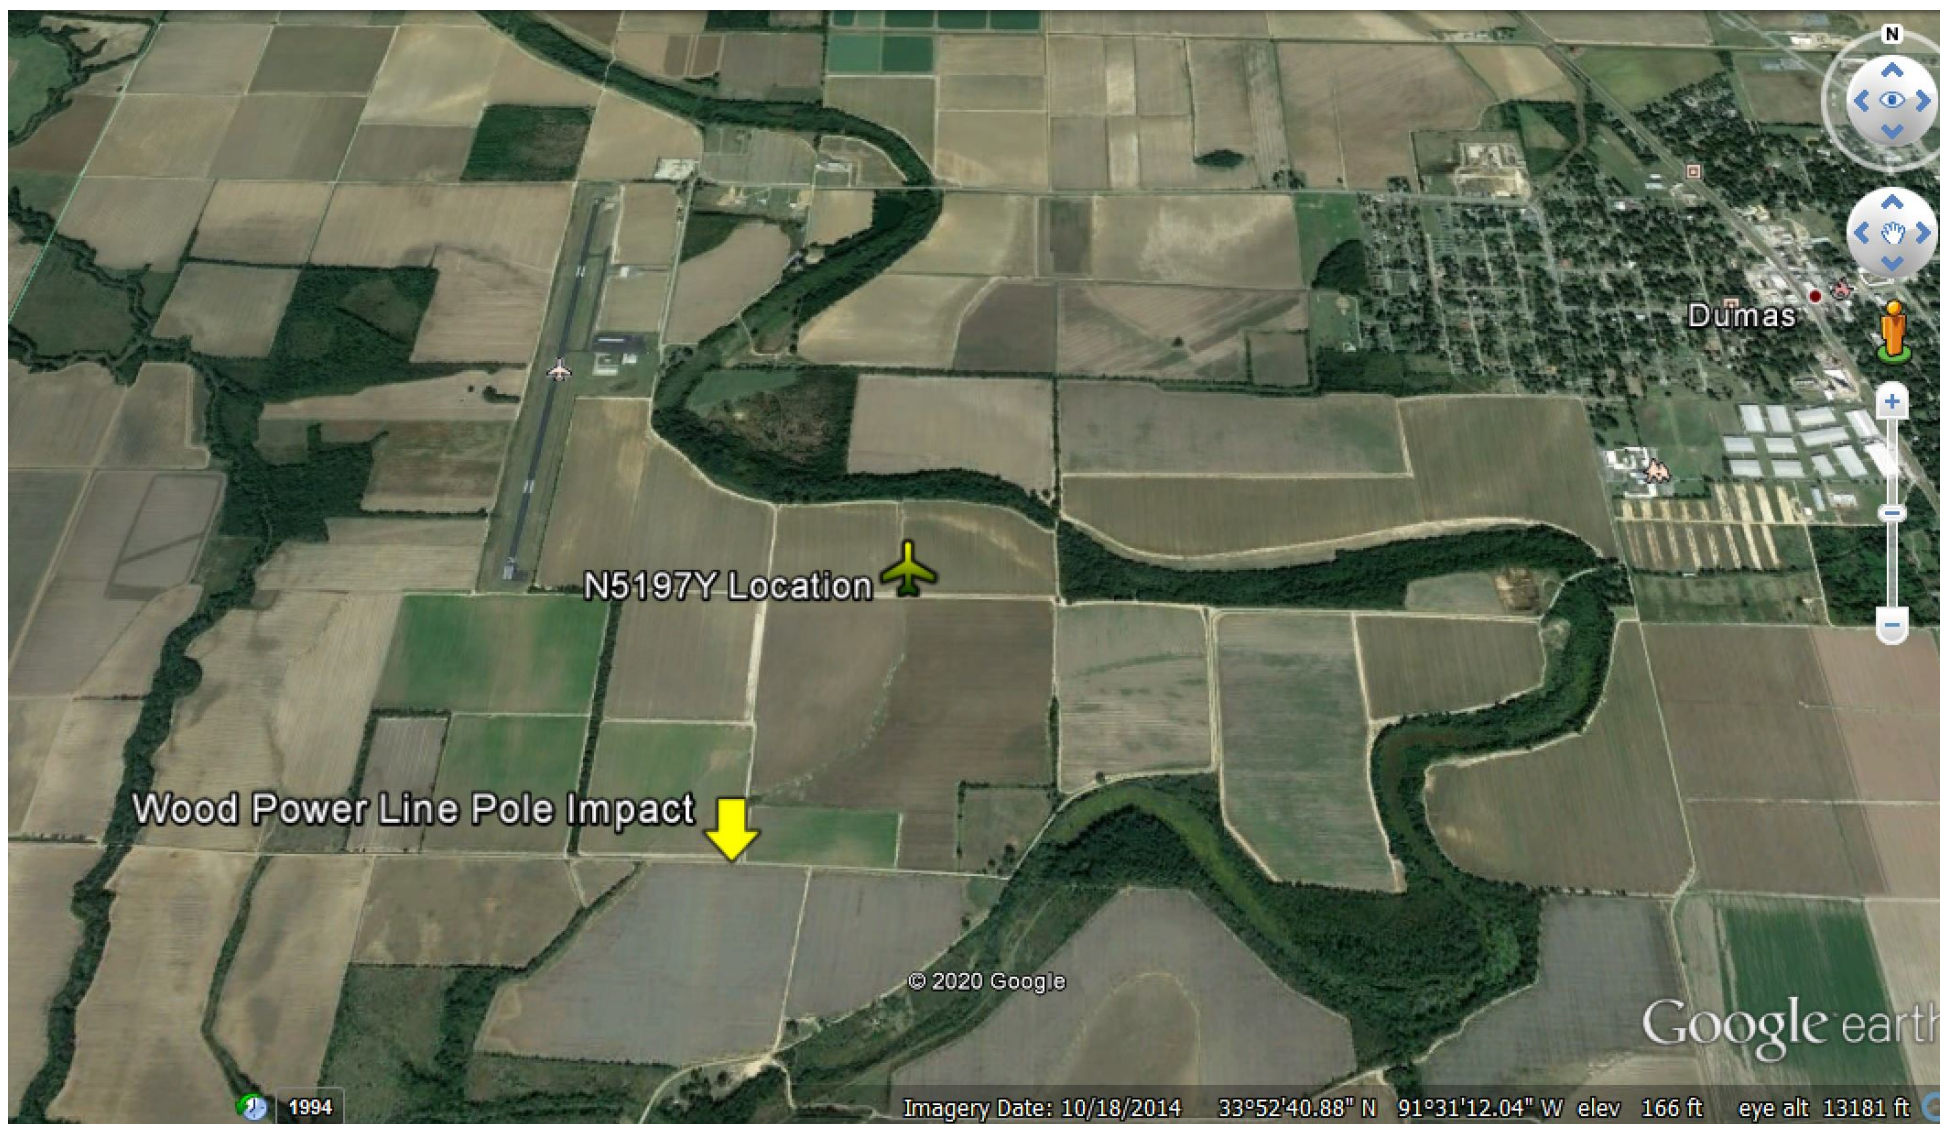
Photo 1 – Google Earth image of where the wood power line pole was impacted and where the airplane came to rest (courtesy of the Federal Aviation Administration).

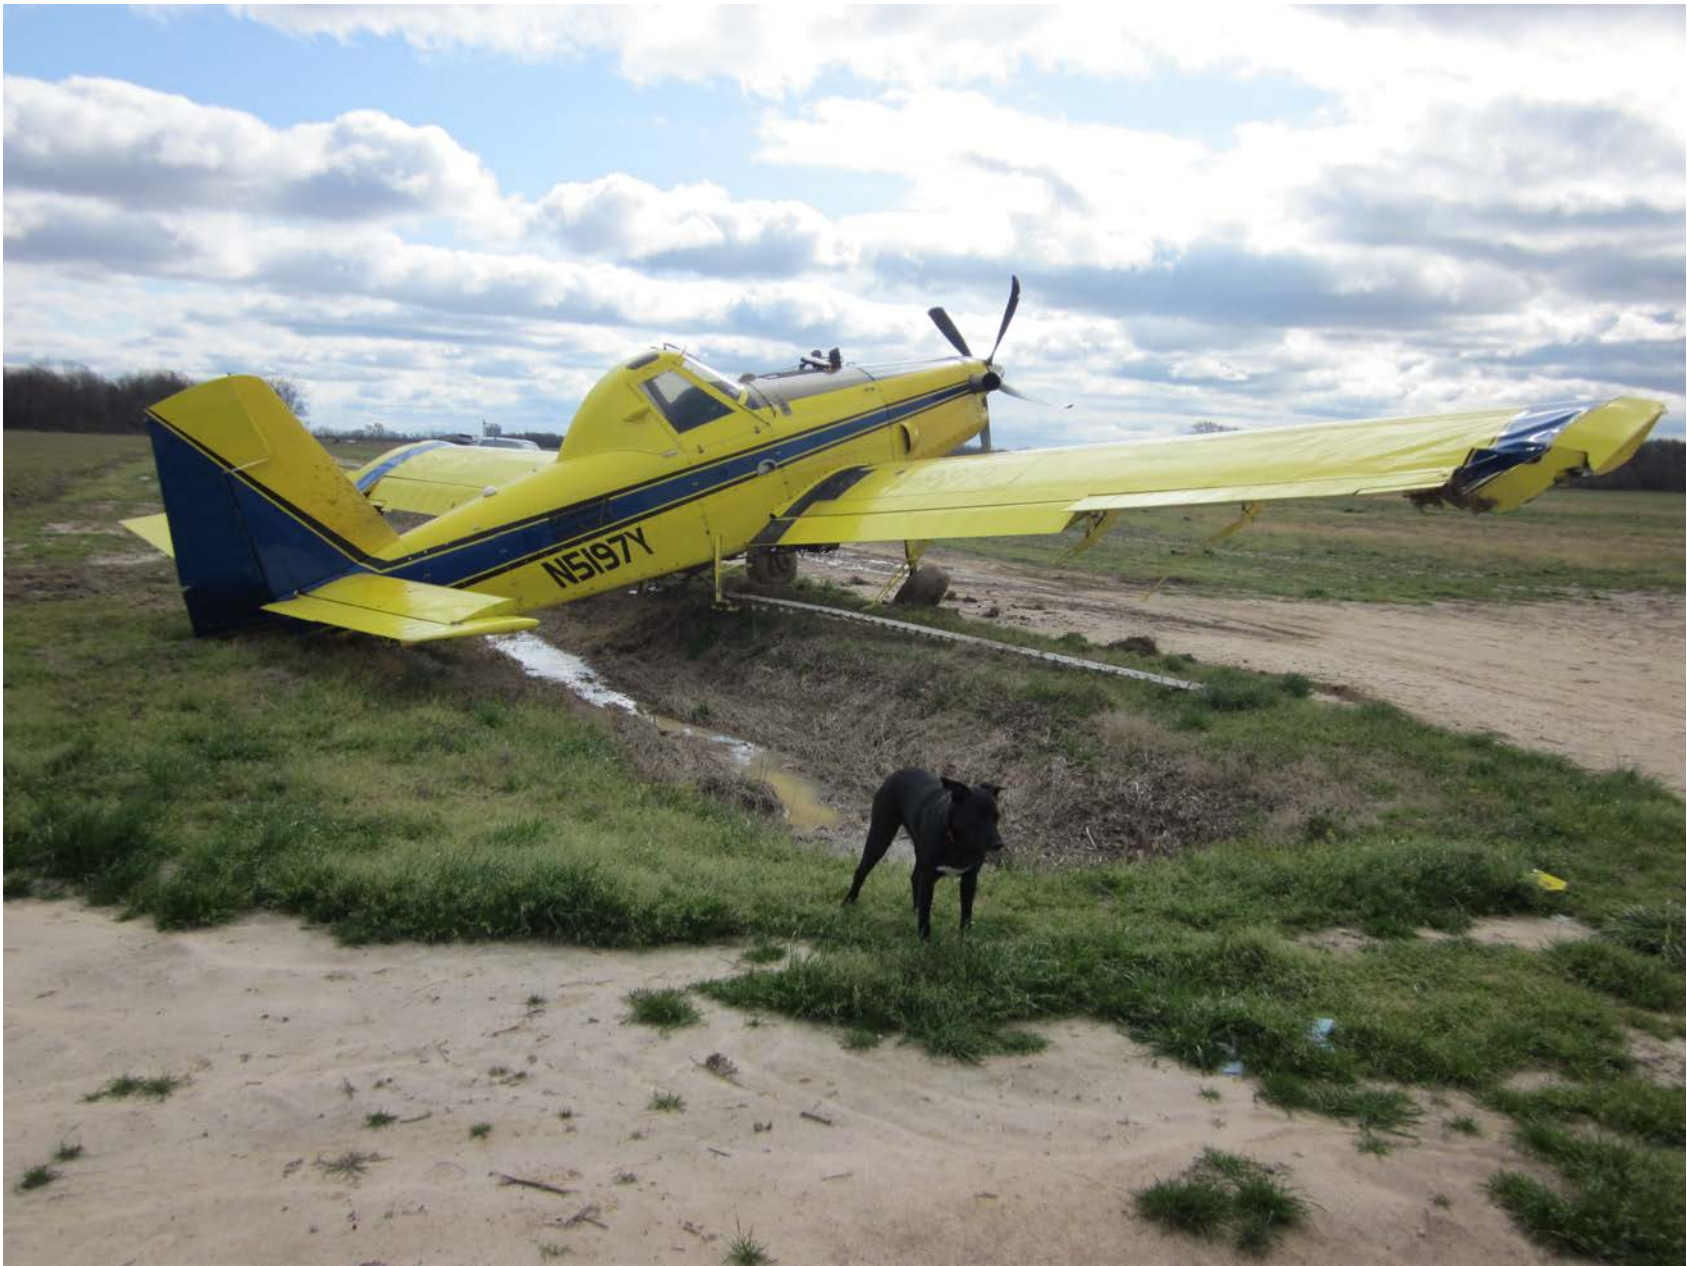
Photo 2 – View of the airplane after it came to rest (courtesy of the Federal Aviation Administration).

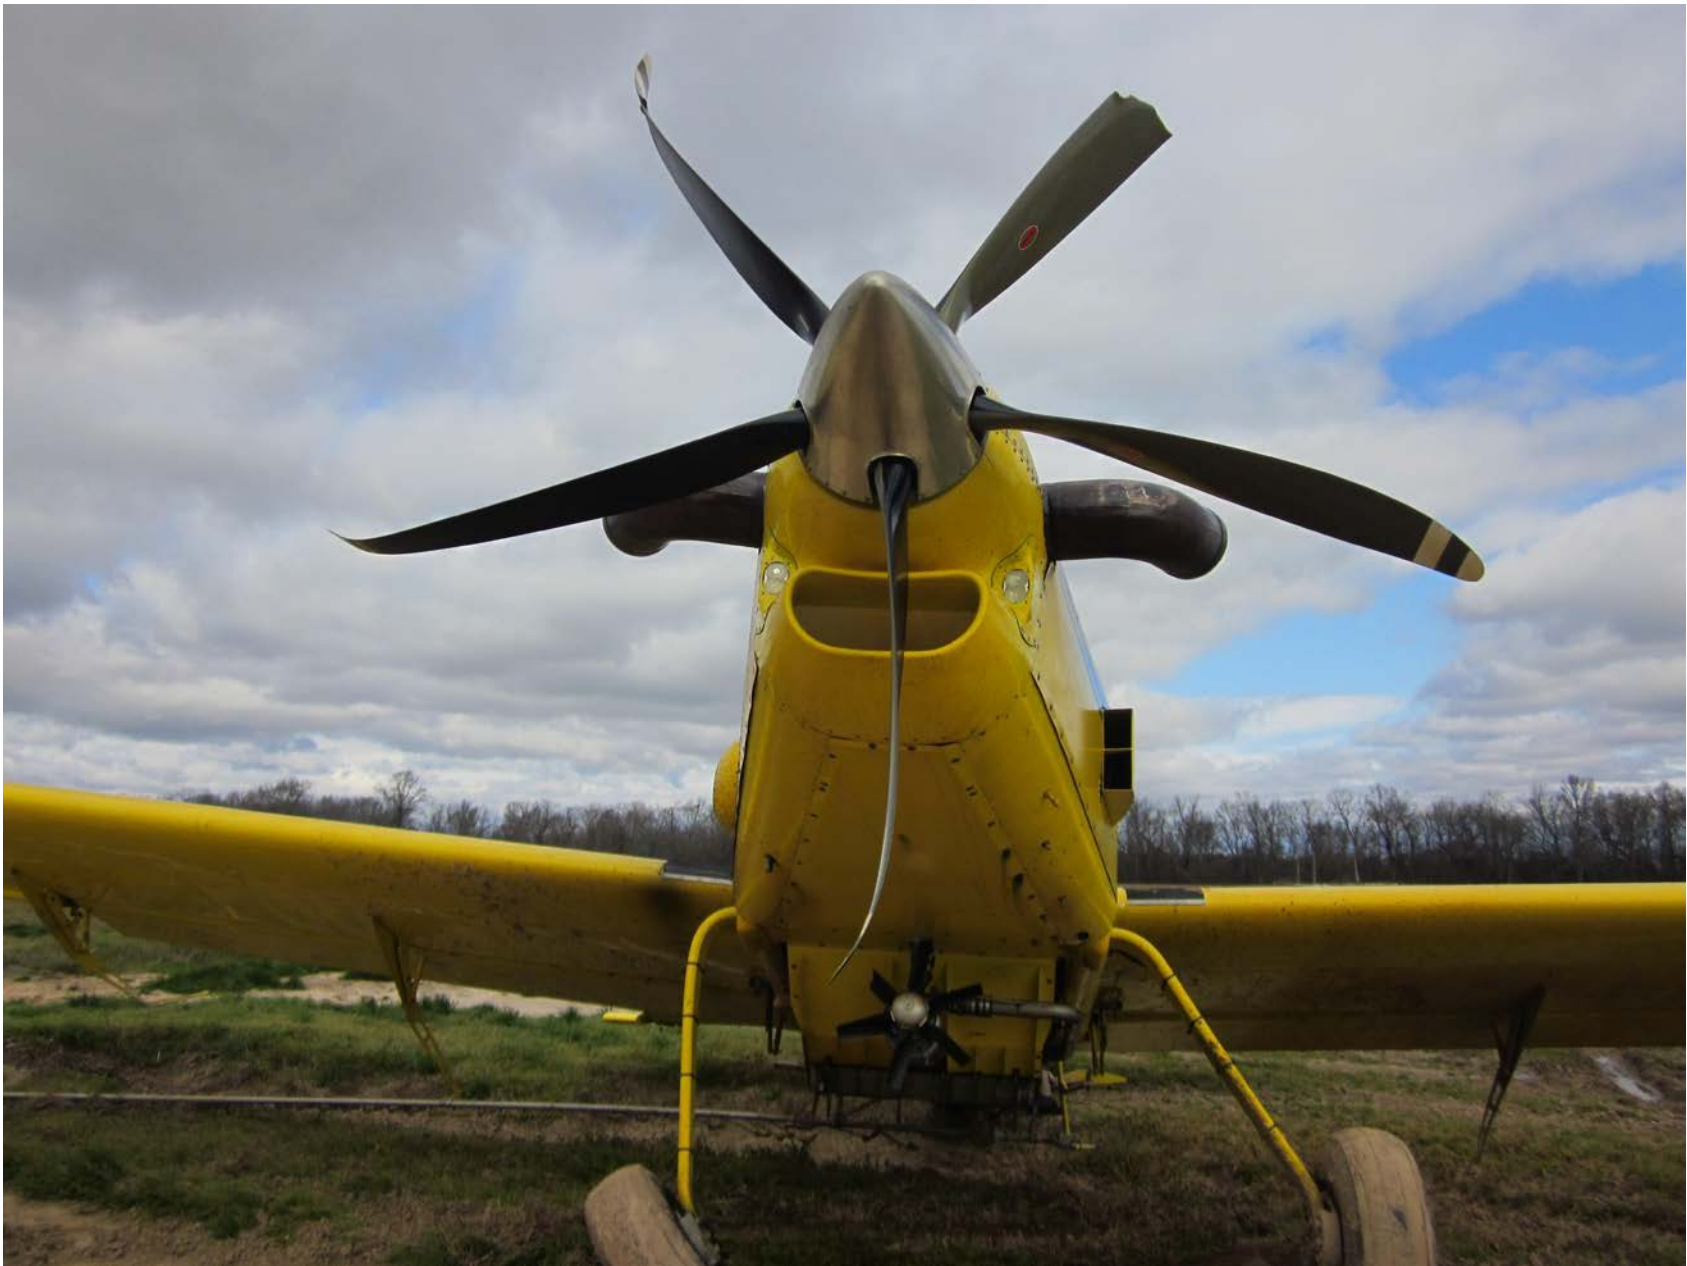
Photo 3 – View of the airplane after it came to rest (courtesy of the Federal Aviation Administration).

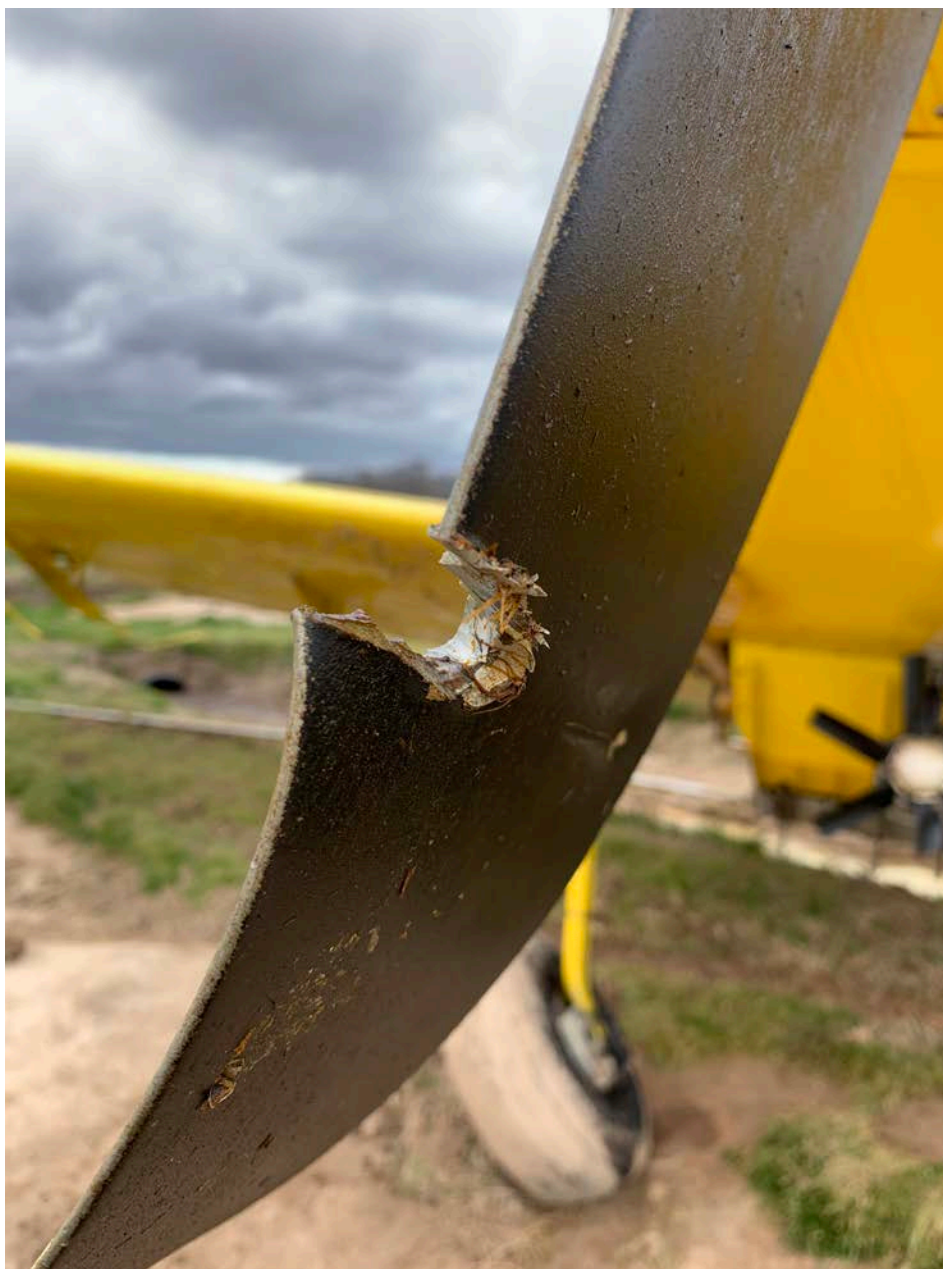
Photo 4 – View of the damage to one of the metal propeller blades (courtesy of the Federal Aviation Administration).

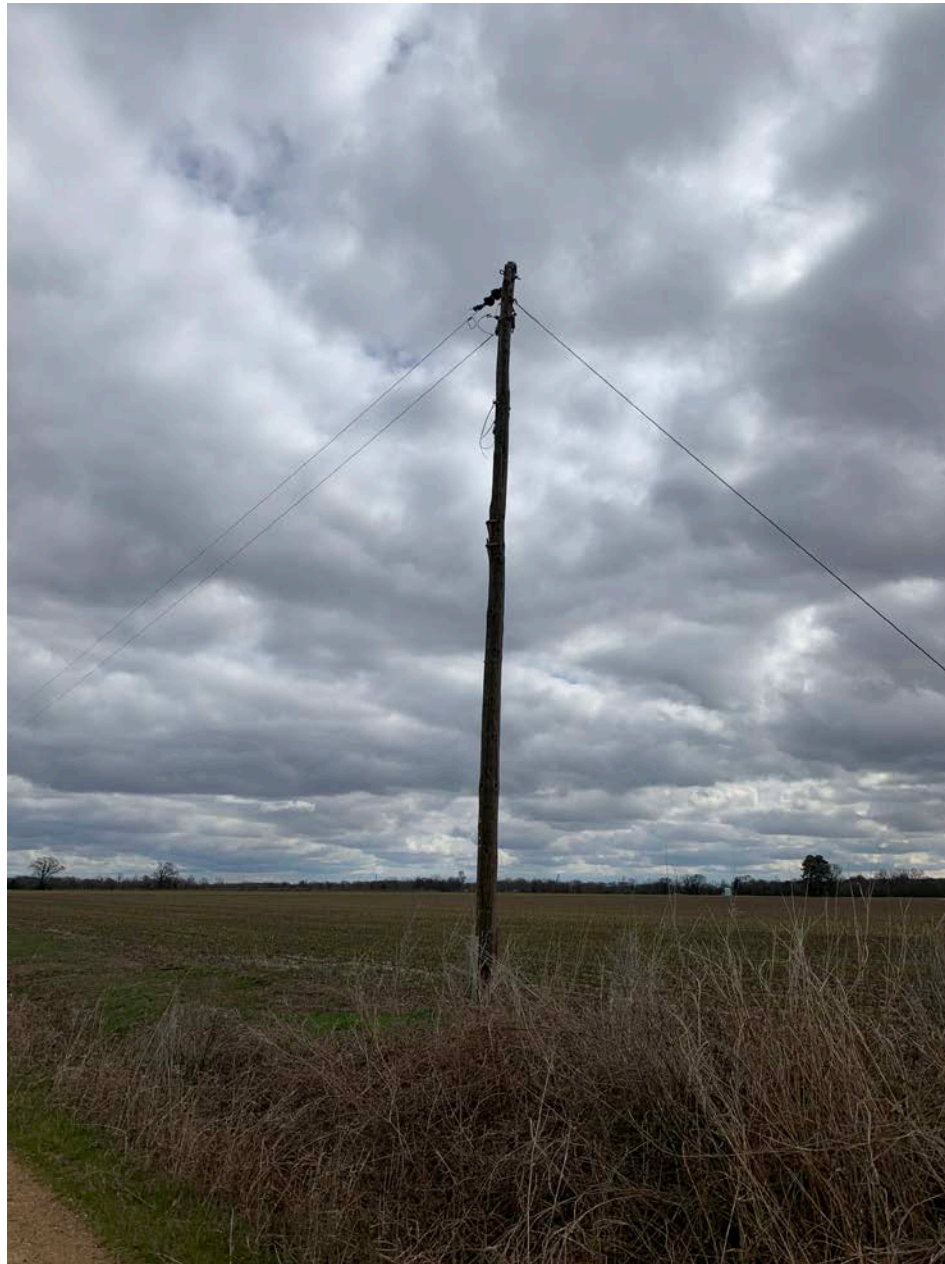
Photo 5 – View of the wood power line pole in the field (courtesy of the Federal Aviation Administration).

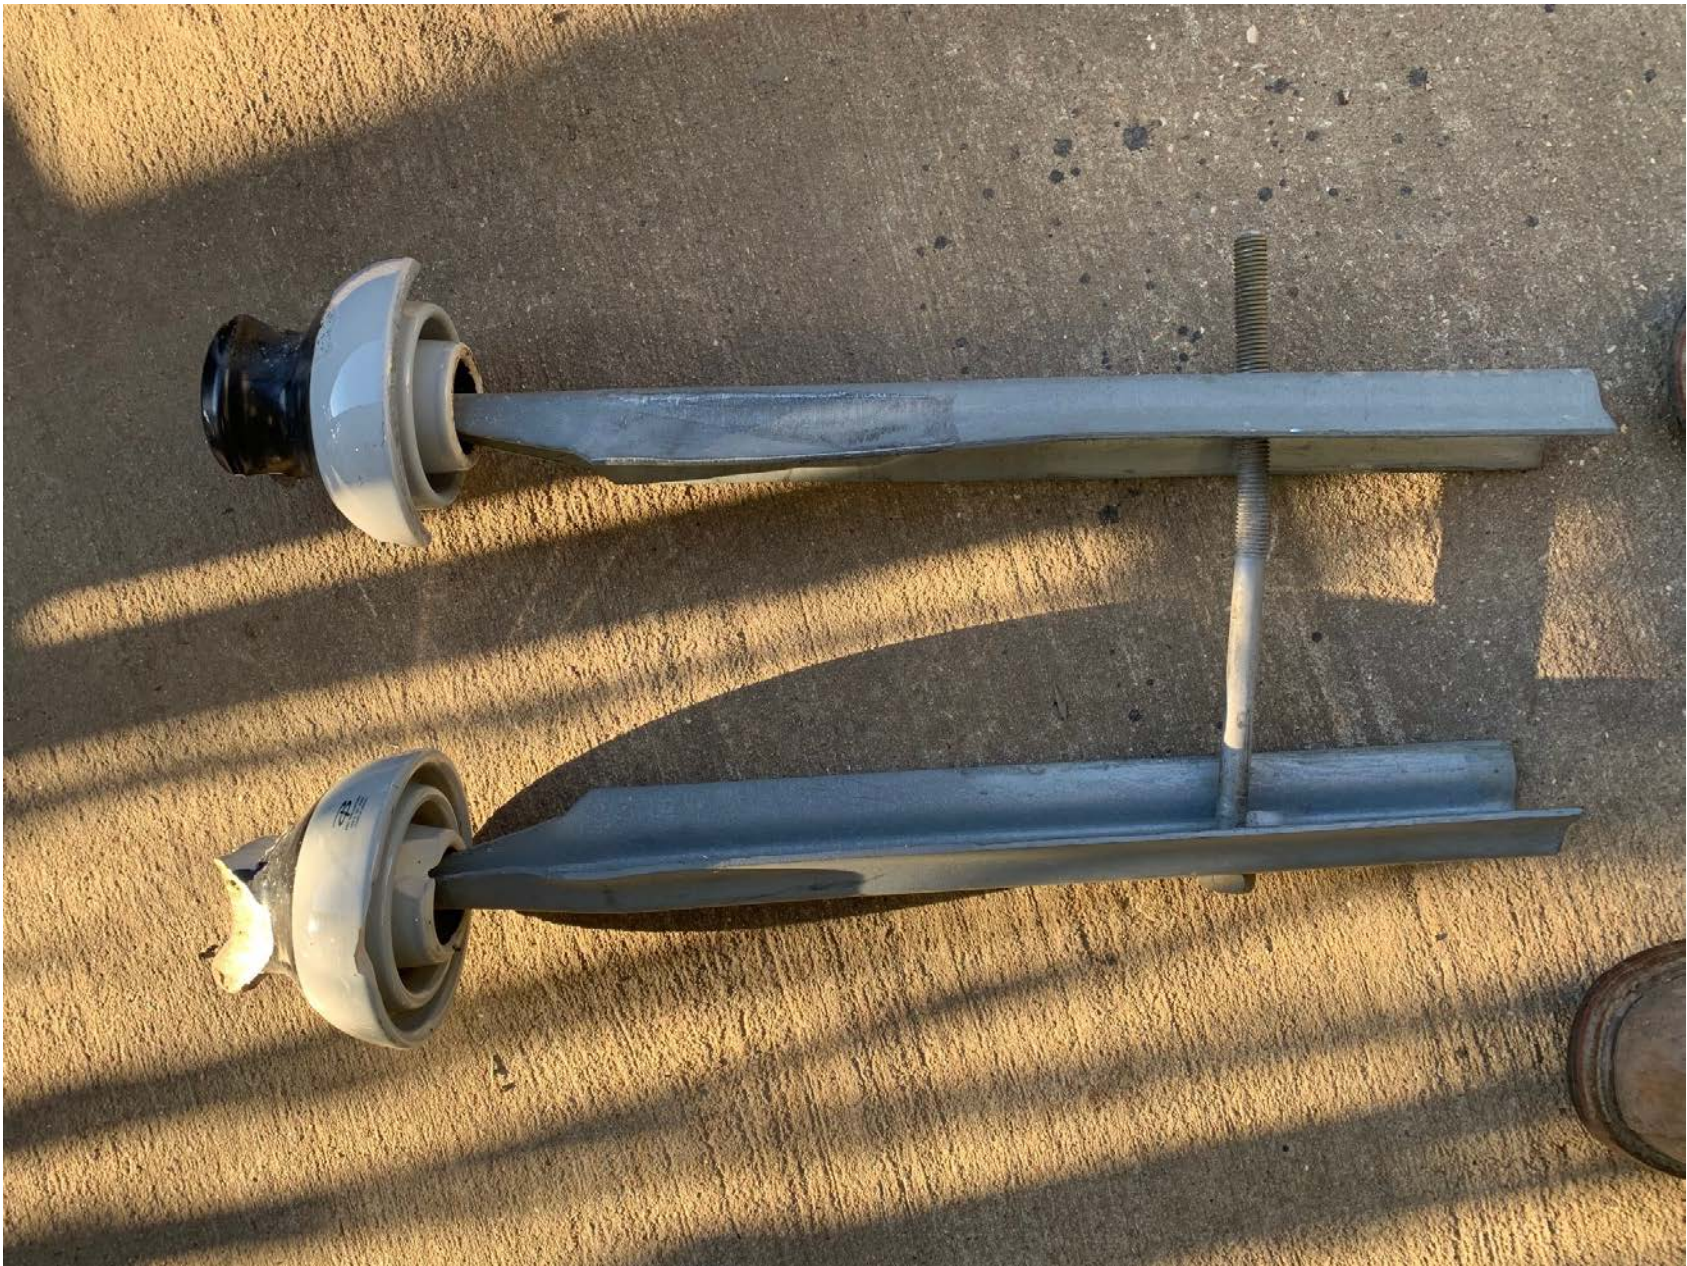
Photo 6 – View of the metal bracket that was mounted on top of the wood power line pole (courtesy of the Federal Aviation Administration).

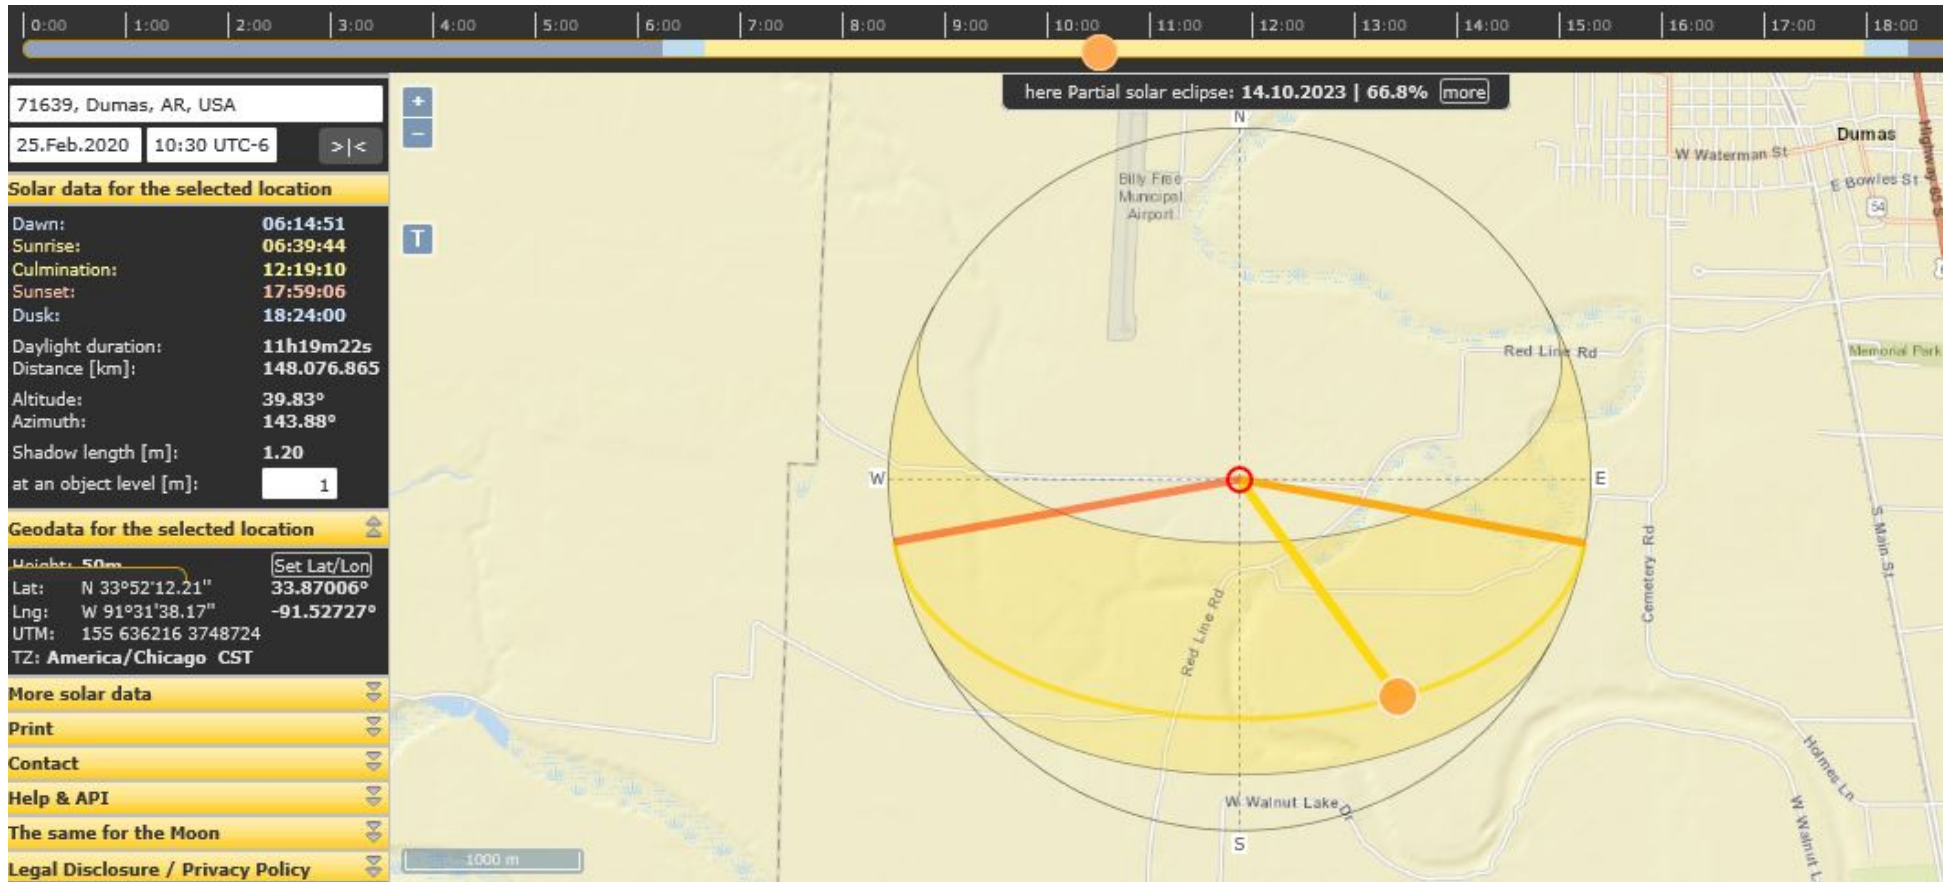
Photo 7 – SunCalc.org image of the accident site showing the altitude and azimuth of the sun at the time of the accident (courtesy of SunCalc.org)
