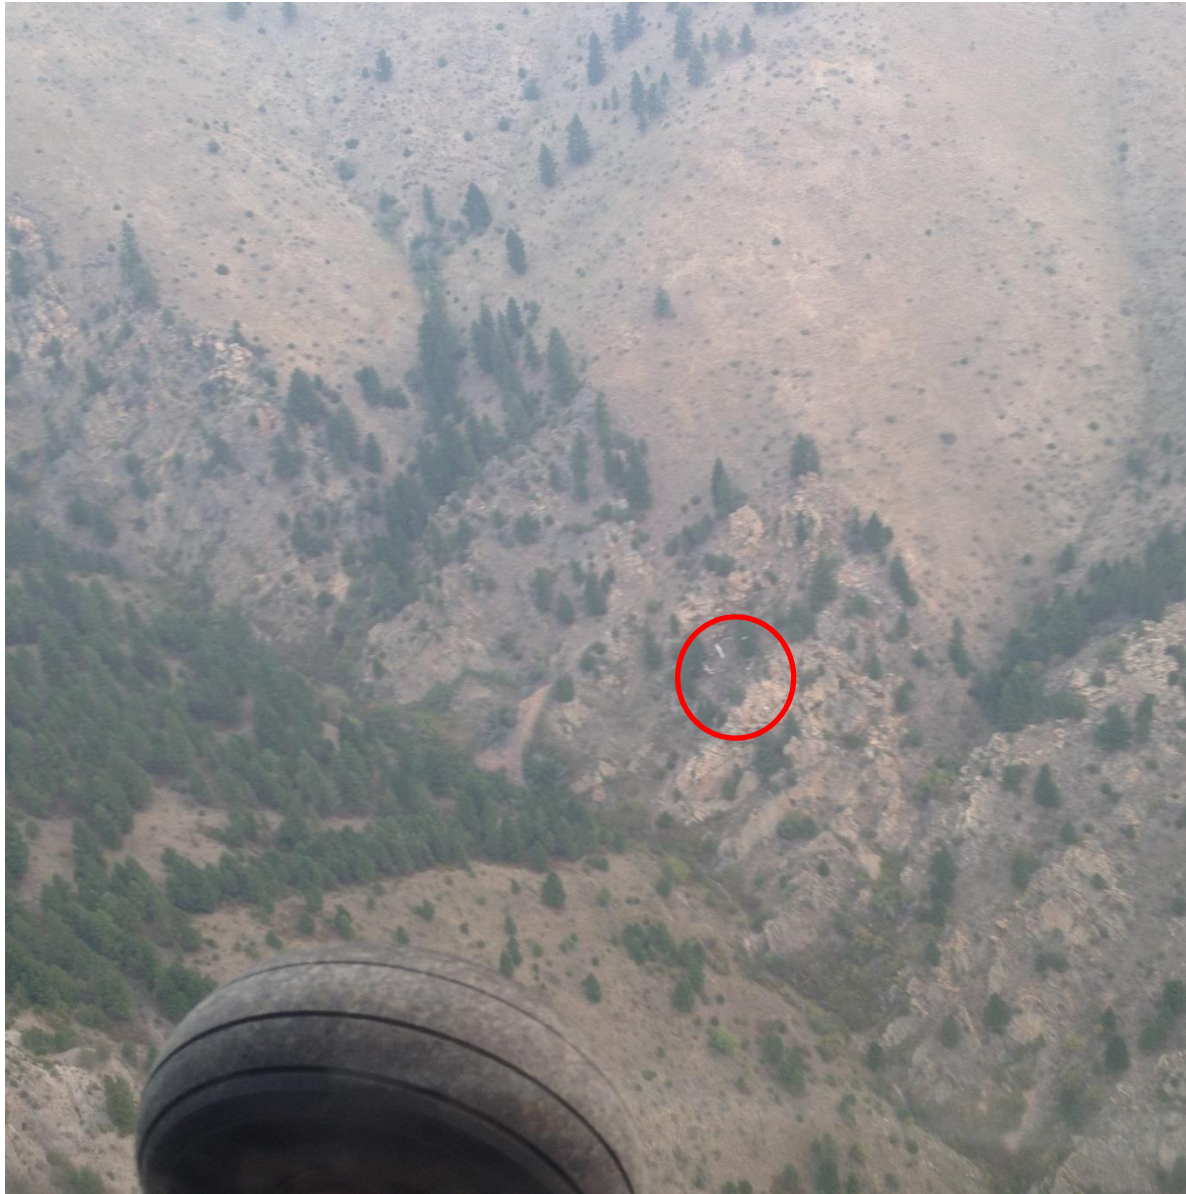
Photograph 1 – Aerial View of Accident Site (Courtesy of Montana Department of Aeronautics)

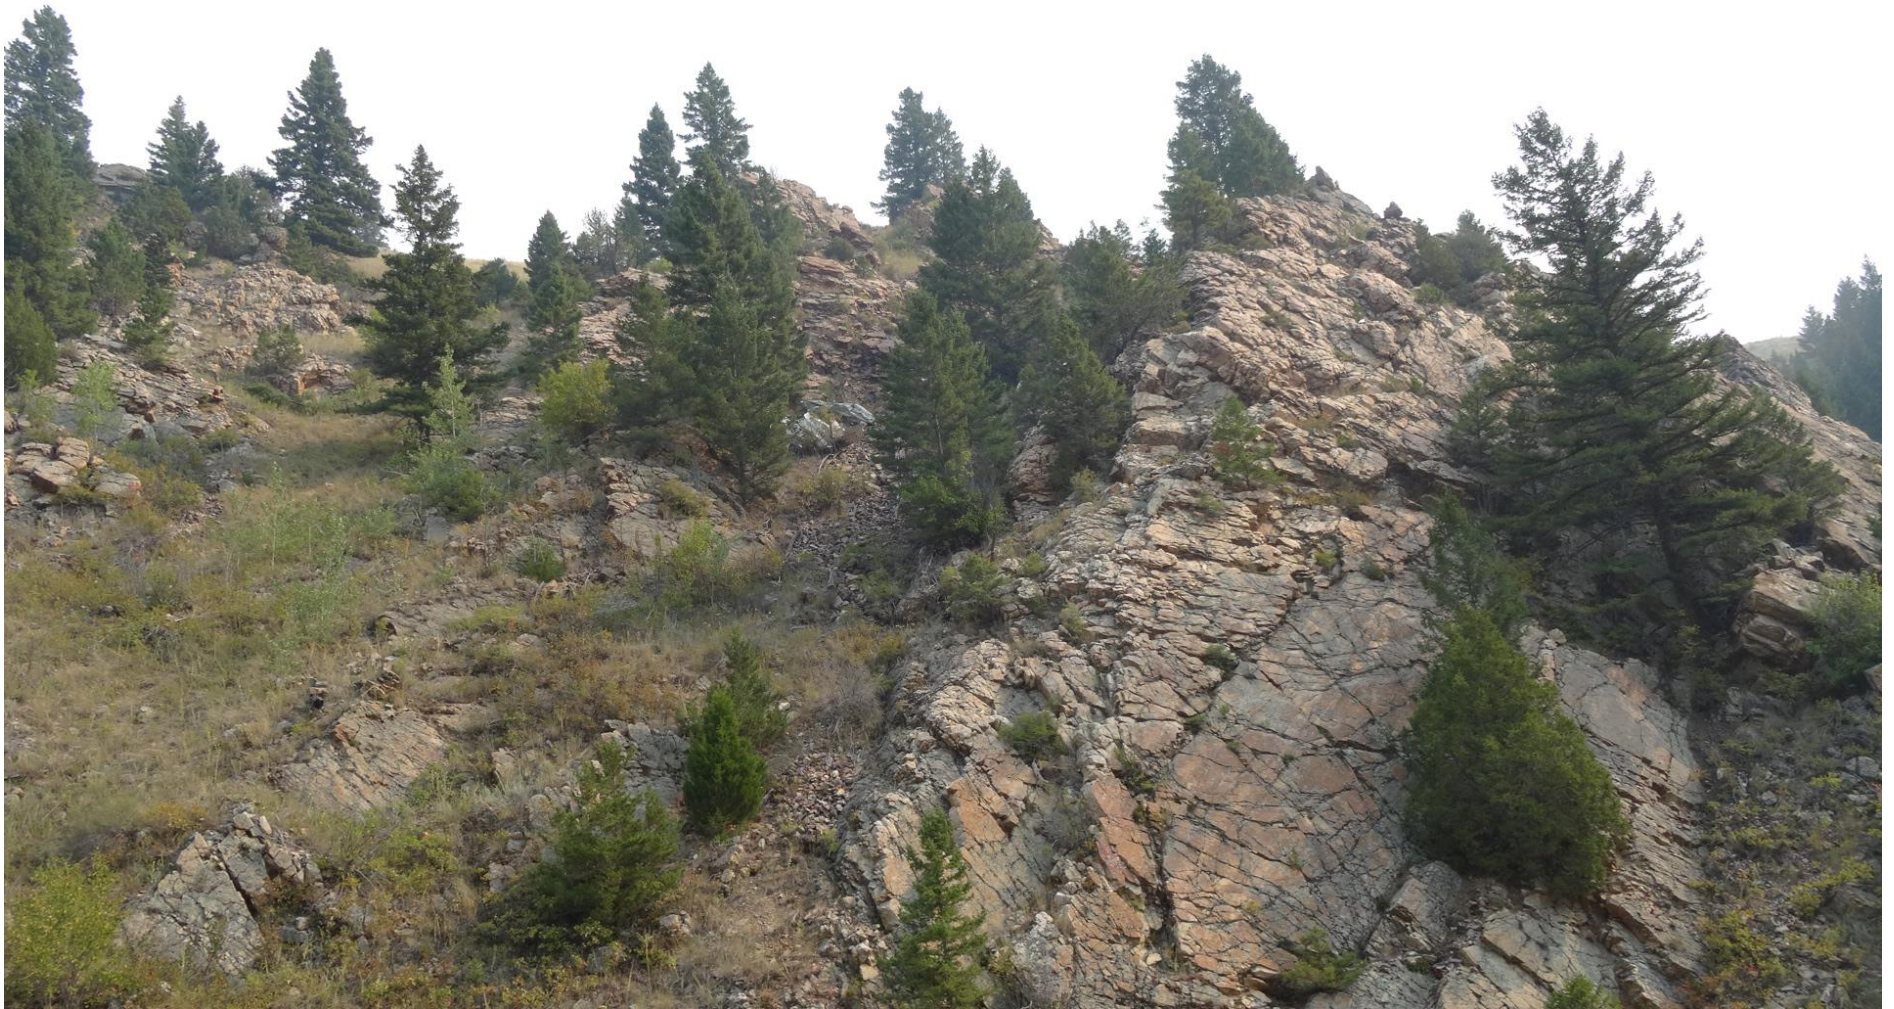
Photograph 2 – View of Accident Site from Canyon

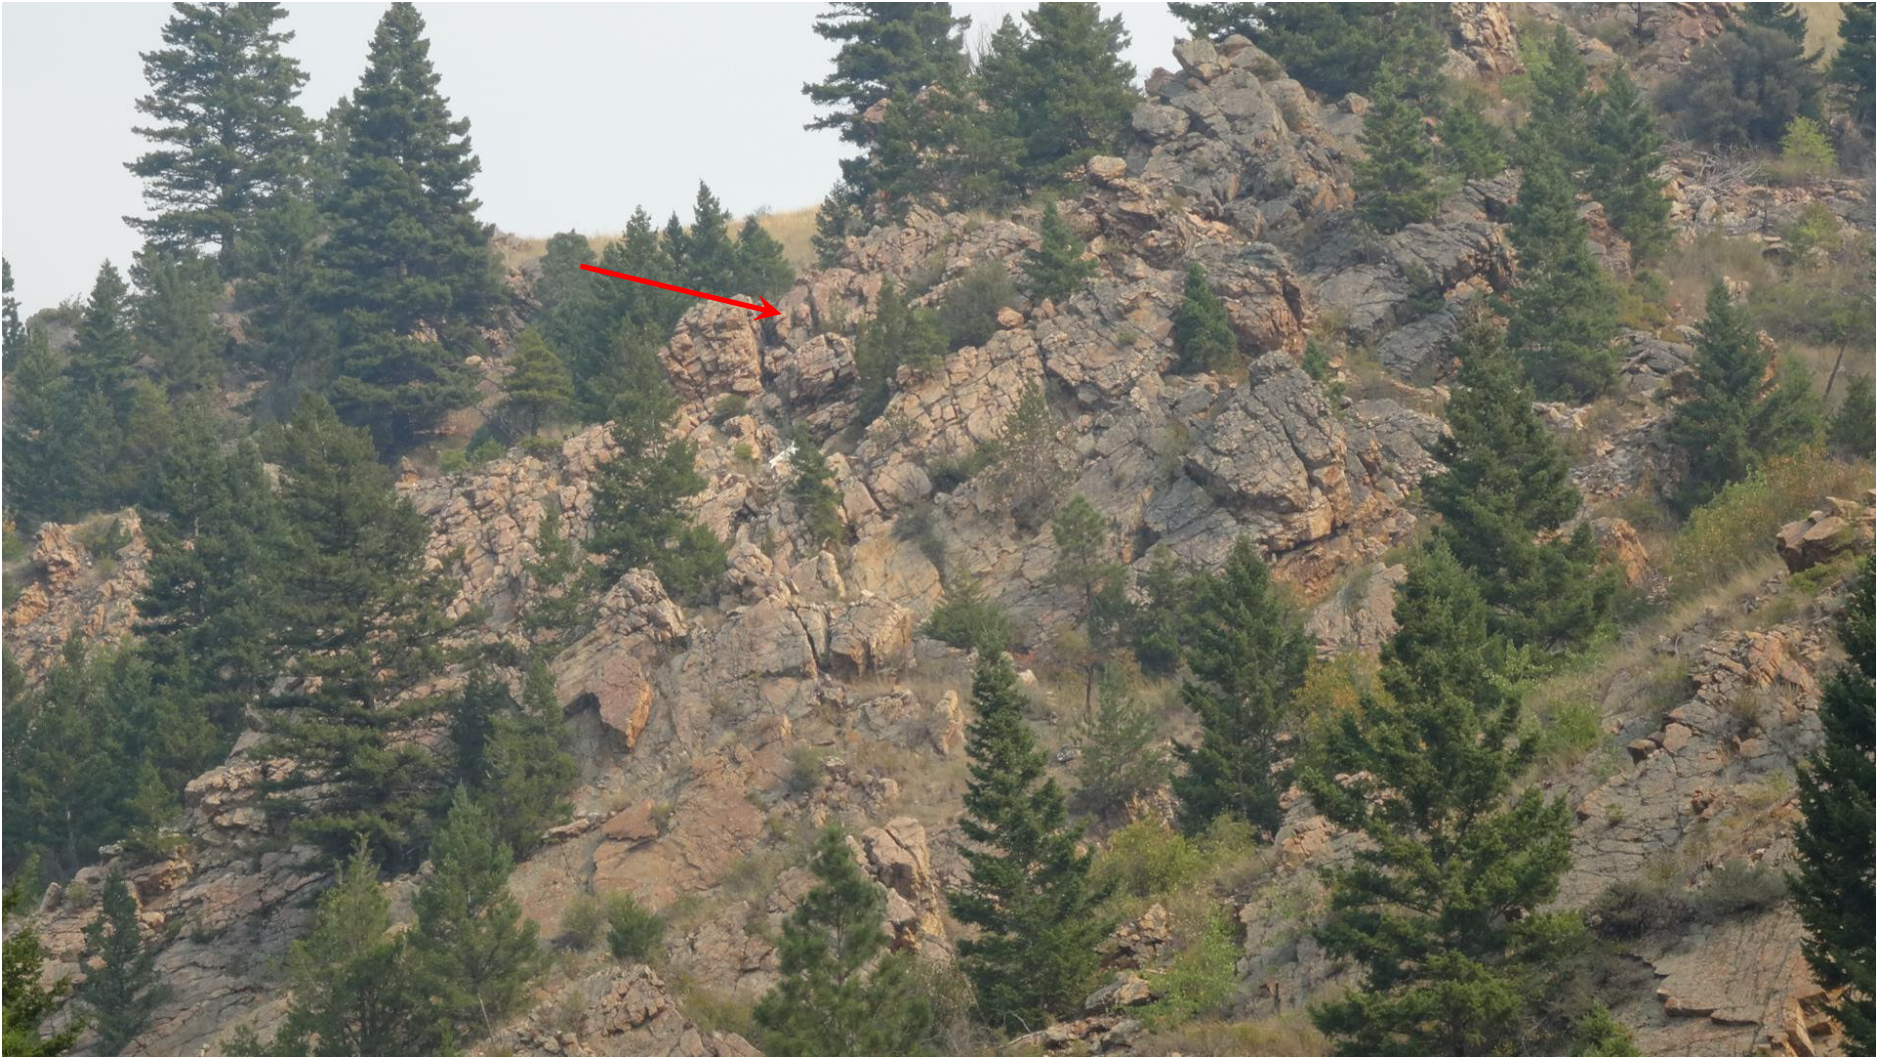
Photograph 3 – View of Initial Impact Point

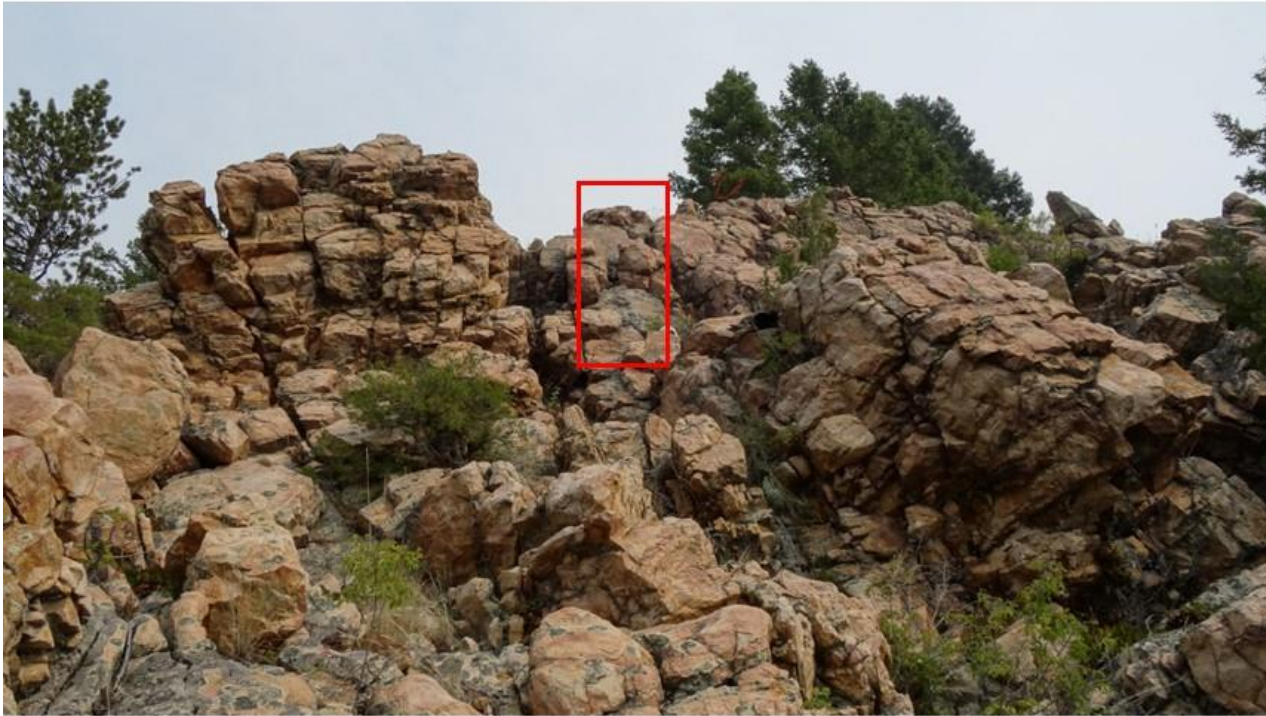
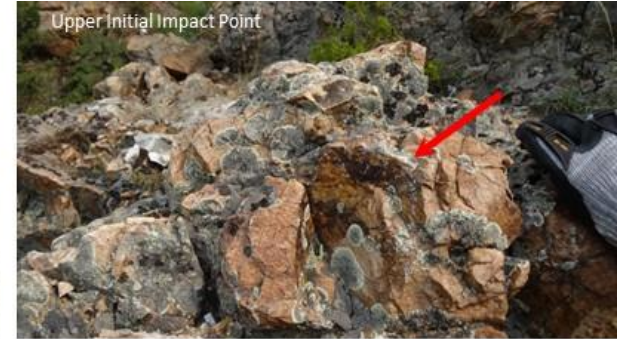
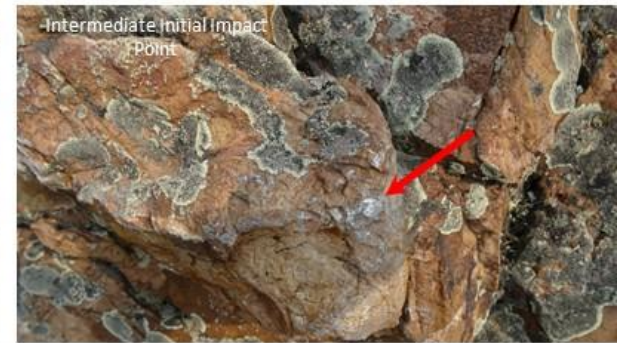
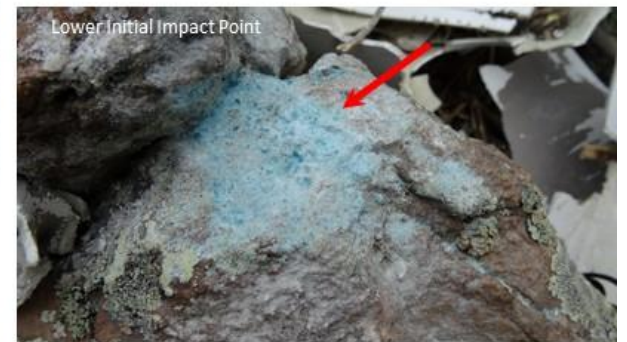
Photograph 4 – Close-up View of Initial Impact Point

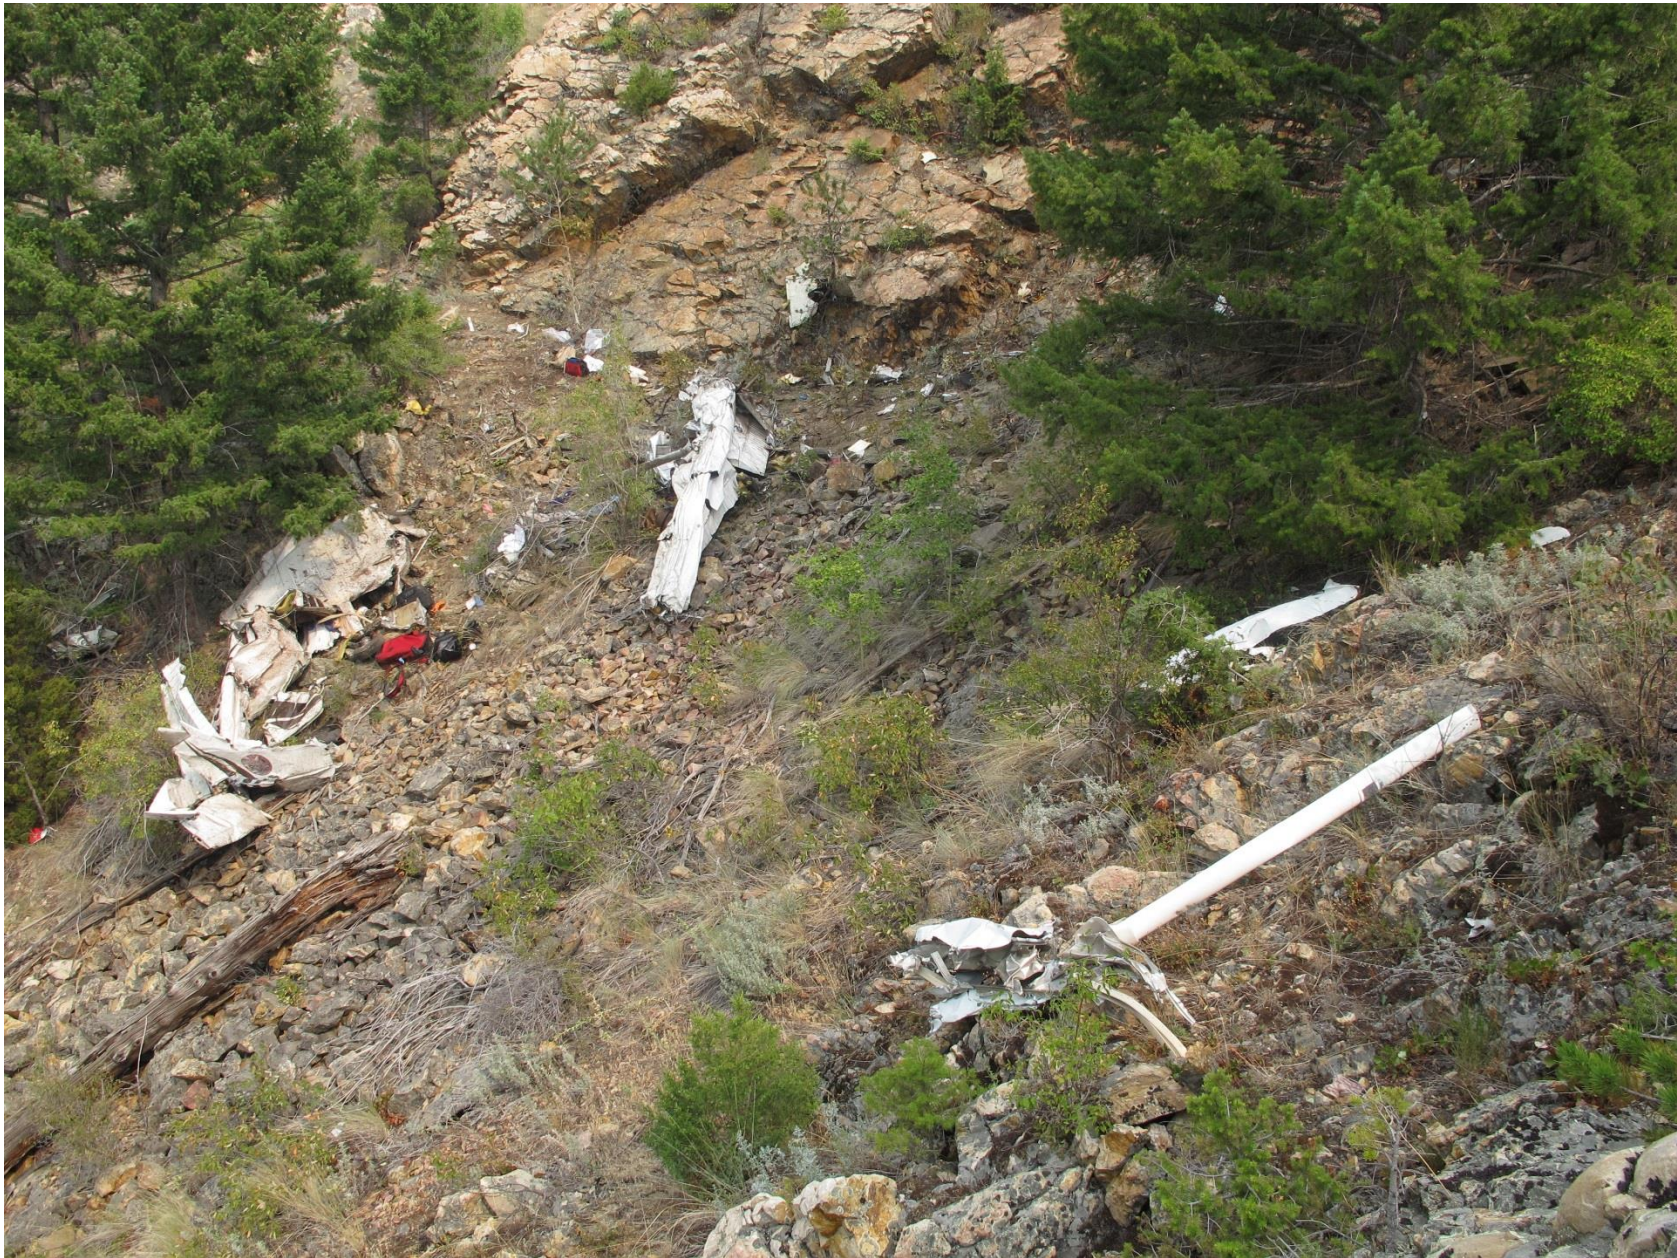
Photograph 5 – View of Main Wreckage and Left Wing from Upper Initial Impact Point (Courtesy of Textron Aviation)

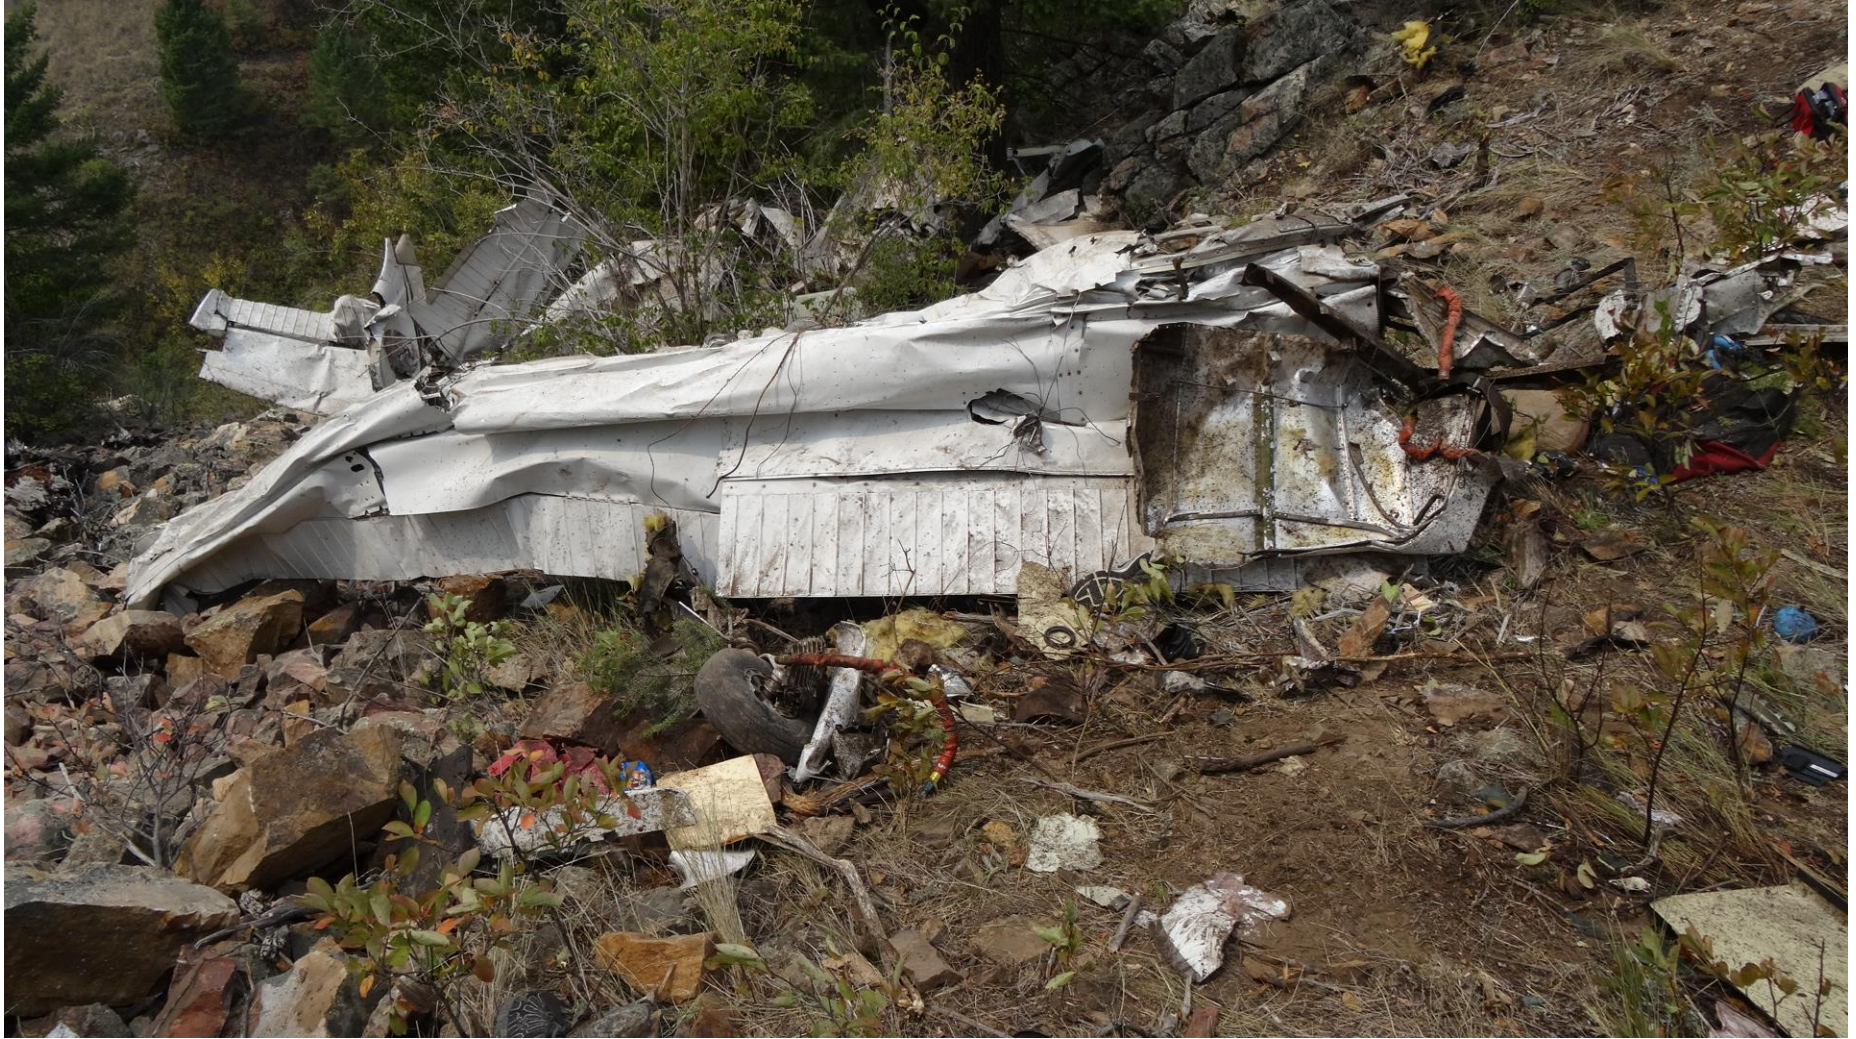
Photograph 6 – View of the Left Wing

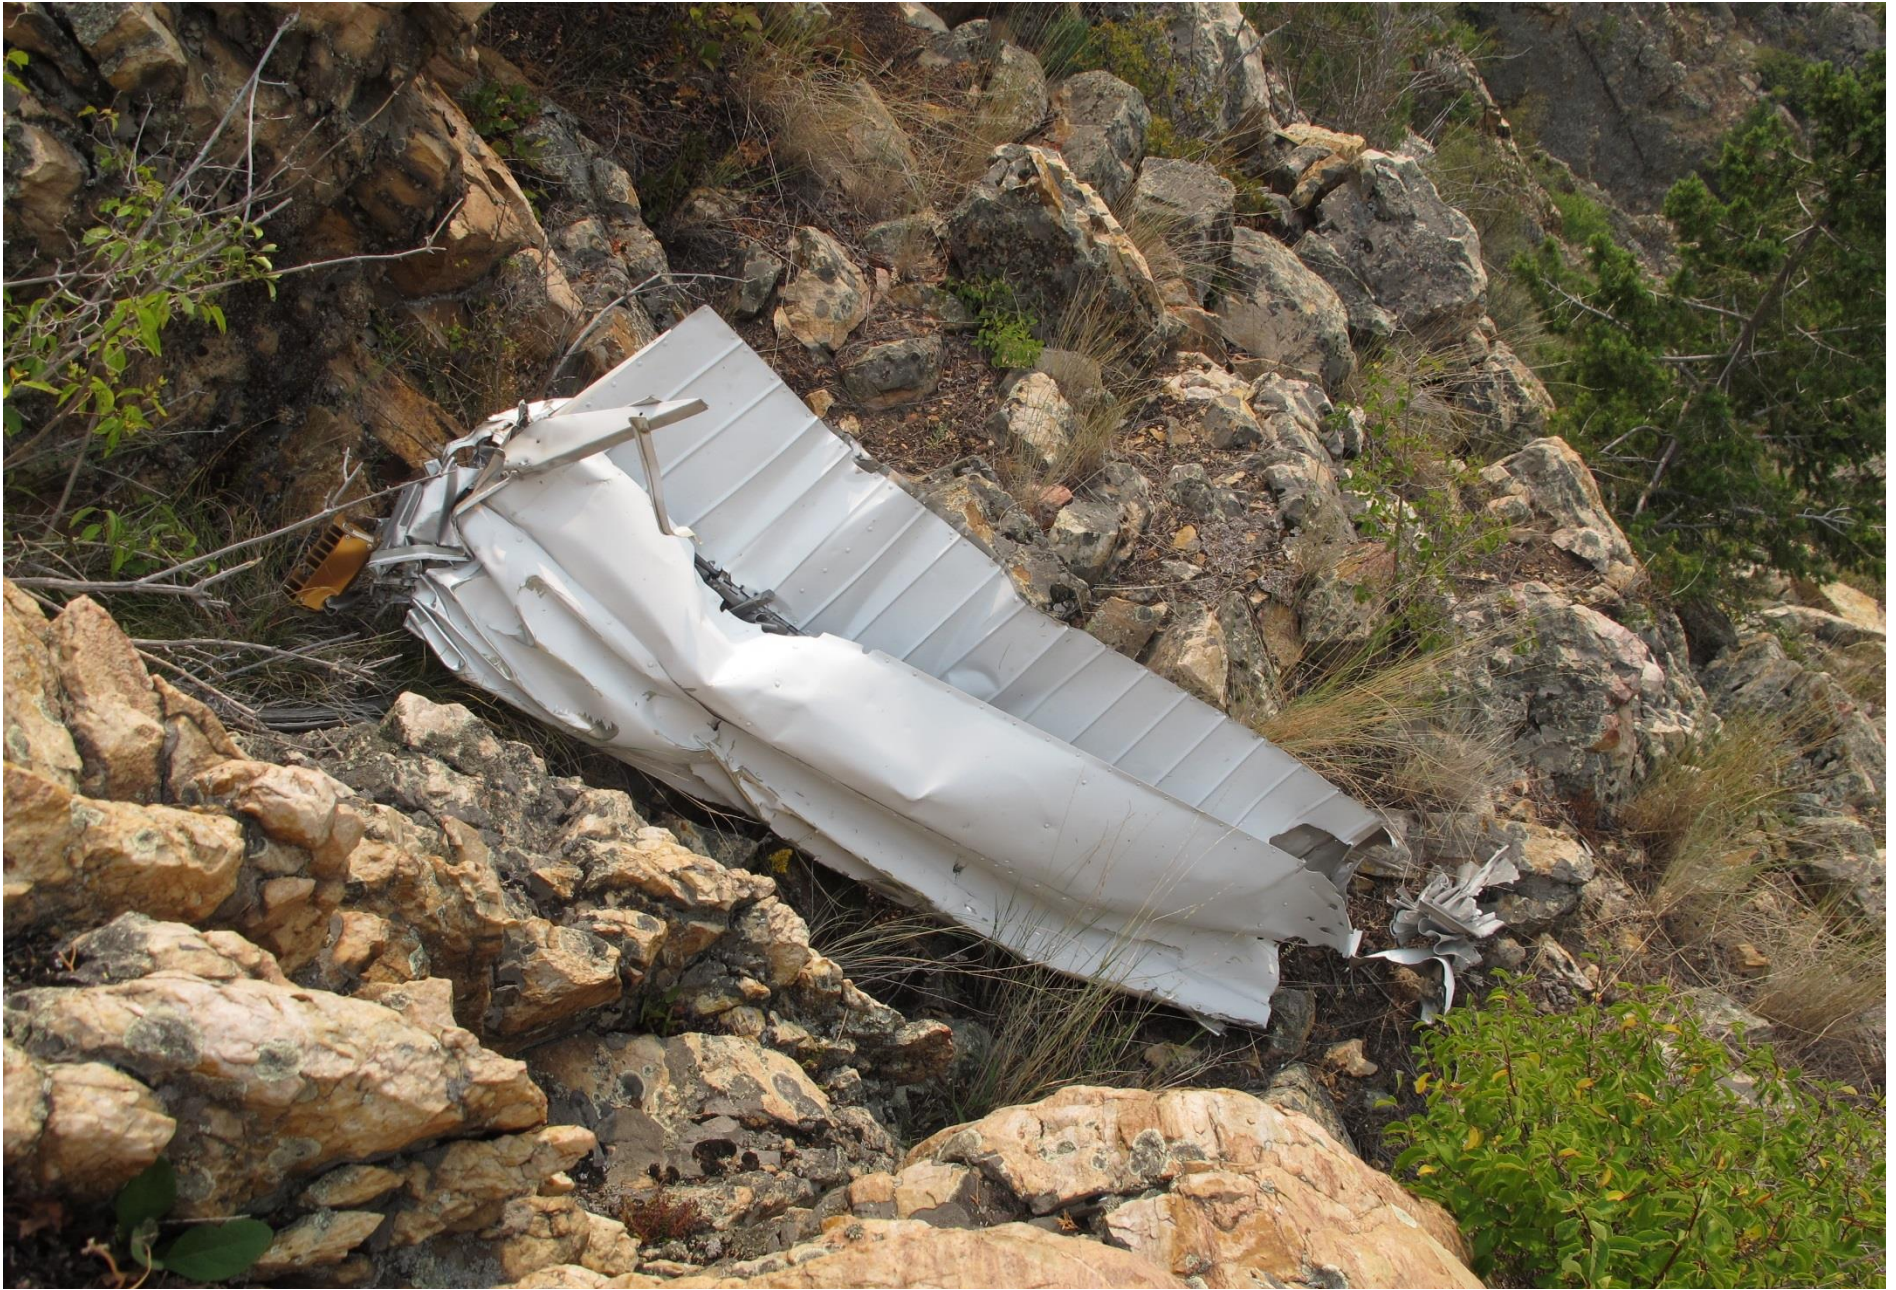
Photograph 7 – View of Right Wing (Courtesy of Textron Aviation)

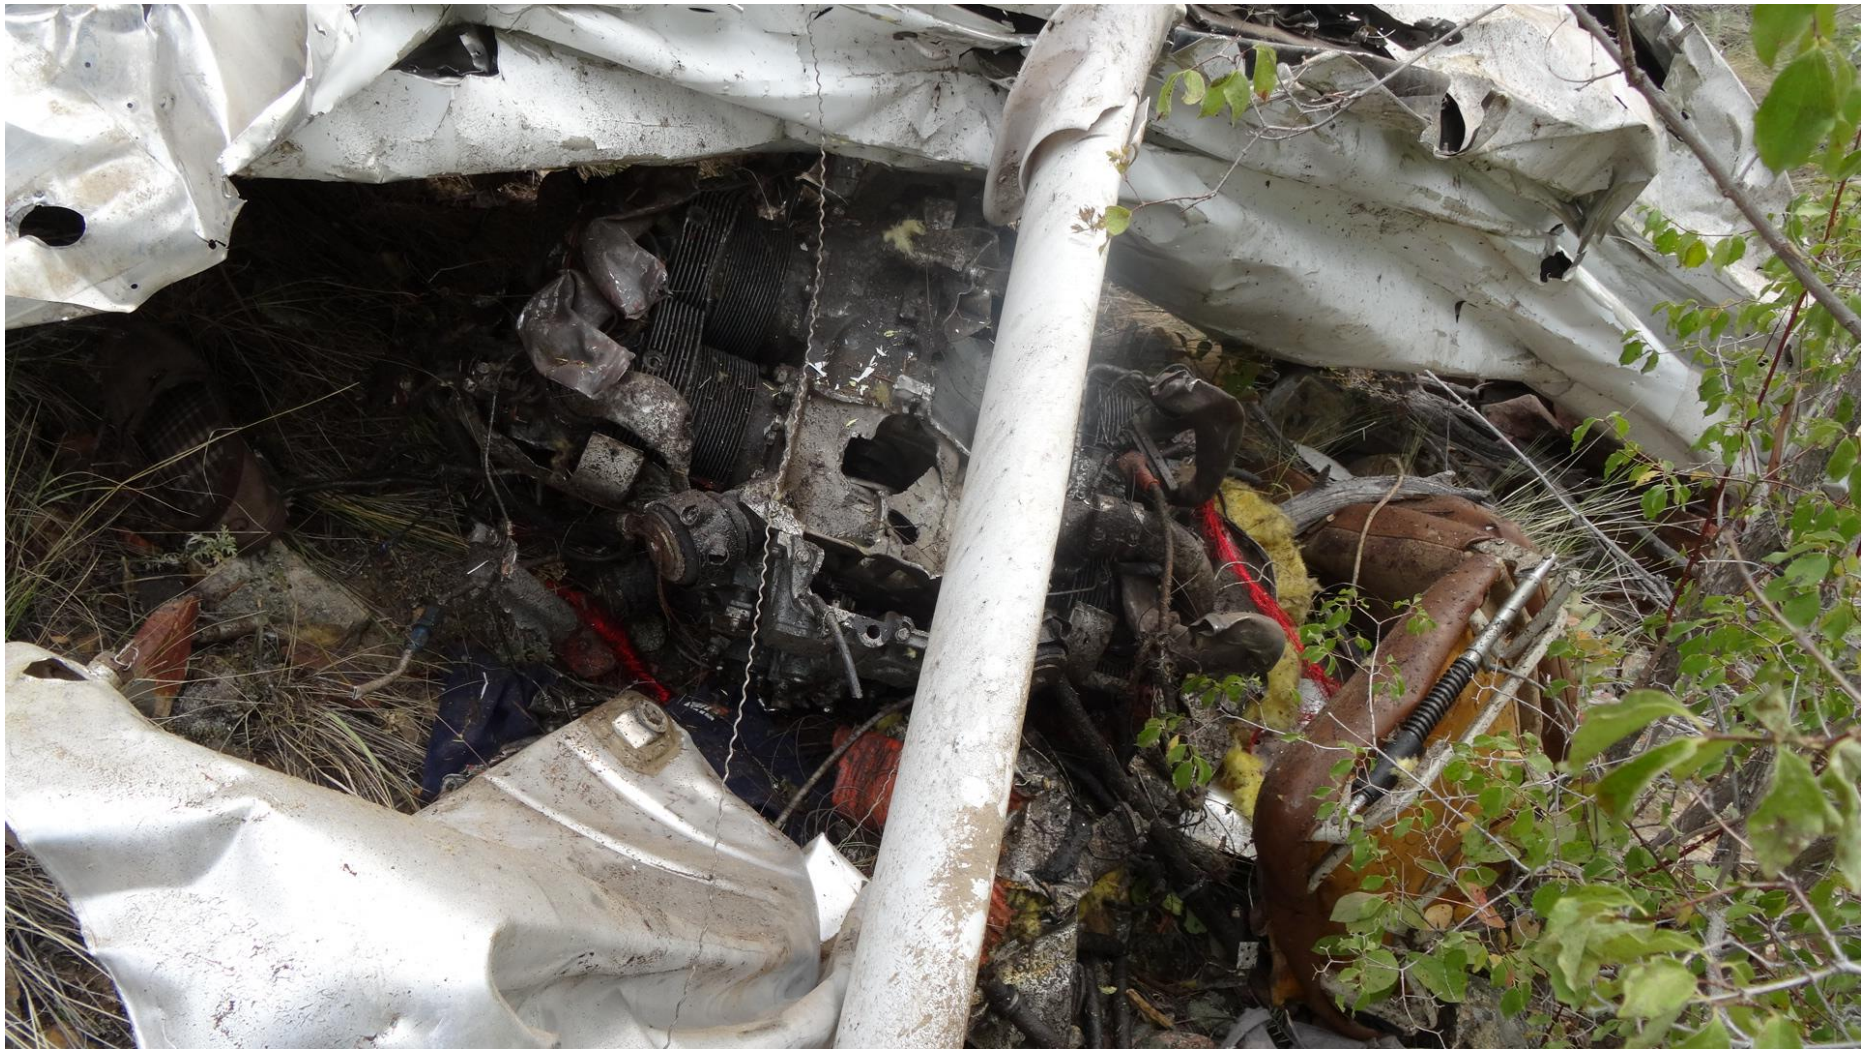
Photo 8 – View of Engine at Accident Site

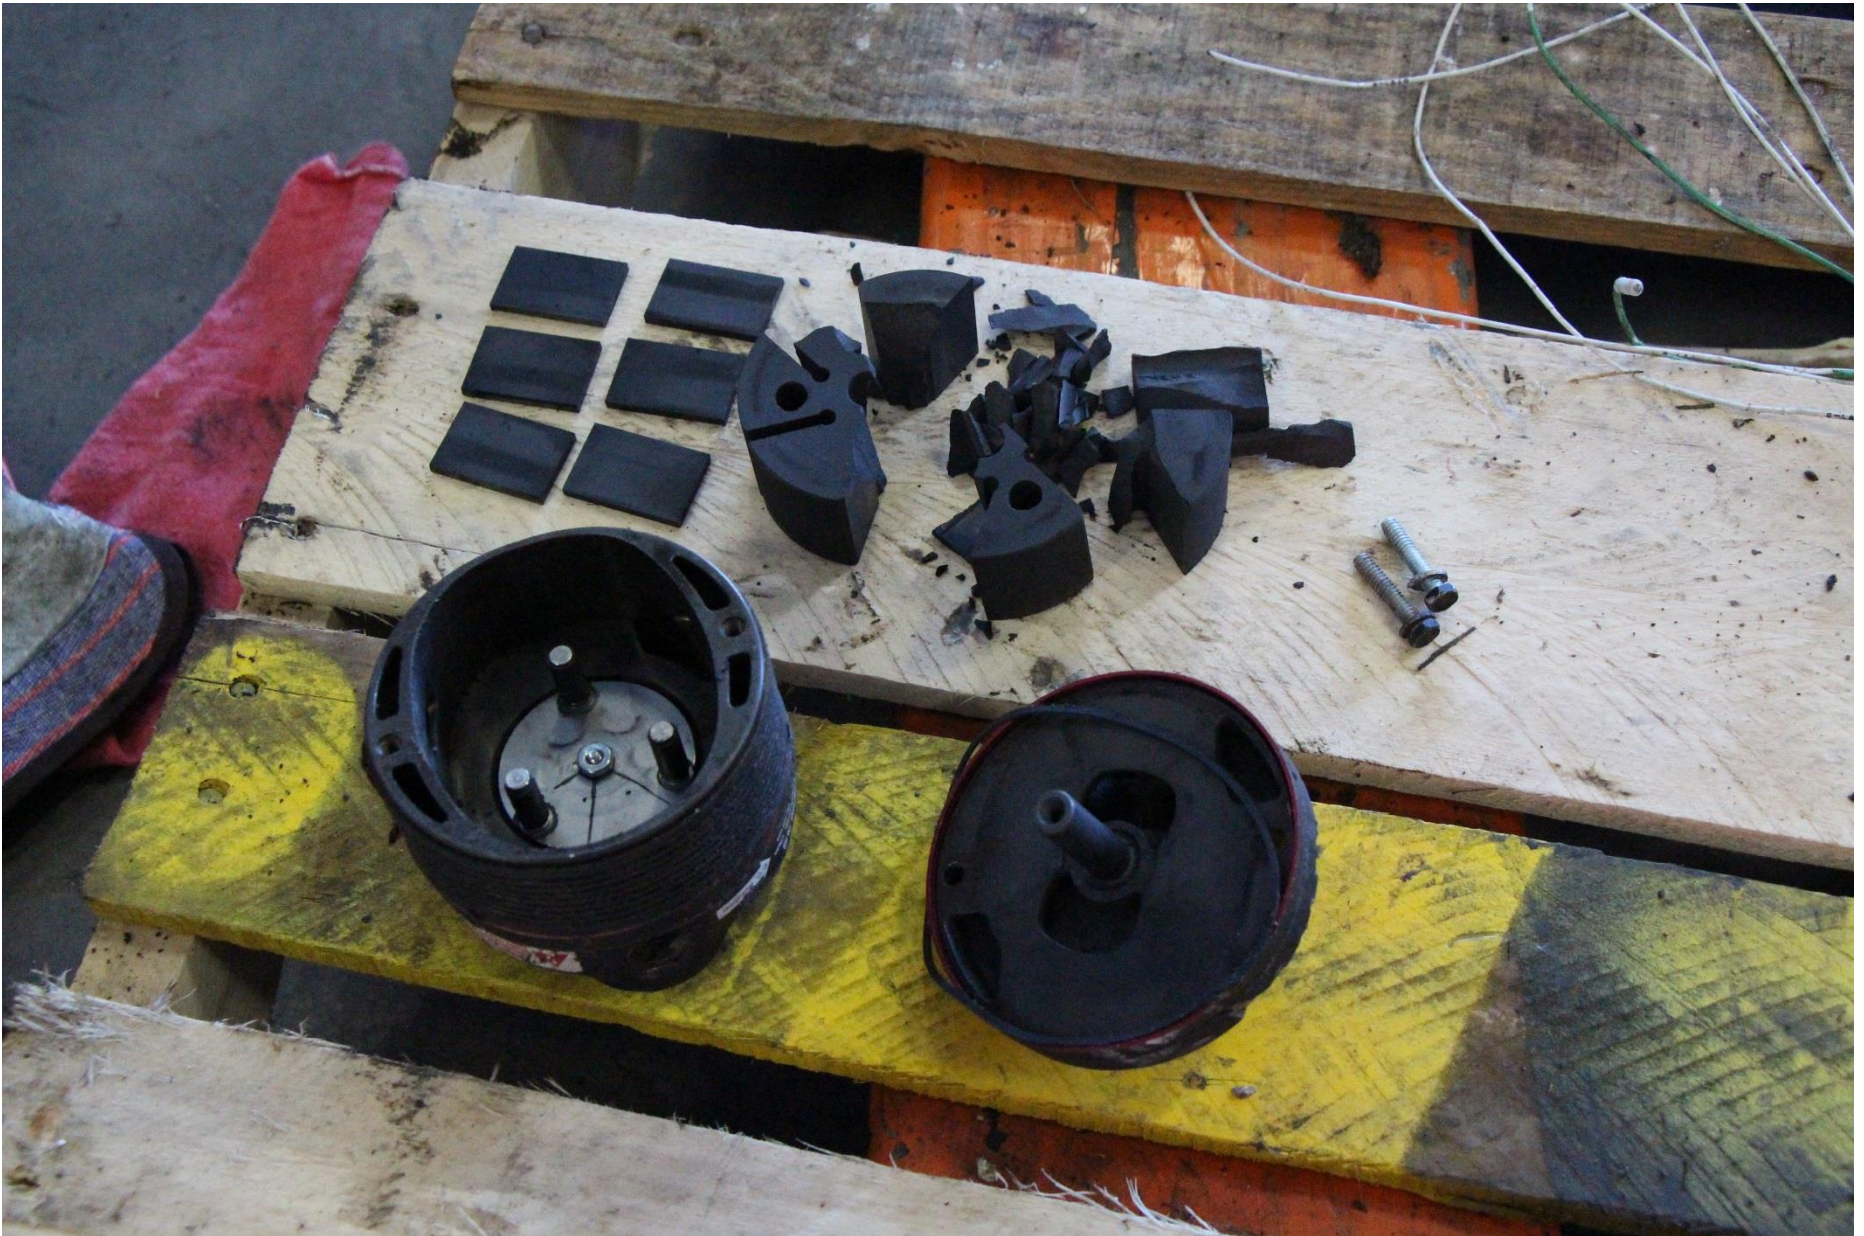
Photo 9 – View of Disassembled Vacuum Pump

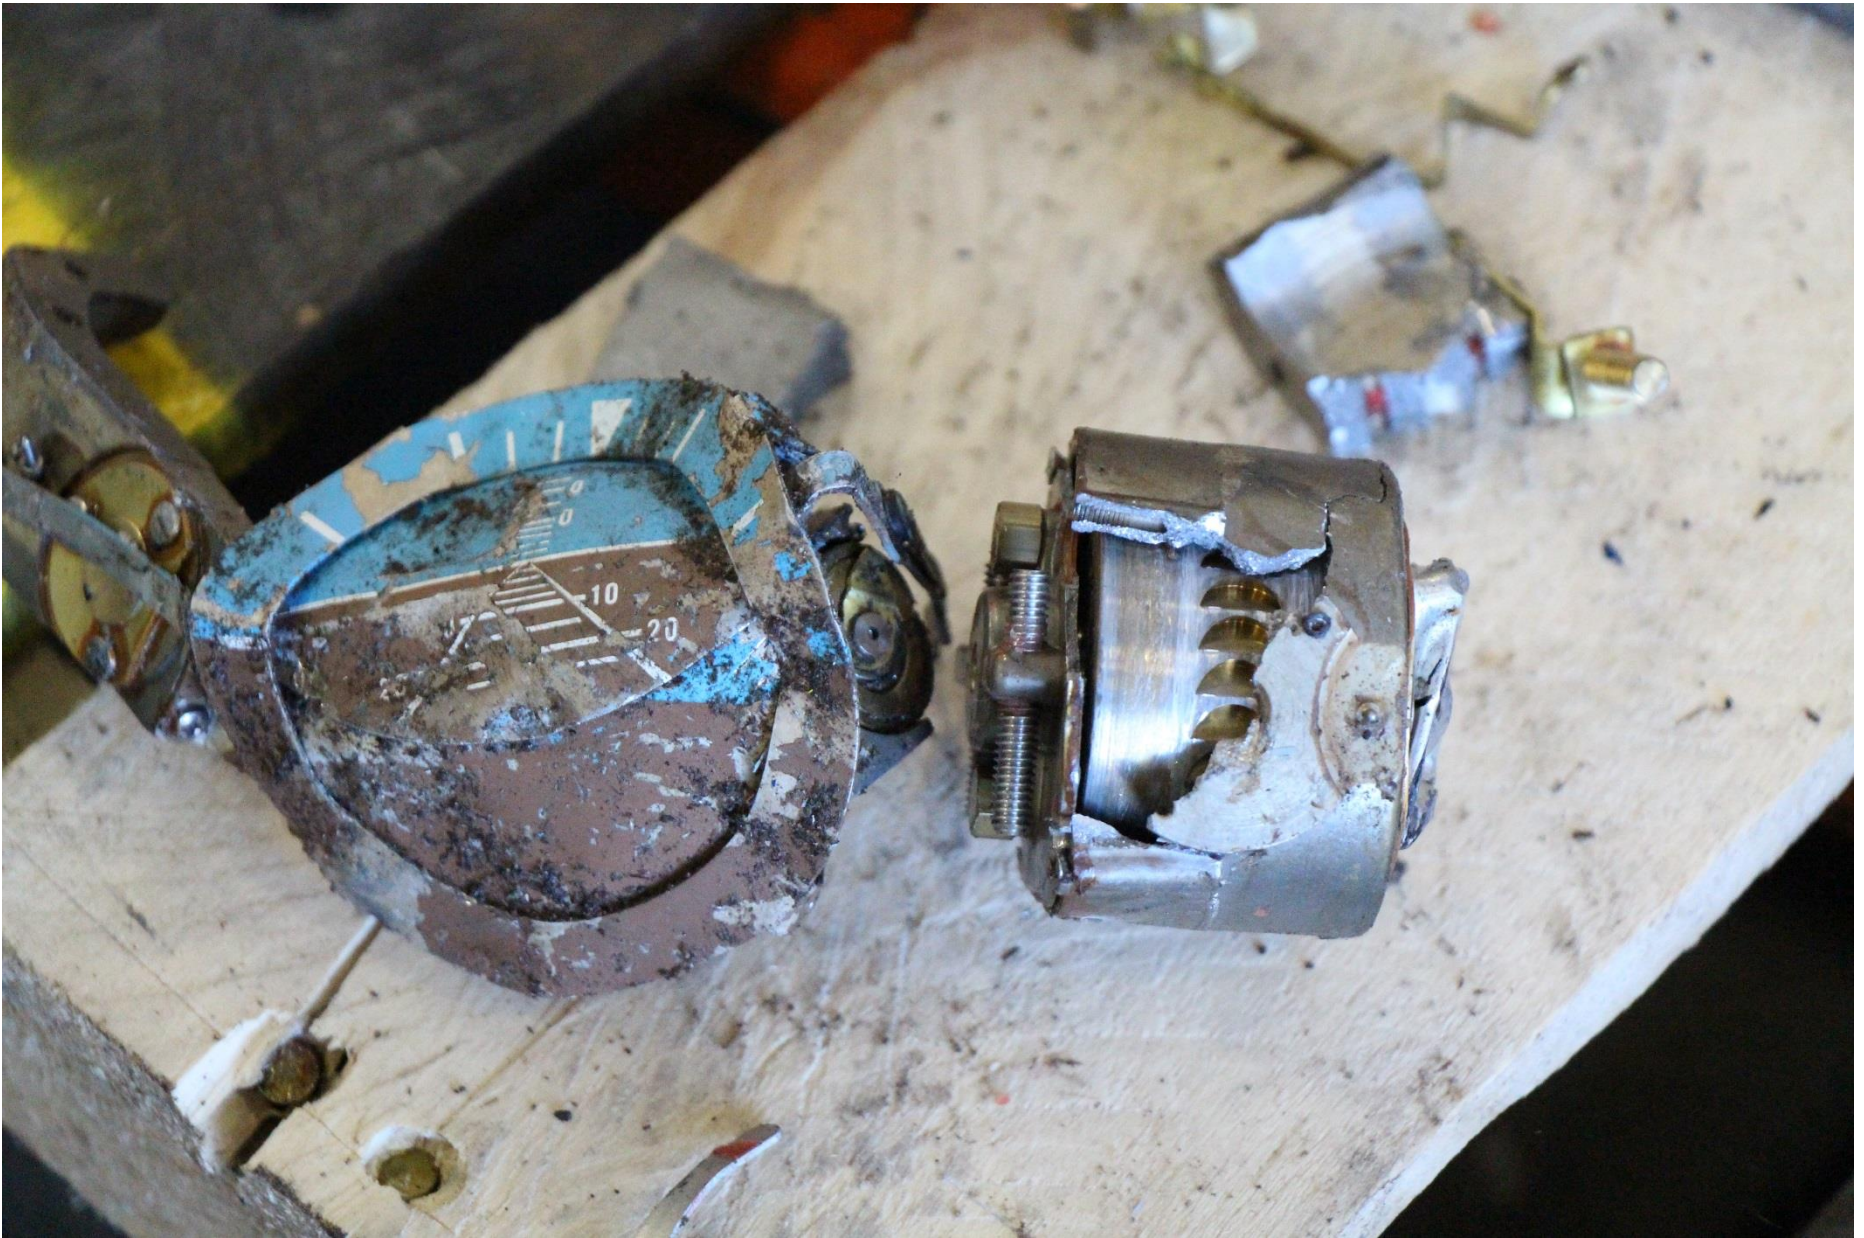
Photo 10 – View of Attitude Indicator
