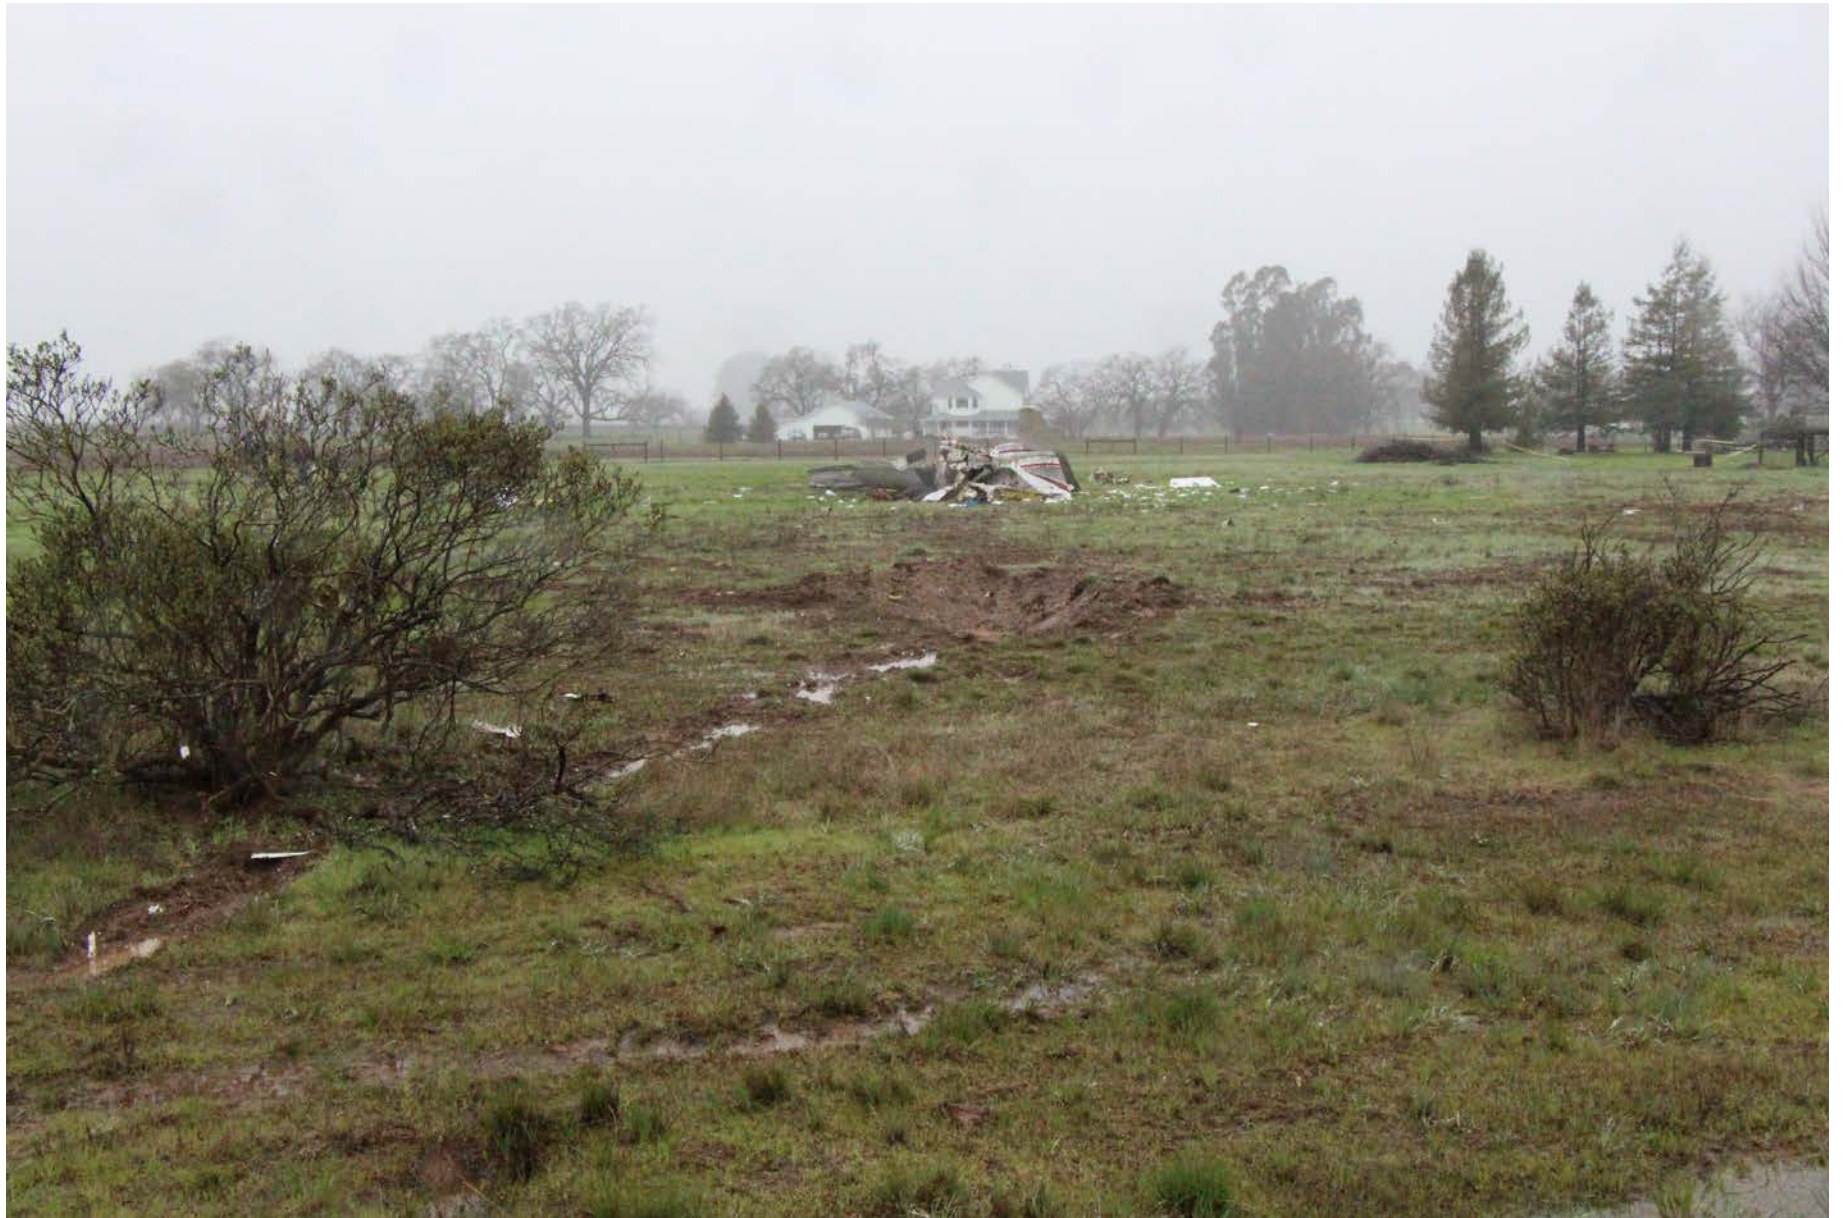
Photo 1 – View of Accident Site from Initial Impact Point

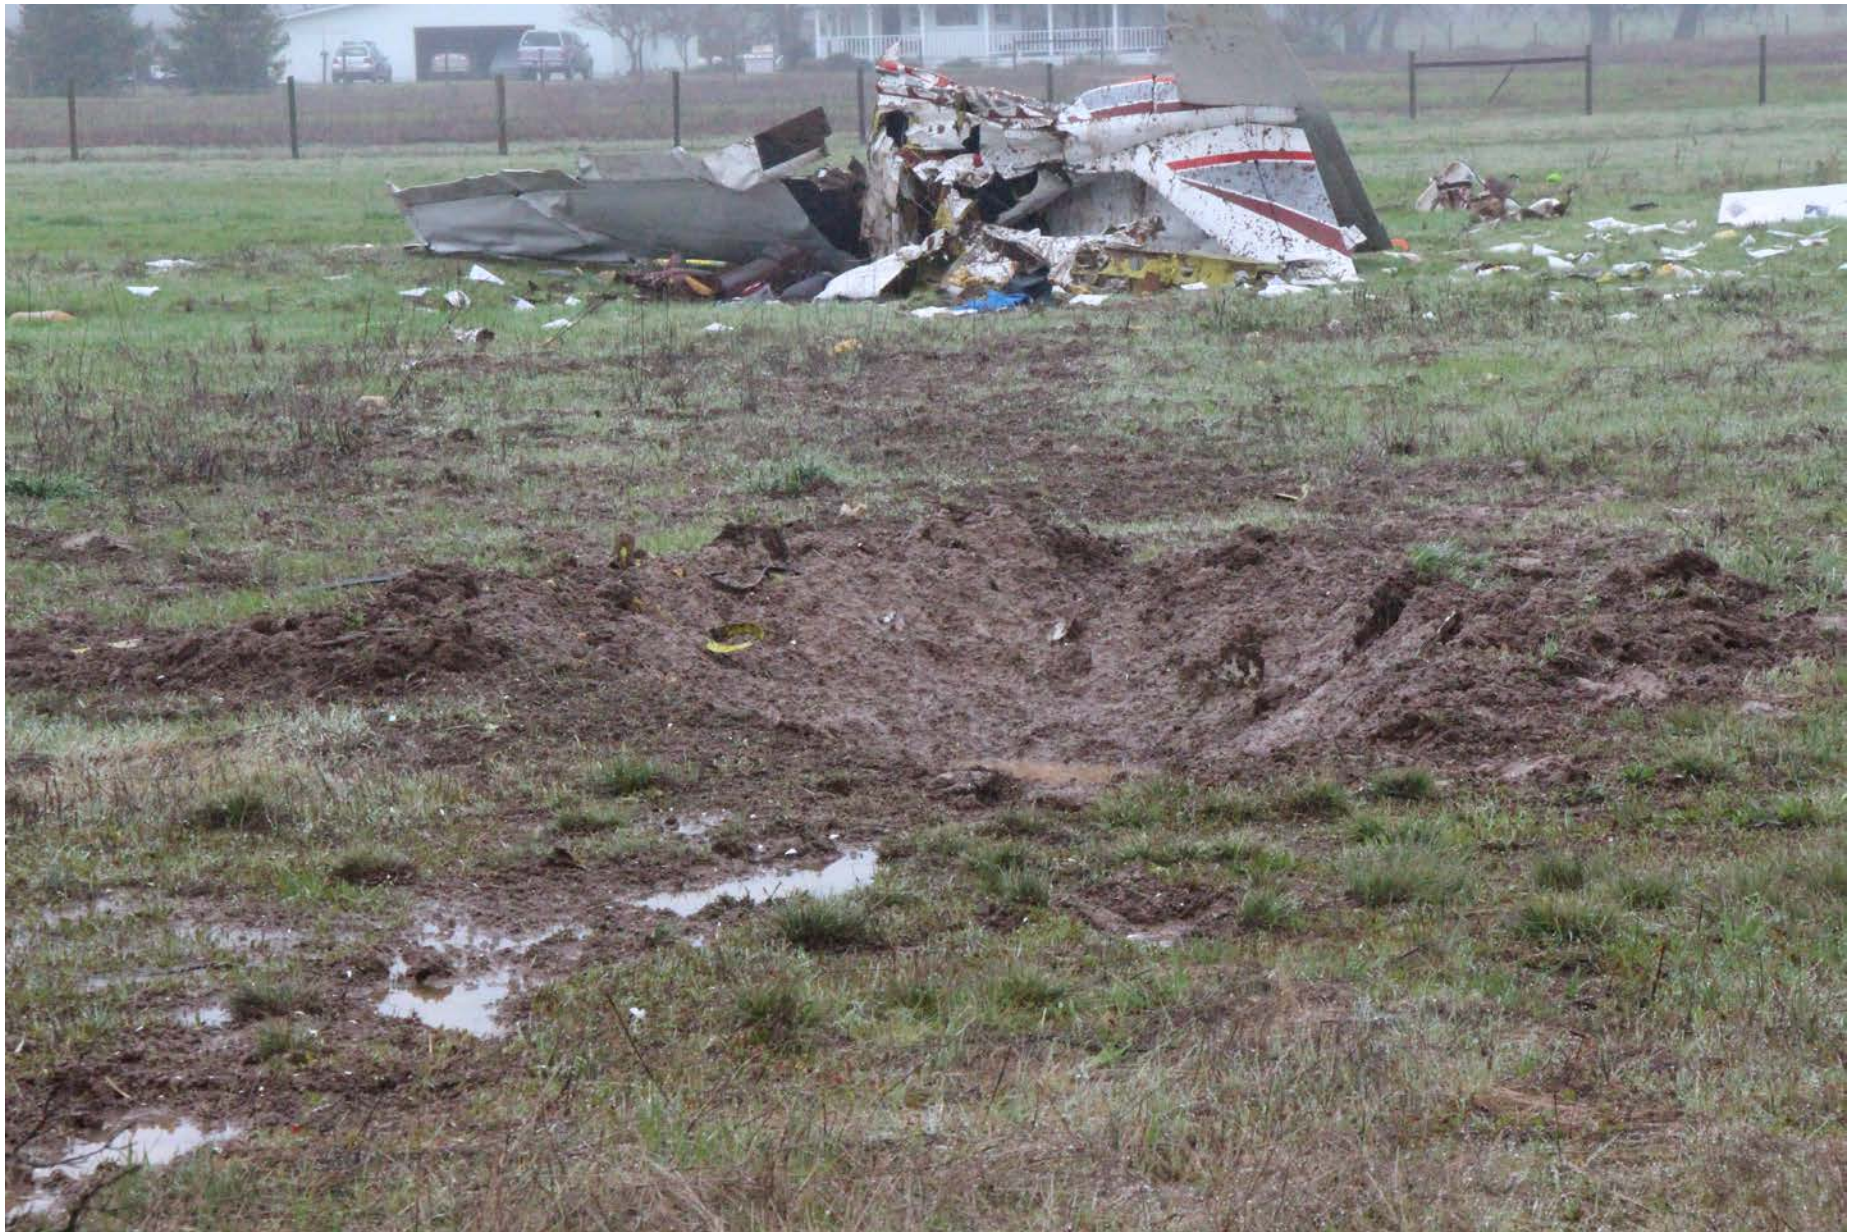
Photo 2 – View of Intermediate Ground Scar at Accident Site

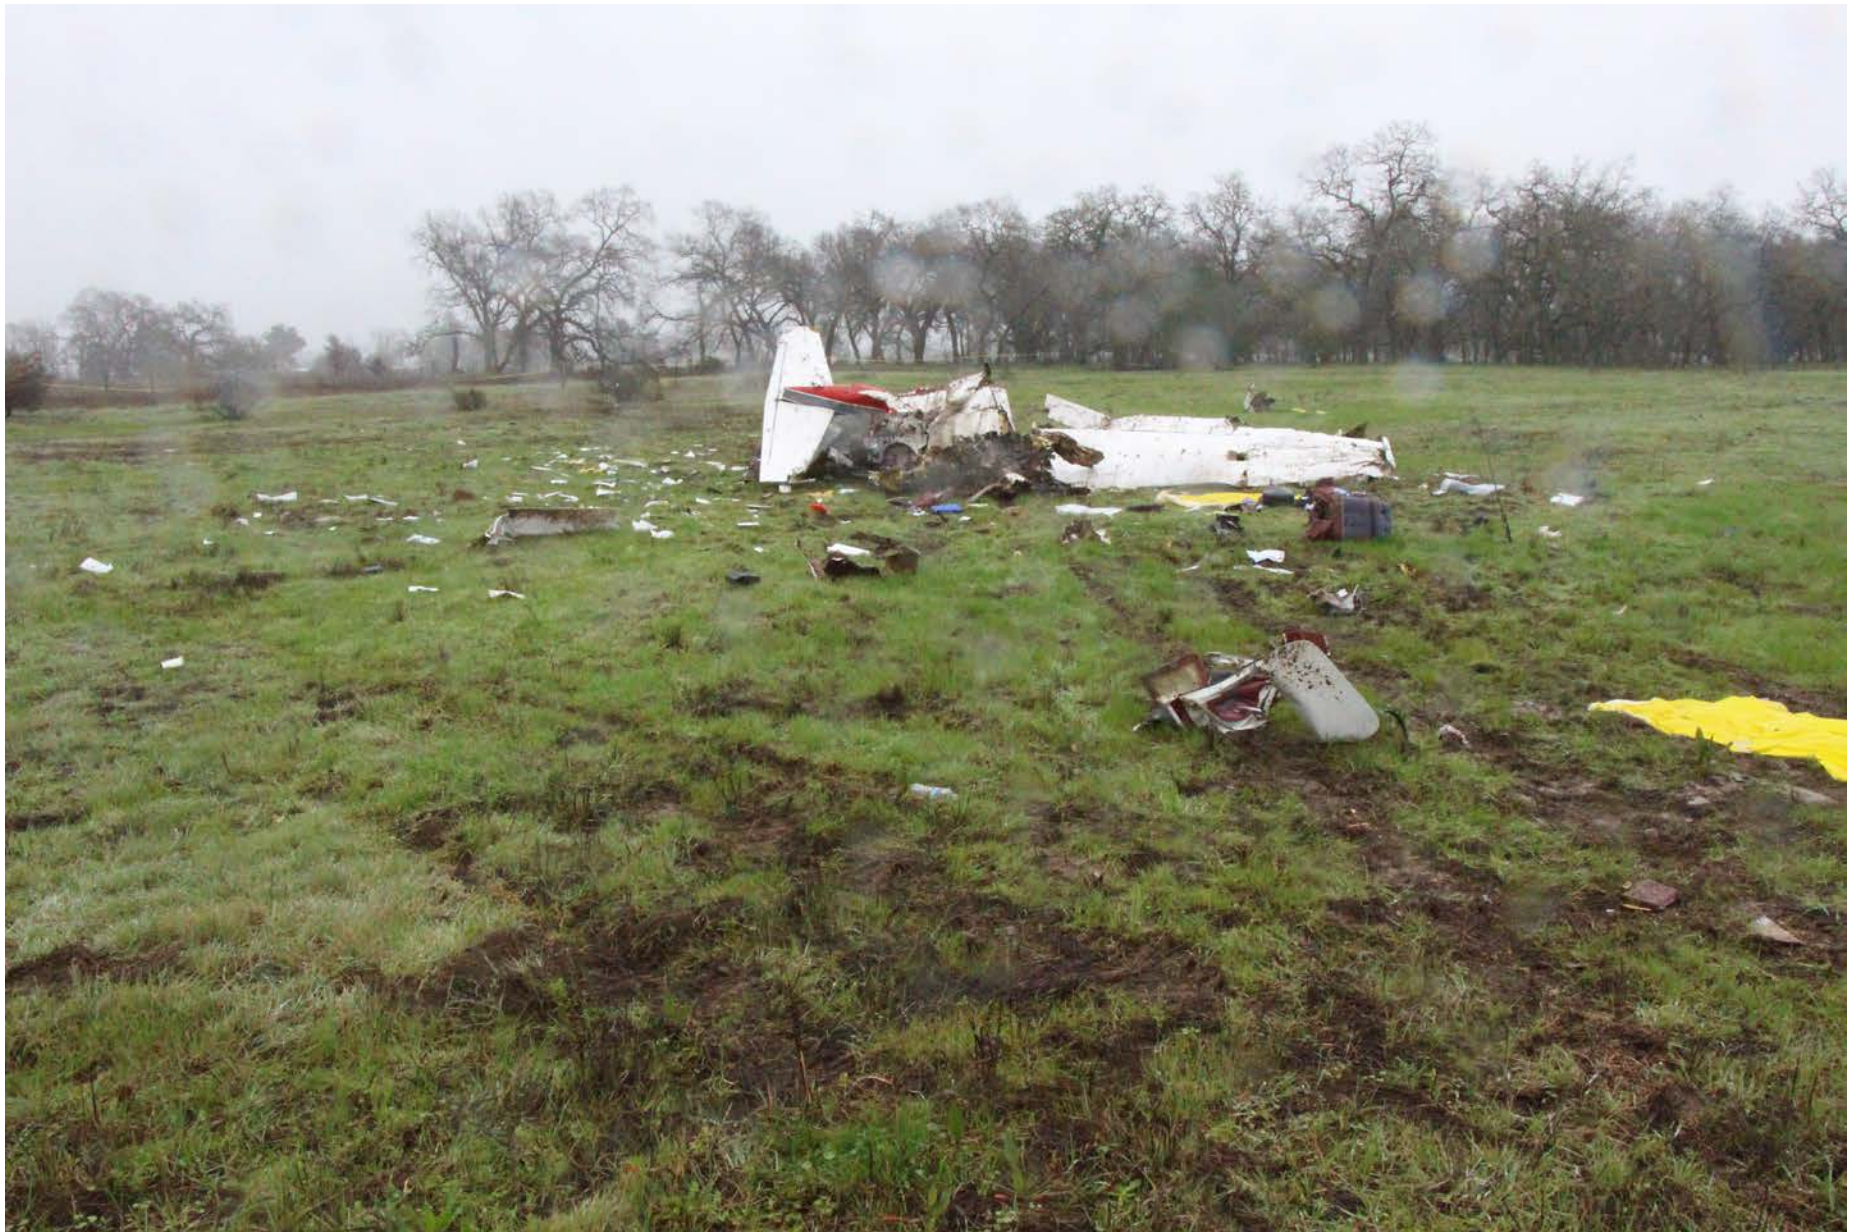
Photo 3 – View of Main Wreckage from the East

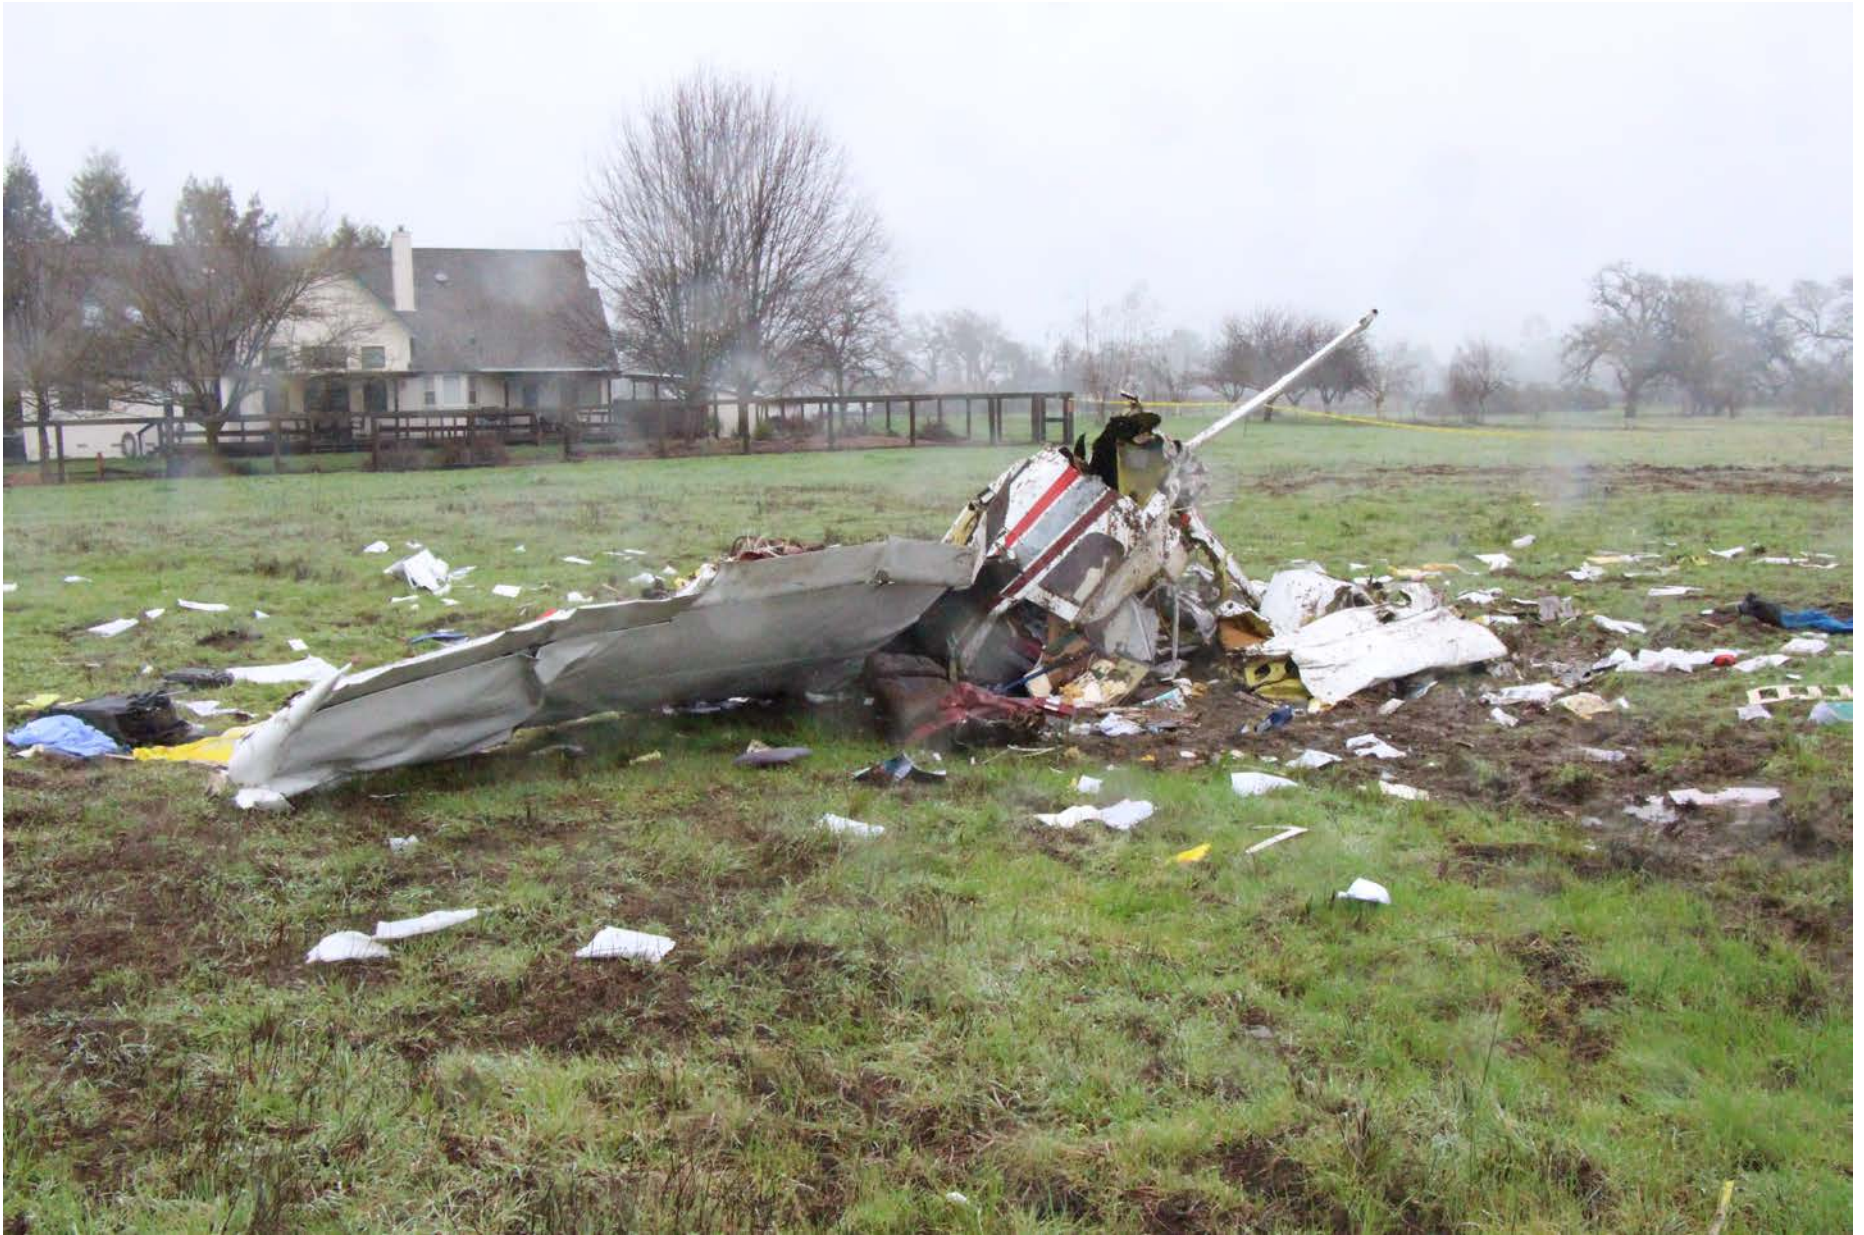
Photo 4 – View of Main Wreckage from the West

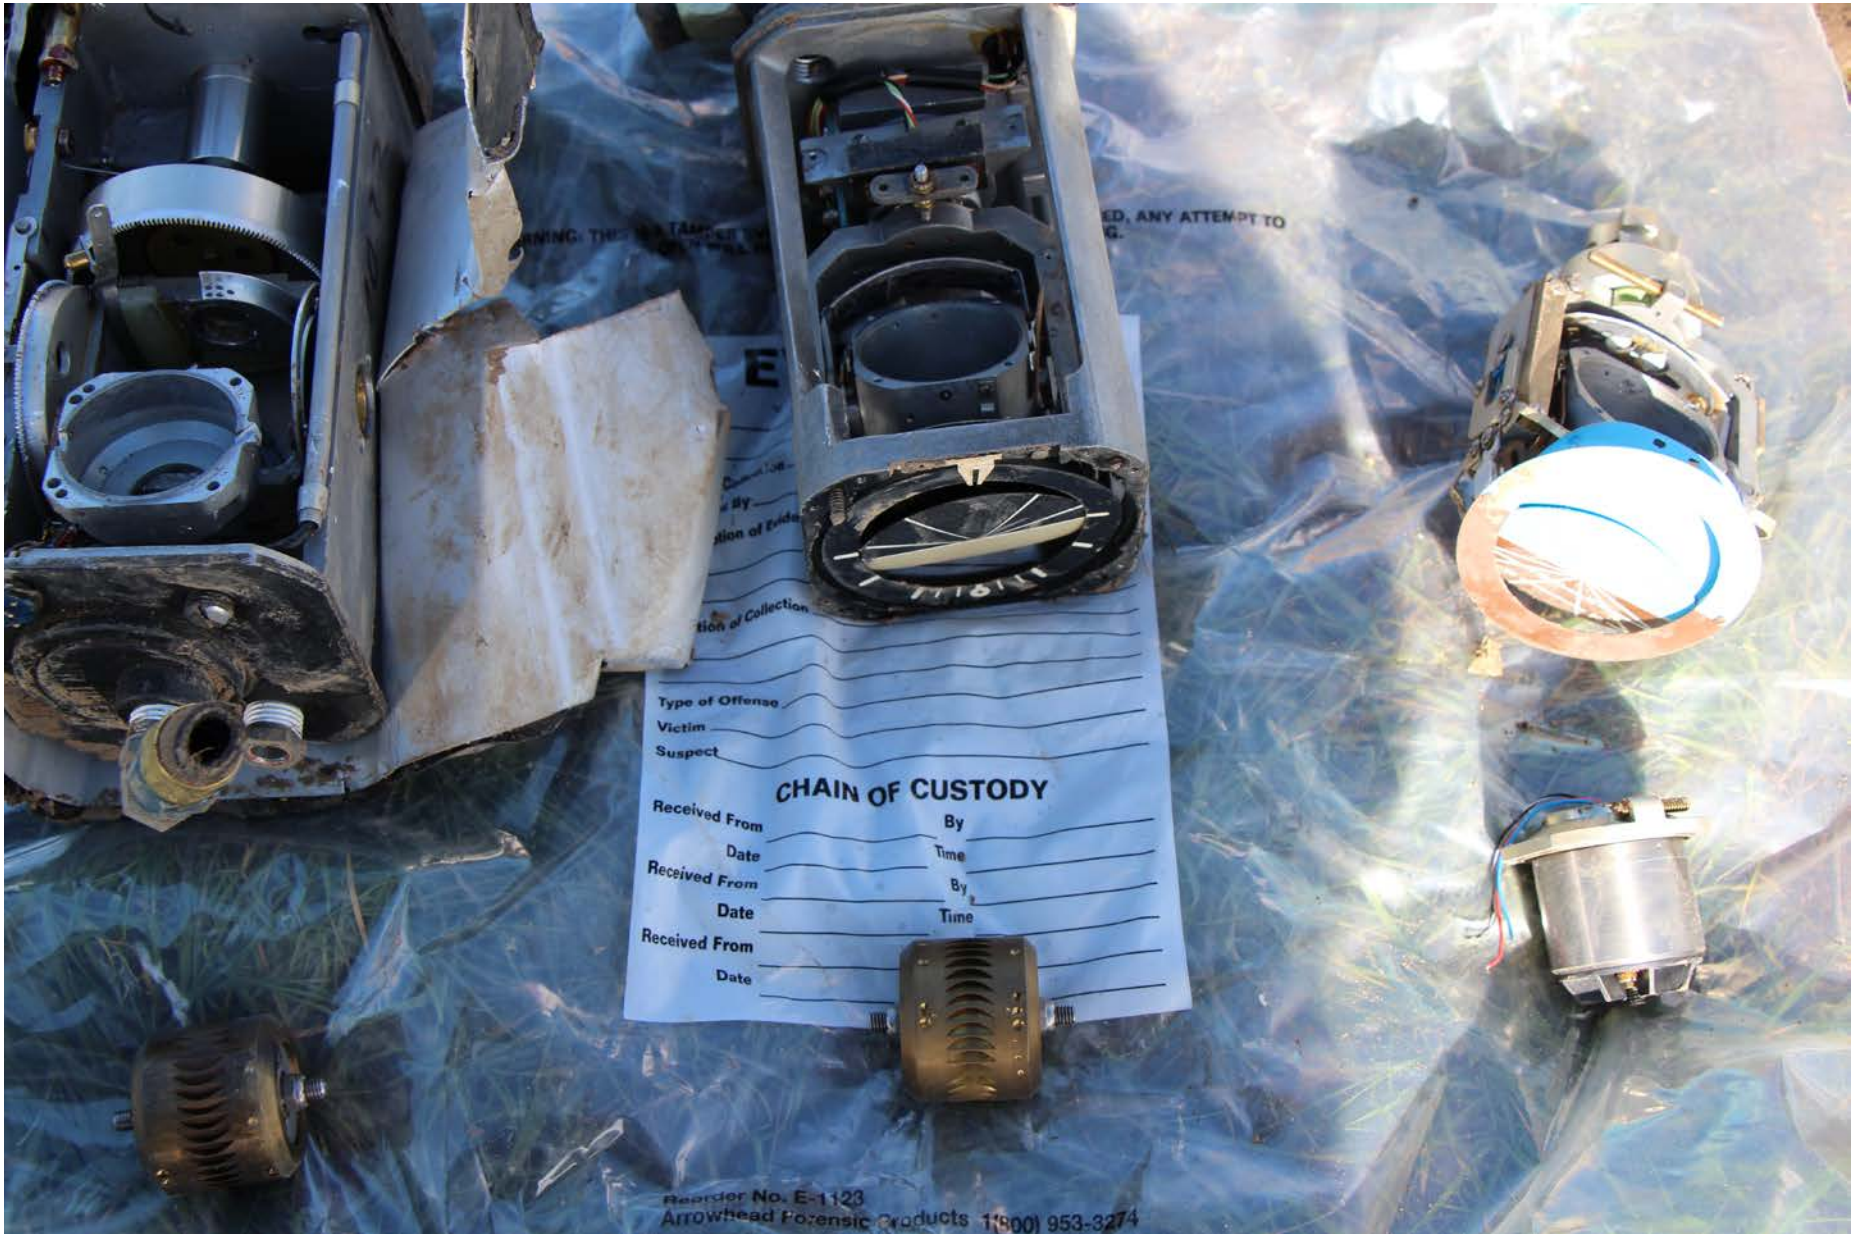
Photo 5 –Vacuum Driven Instruments Recovered from Accident Site

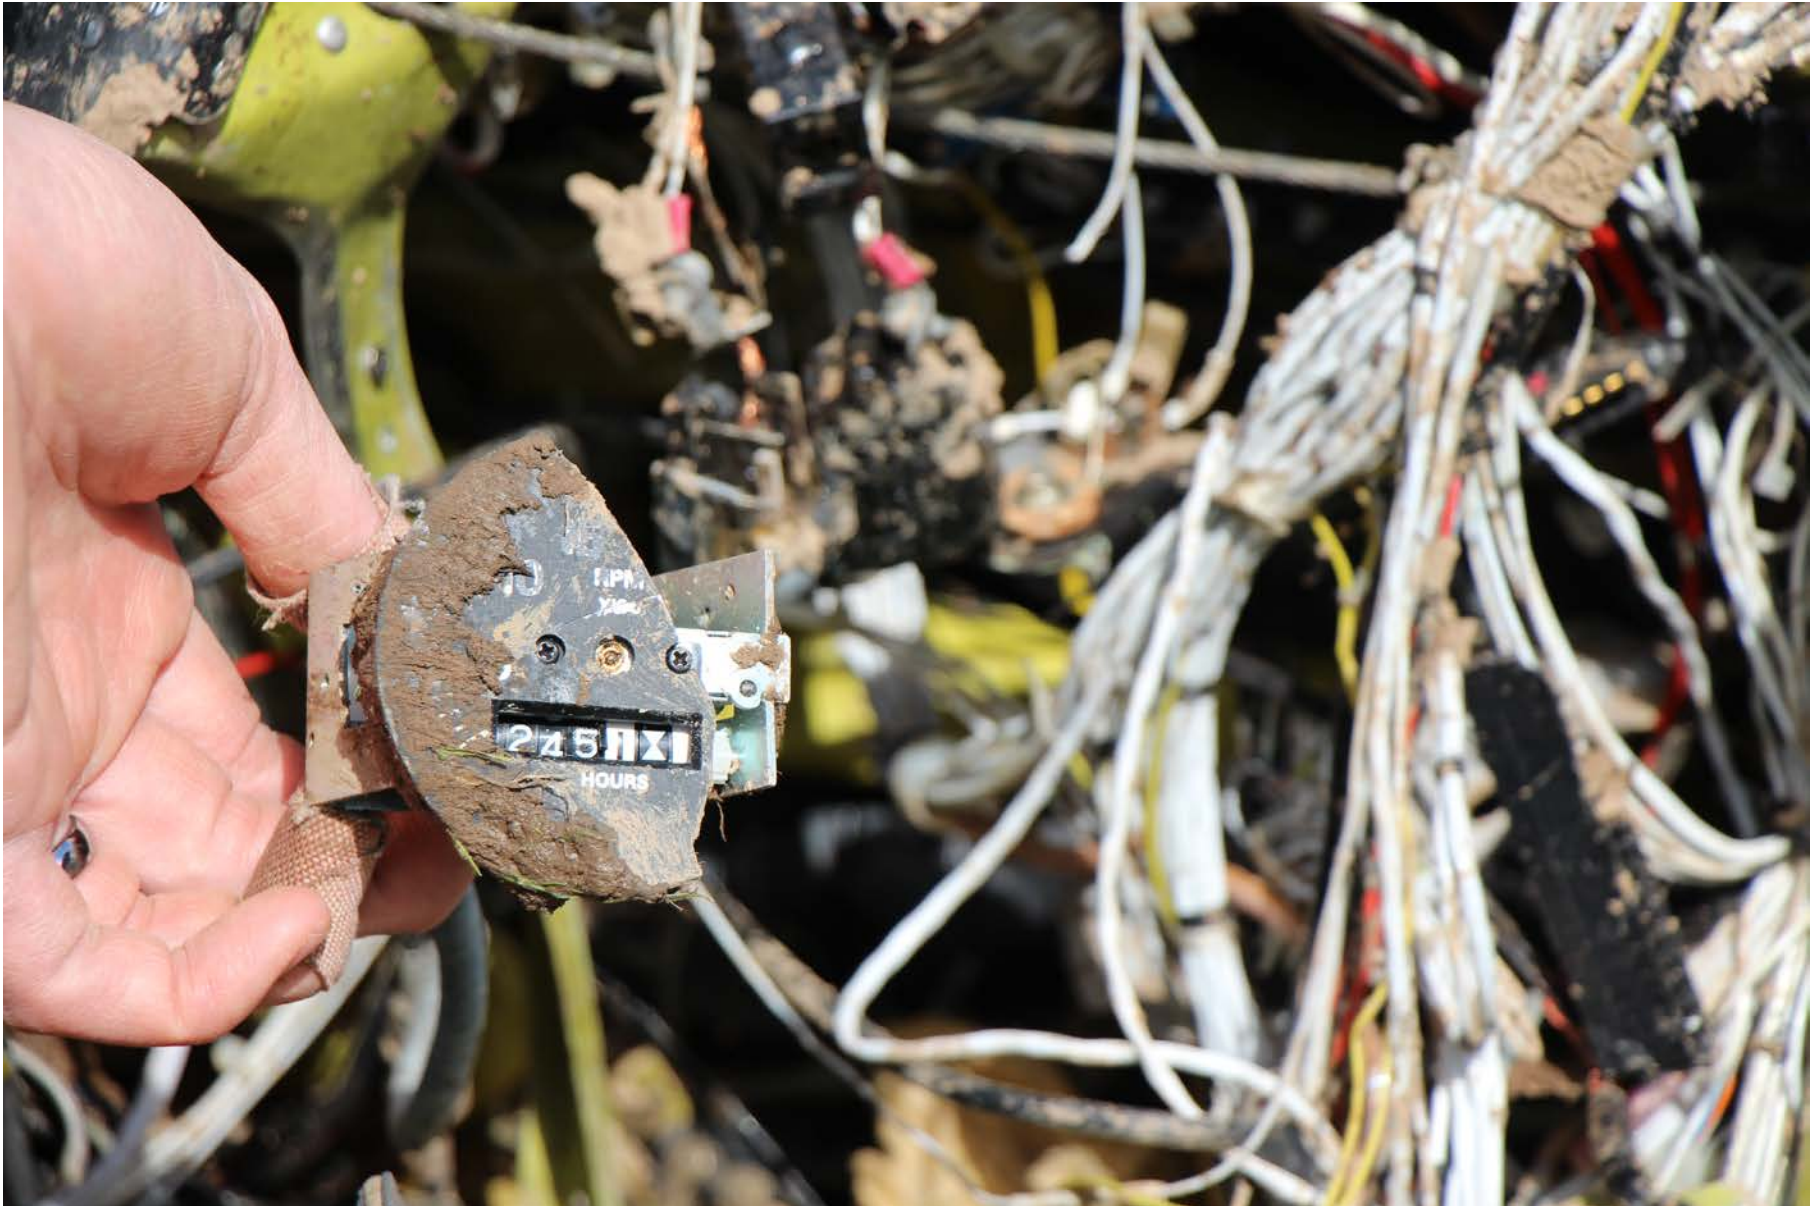
Photo 6 – Photograph of Tachometer Recovered from Accident Site

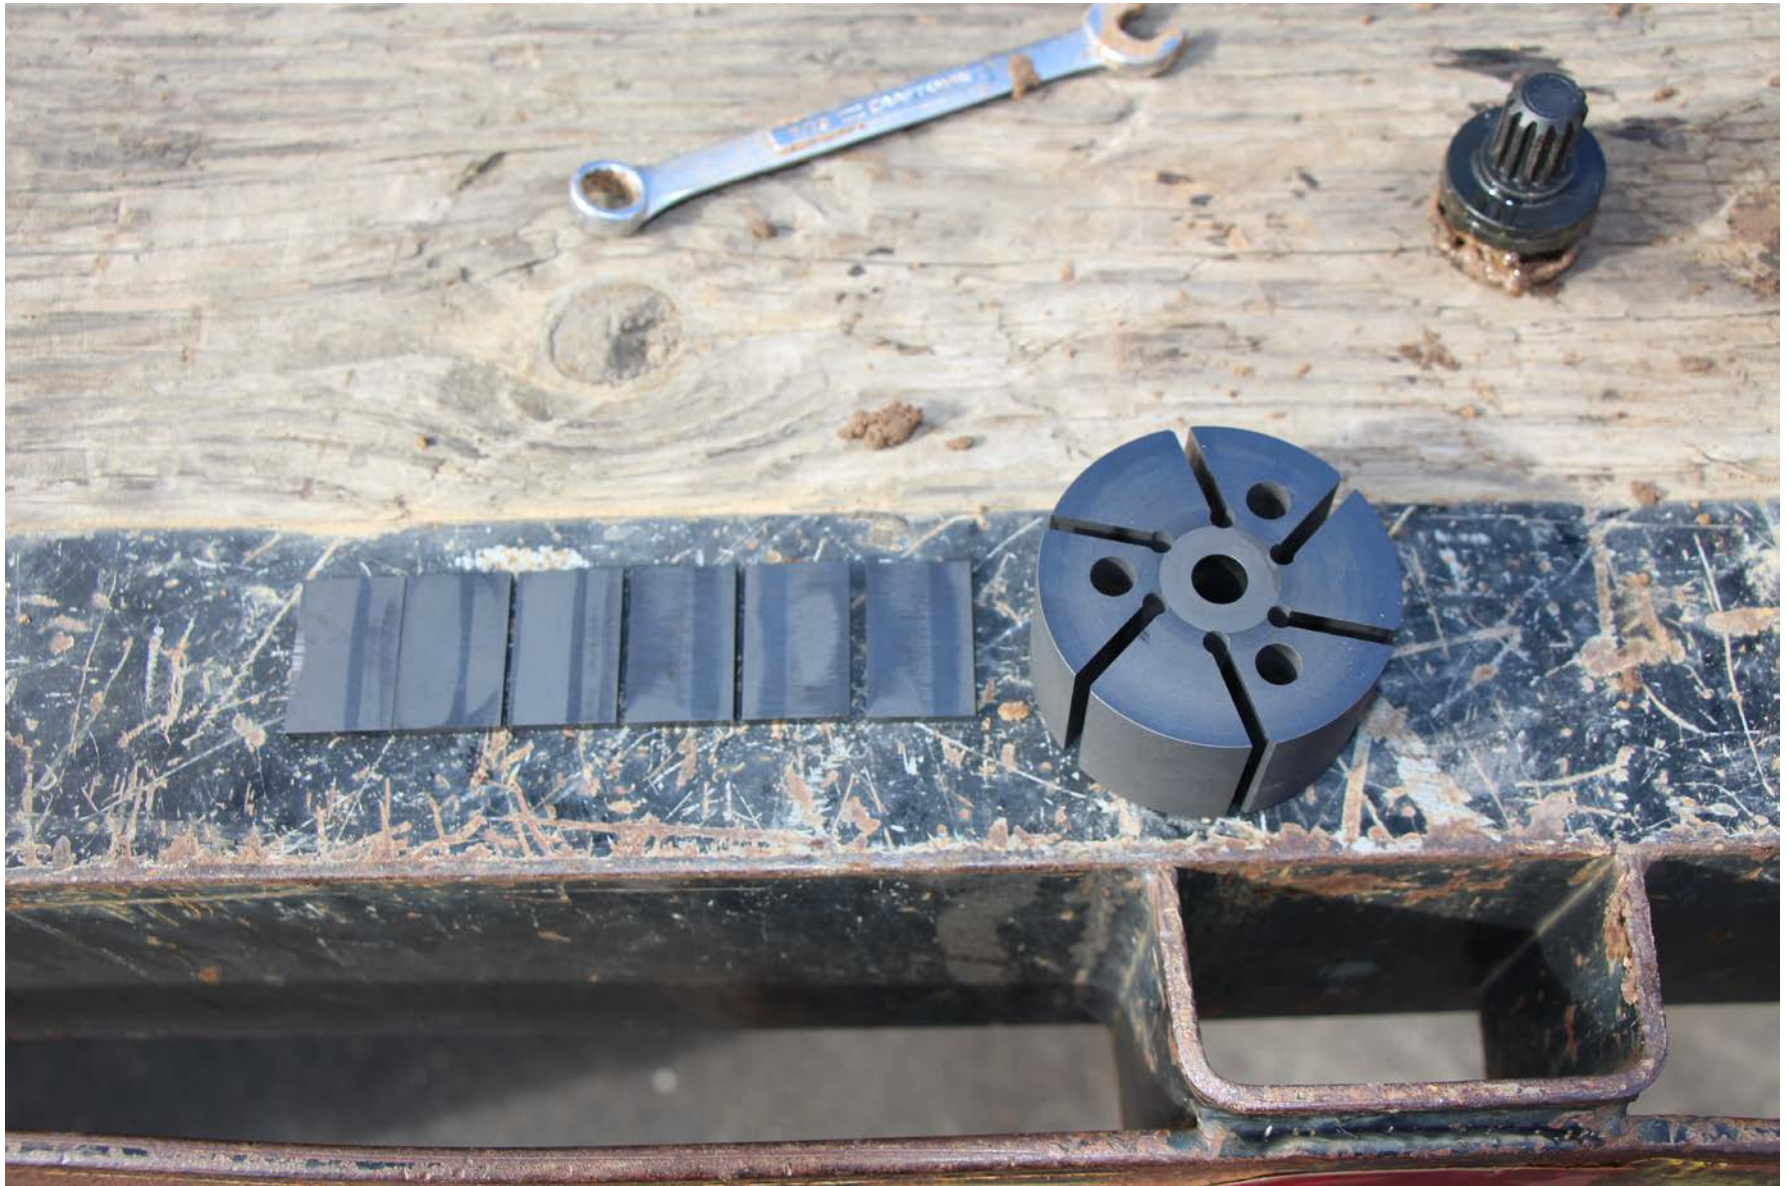
Photo 7 – Photograph of Rotor and Carbon Vanes
