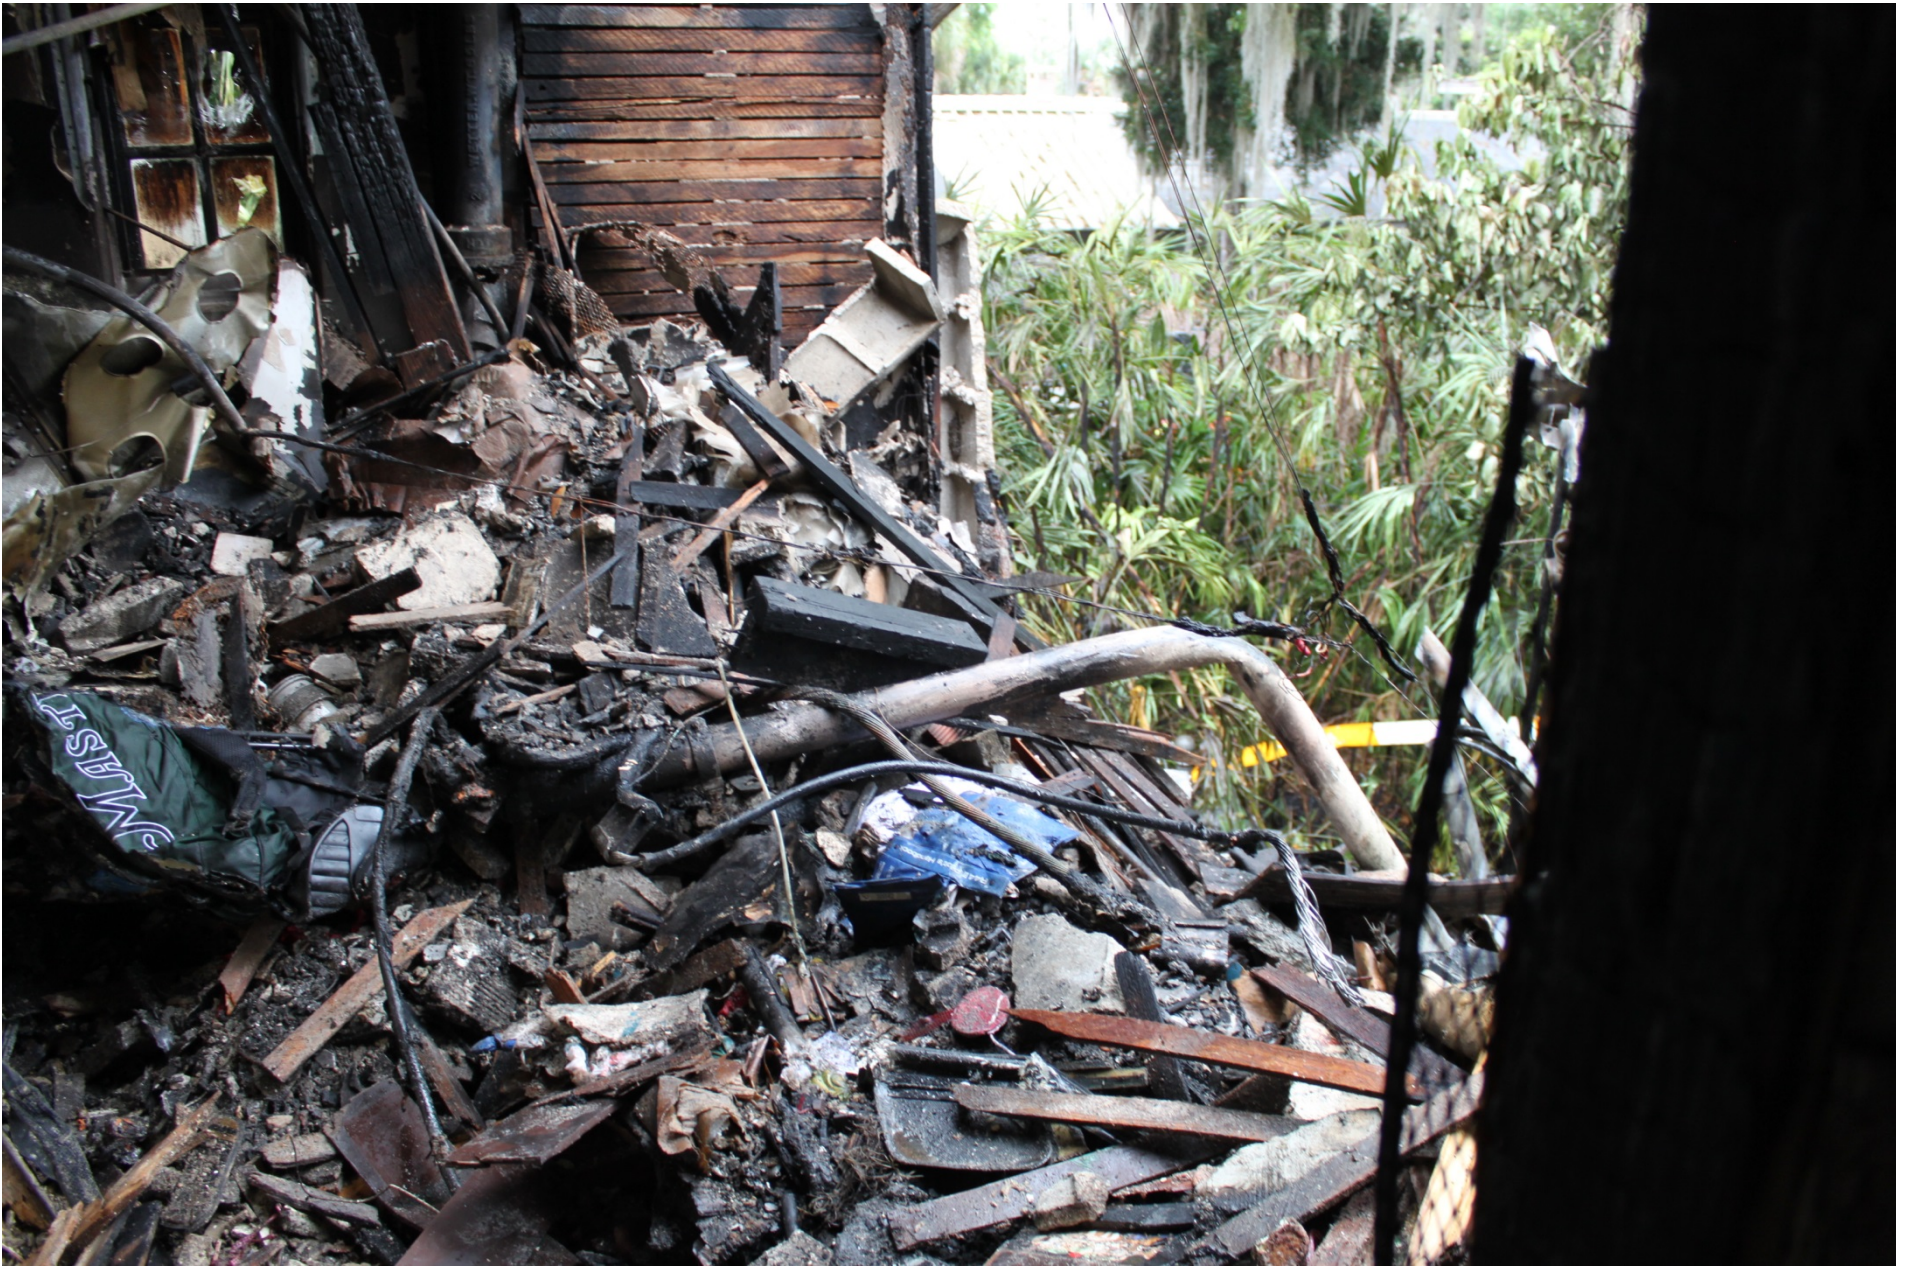
Photo 1 –View of main wreckage

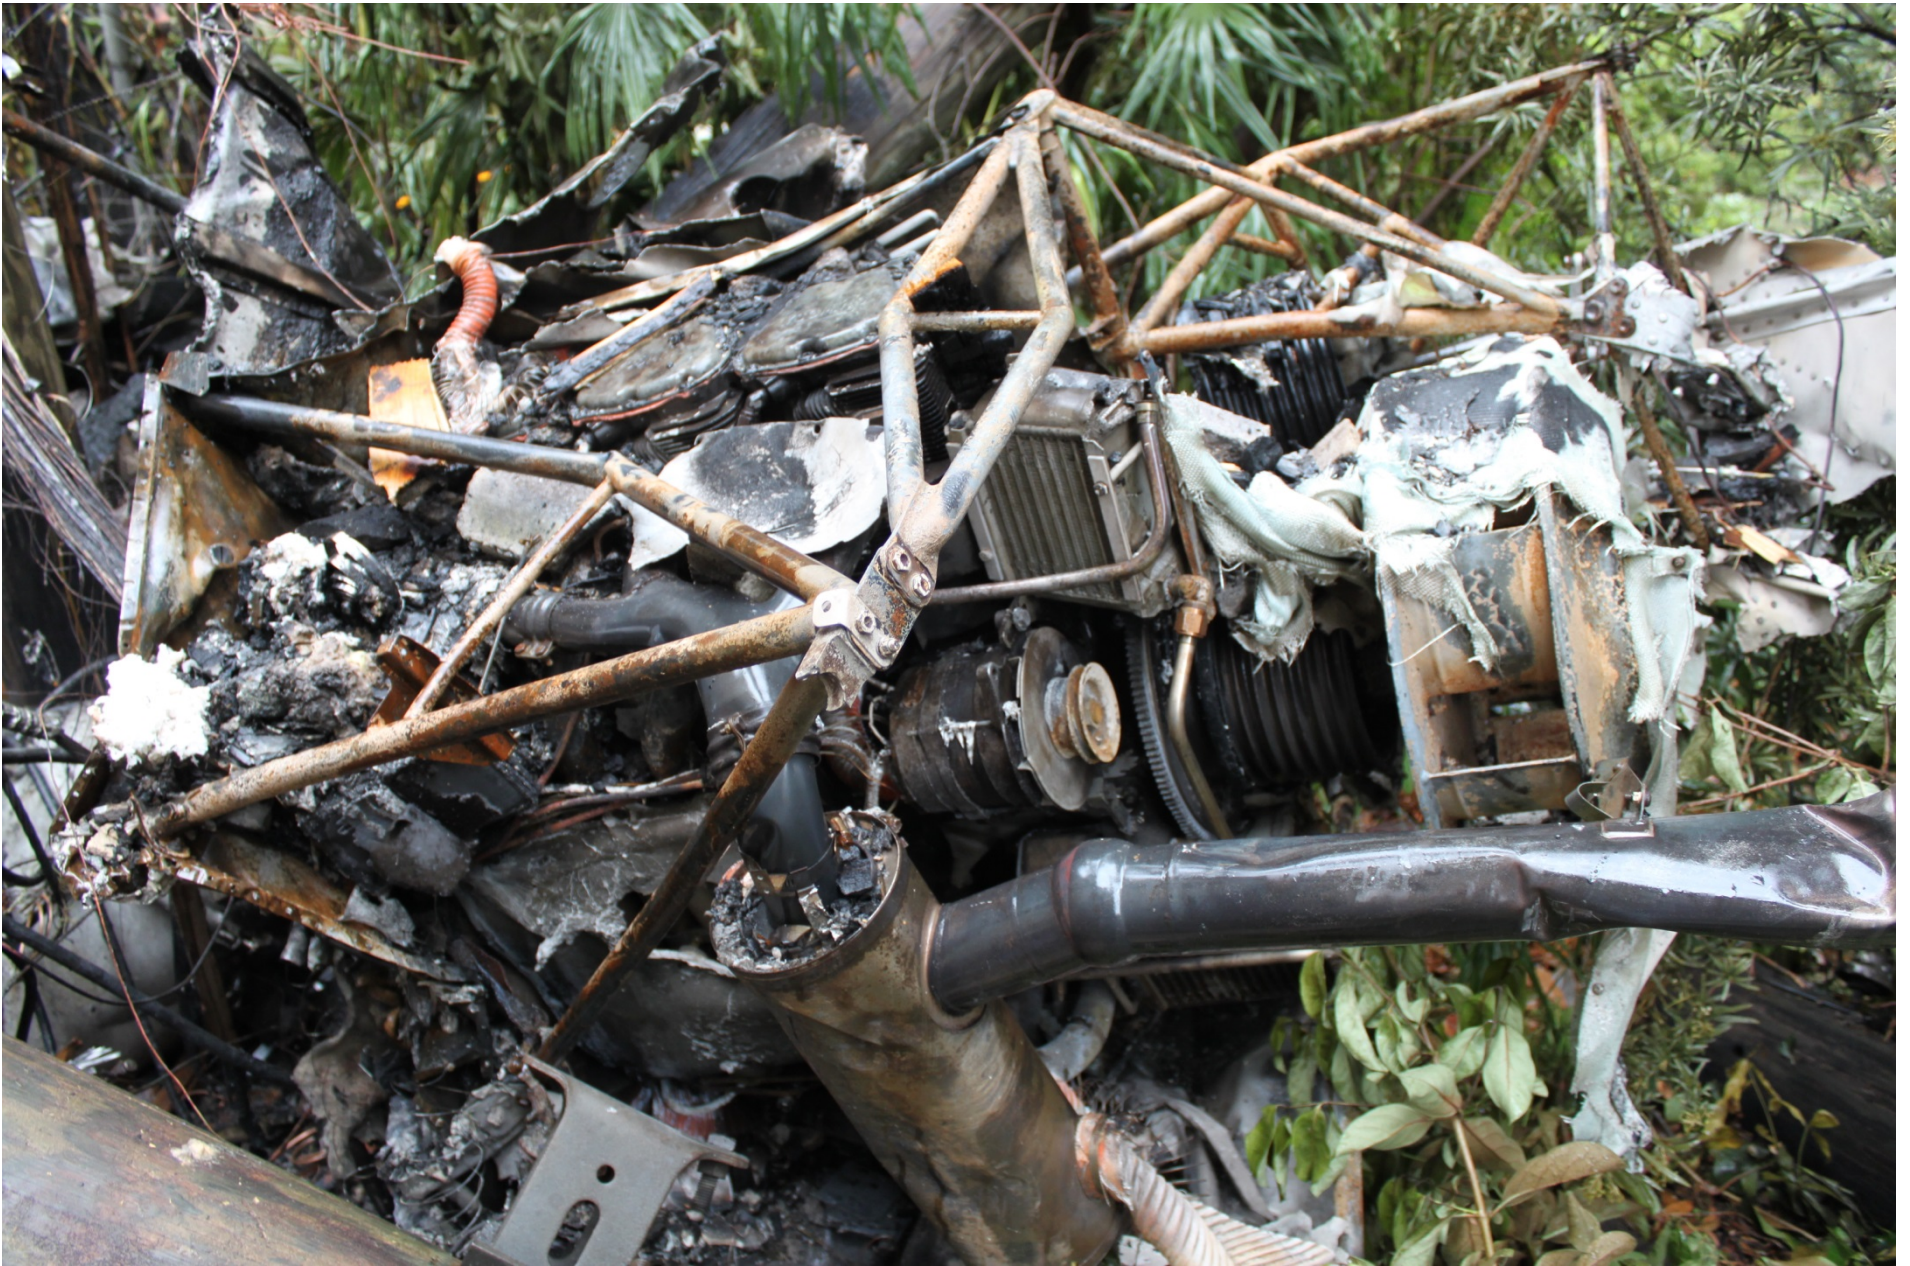
Photo 2 – View of engine assembly

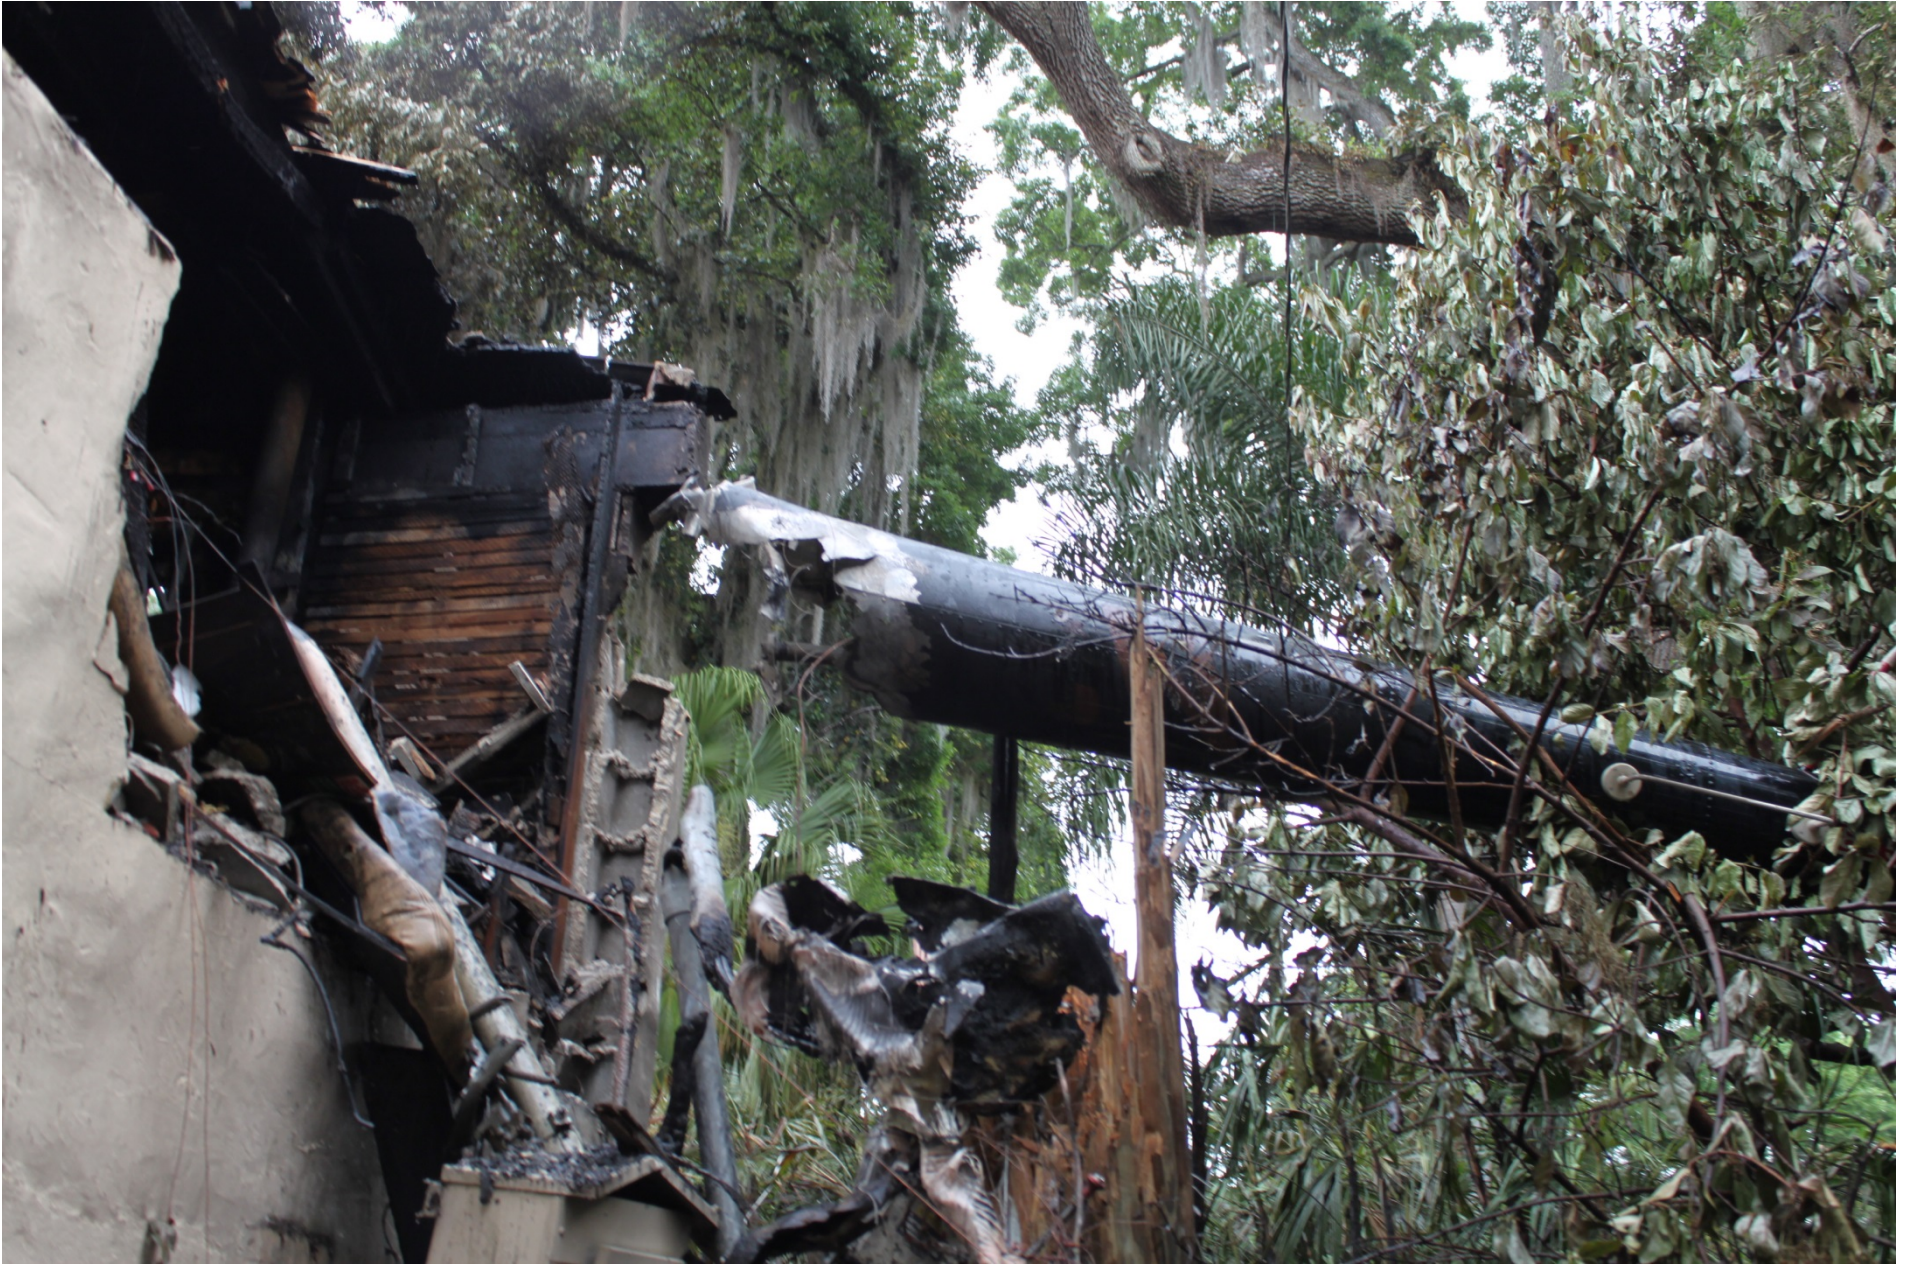
Photo 3 – View of tail boom in tree at wreckage site

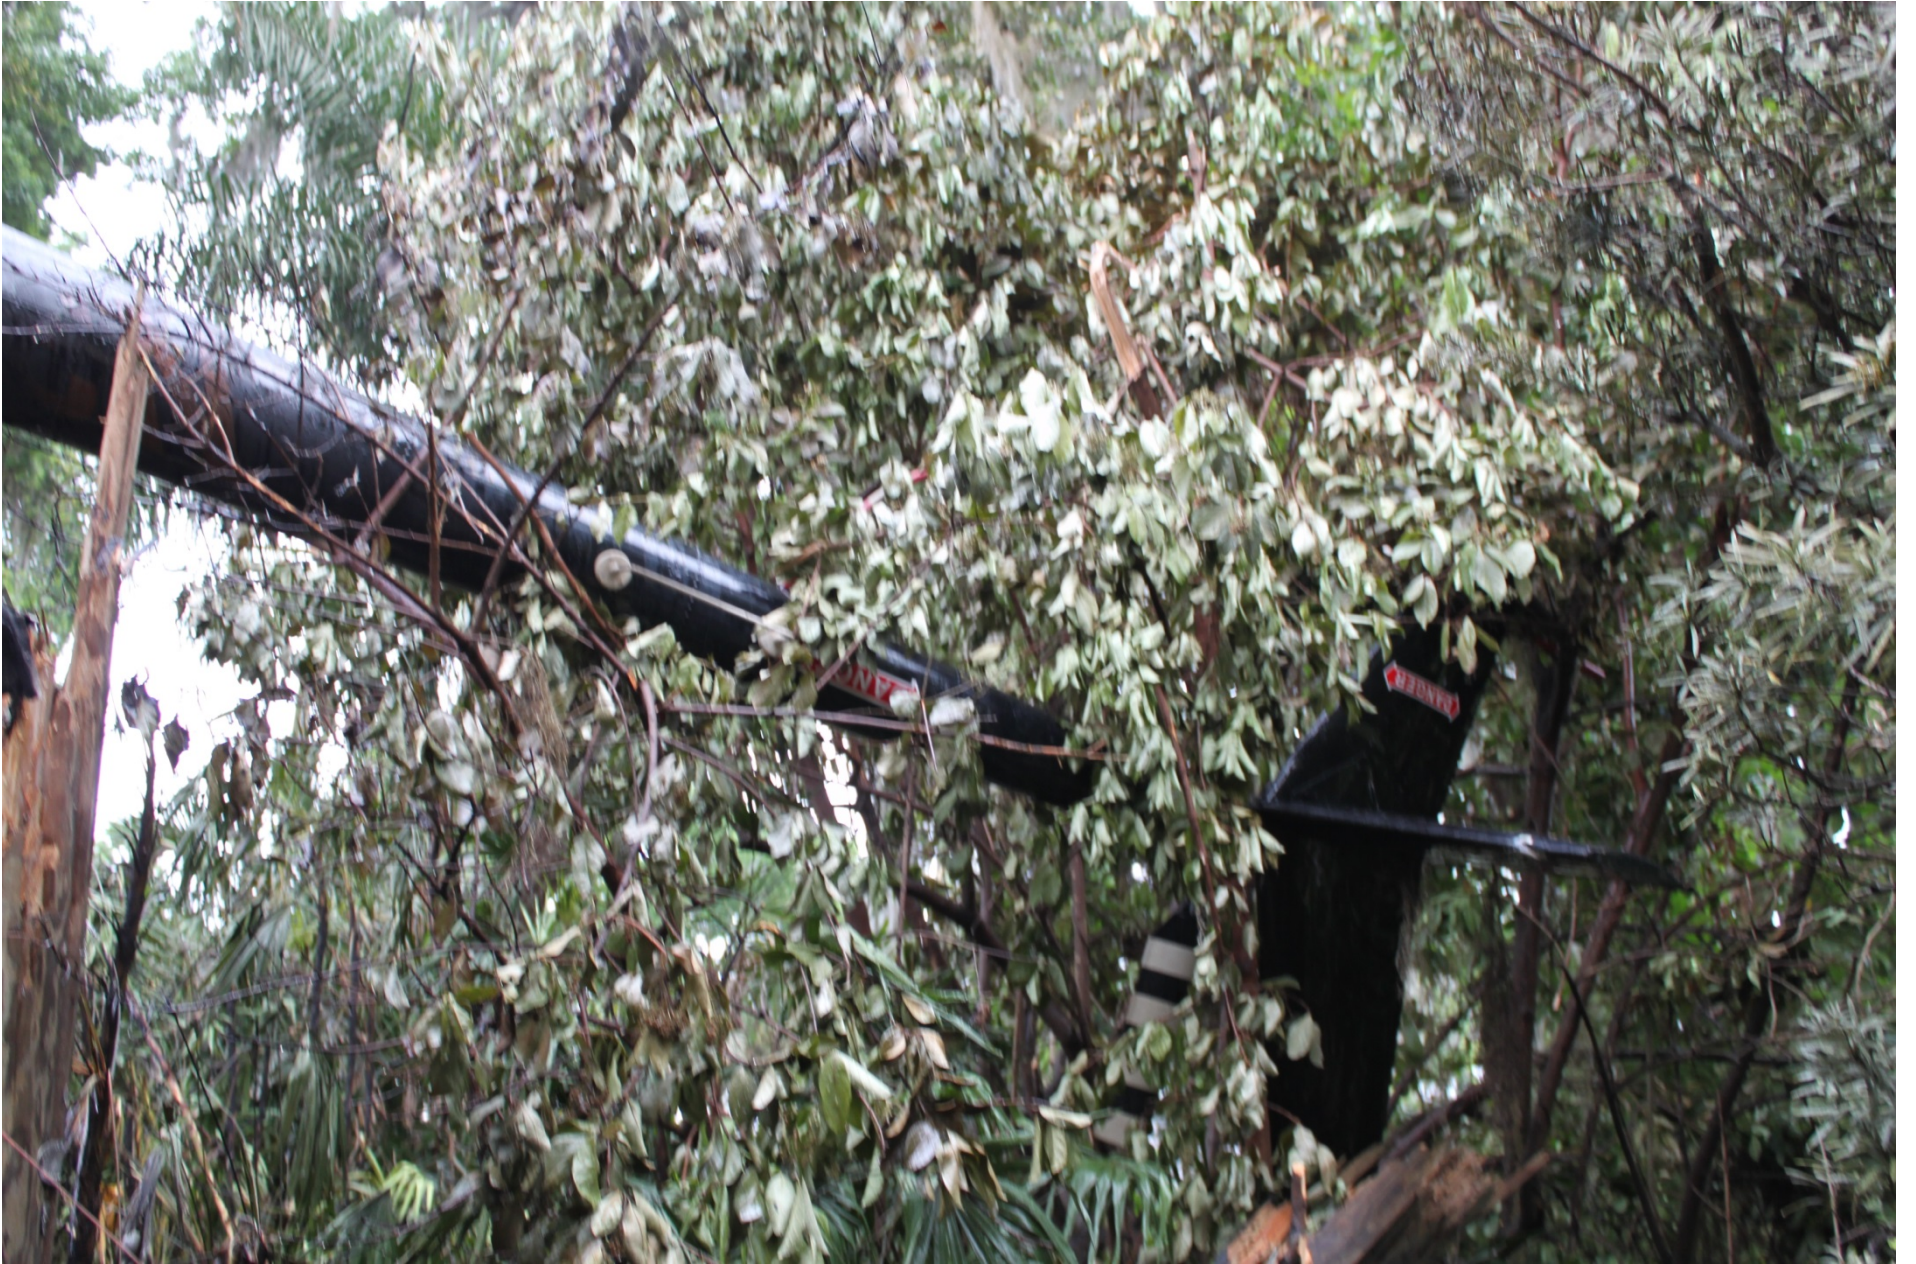
Photo 4 – View of tail boom vertical fins and rotor blades in tree

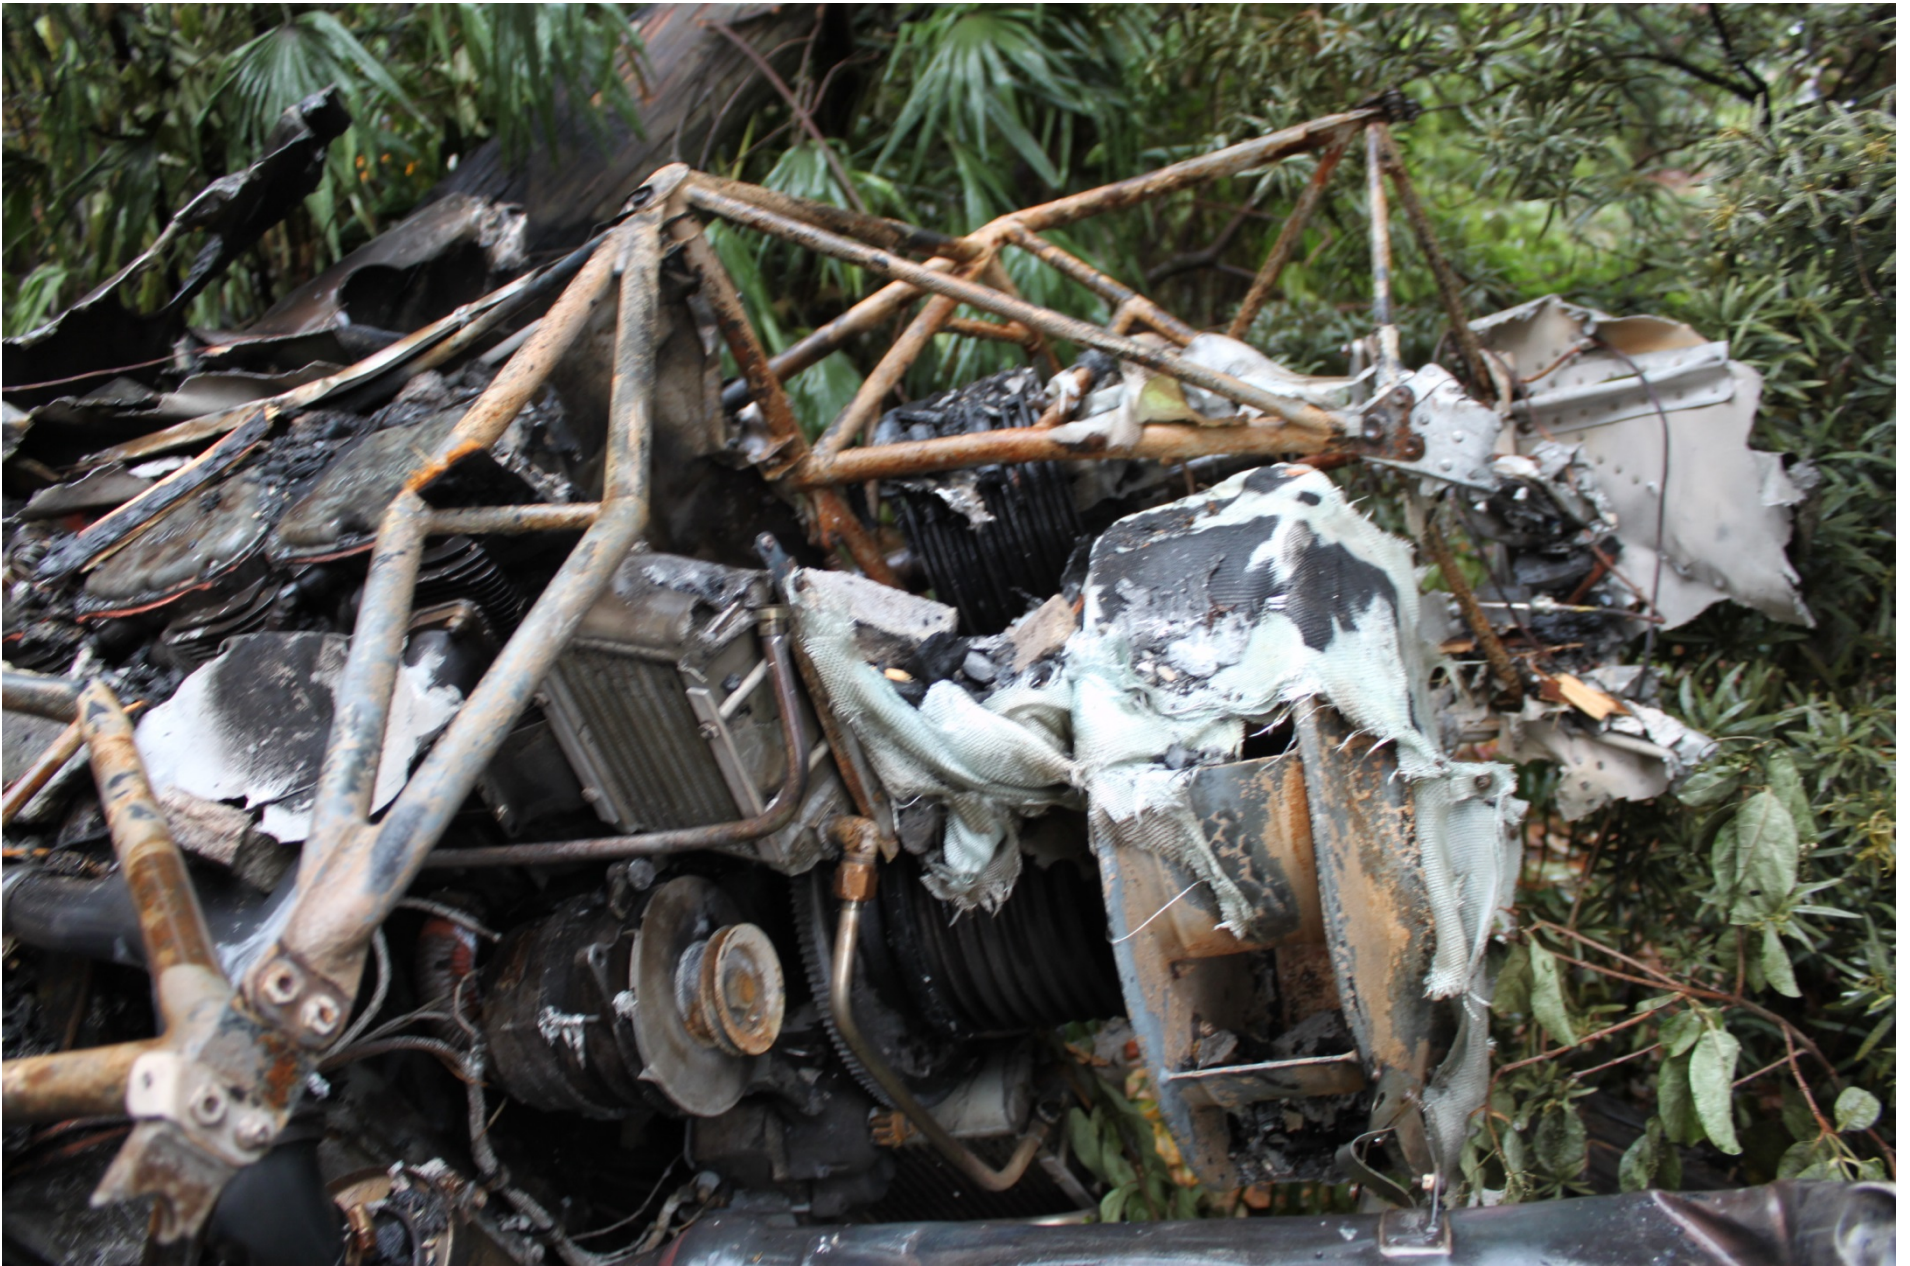
Photo 5 – View of engine fan

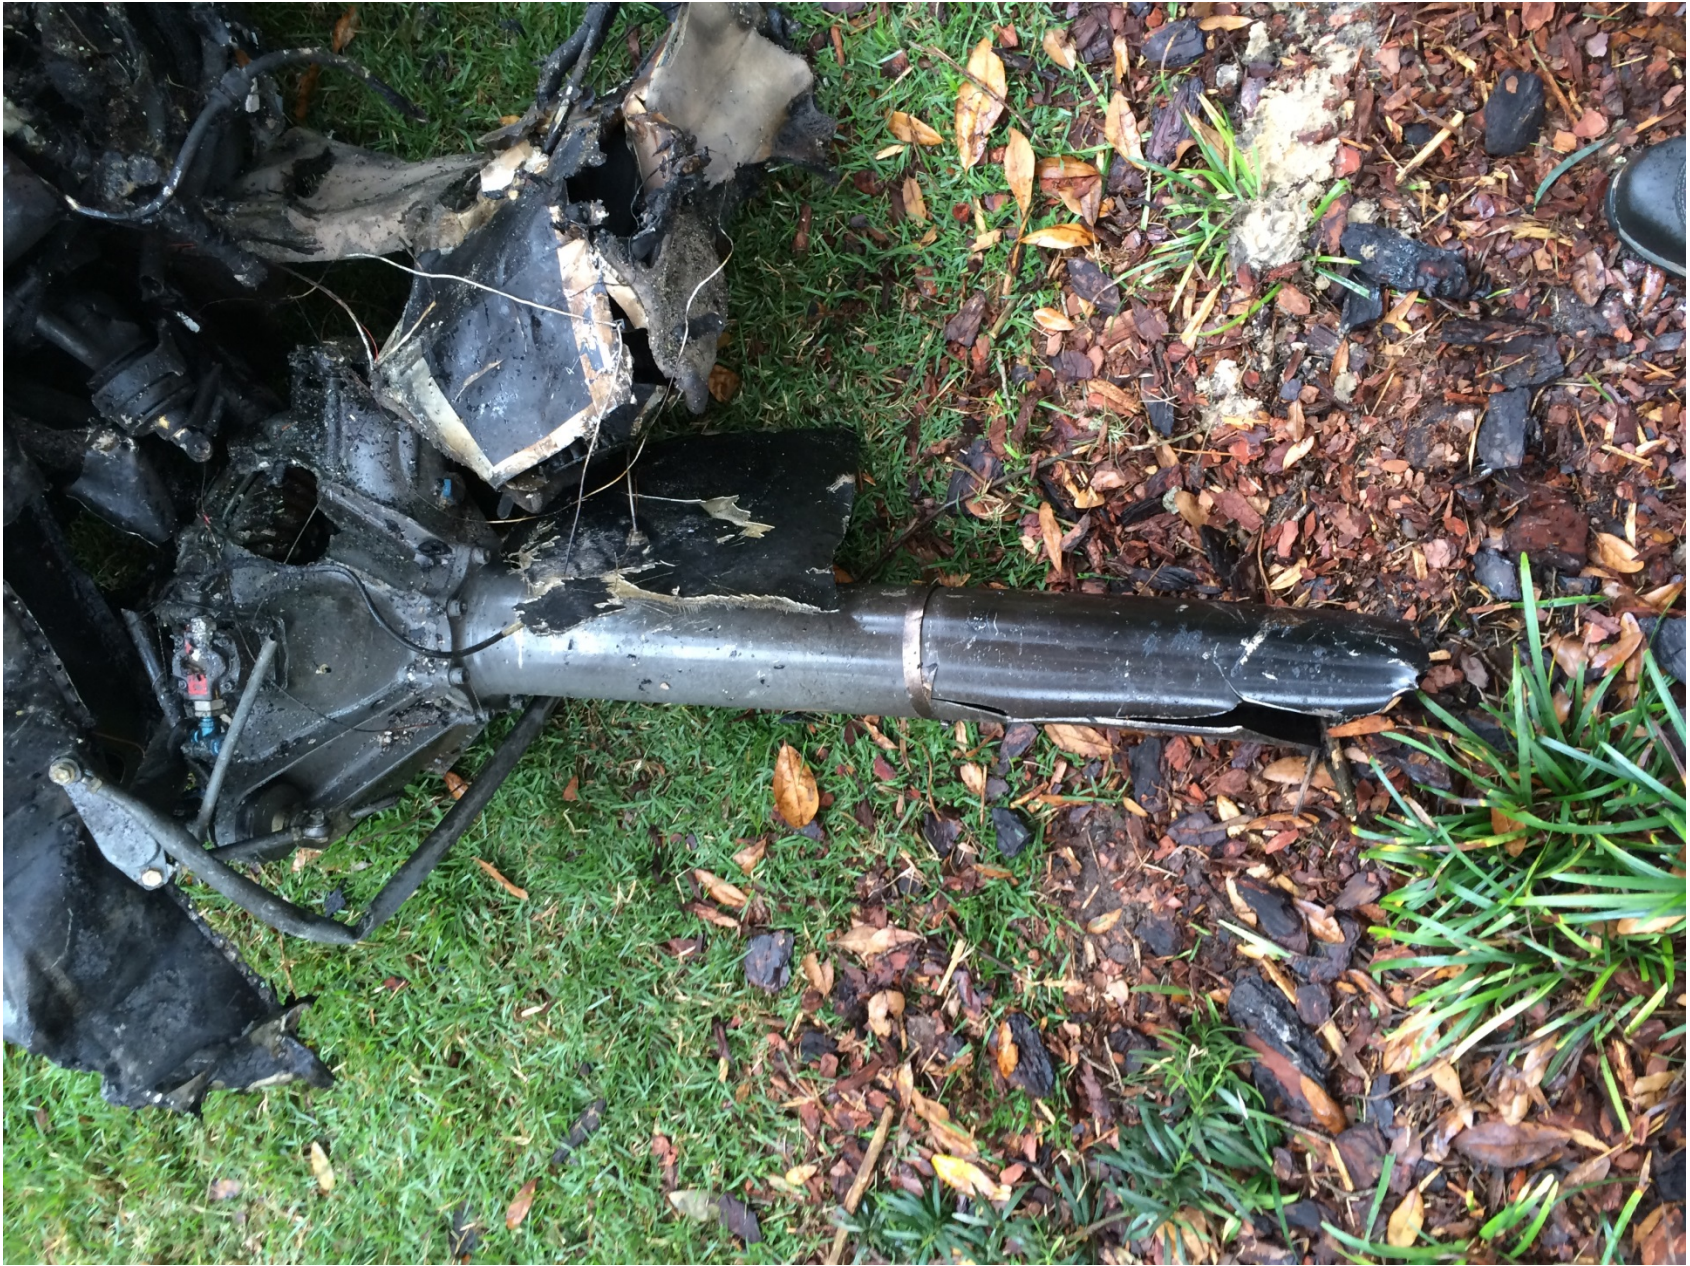
Photo 6 –View of main rotor mast

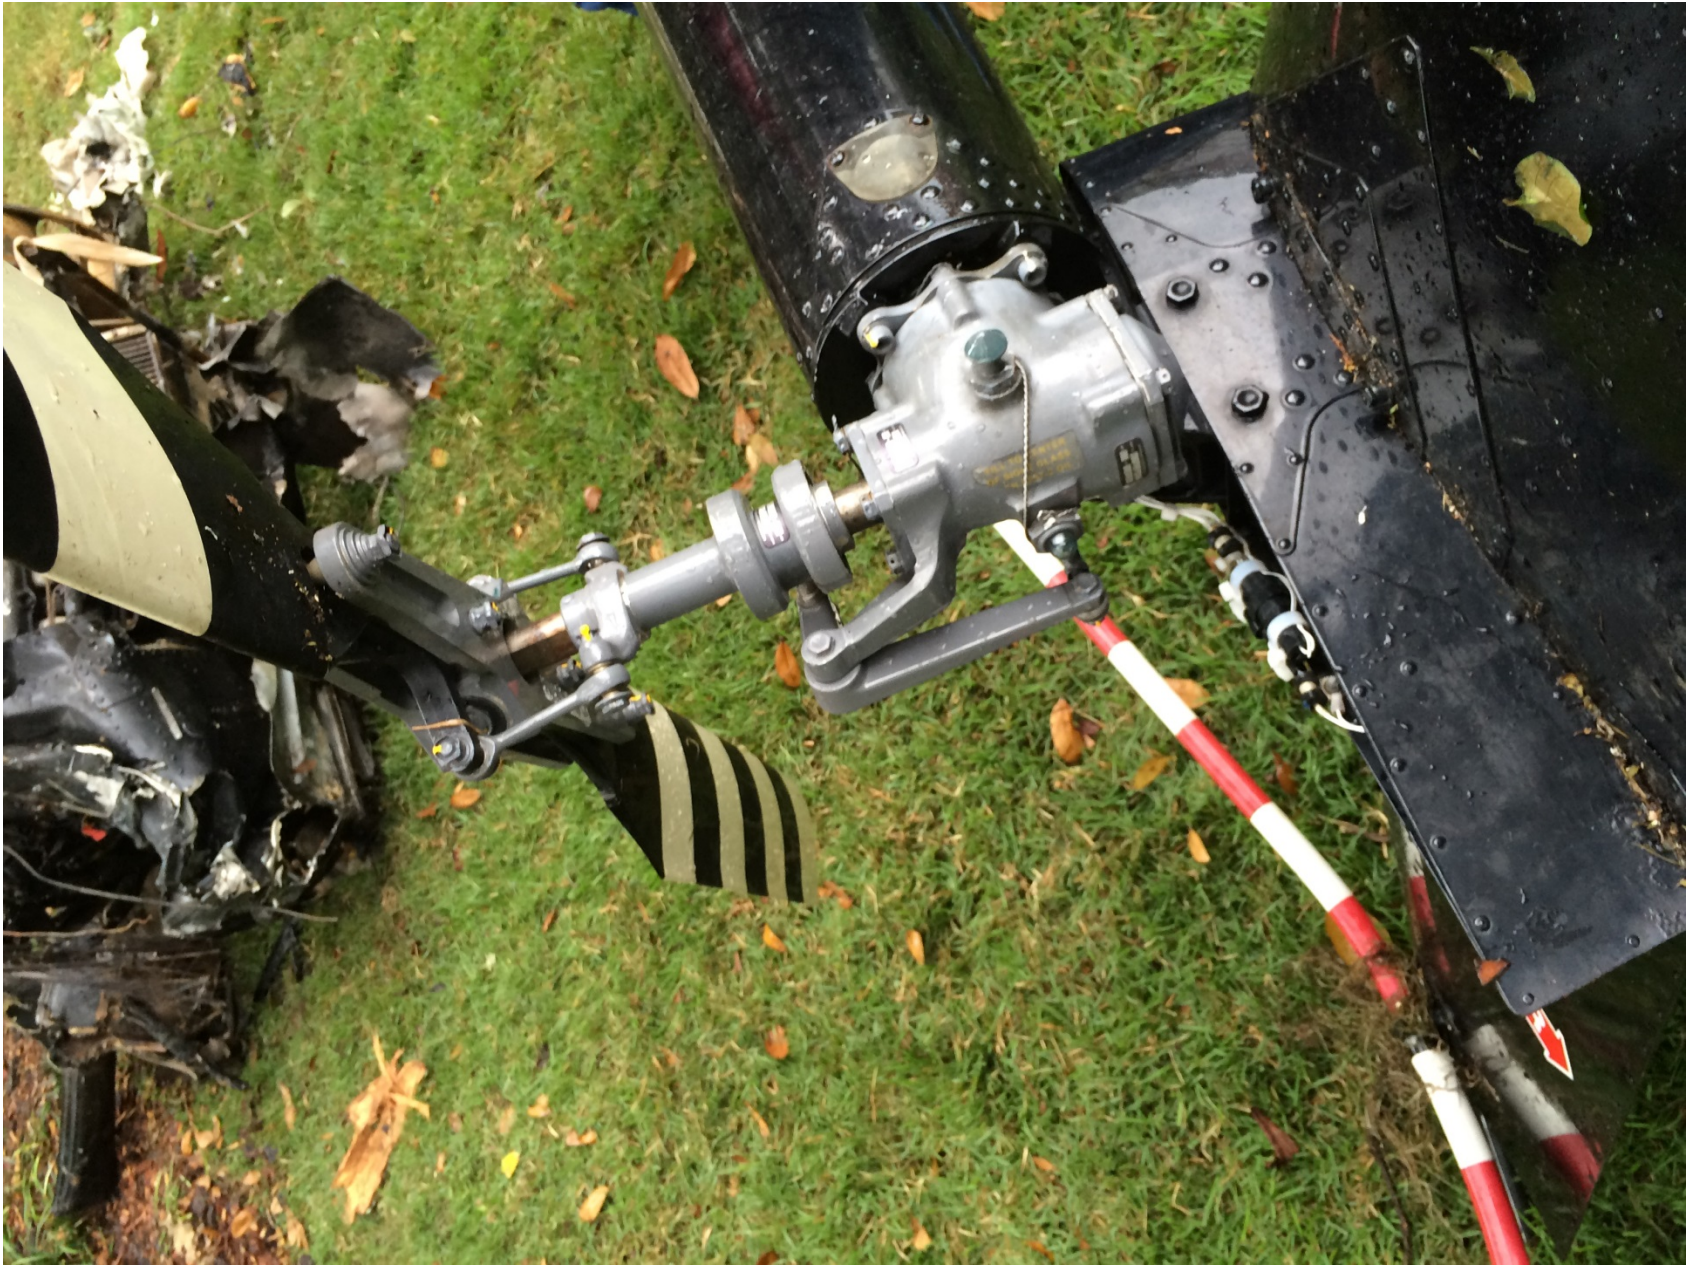
Photo 7 –View of tail rotor gear box

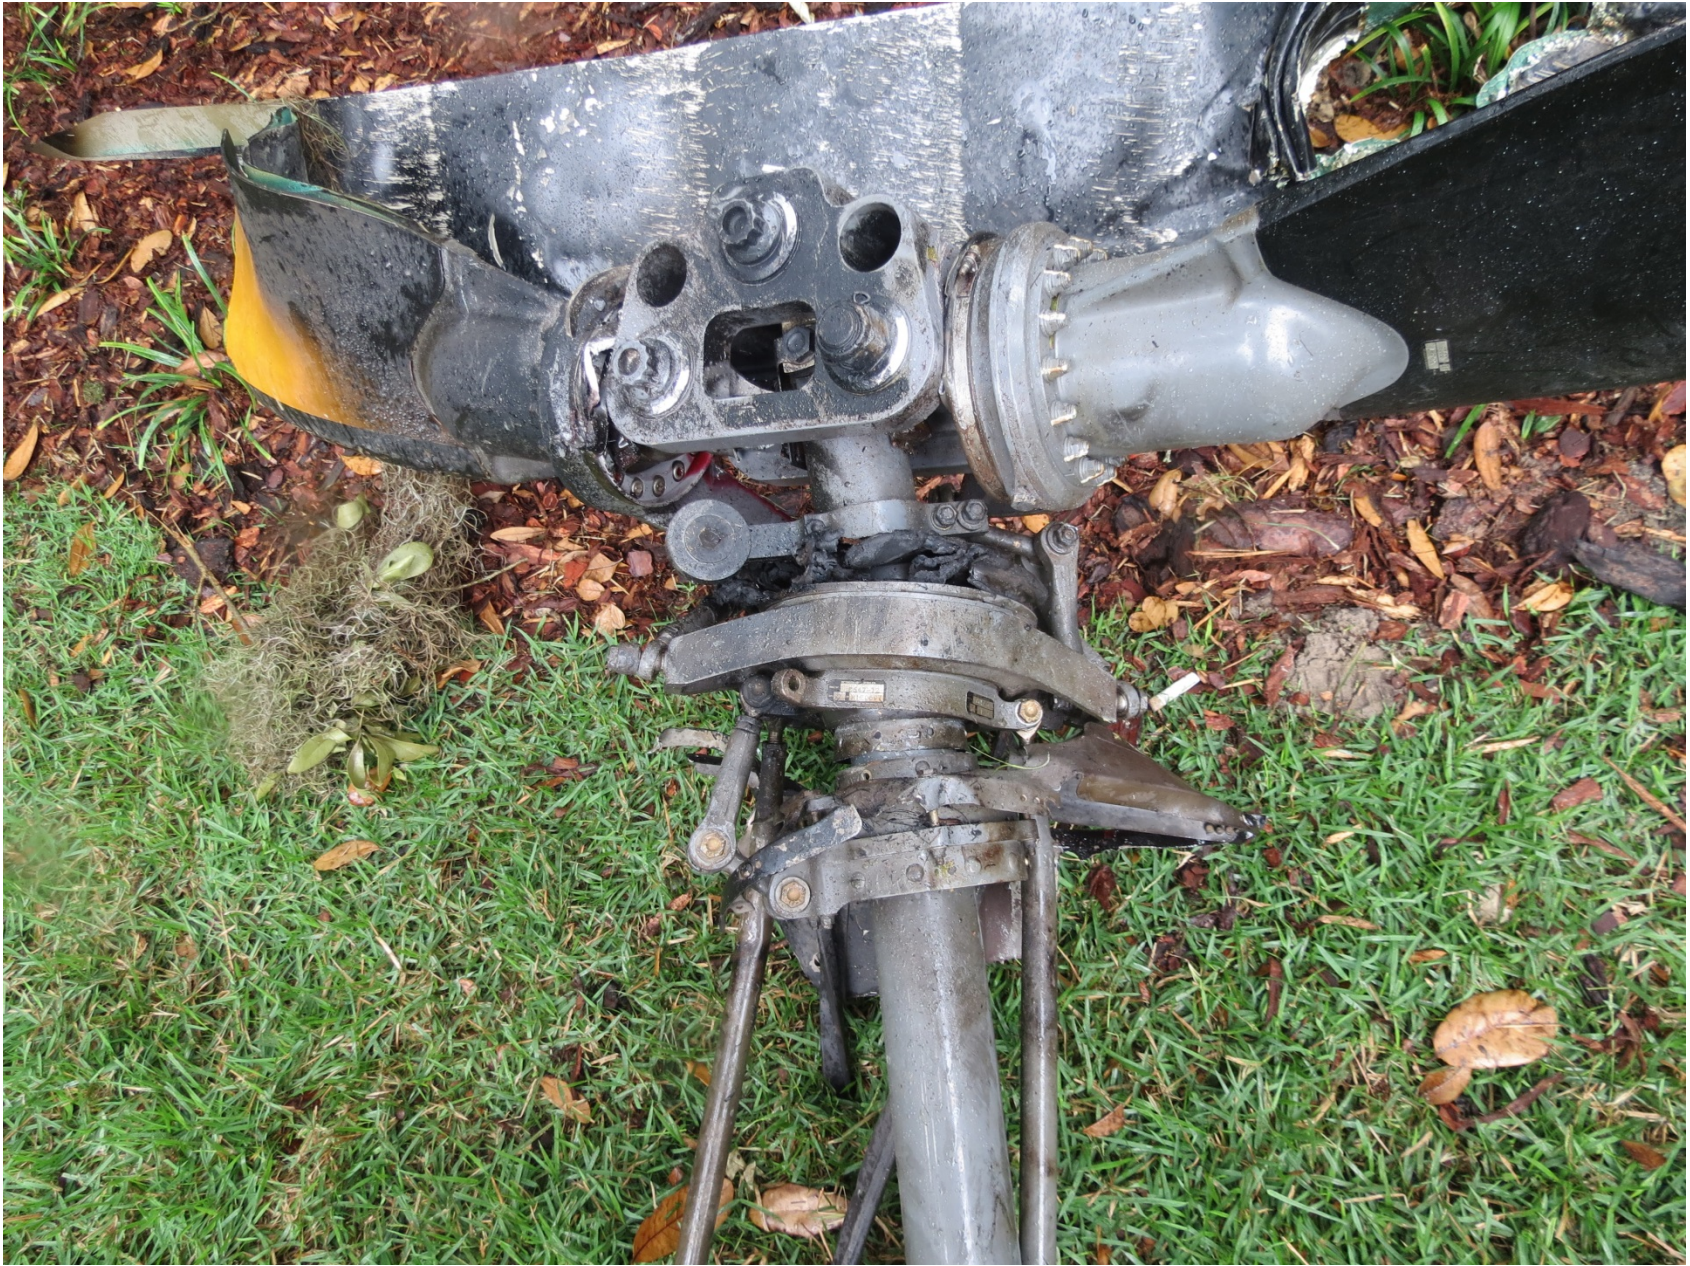
Photo 8 – View of main rotor swash plate and main rotor head

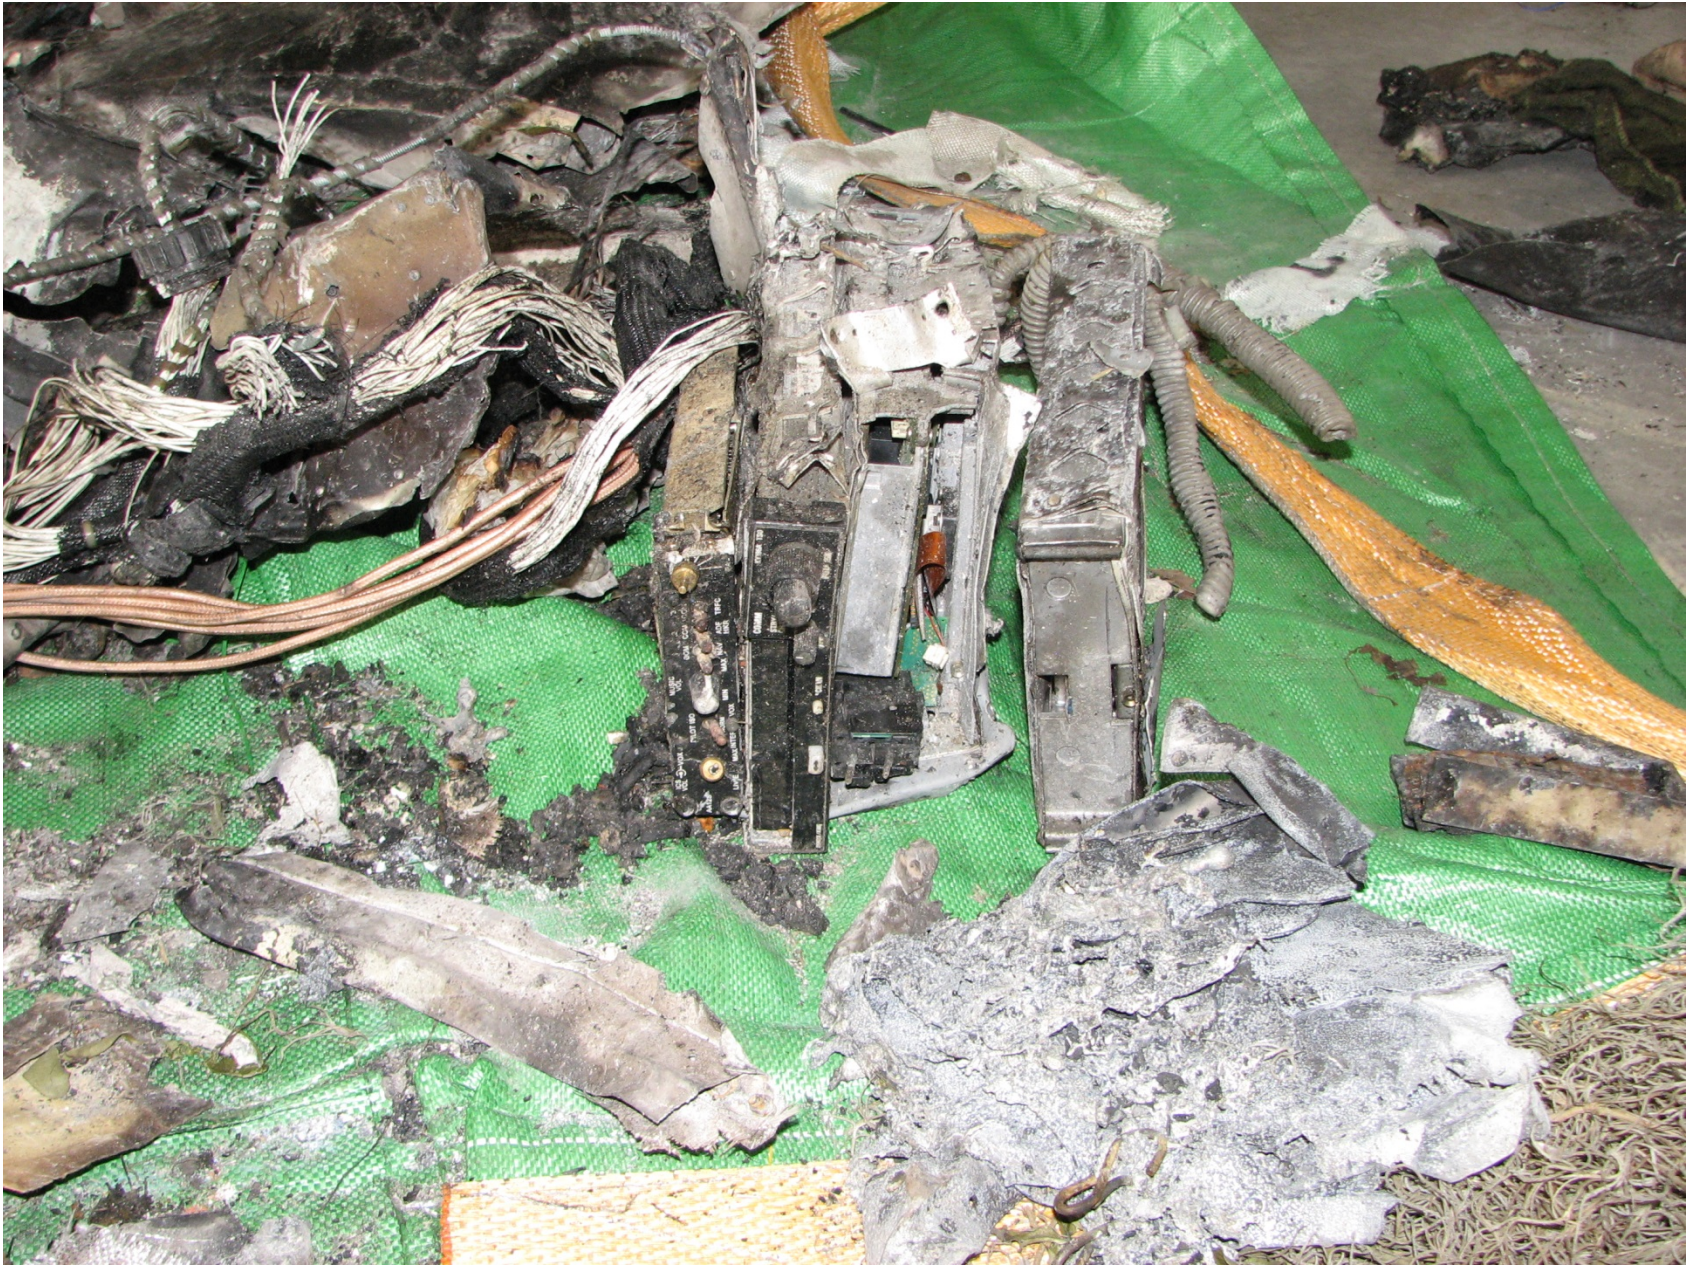
Photo 9 – View of fragments of recovered cockpit

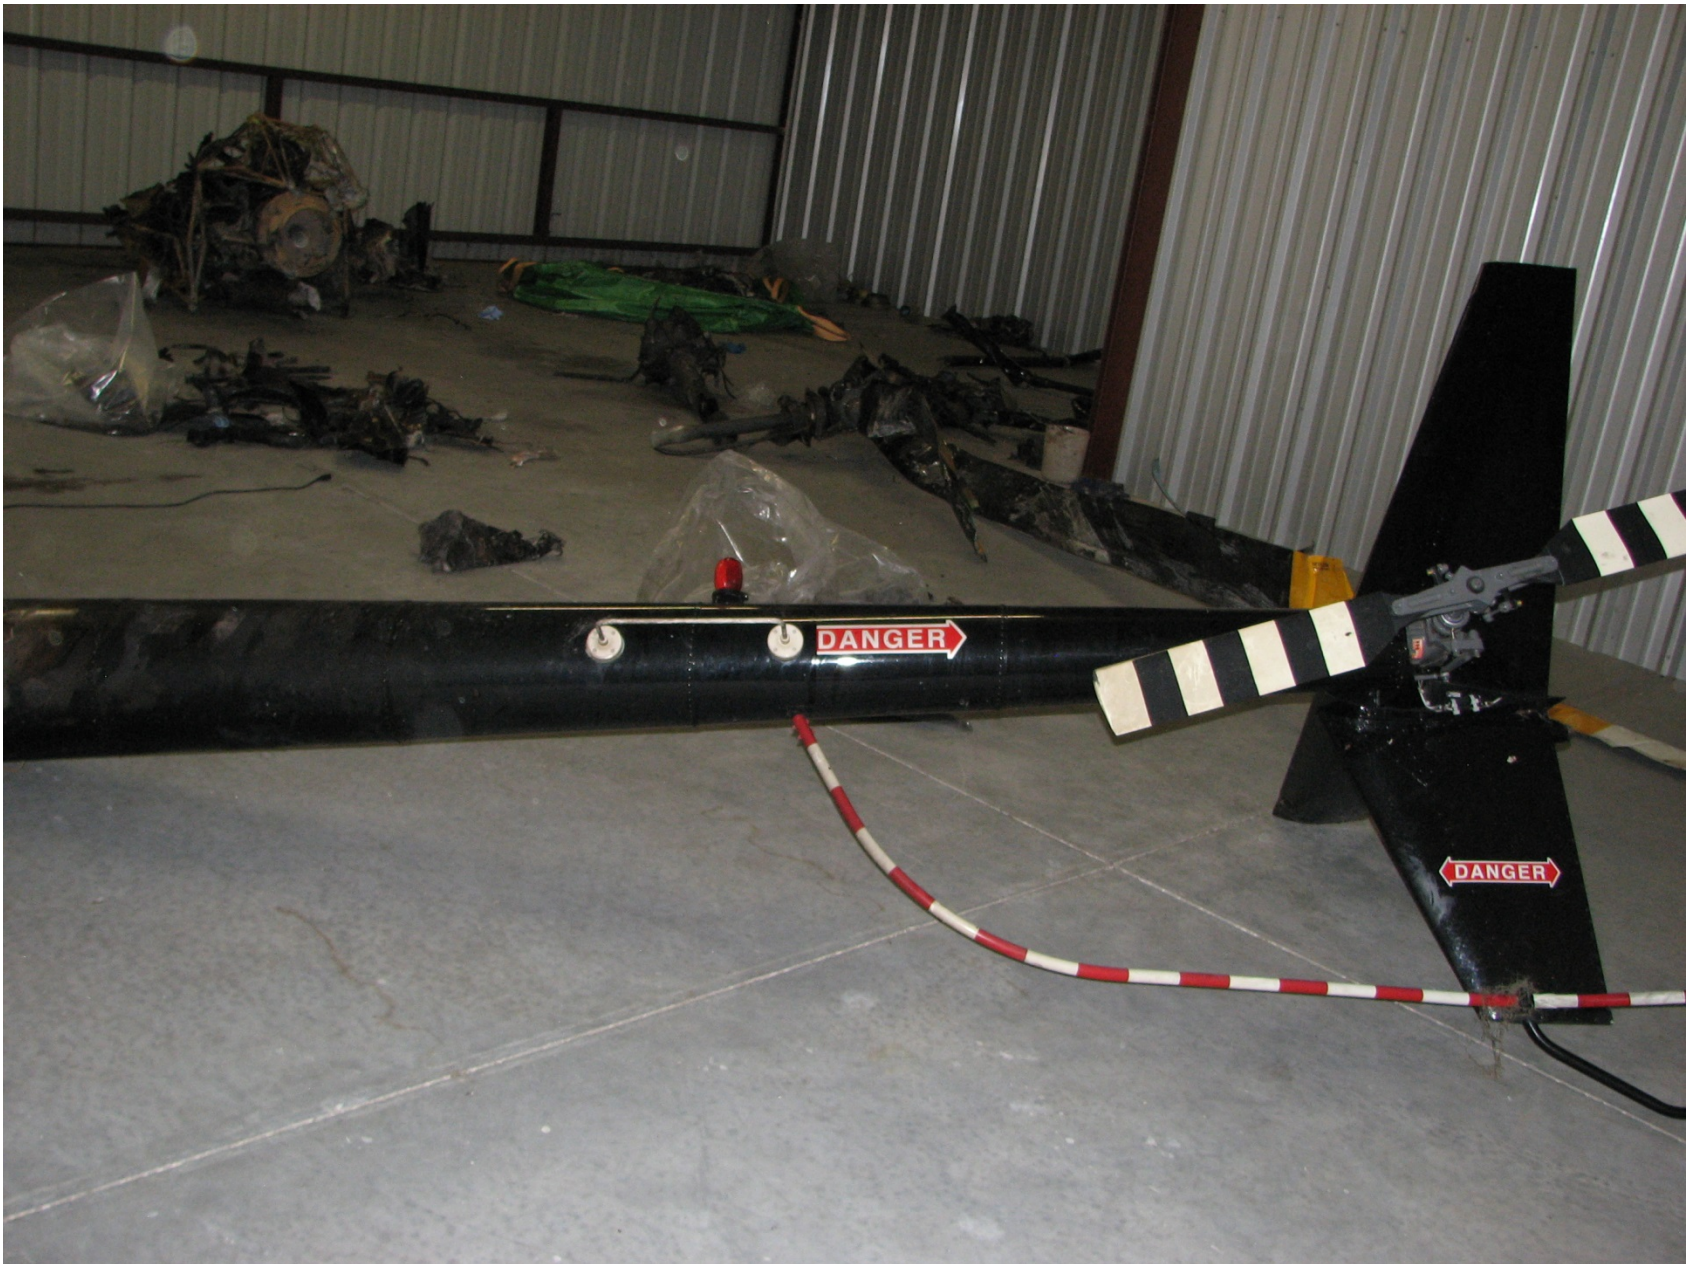
Photo 10 – View of recovered tail boom
