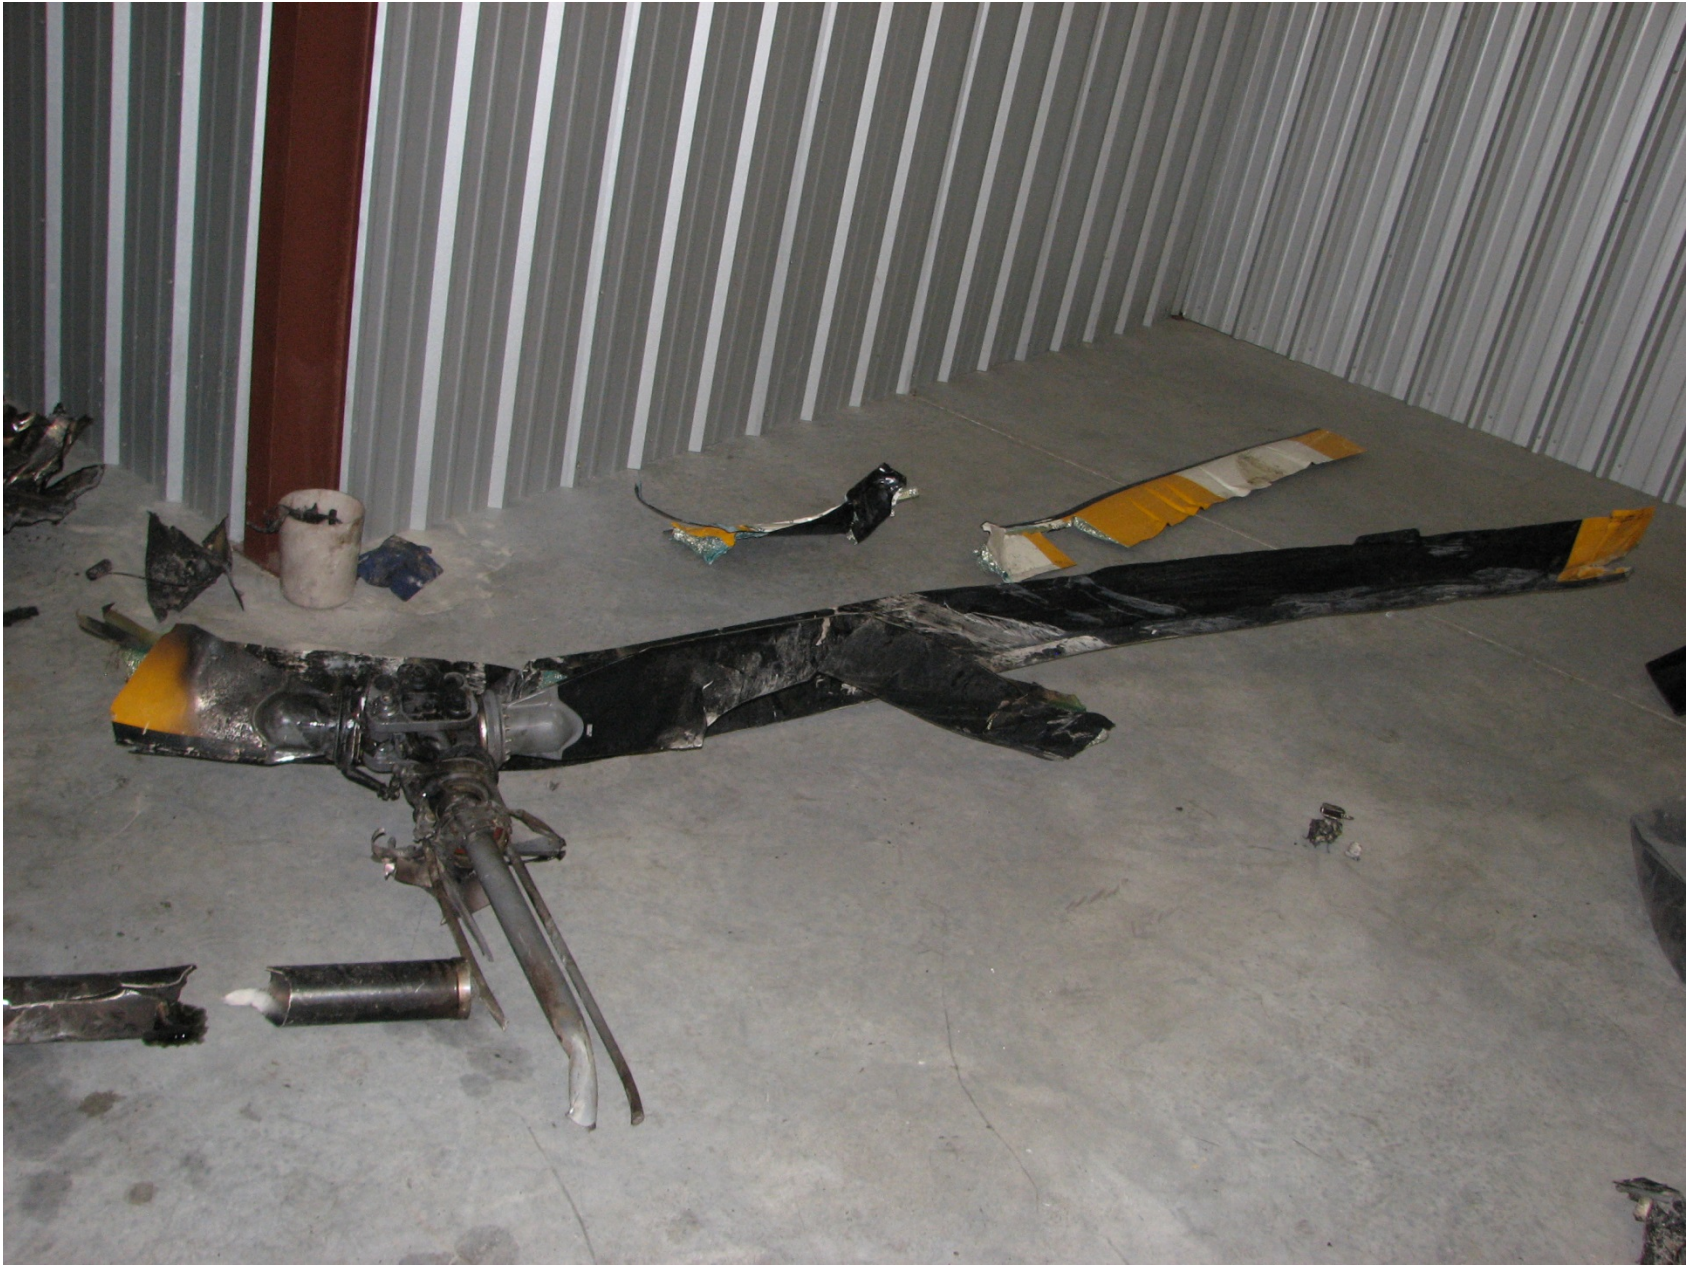
Photo 11 – View of main rotor head and blades

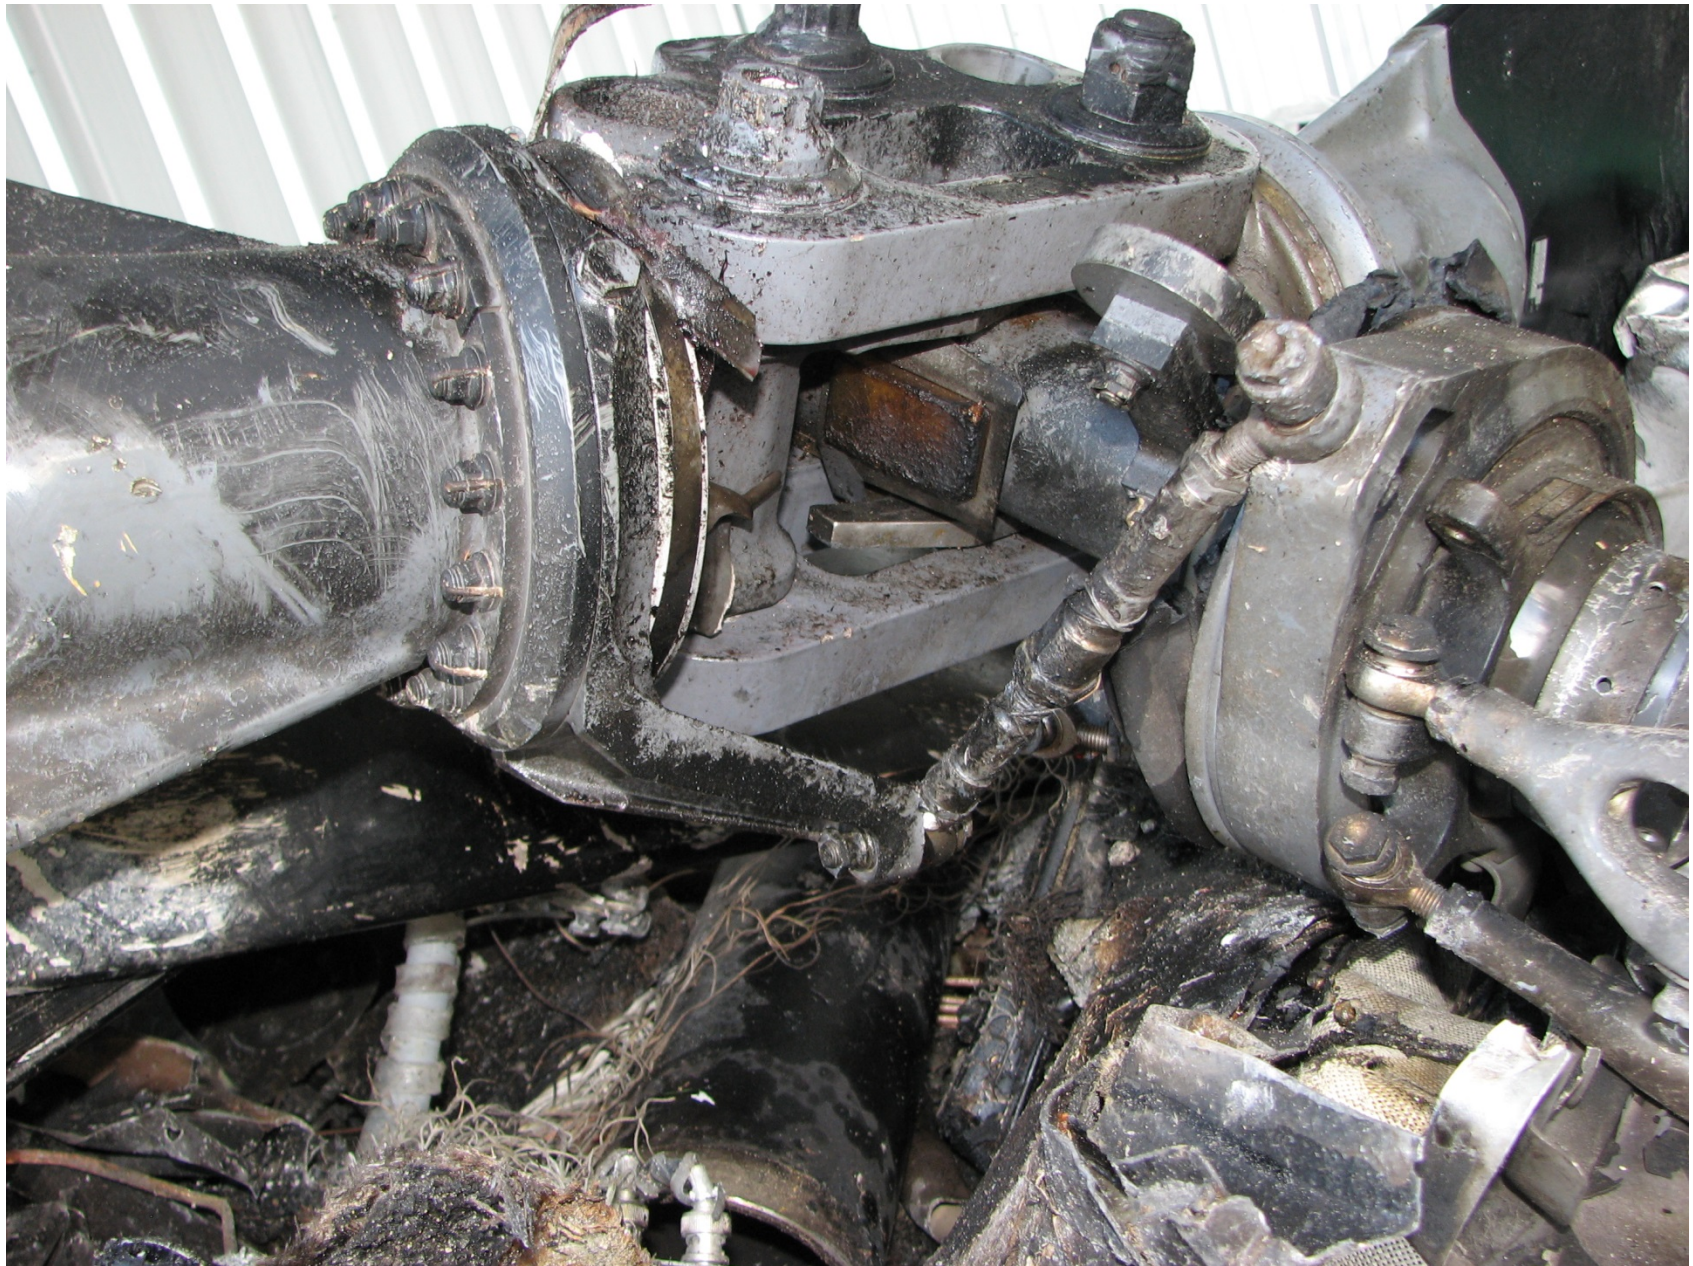
Photo 12 – View of main rotor head and swash plate

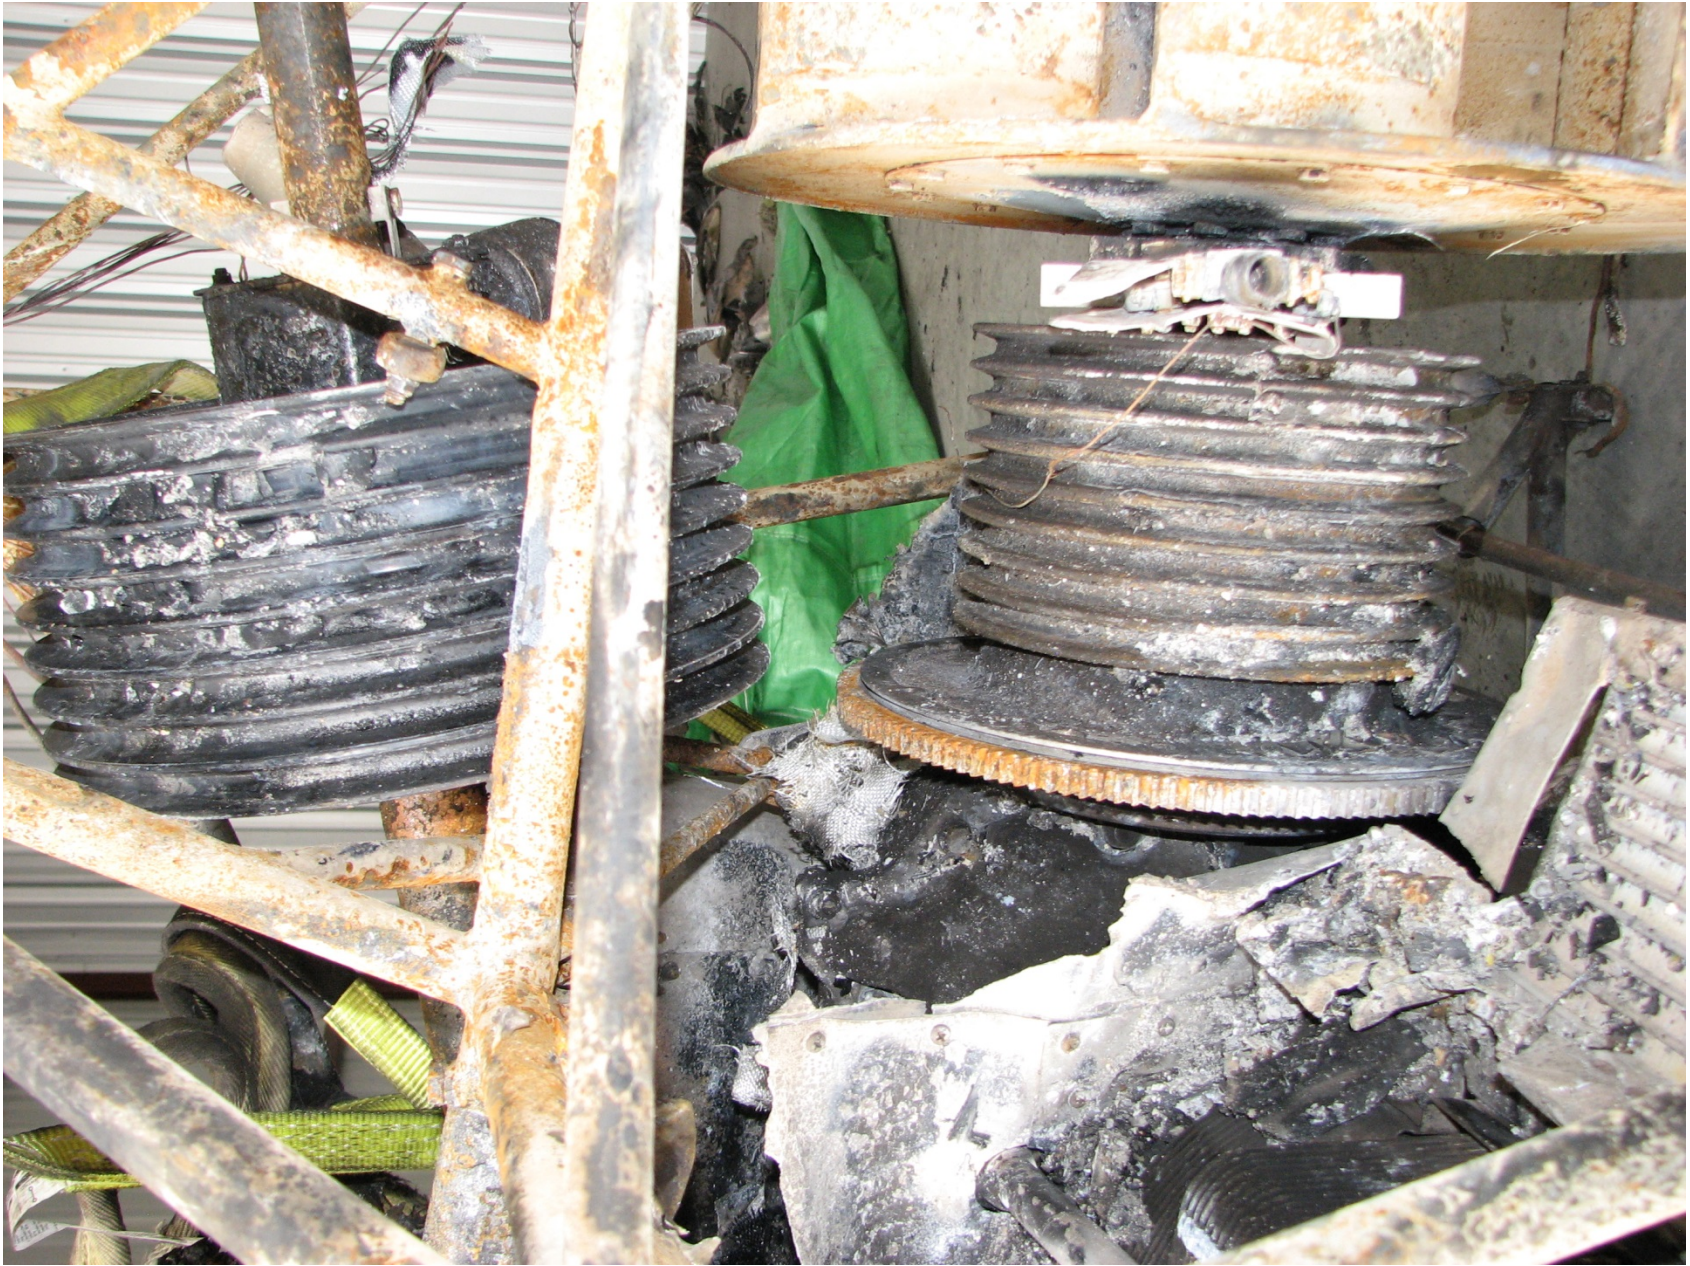
Photo 13 –View of belt drive

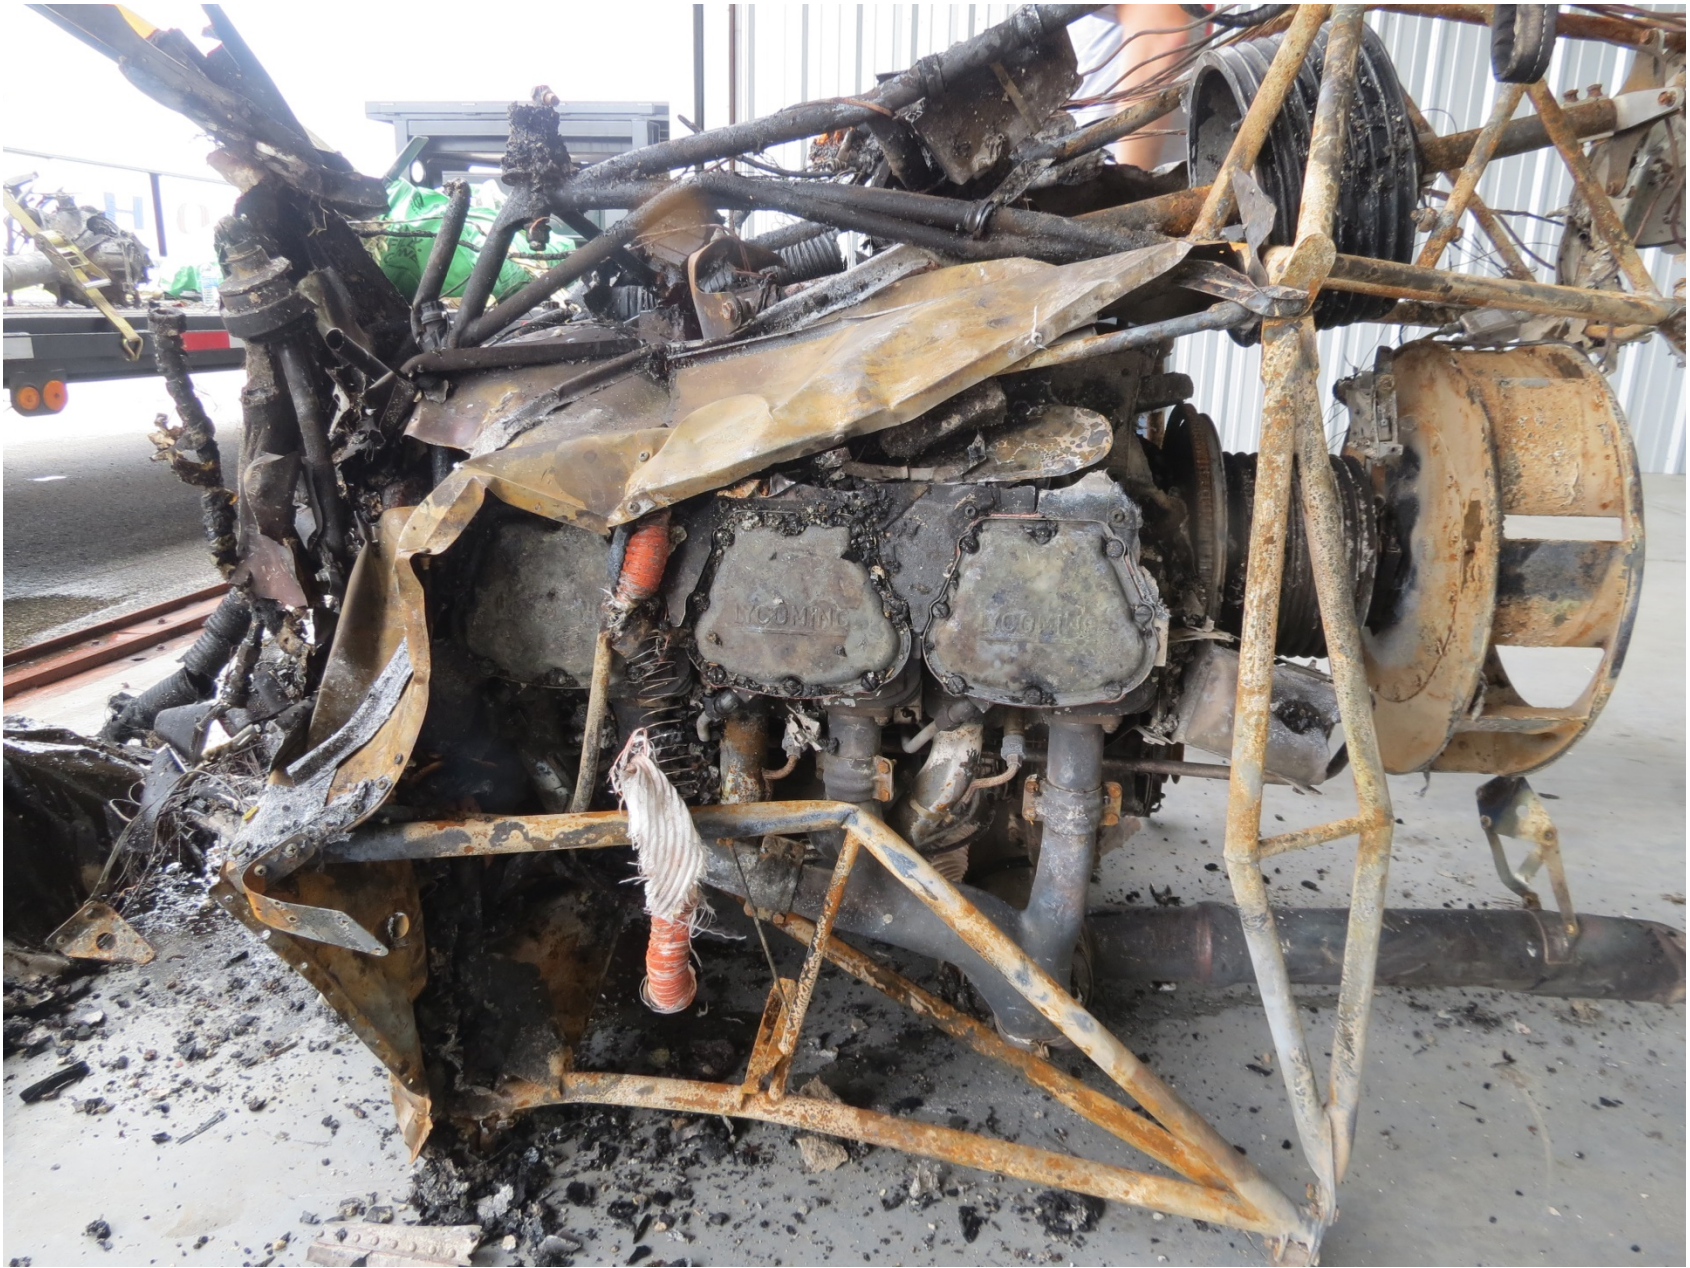
Photo 14 – View of right side of engine

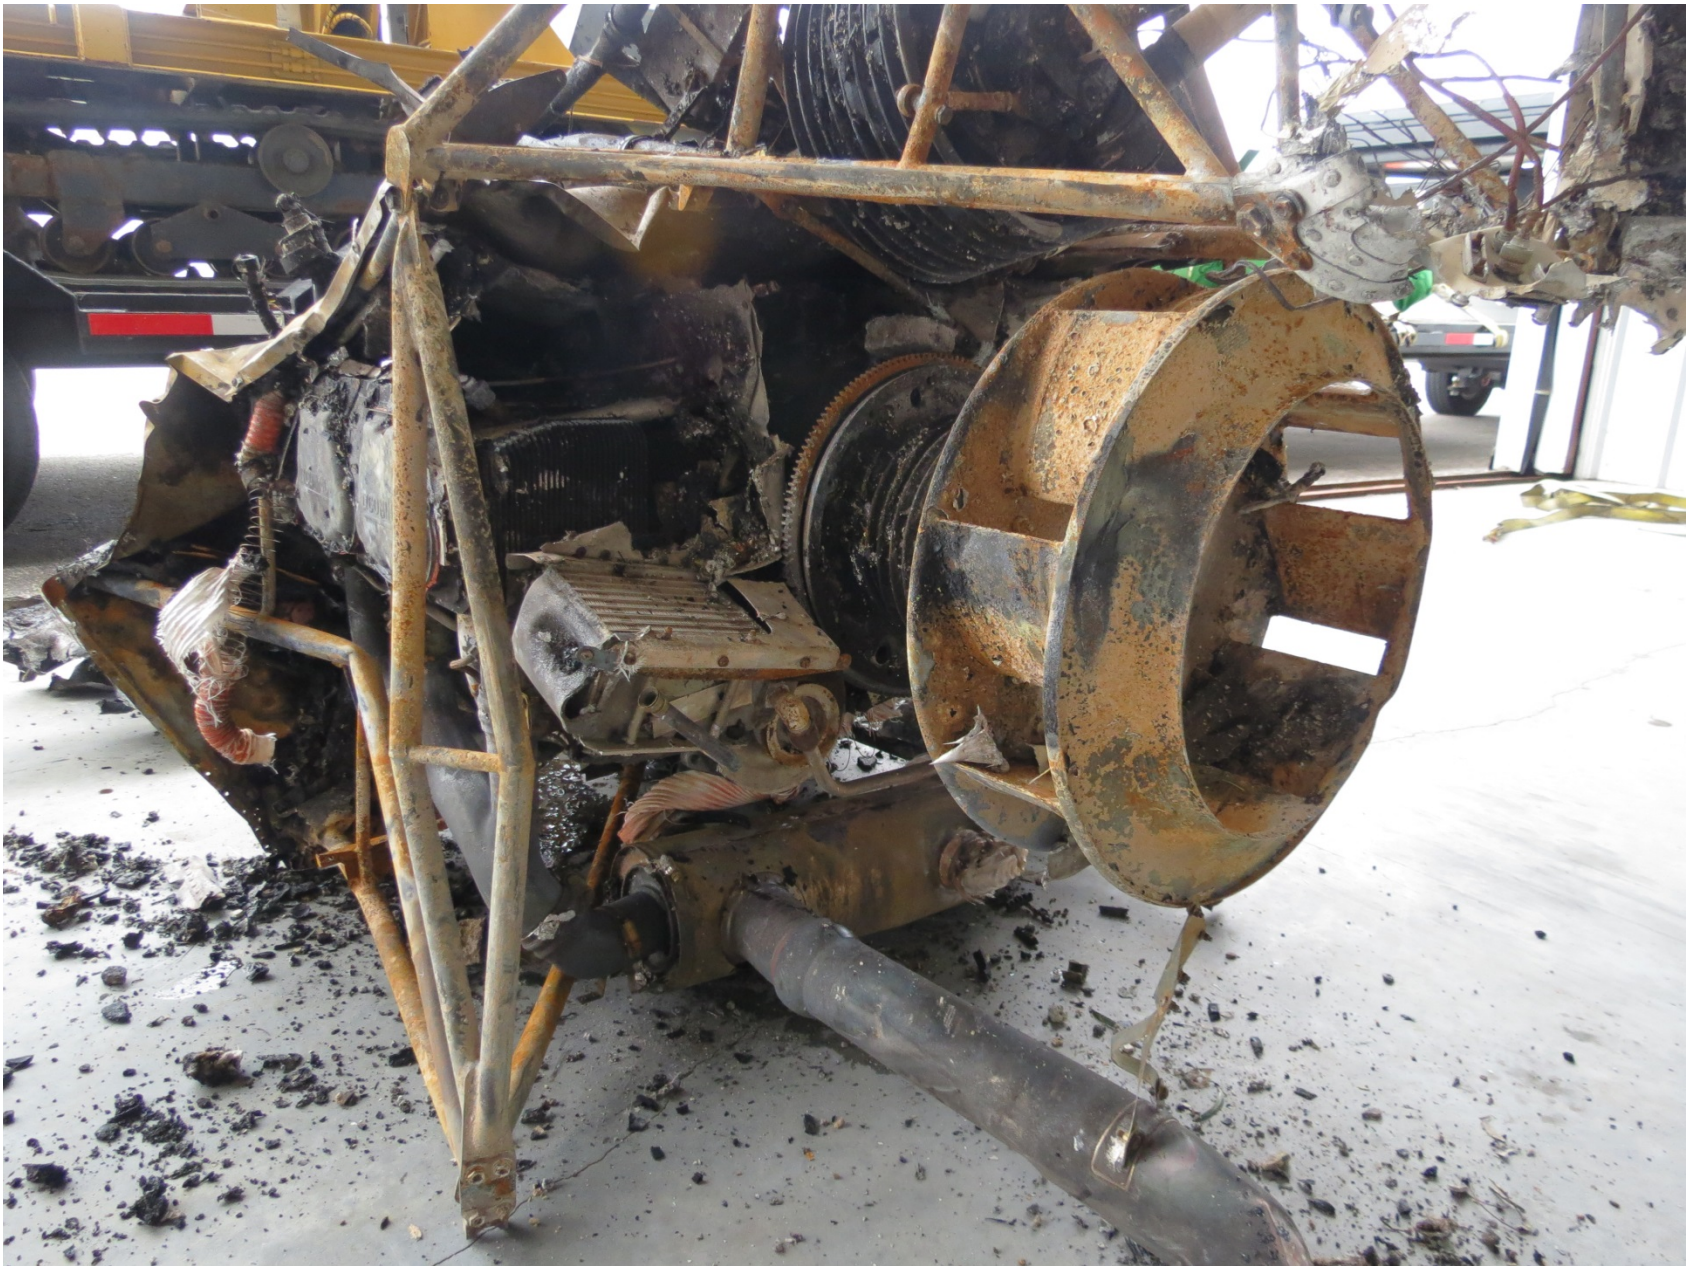
Photo 15 – View of front of engine with drive assembly

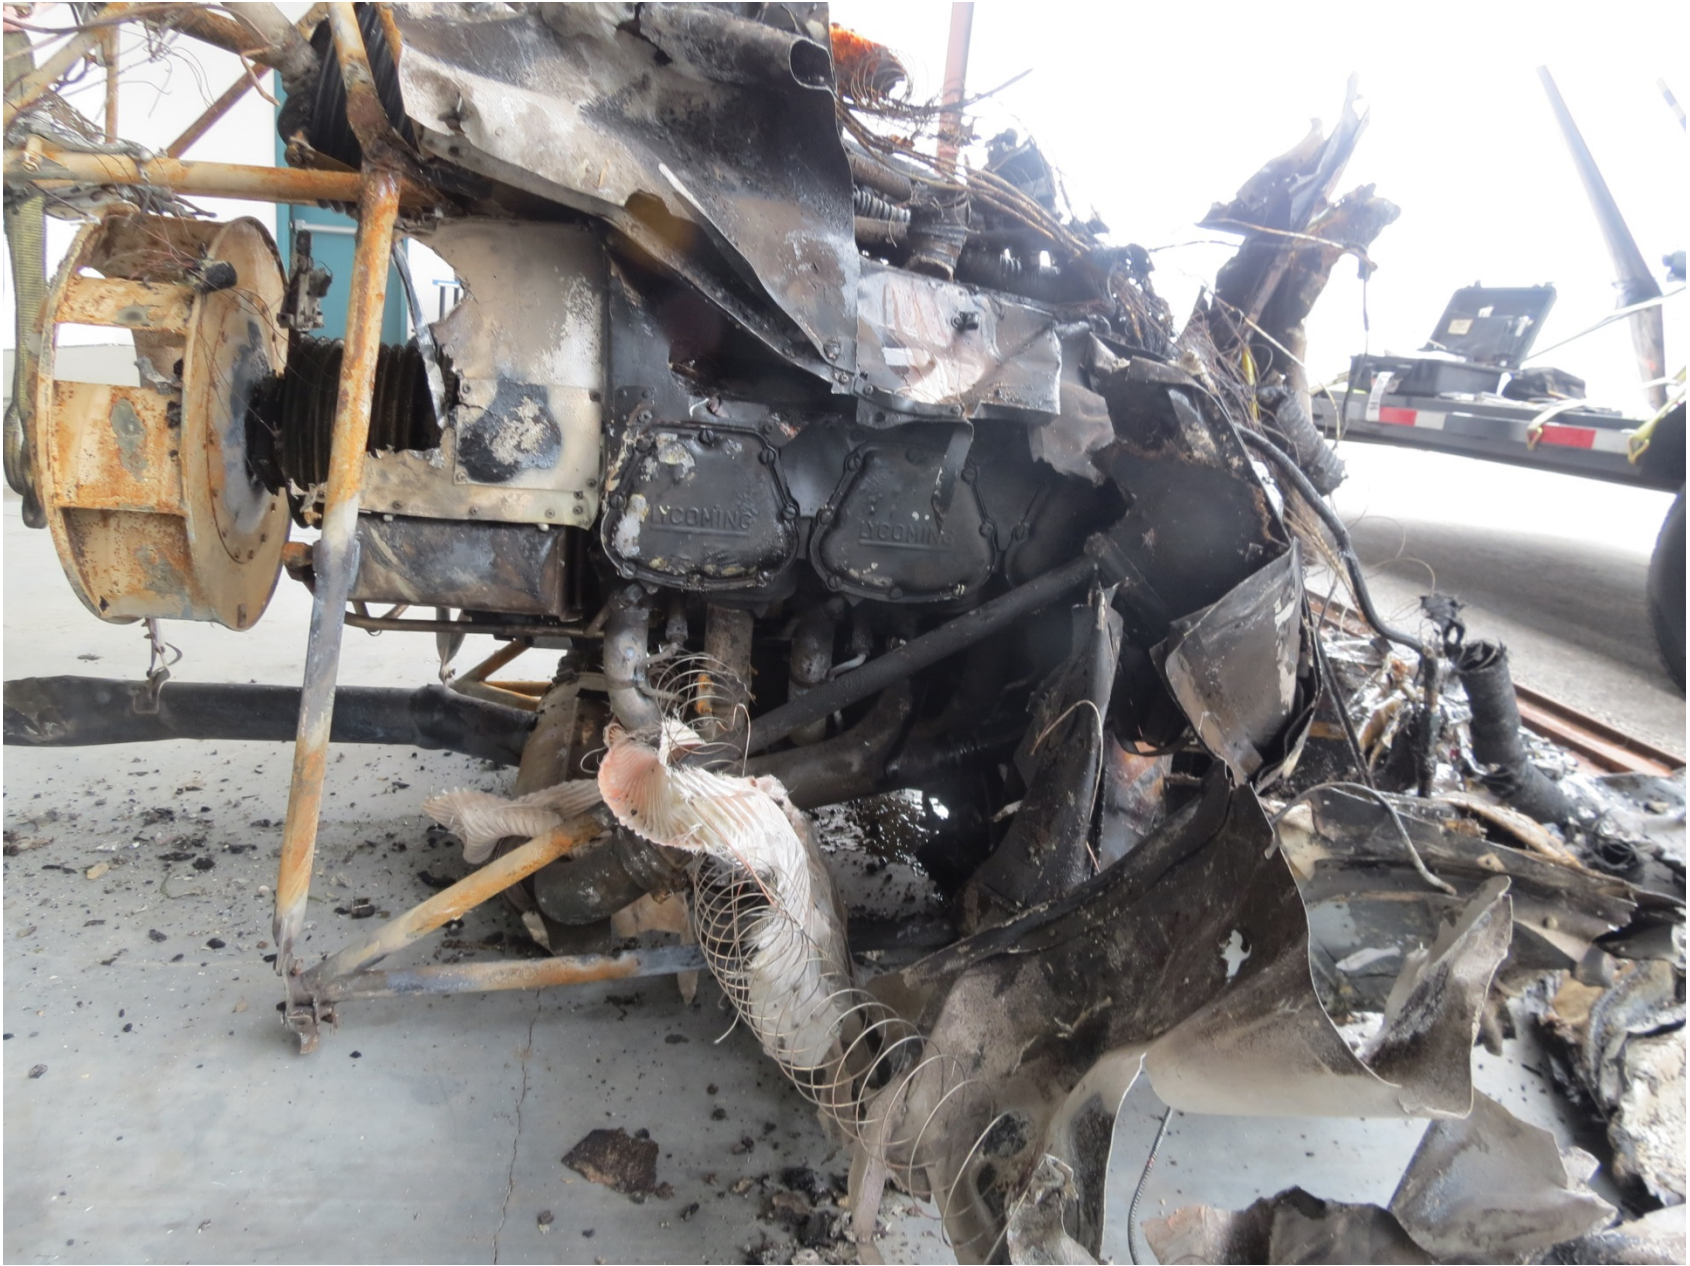
Photo 16 –View of left side of engine

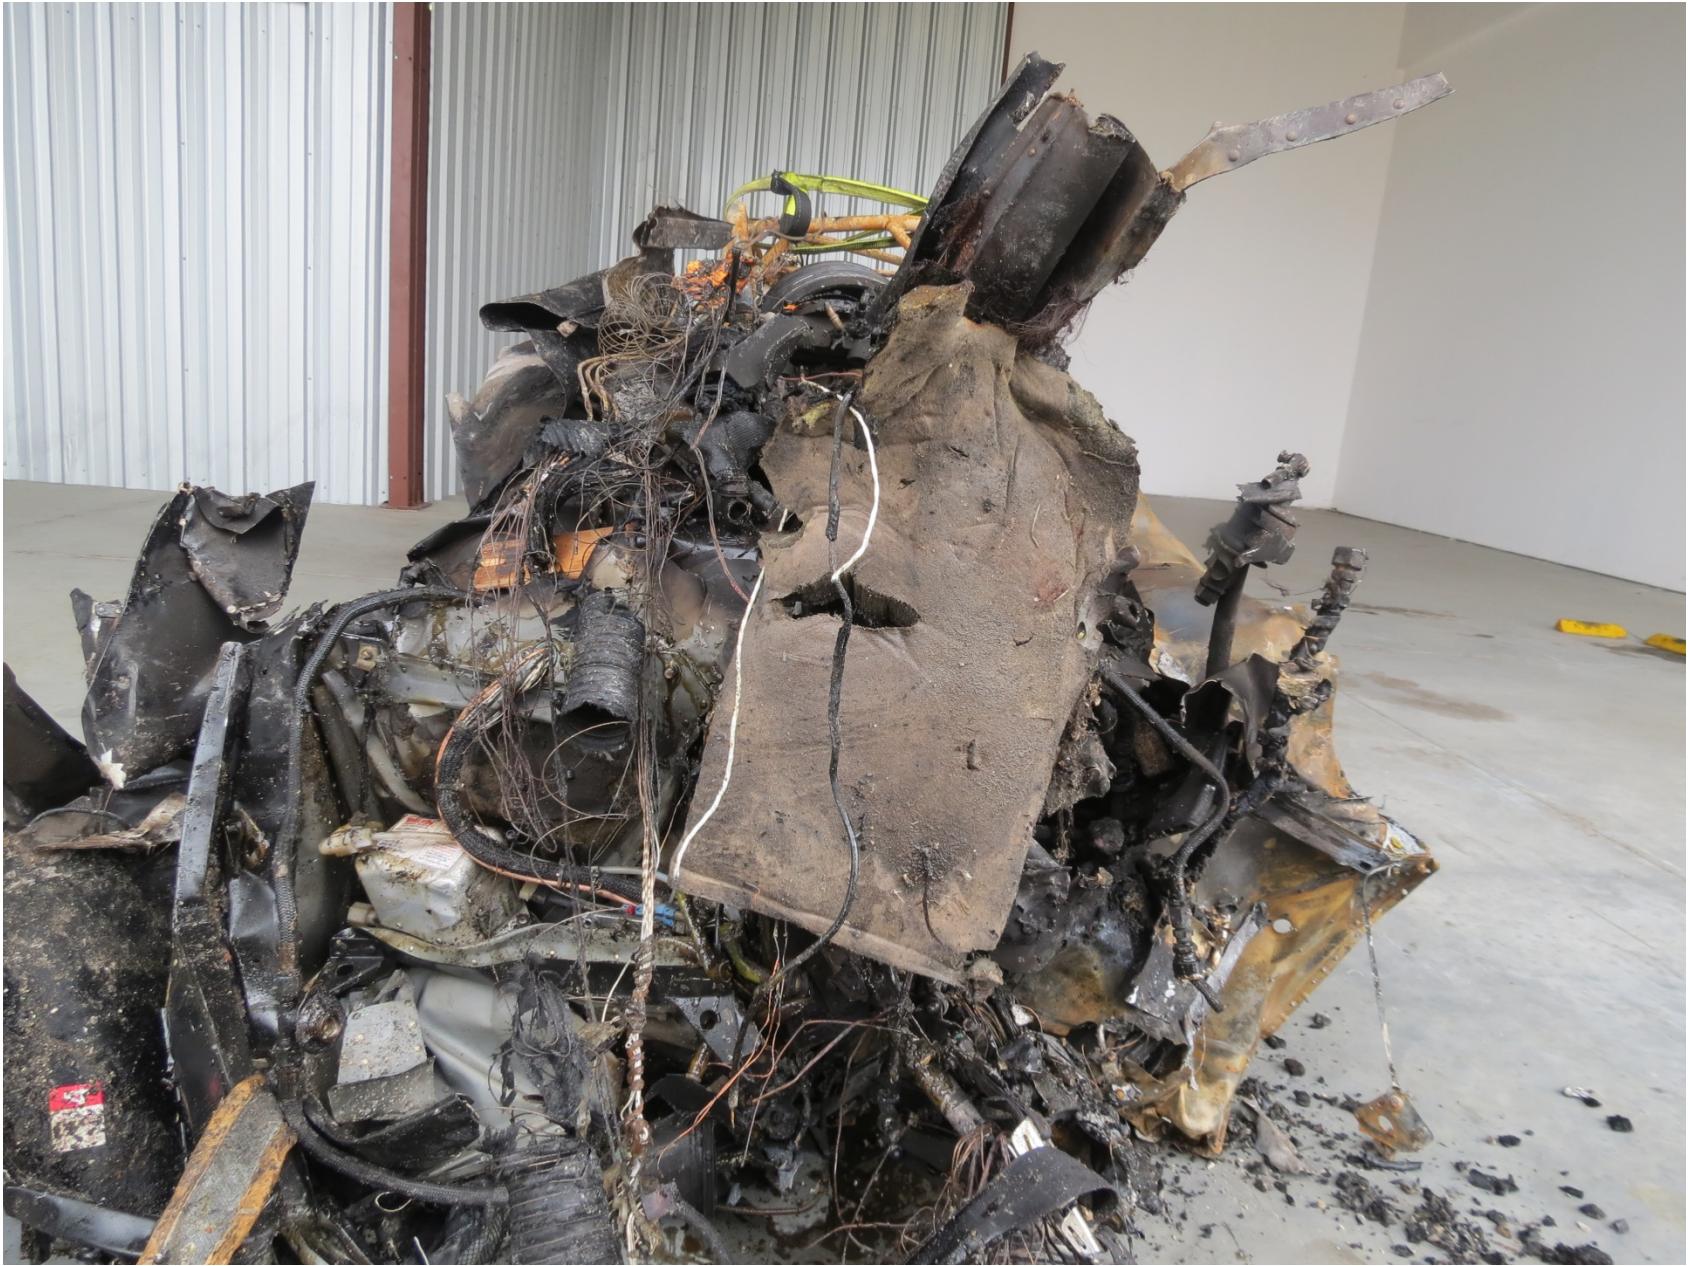
Photo 17 – View of accessory section of engine

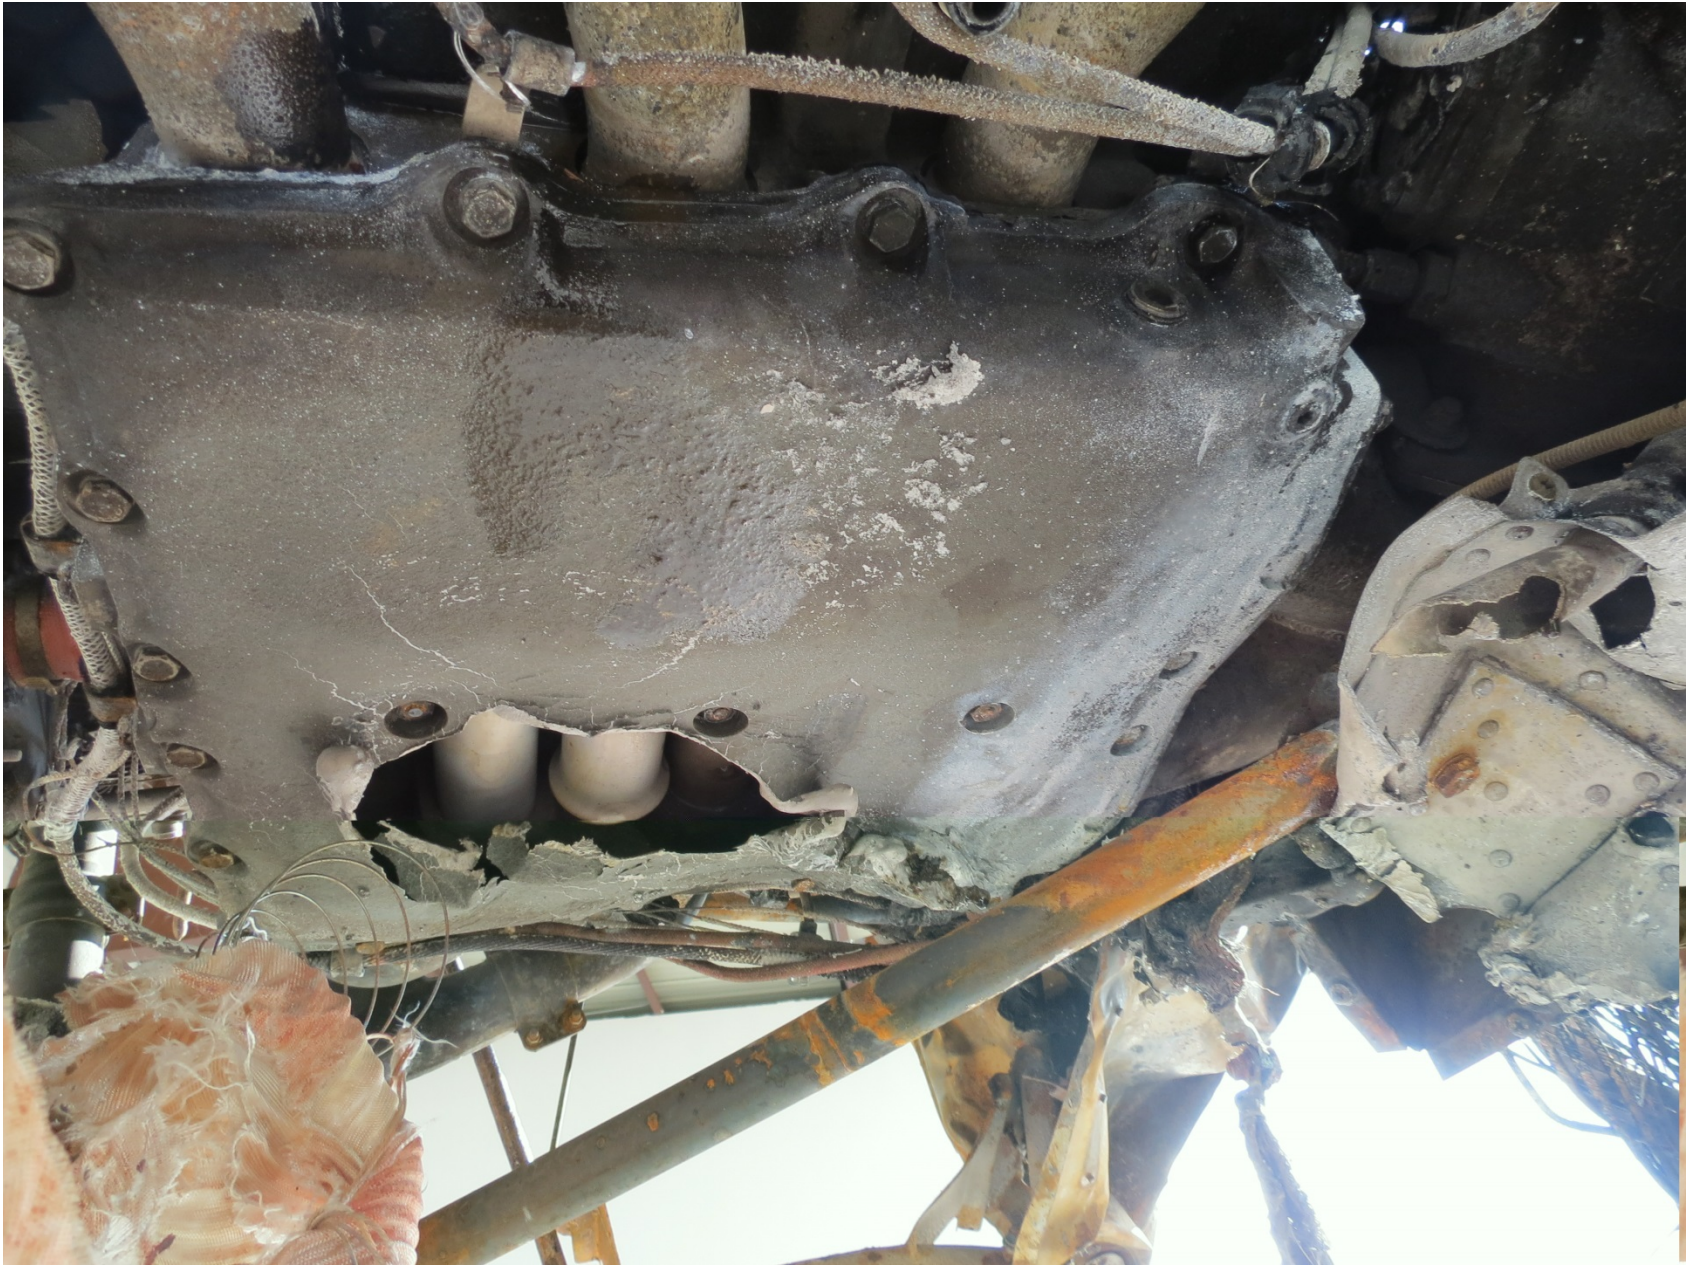
Photo 18 –View of bottom of engine showing engine sump

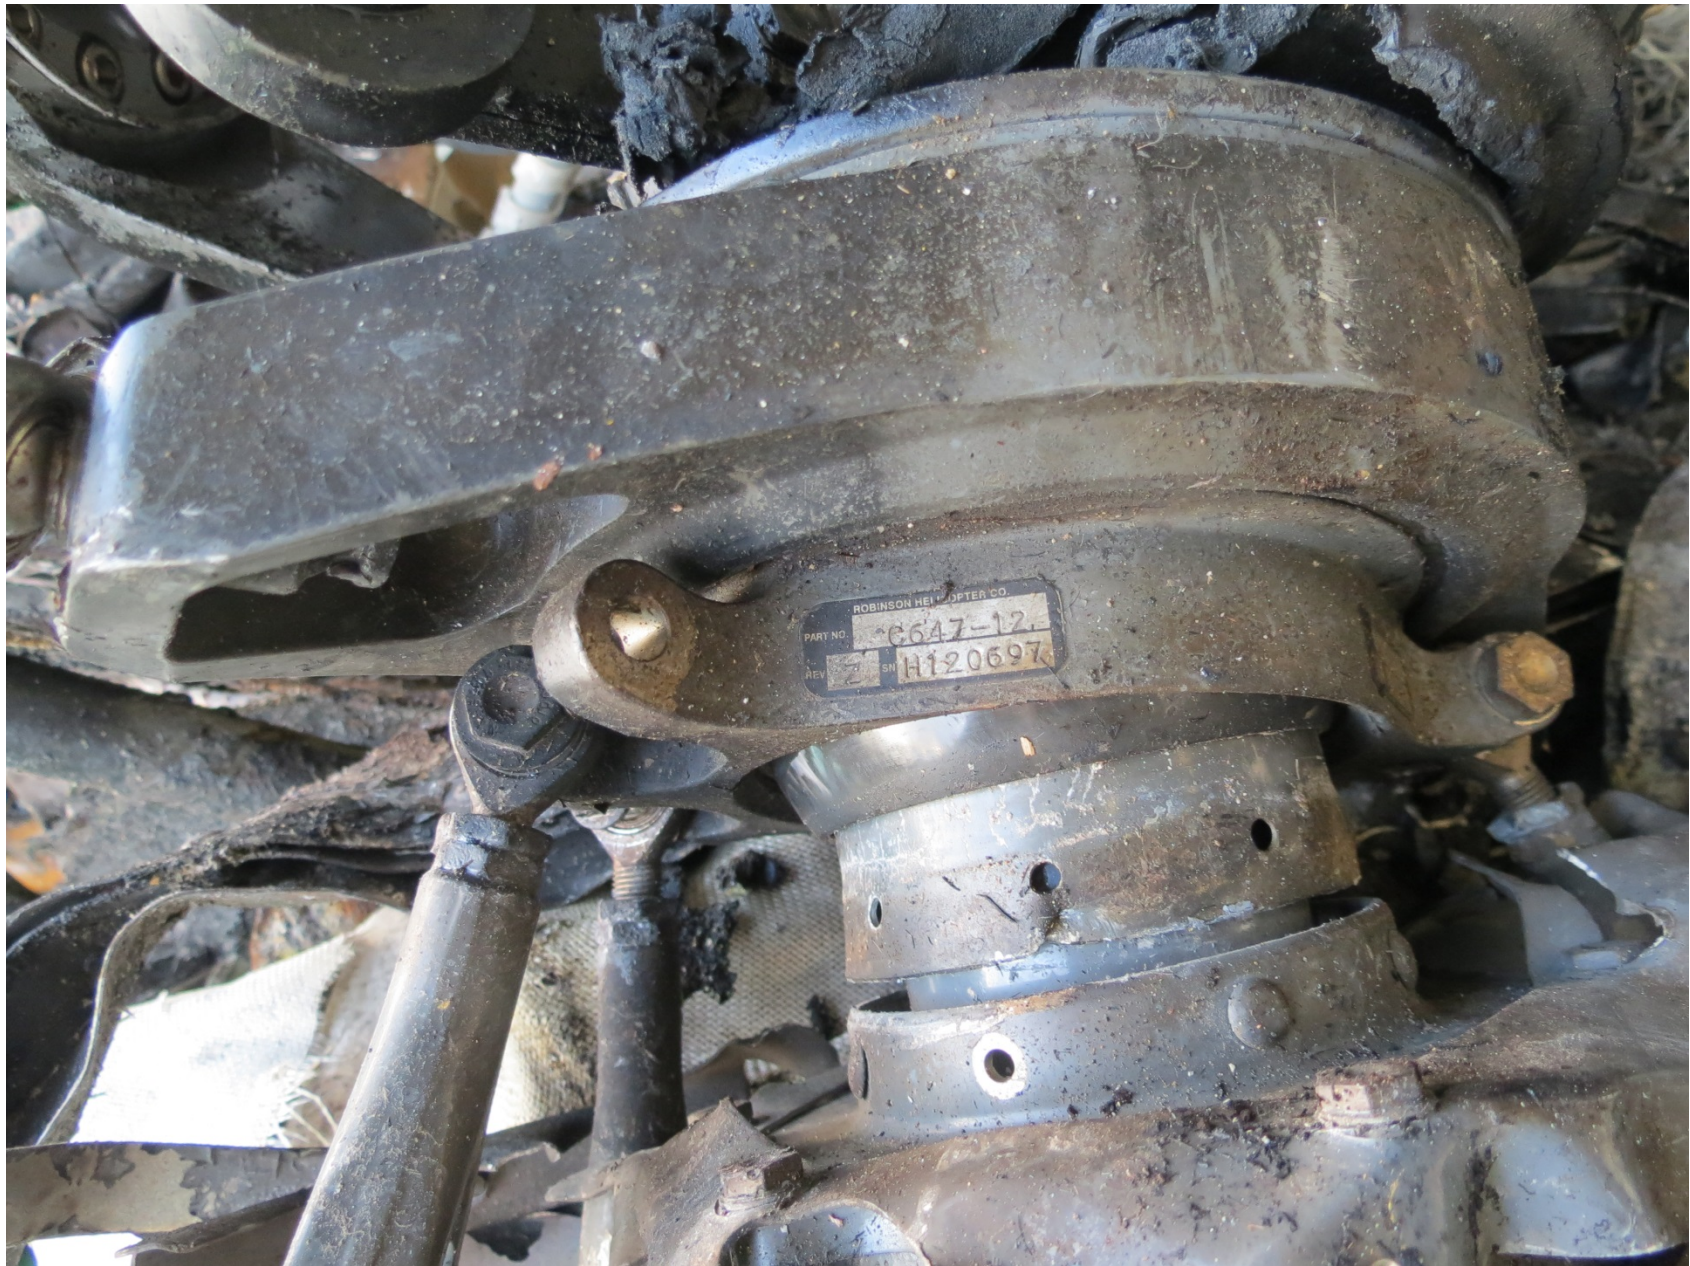
Photo 19 – View of main rotor head/swash plate with missing pitch control linkage

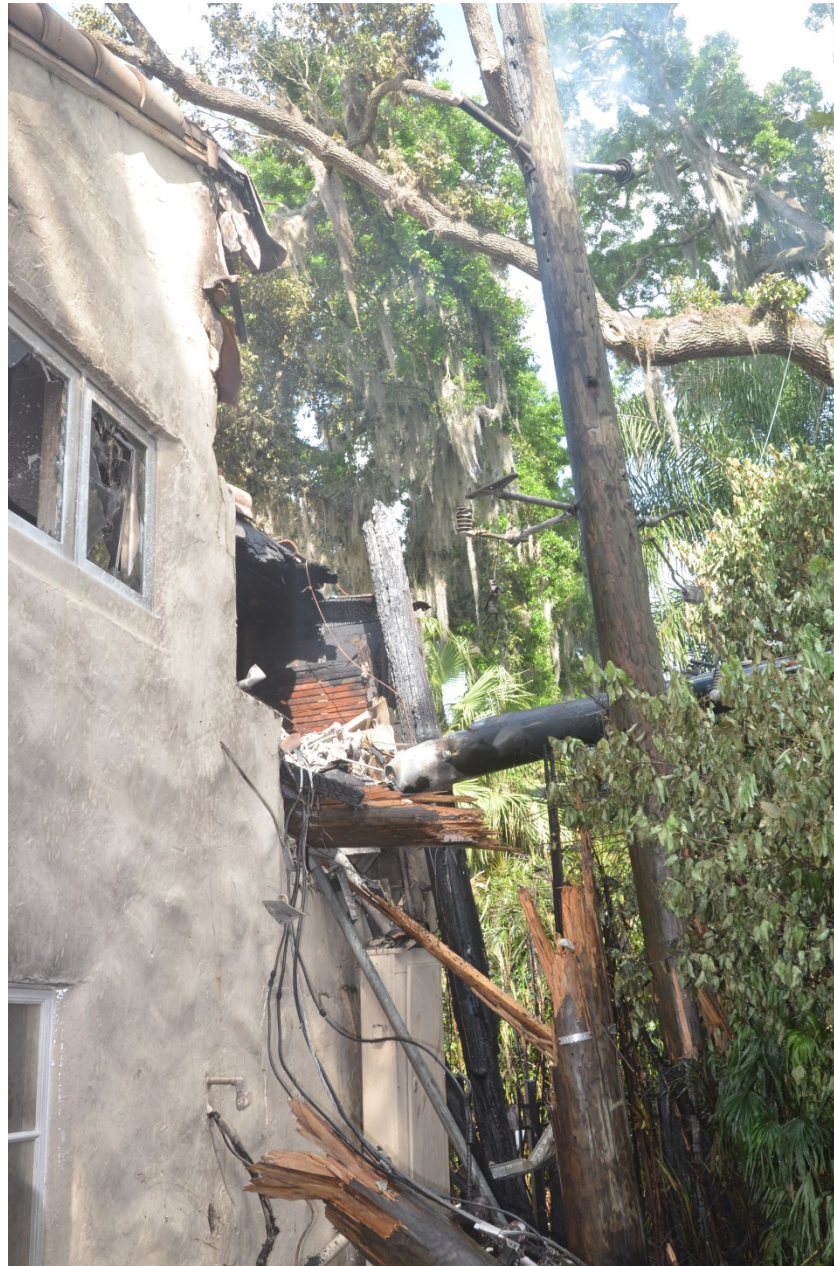
Photo 20 –View of accident site
