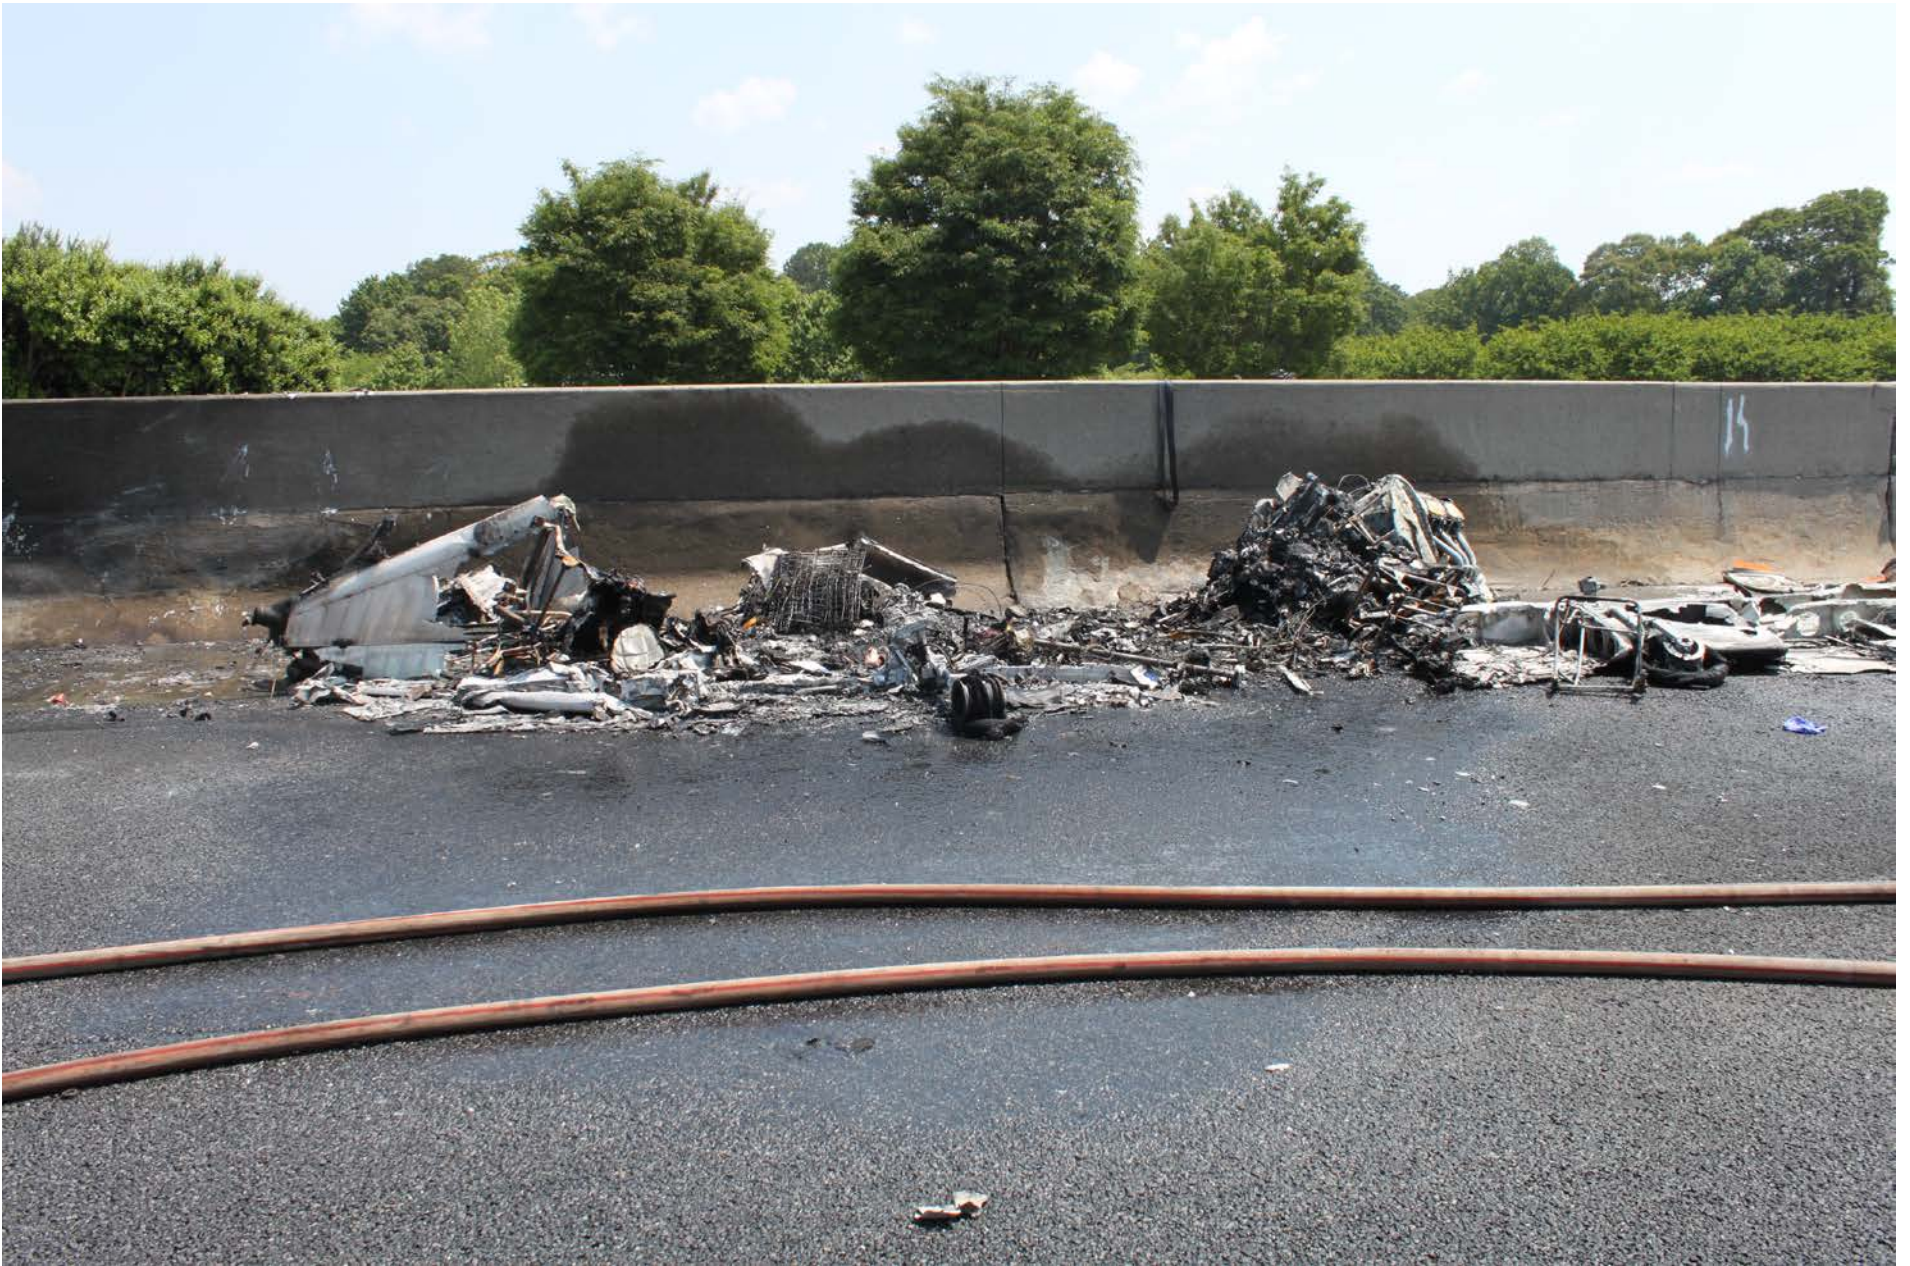
Photo 1 –View of main wreckage

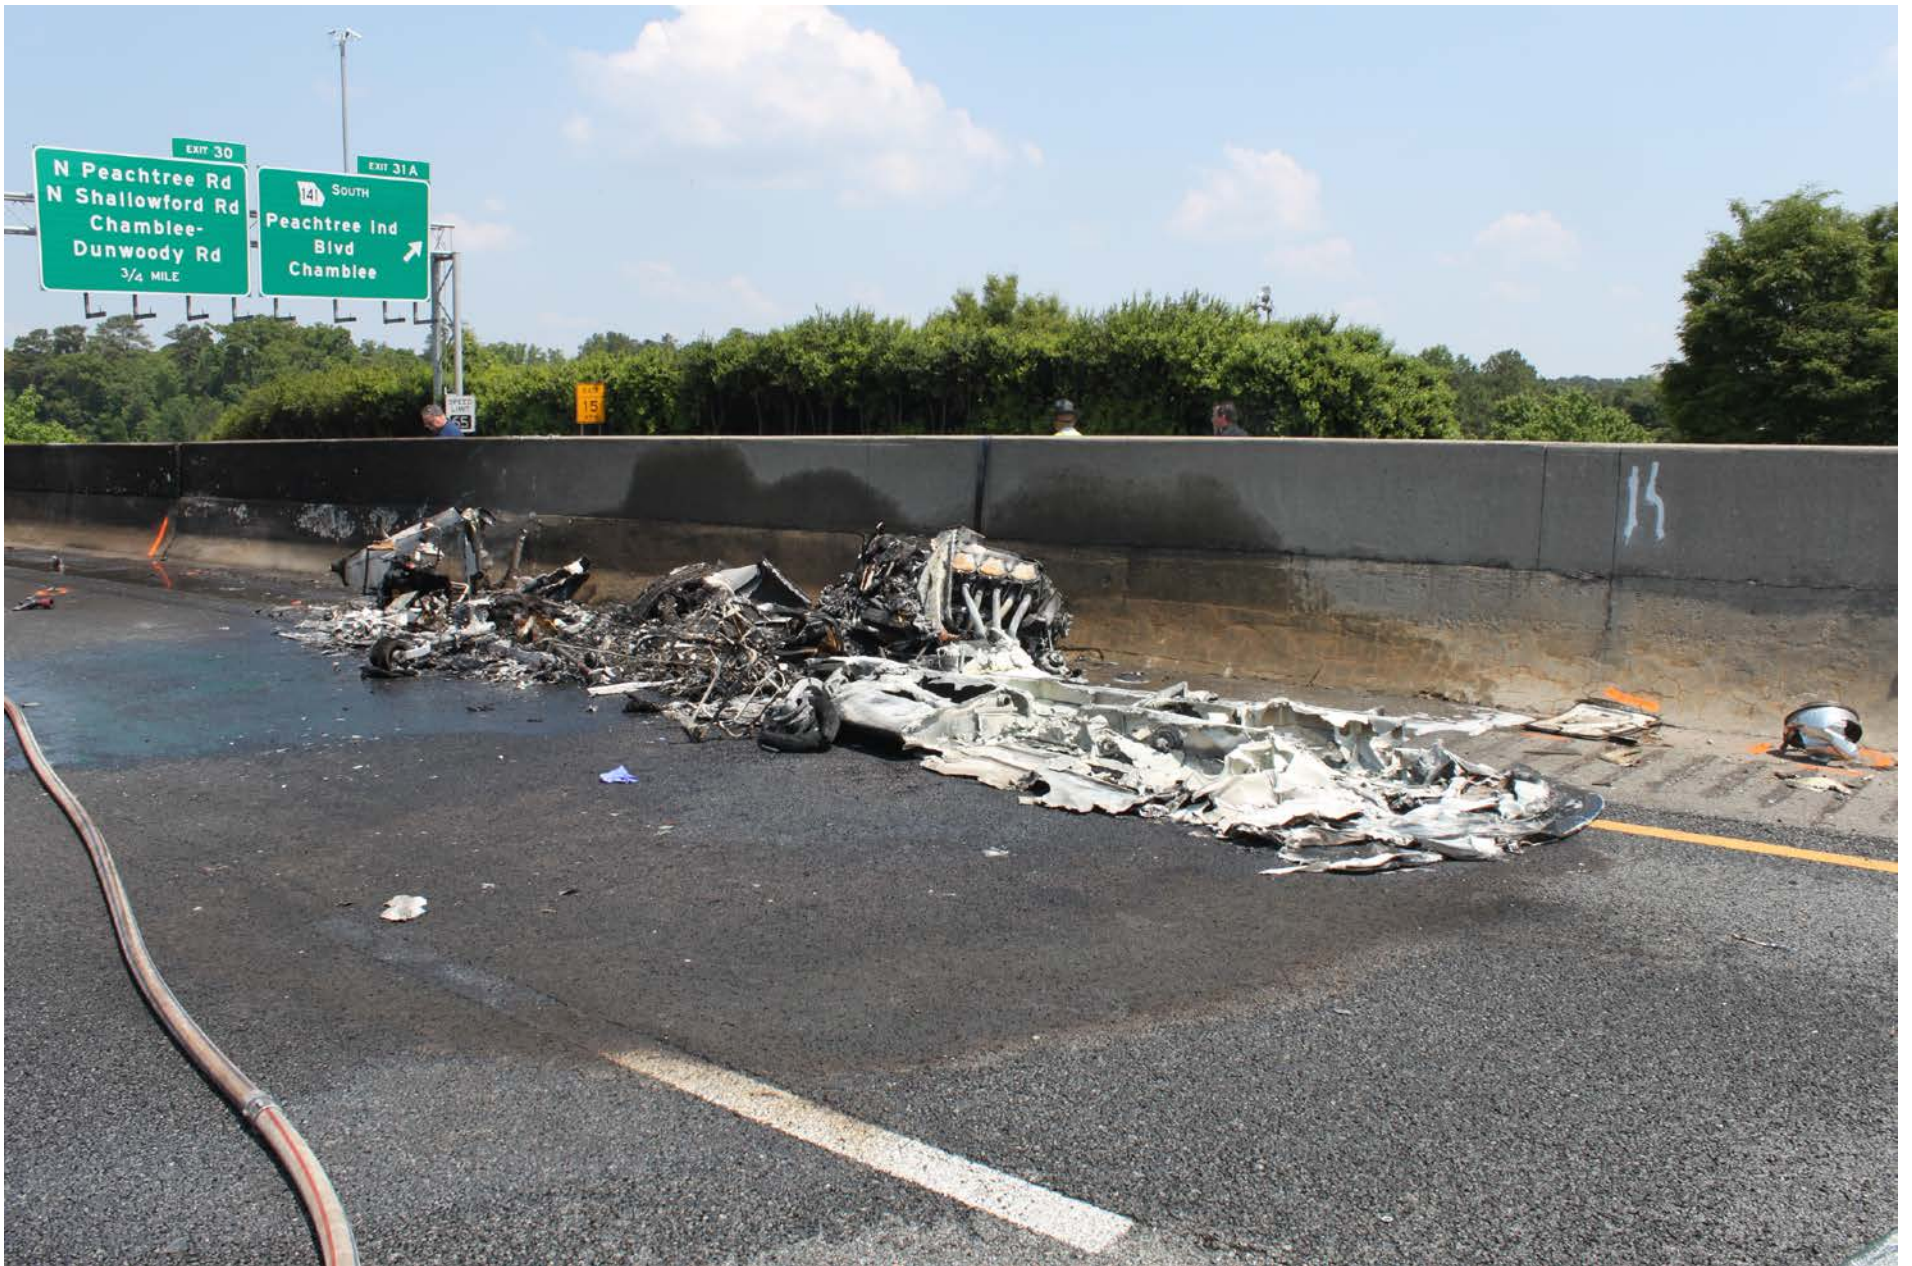
Photo 2 –View of wreckage right side

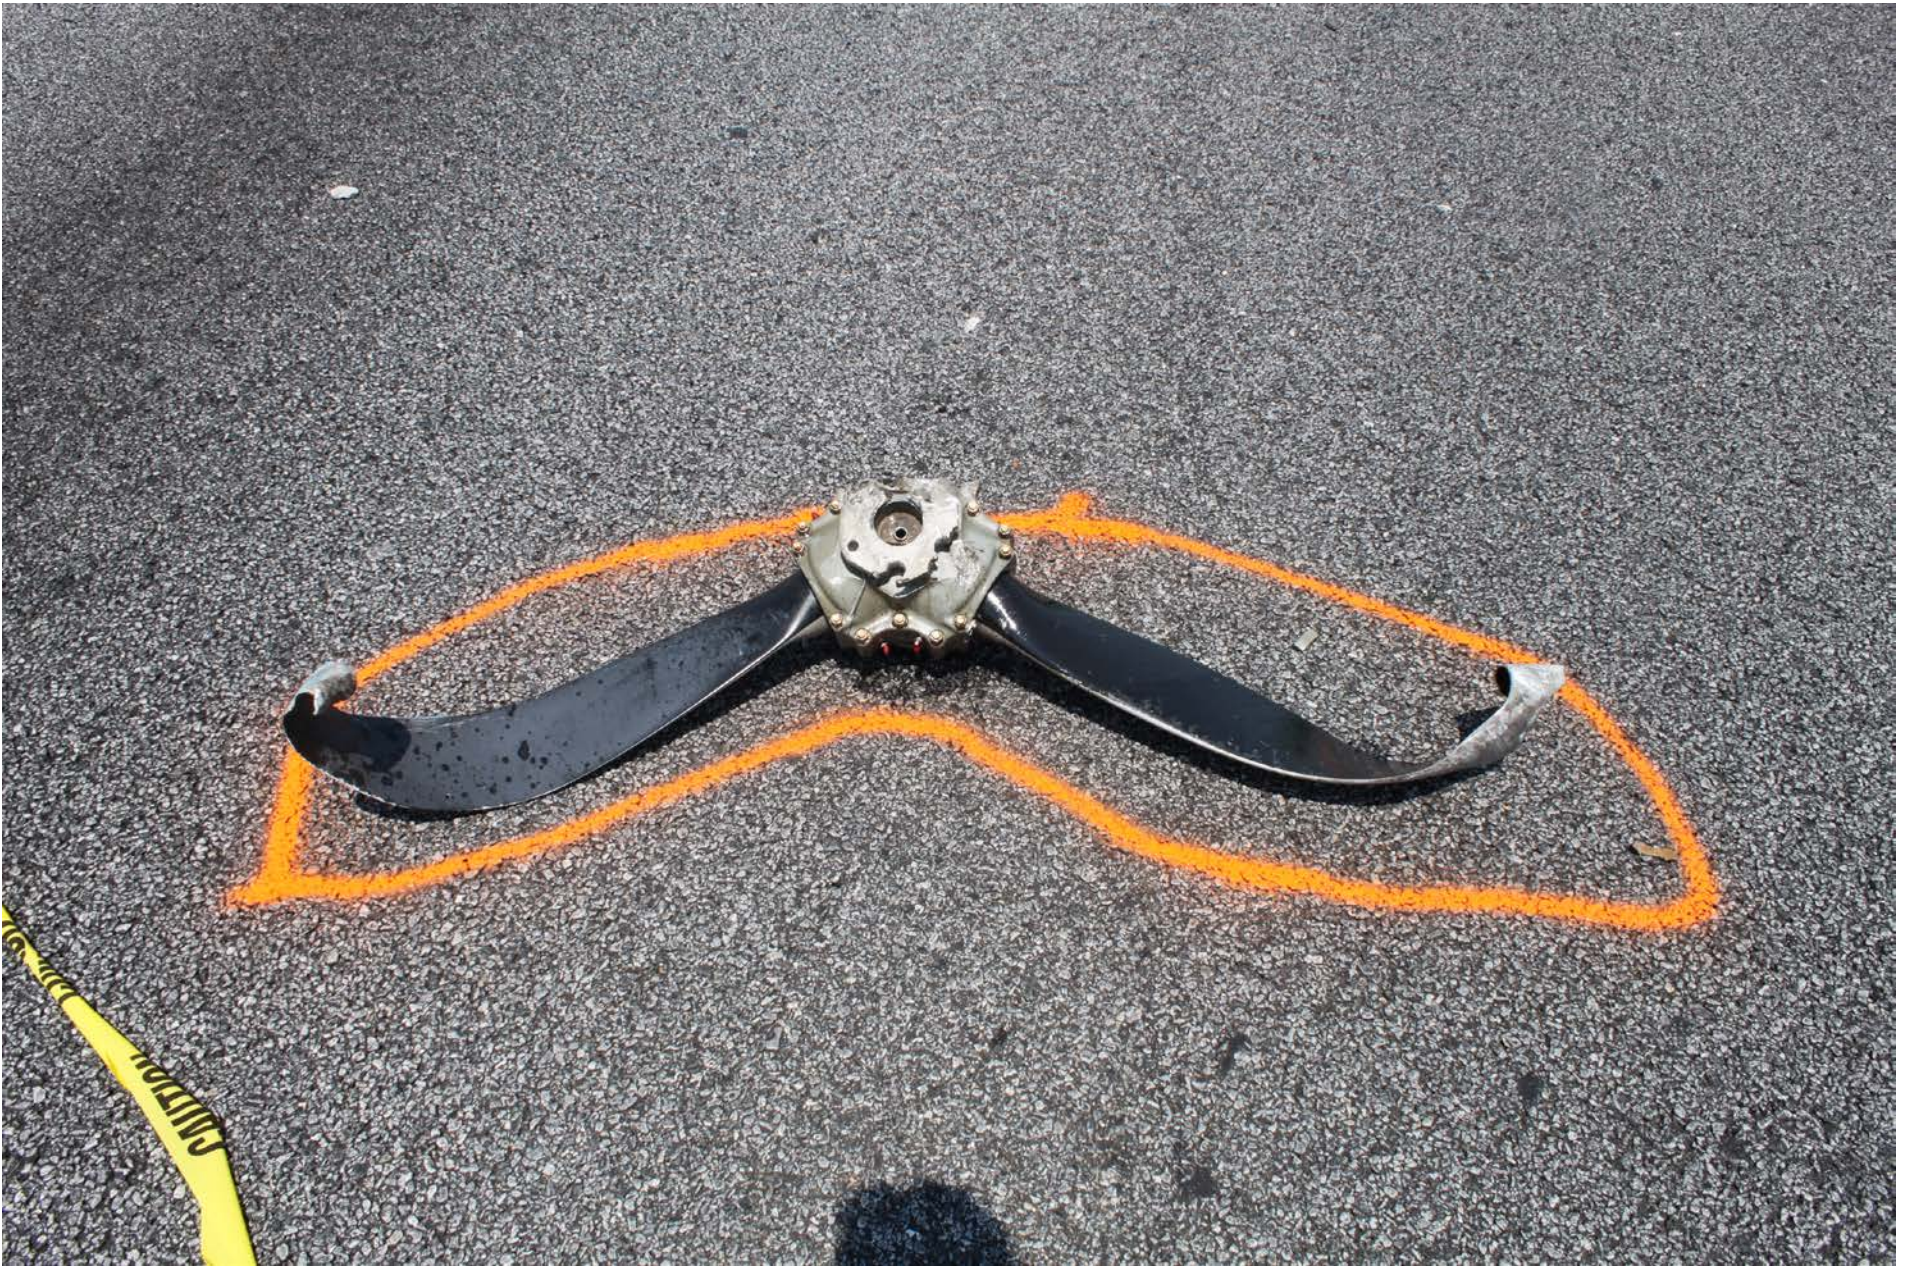
Photo 3 –View of propeller

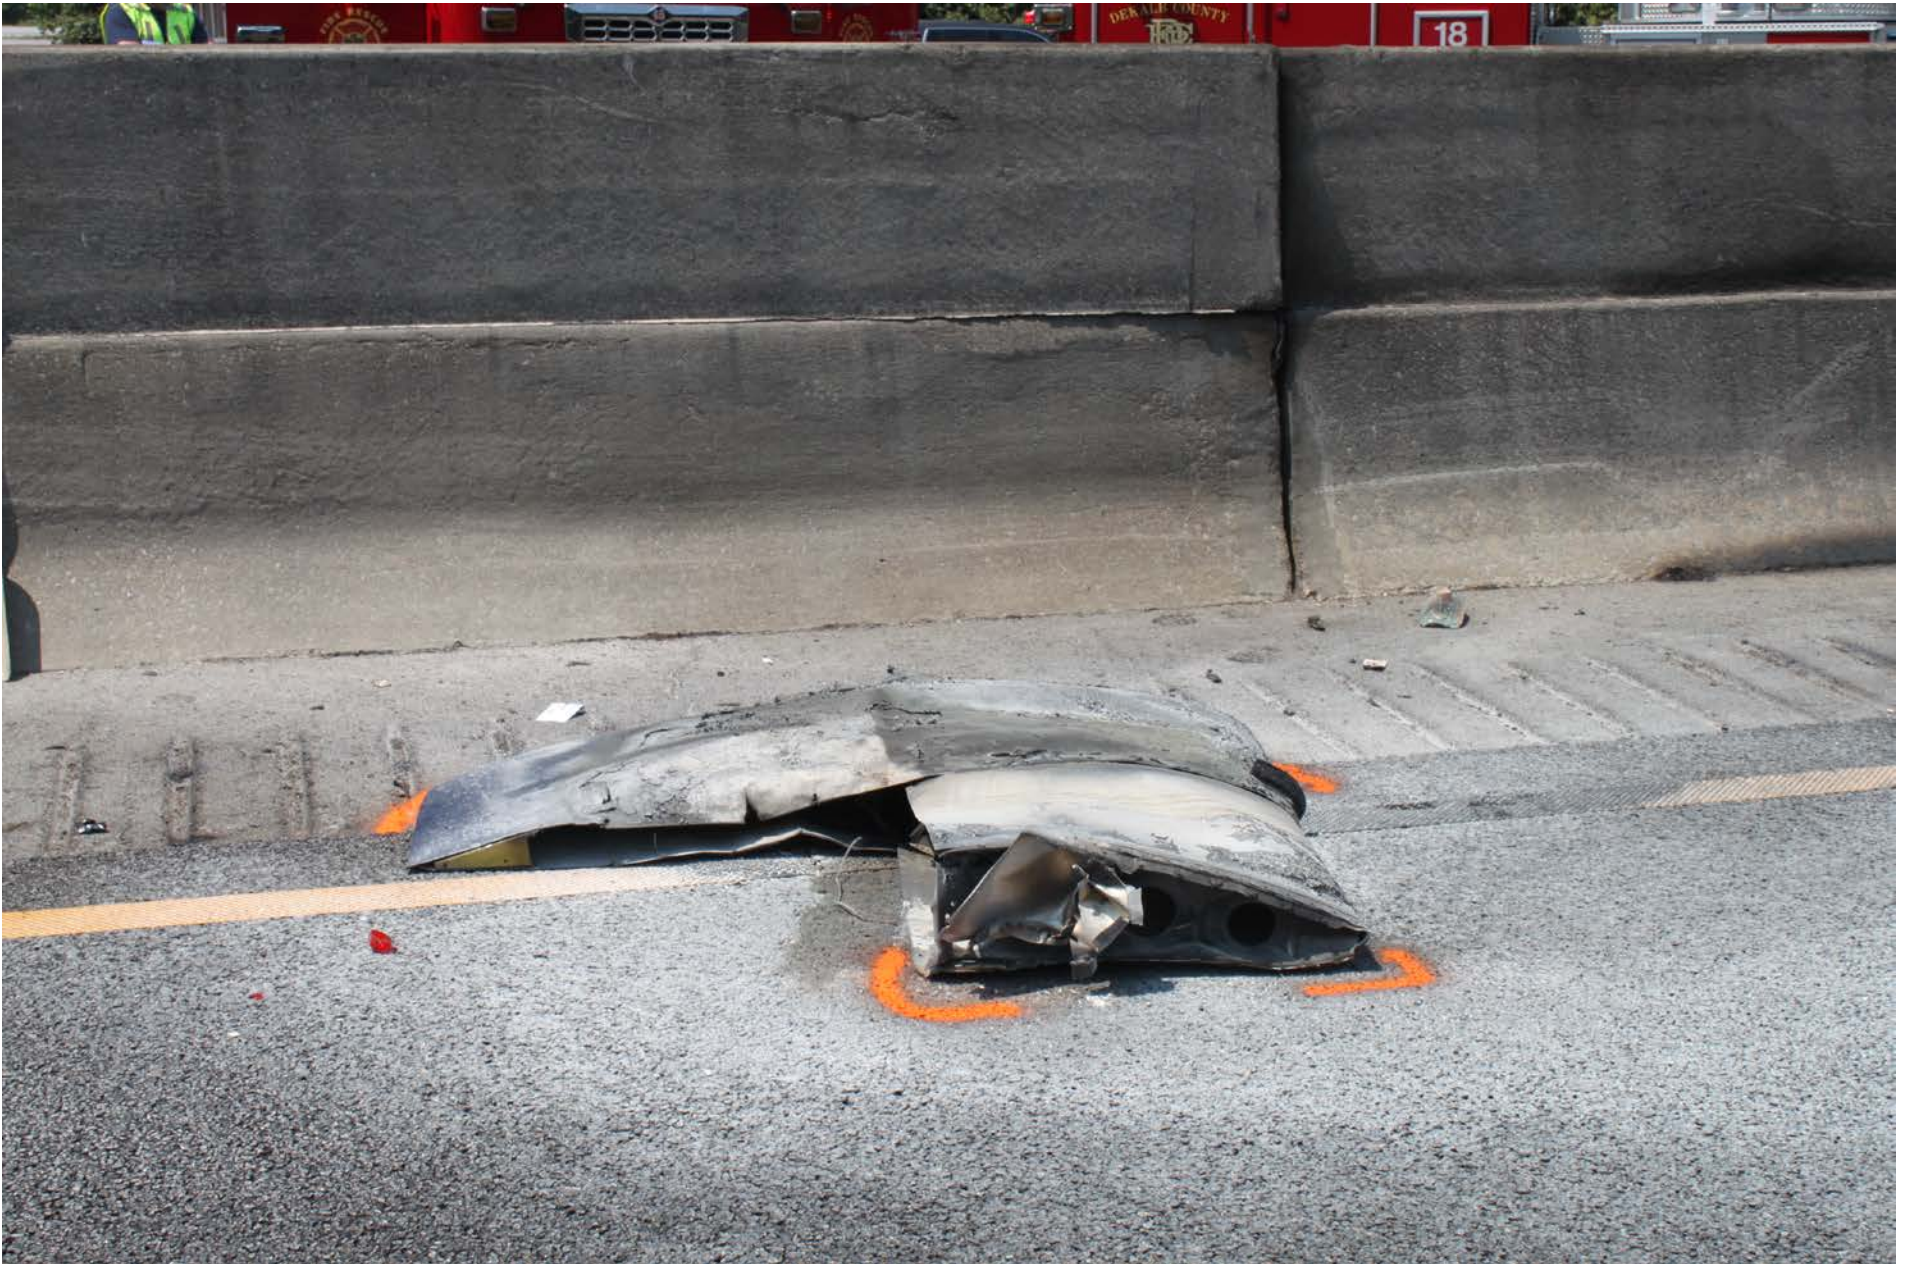
Photo 4 – View of left wing tip

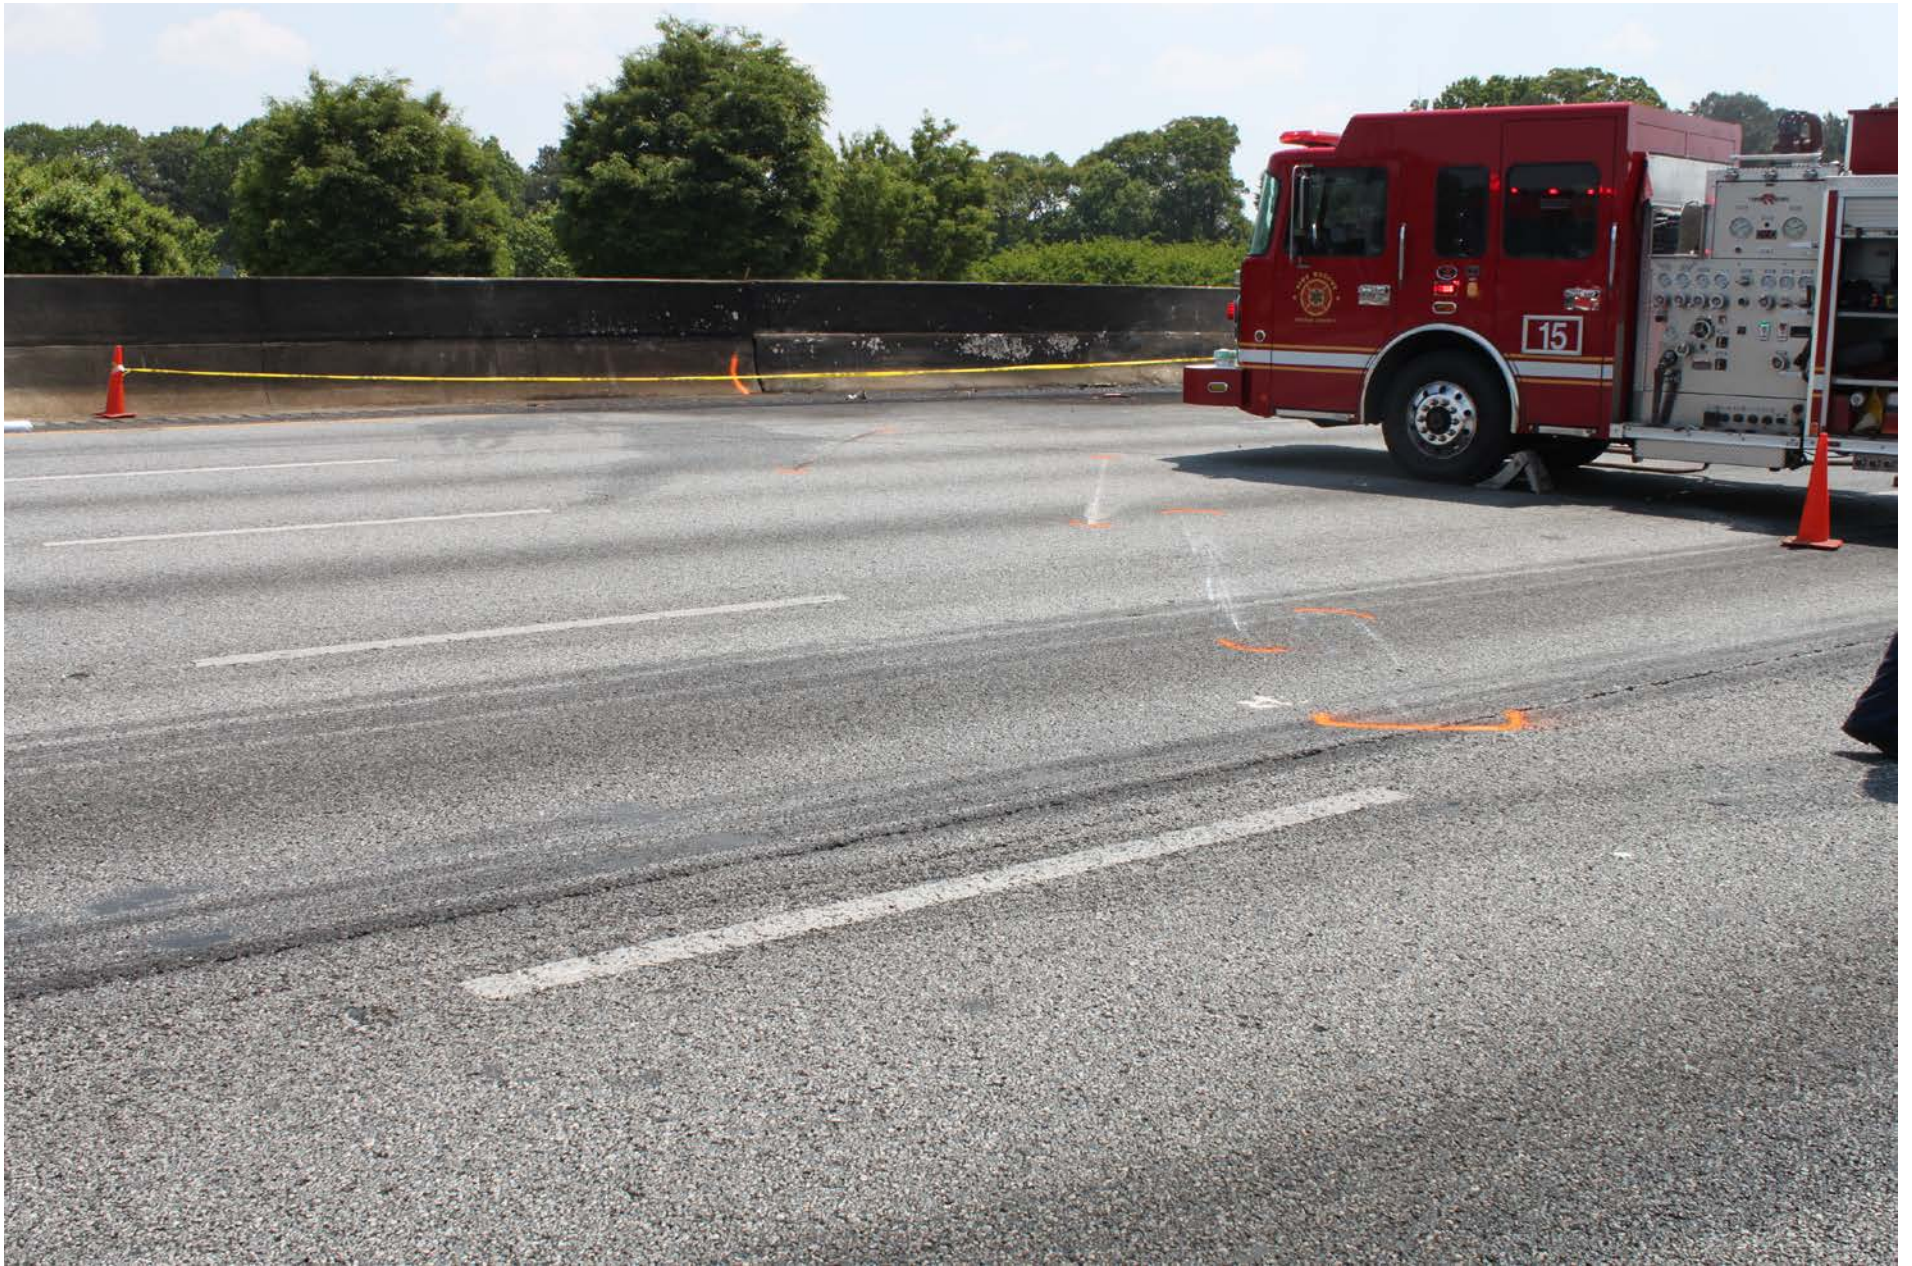
Photo 5 – View of ground scars

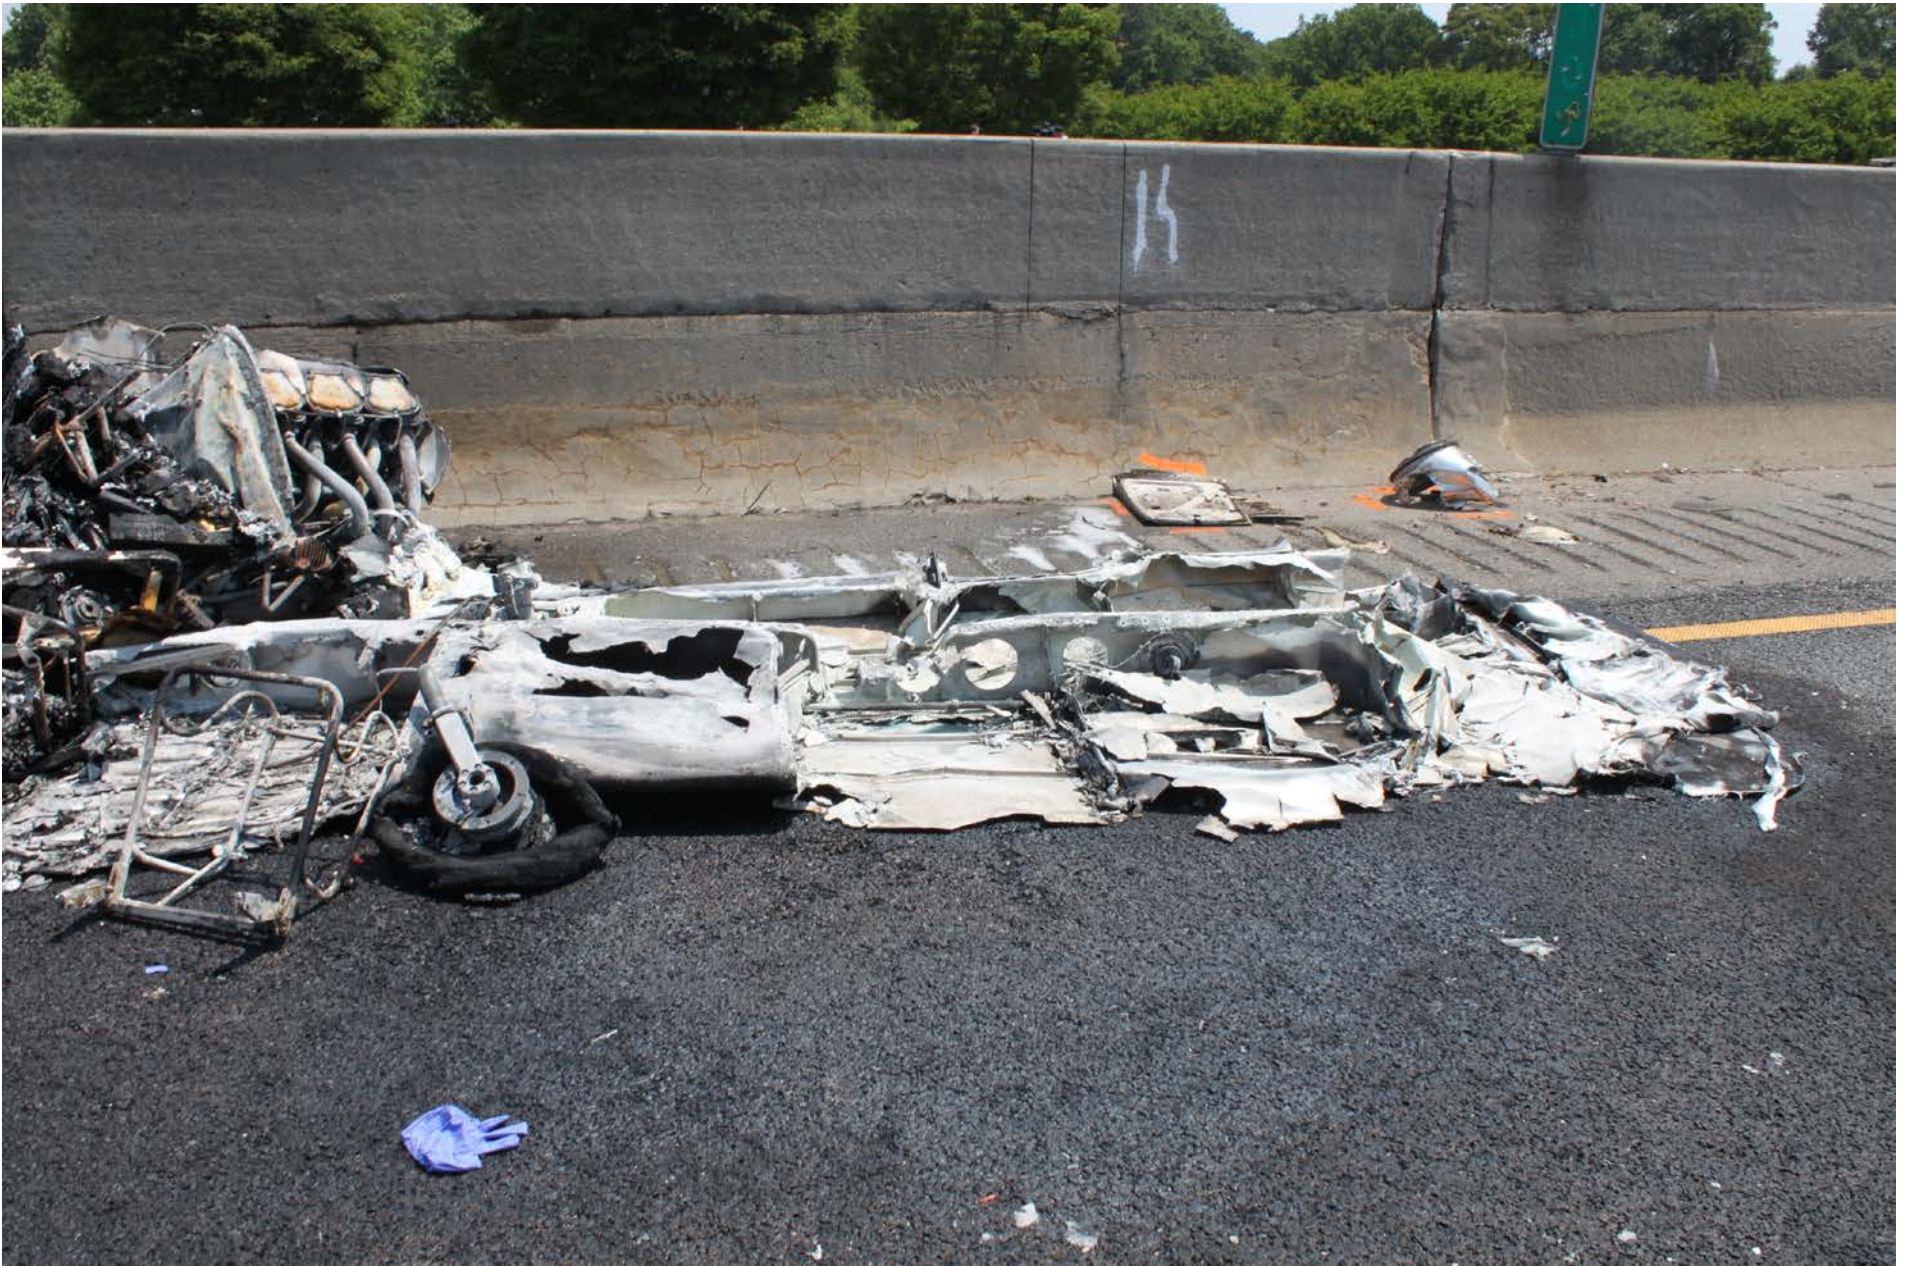
Photo 6 – View of fire damaged right wing

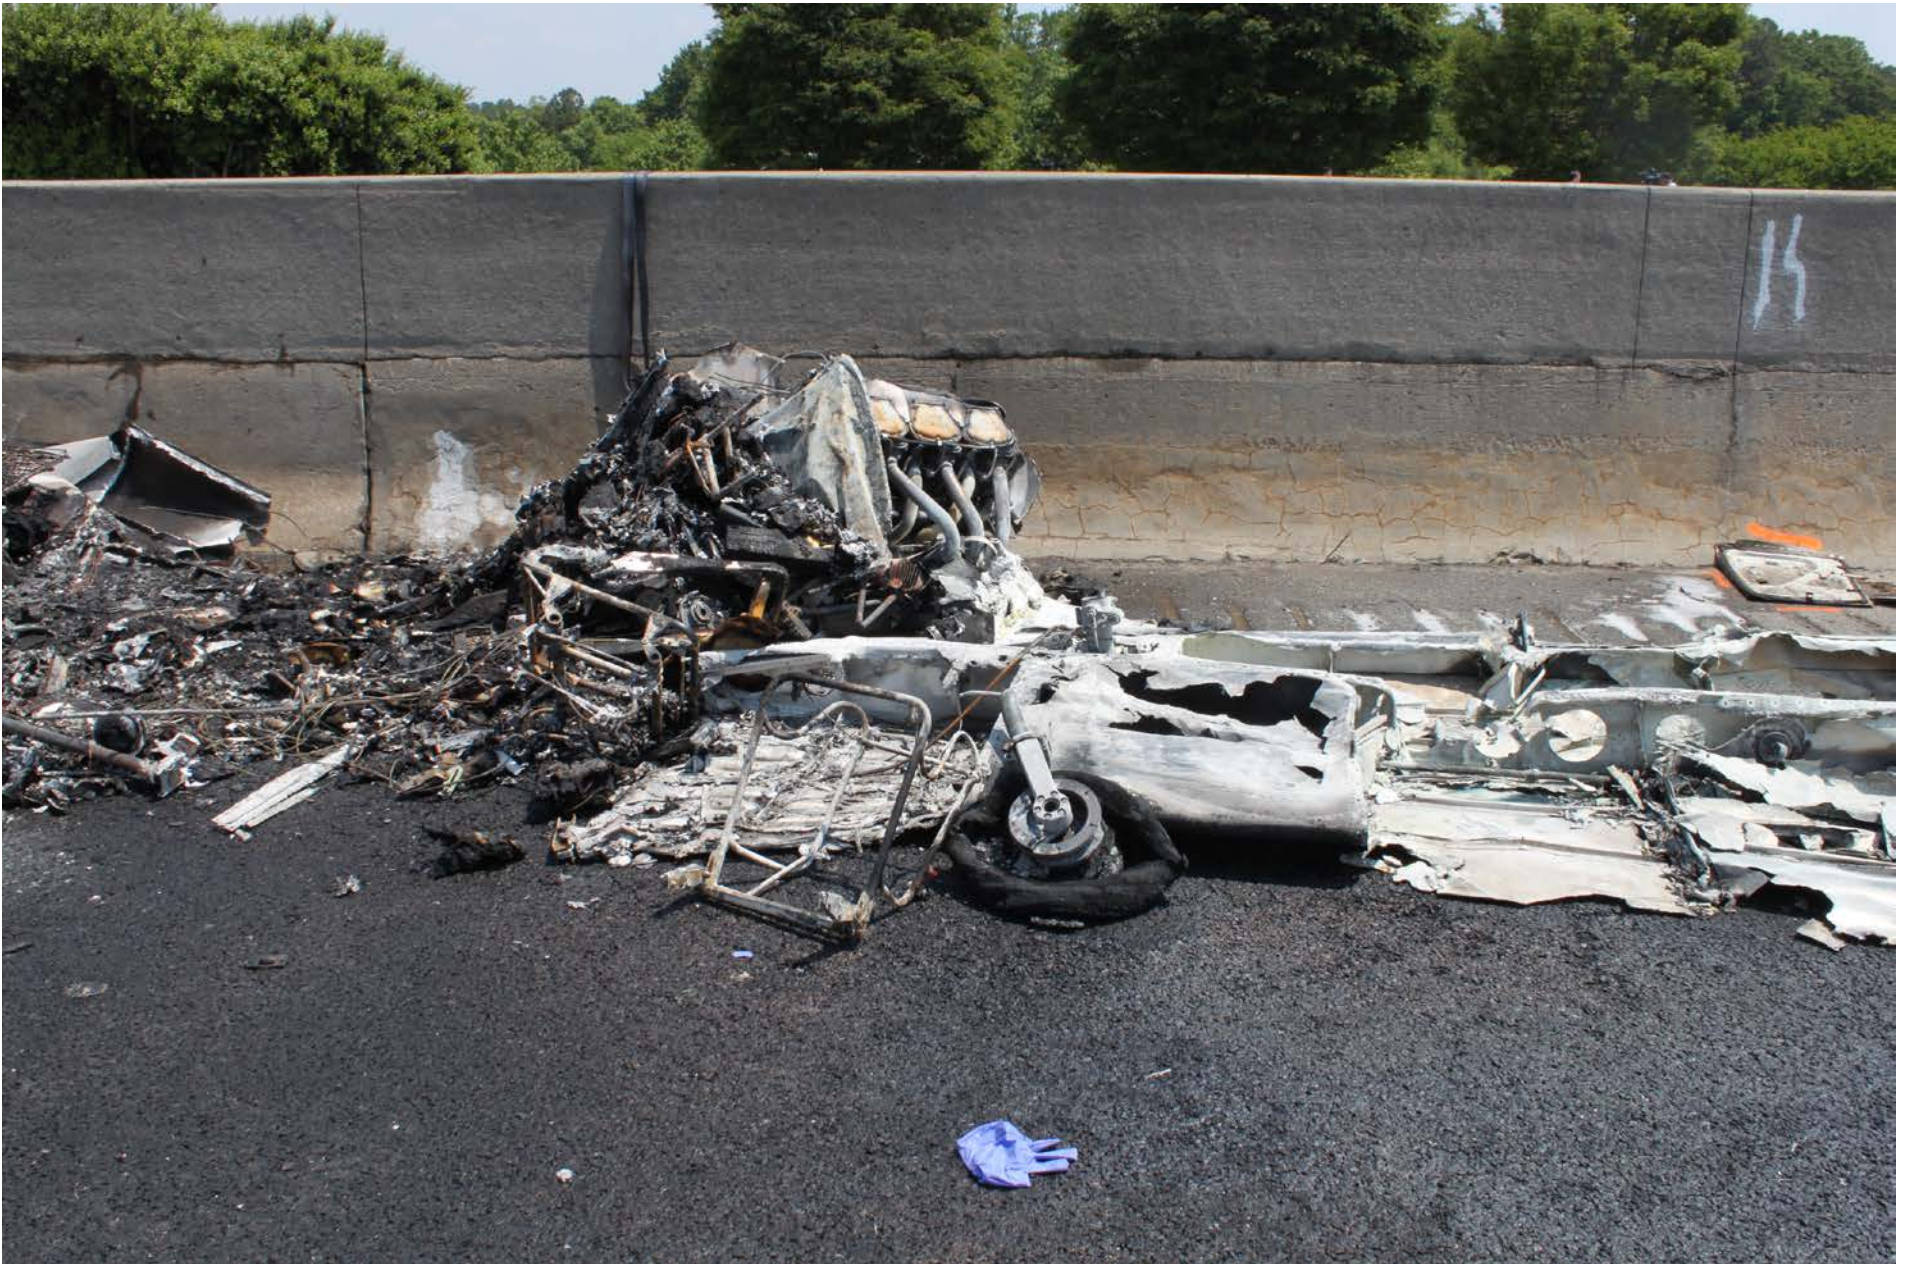
Photo 7 –View of cockpit section

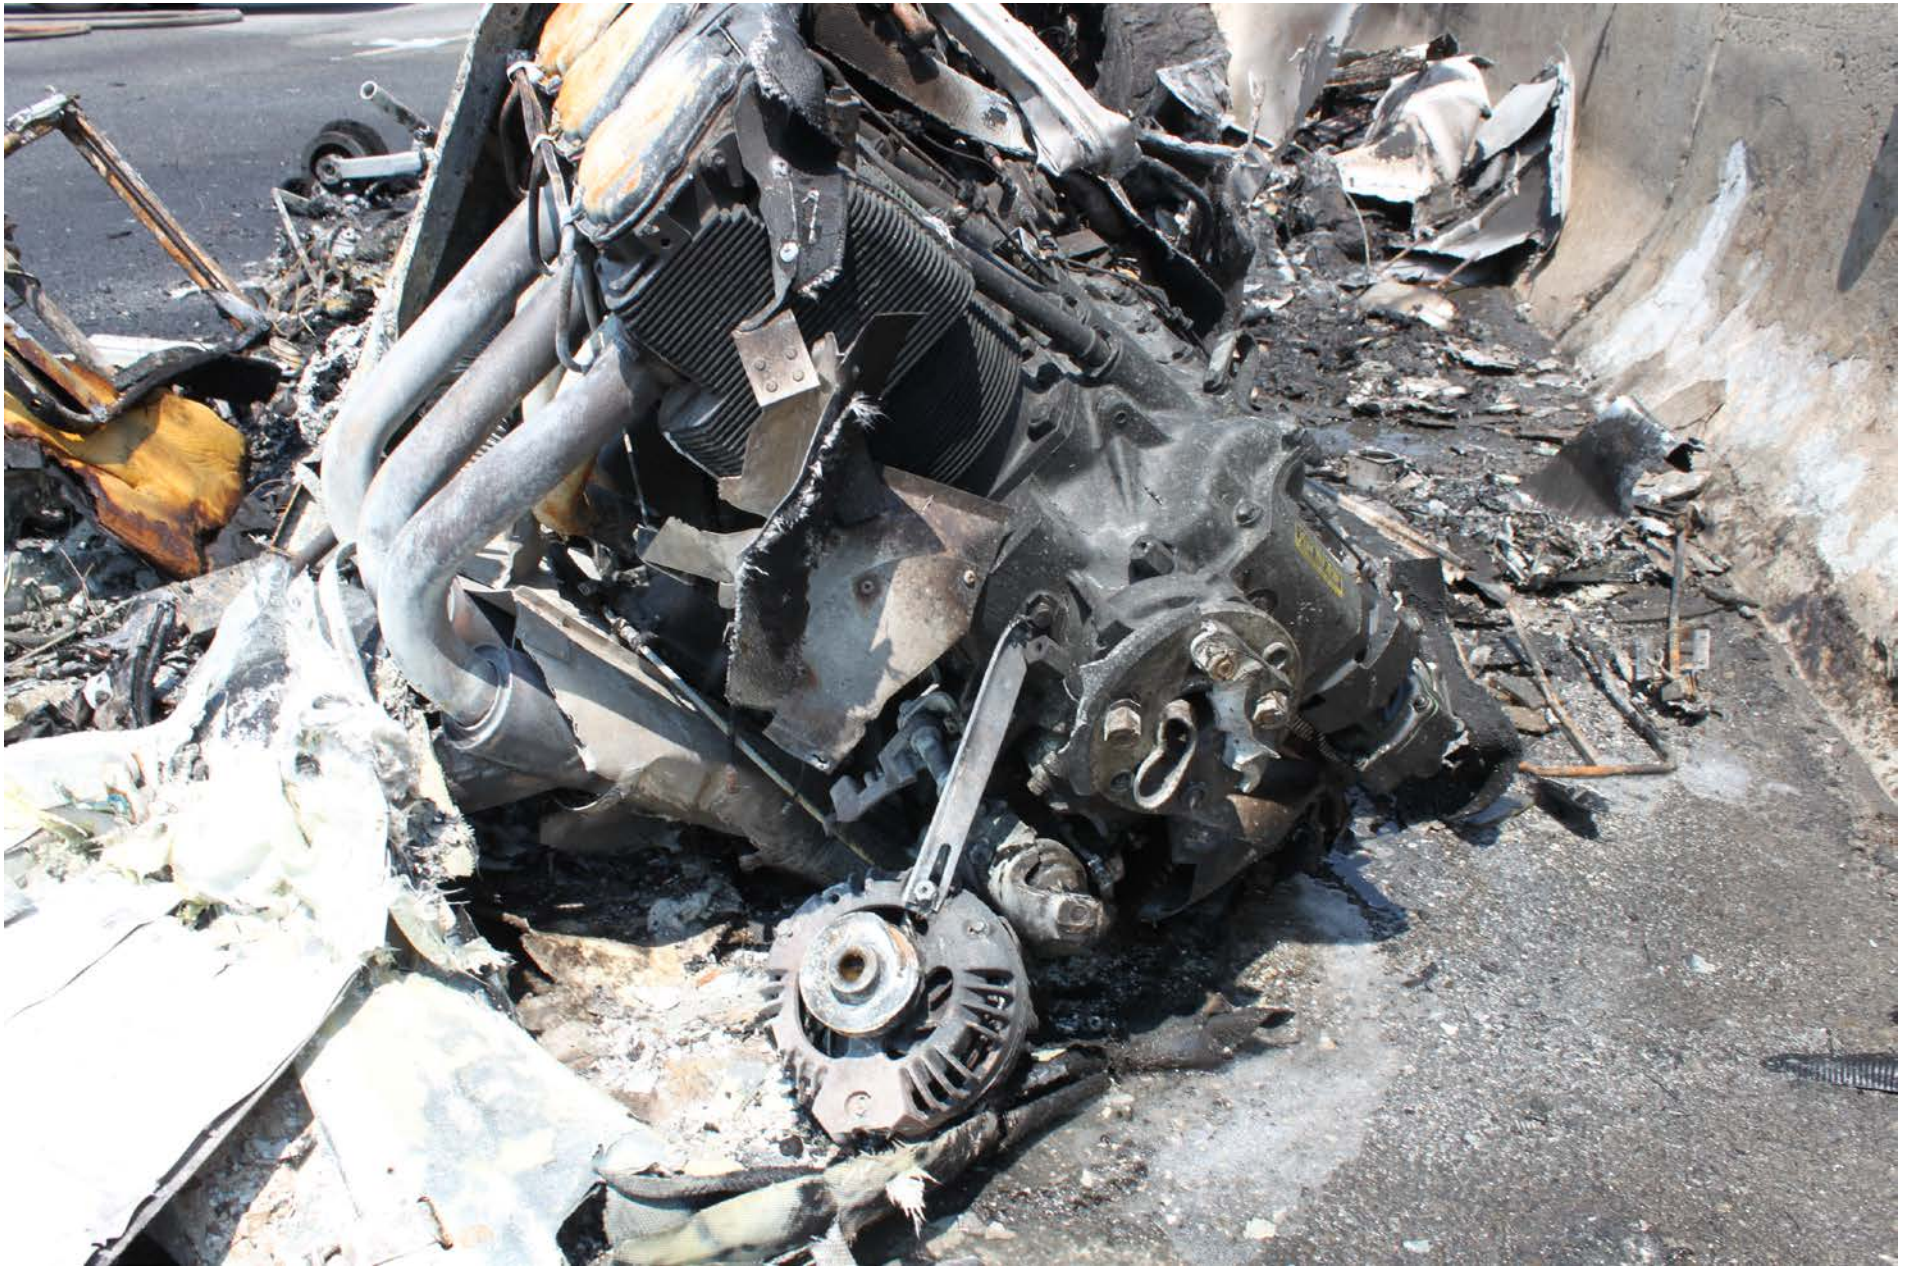
Photo 8 – Front view of engine with broken propeller flange

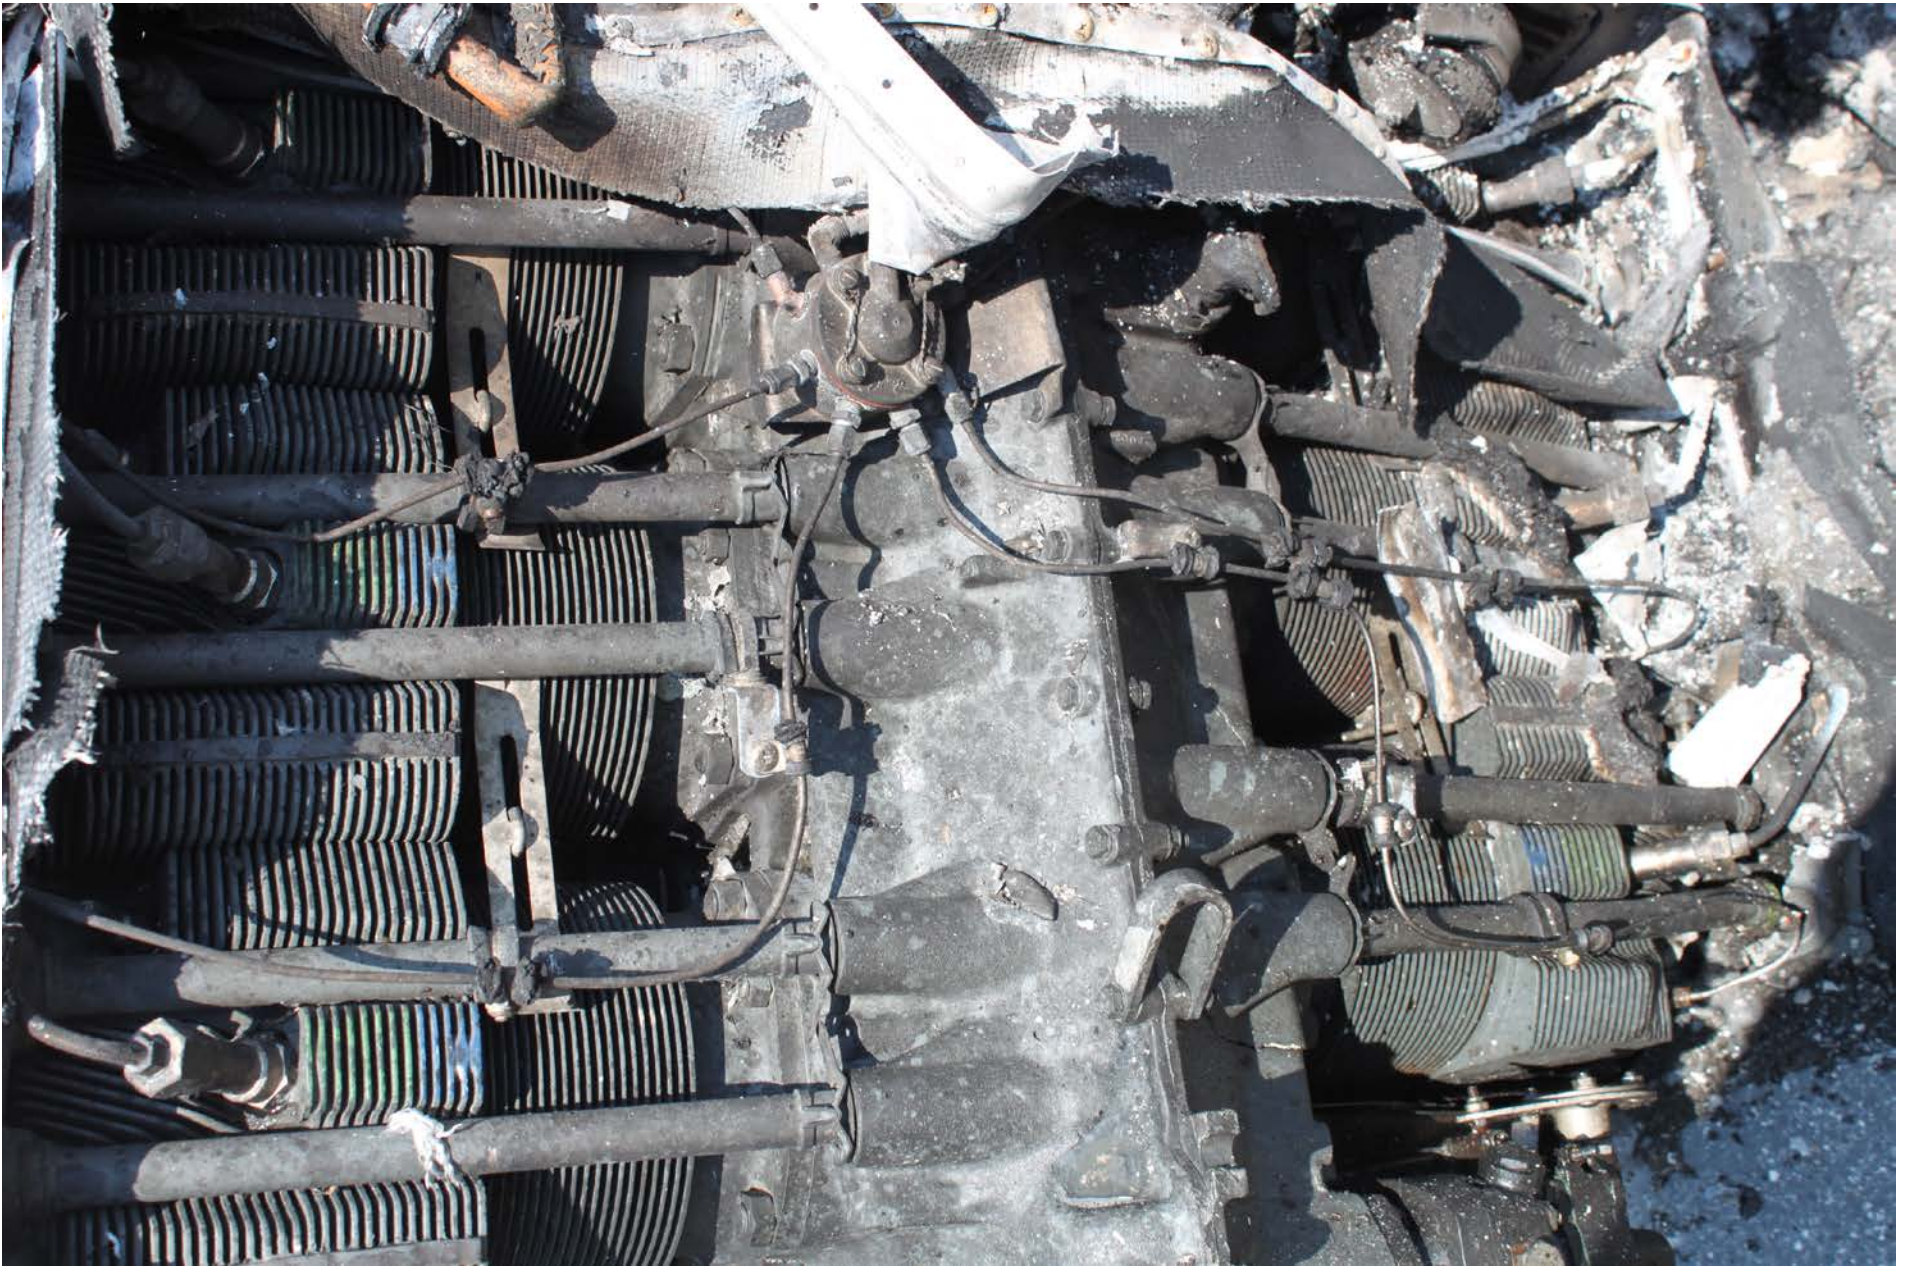
Photo 9 – View of top of engine with fuel manifold
