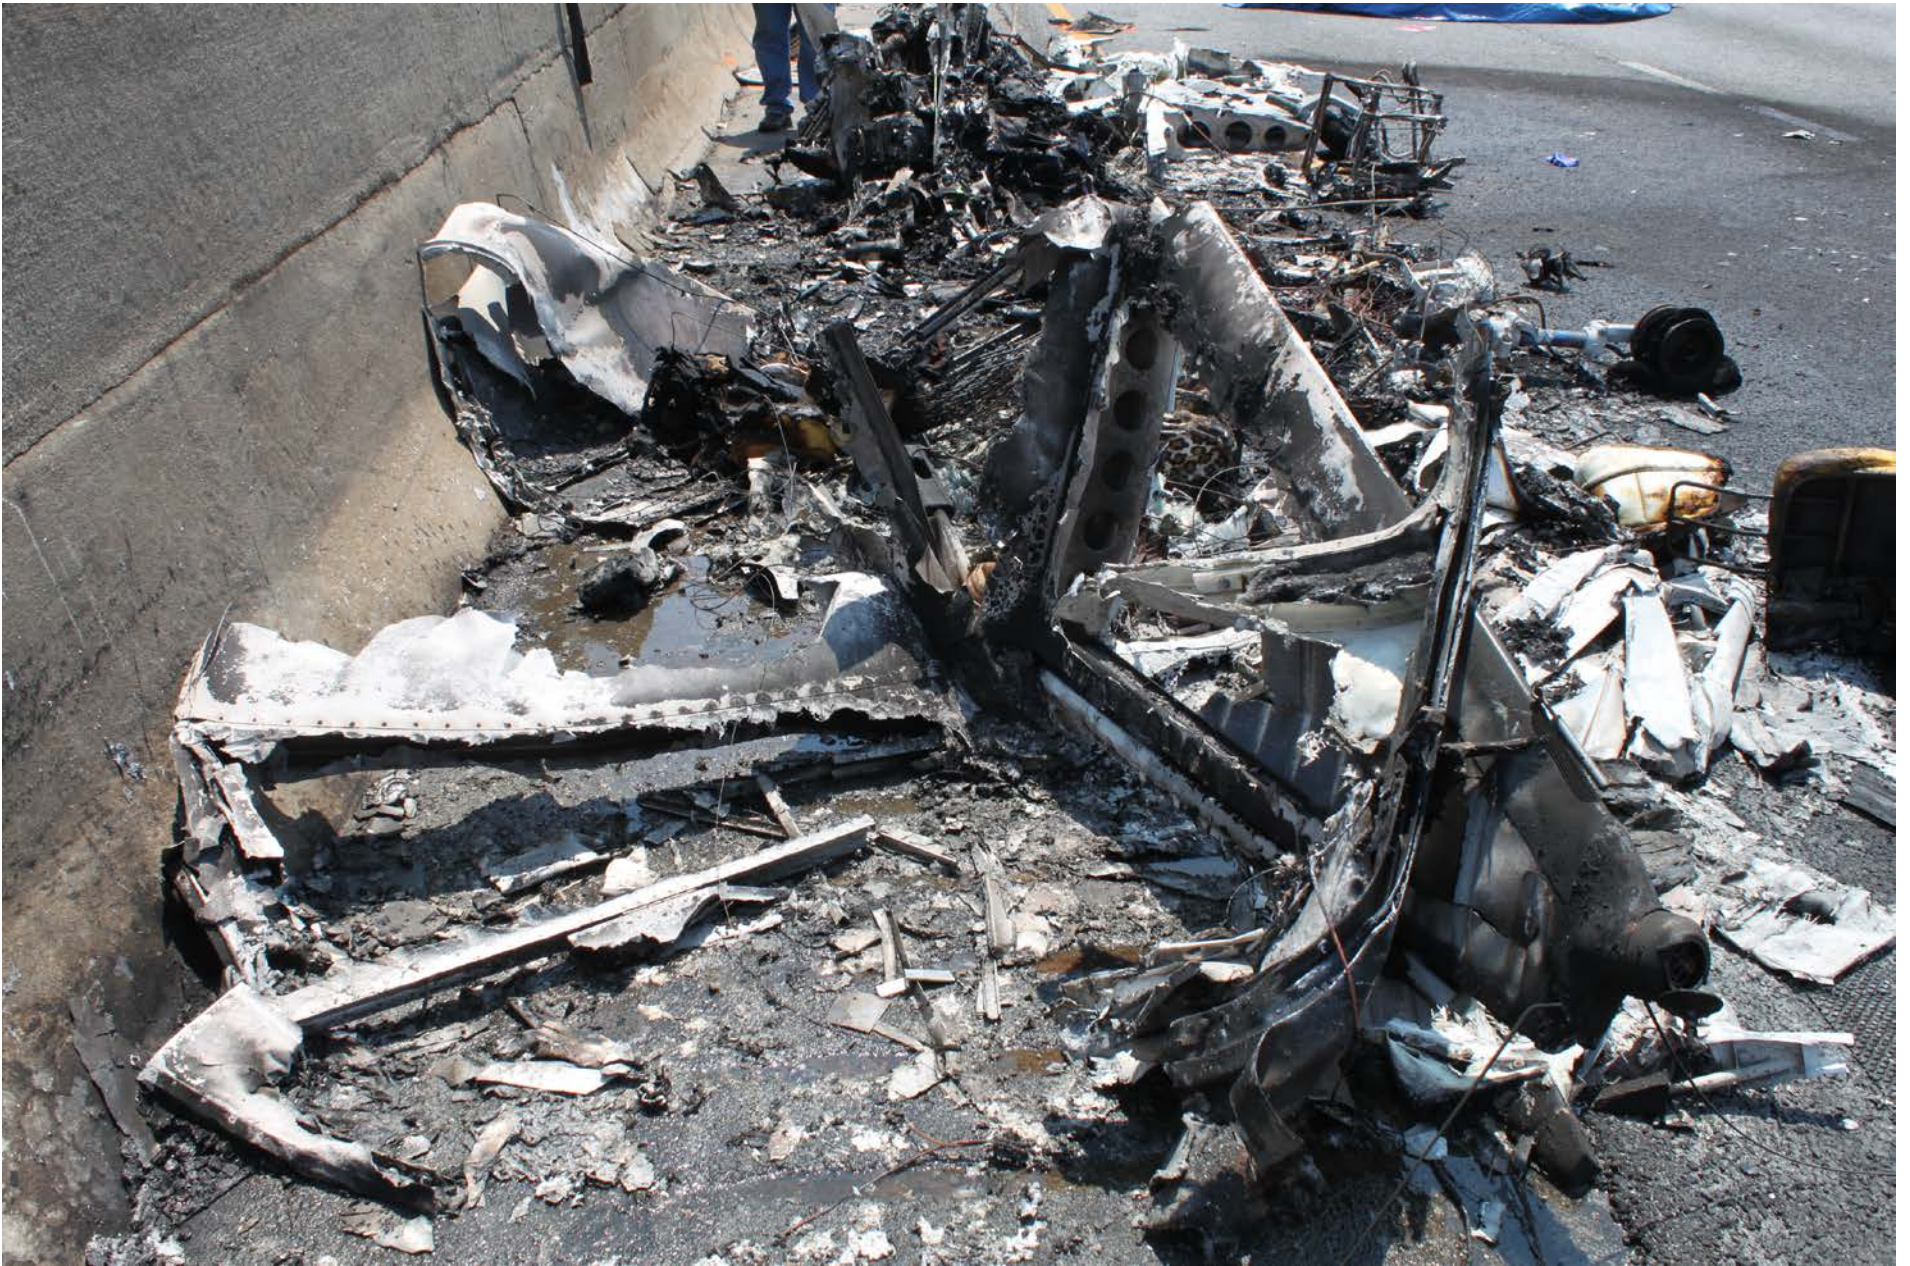
Photo 10 – View of vertical and left horizontal stabilizer fire damaged

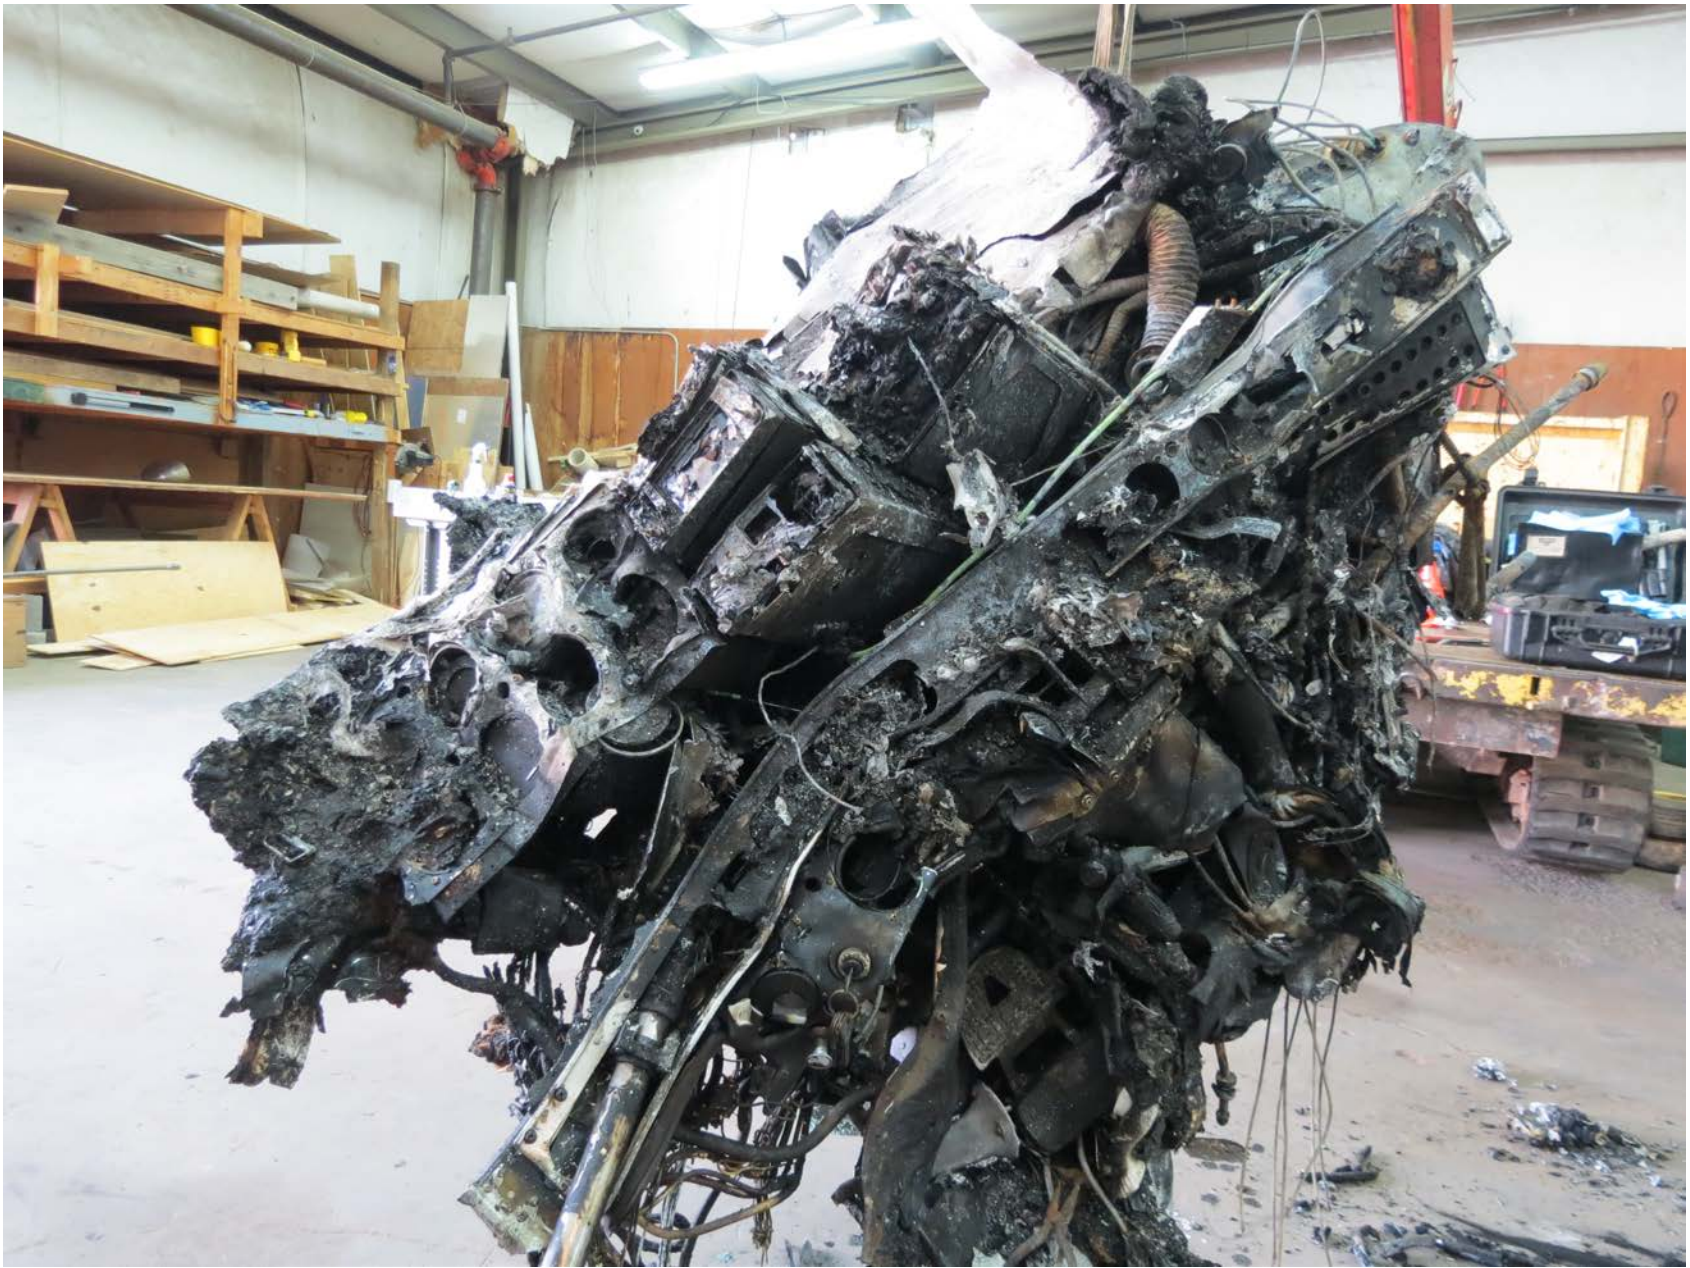
Photo 11 –View of fire damaged instrument panel

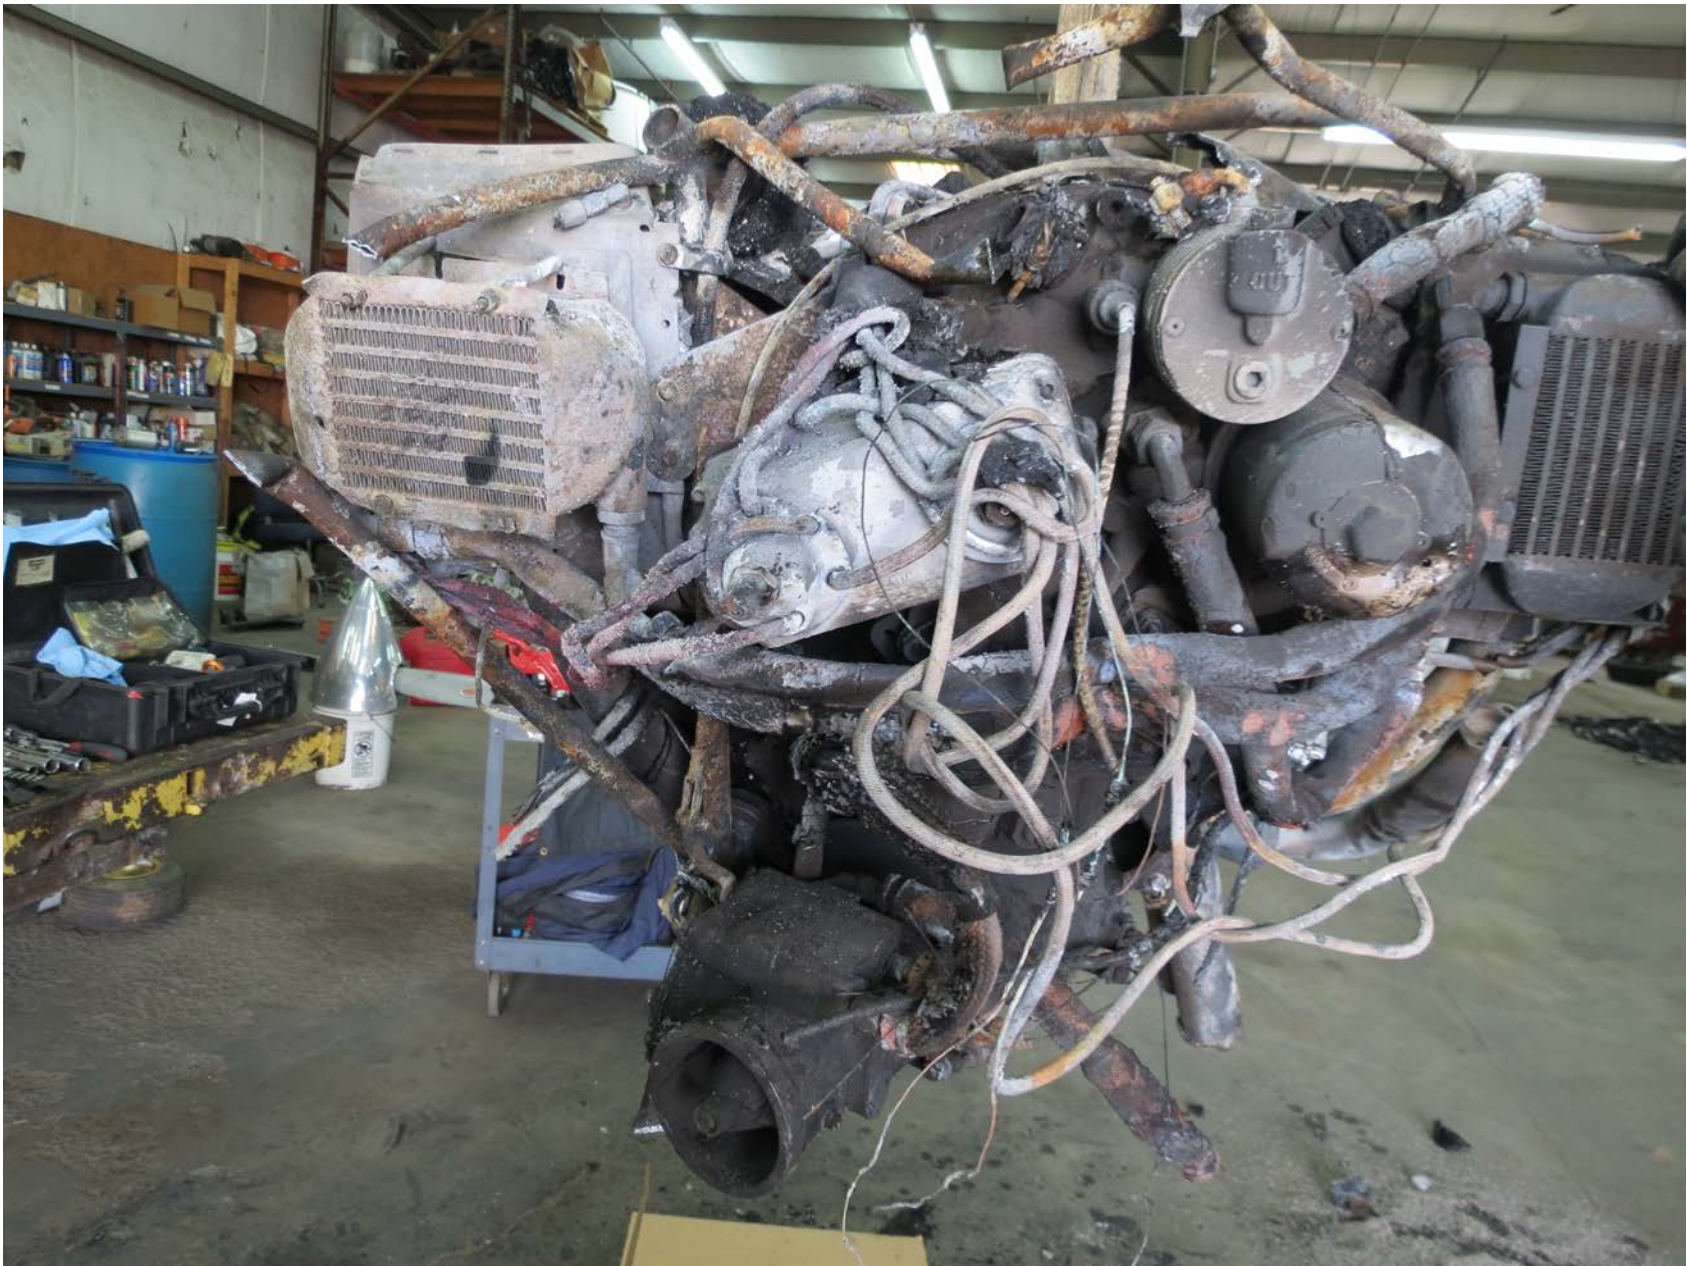
Photo 12 –View of fire damaged engine accessories and fuel servo
