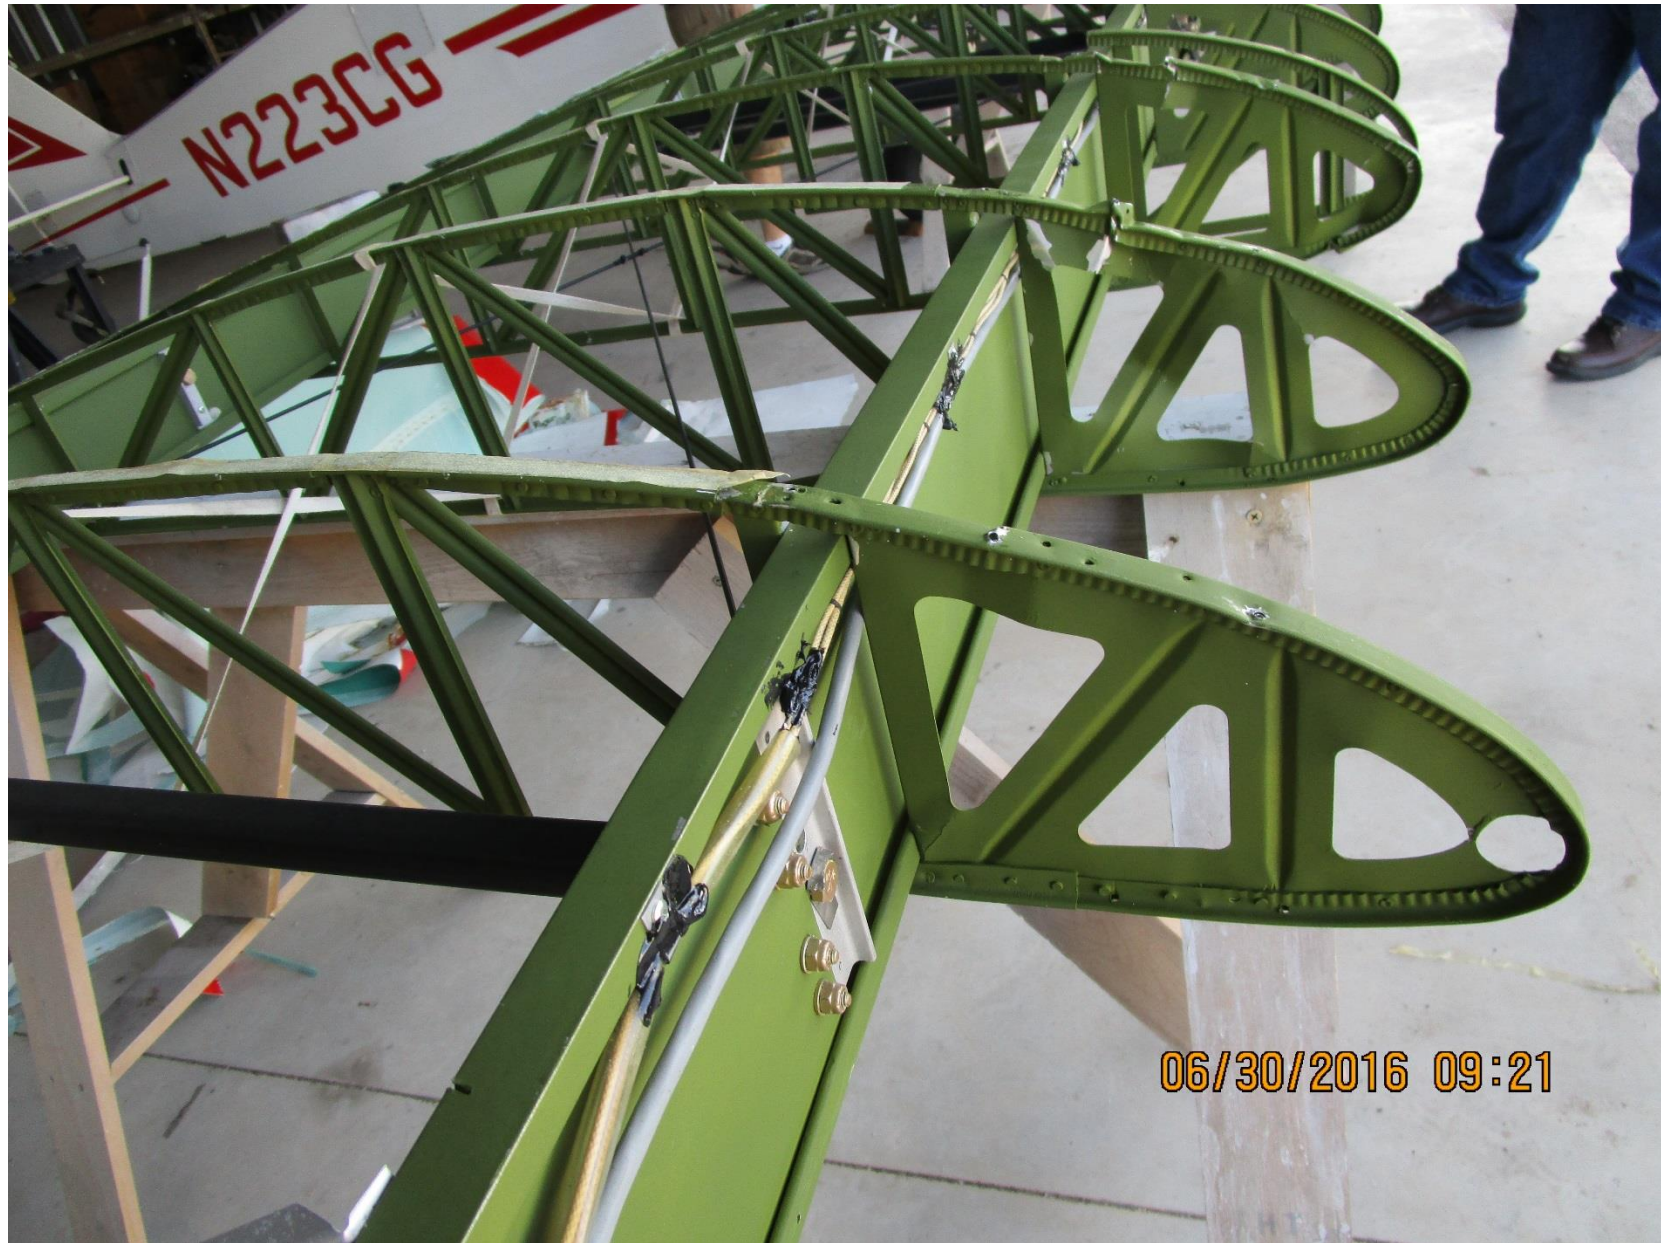
**Photo 1 – View of damaged right wing ribs (photo courtesy of the FAA)**

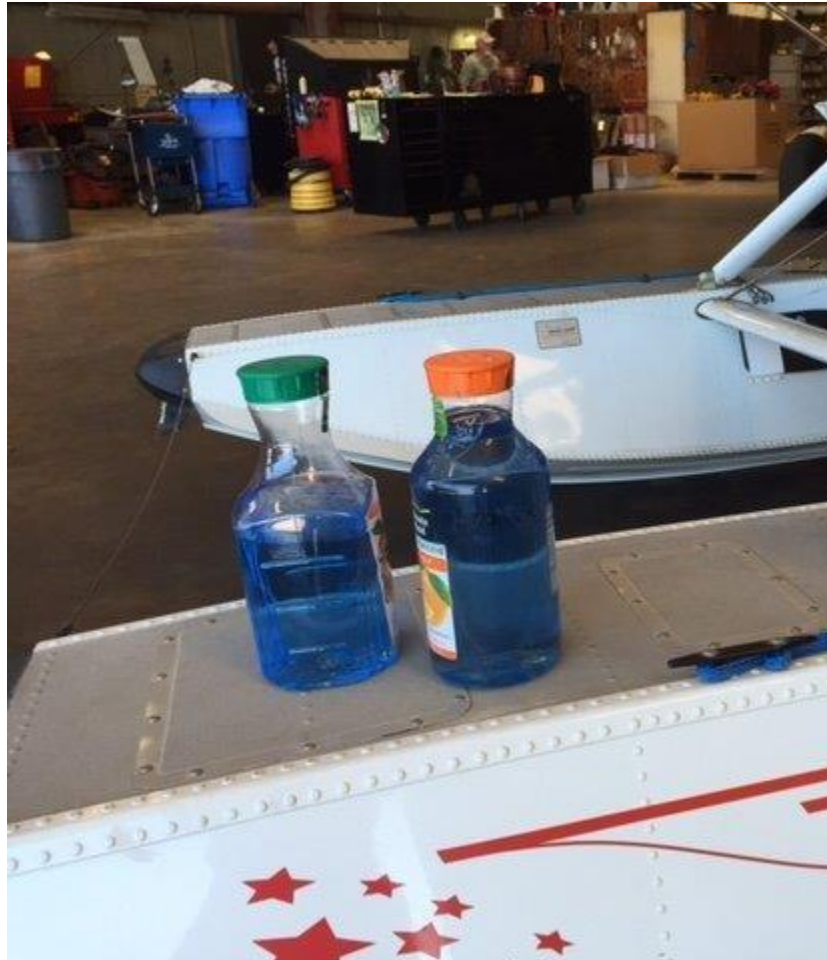
**Photo 2 – View of fuel remaining in fuel tanks (photo courtesy of the FAA)**
