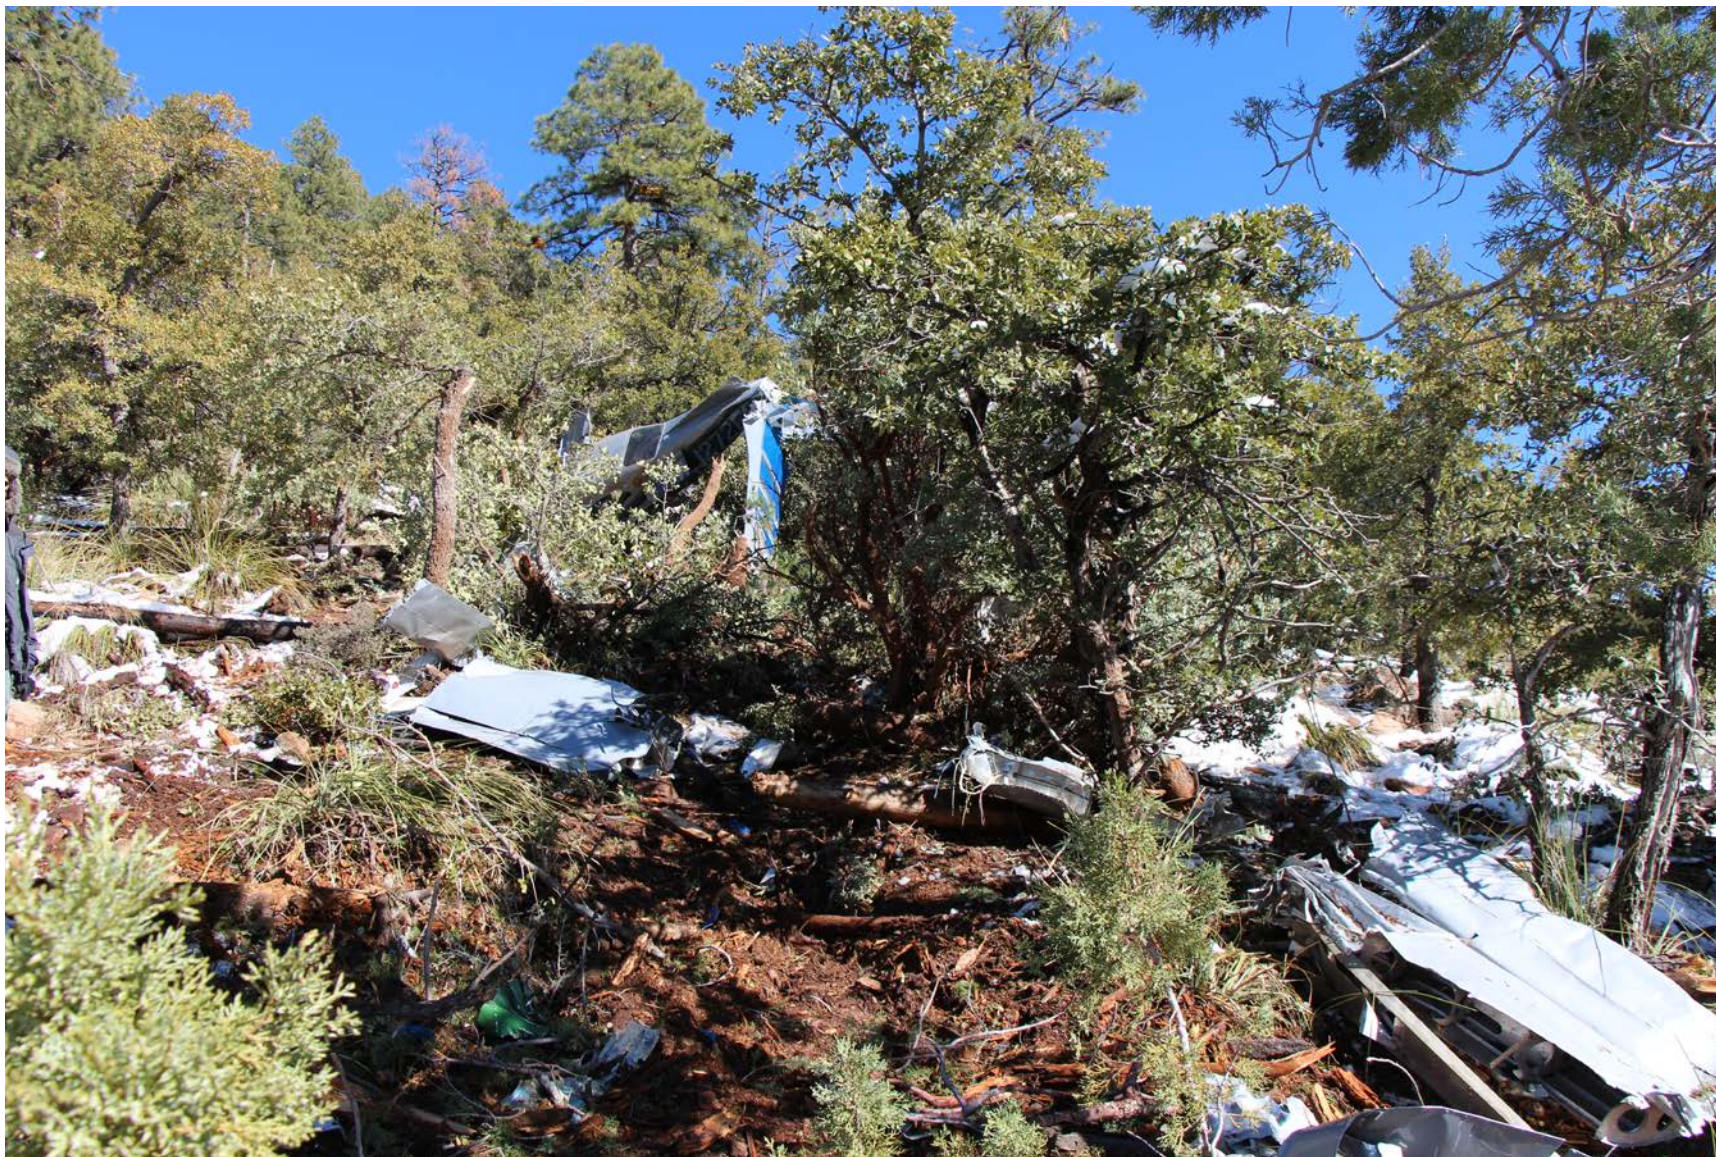
Photo 1 – View of Fuselage and Tail from the Southwest with Wings in the Foreground

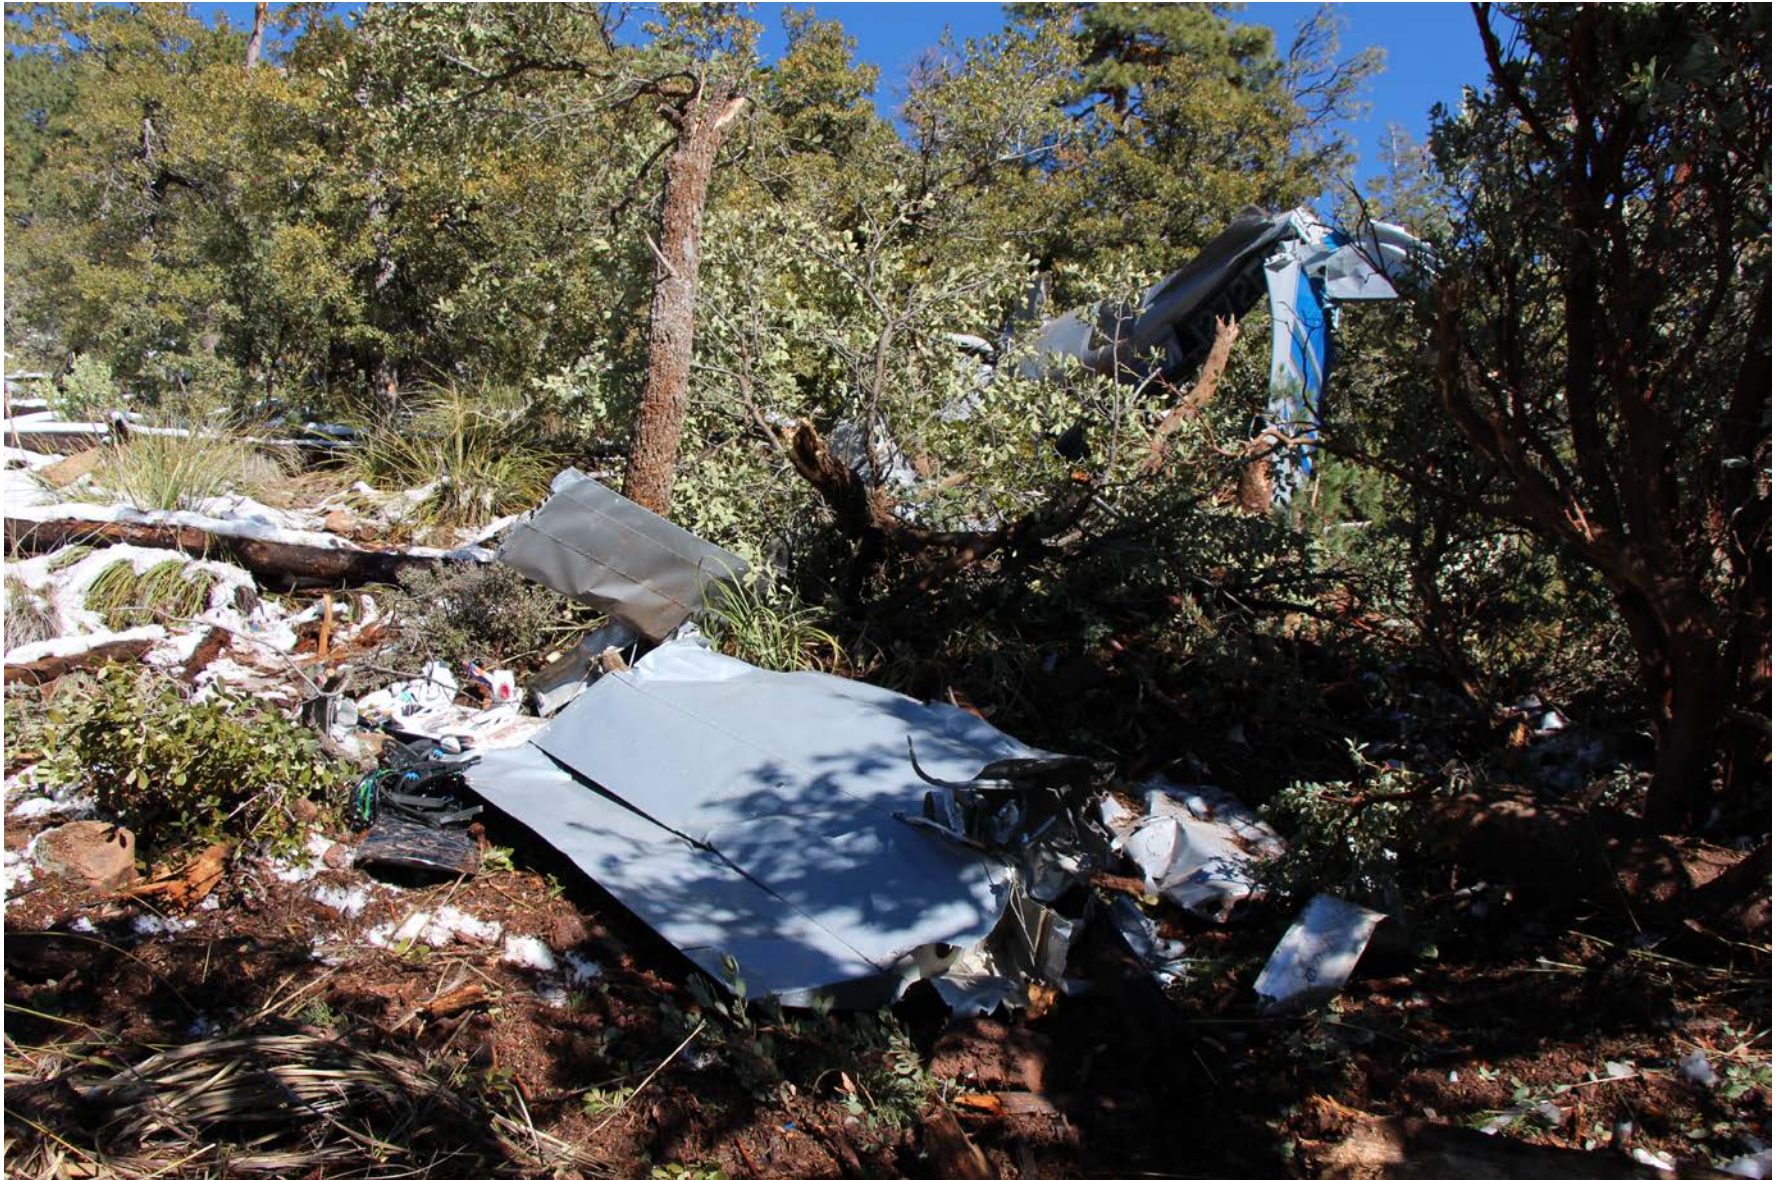
Photo 2 – Fuselage and Tail with Wing Section in Foreground

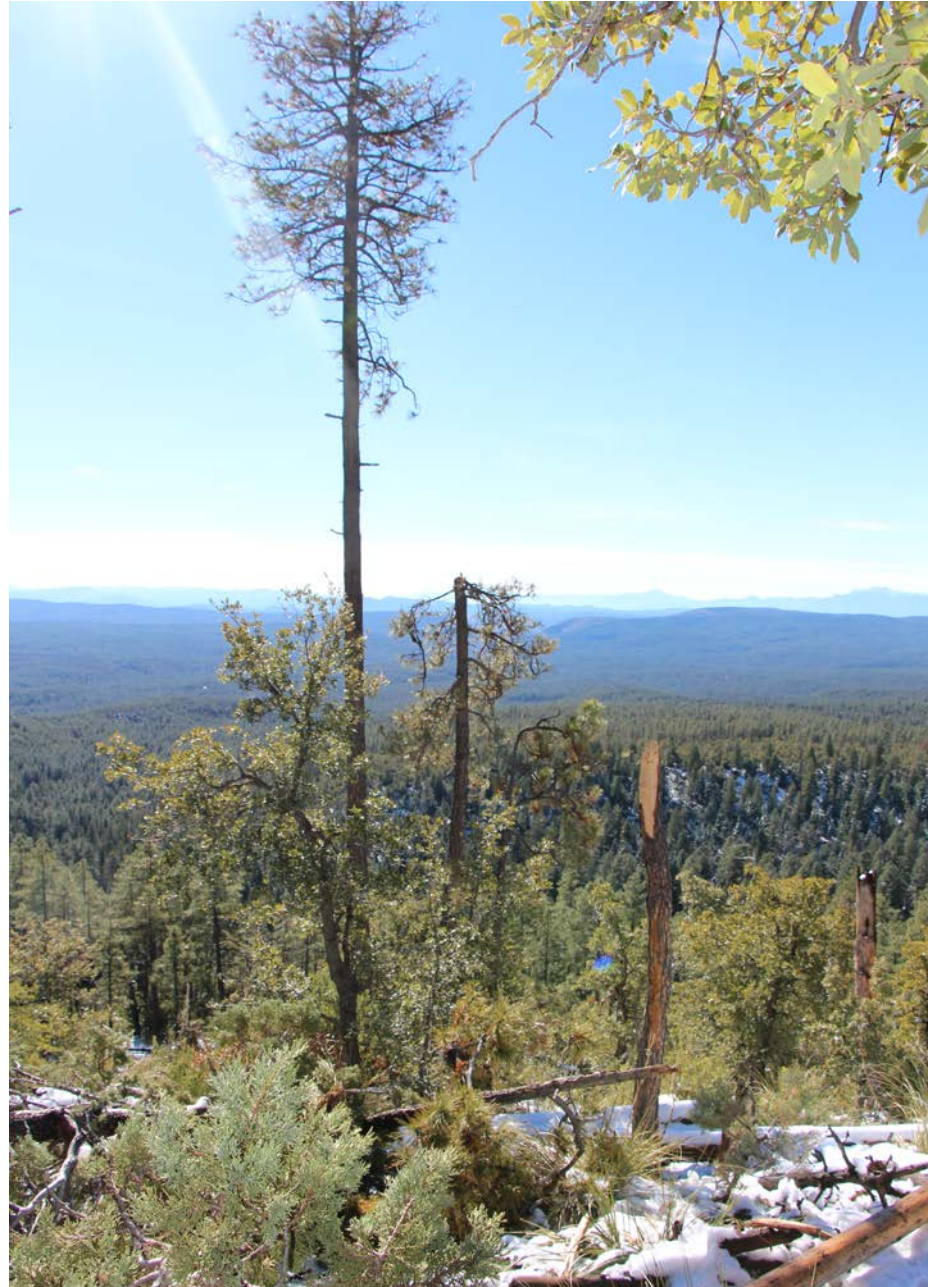
Photo 3 – View of Tree Strikes and Initial Impact Point

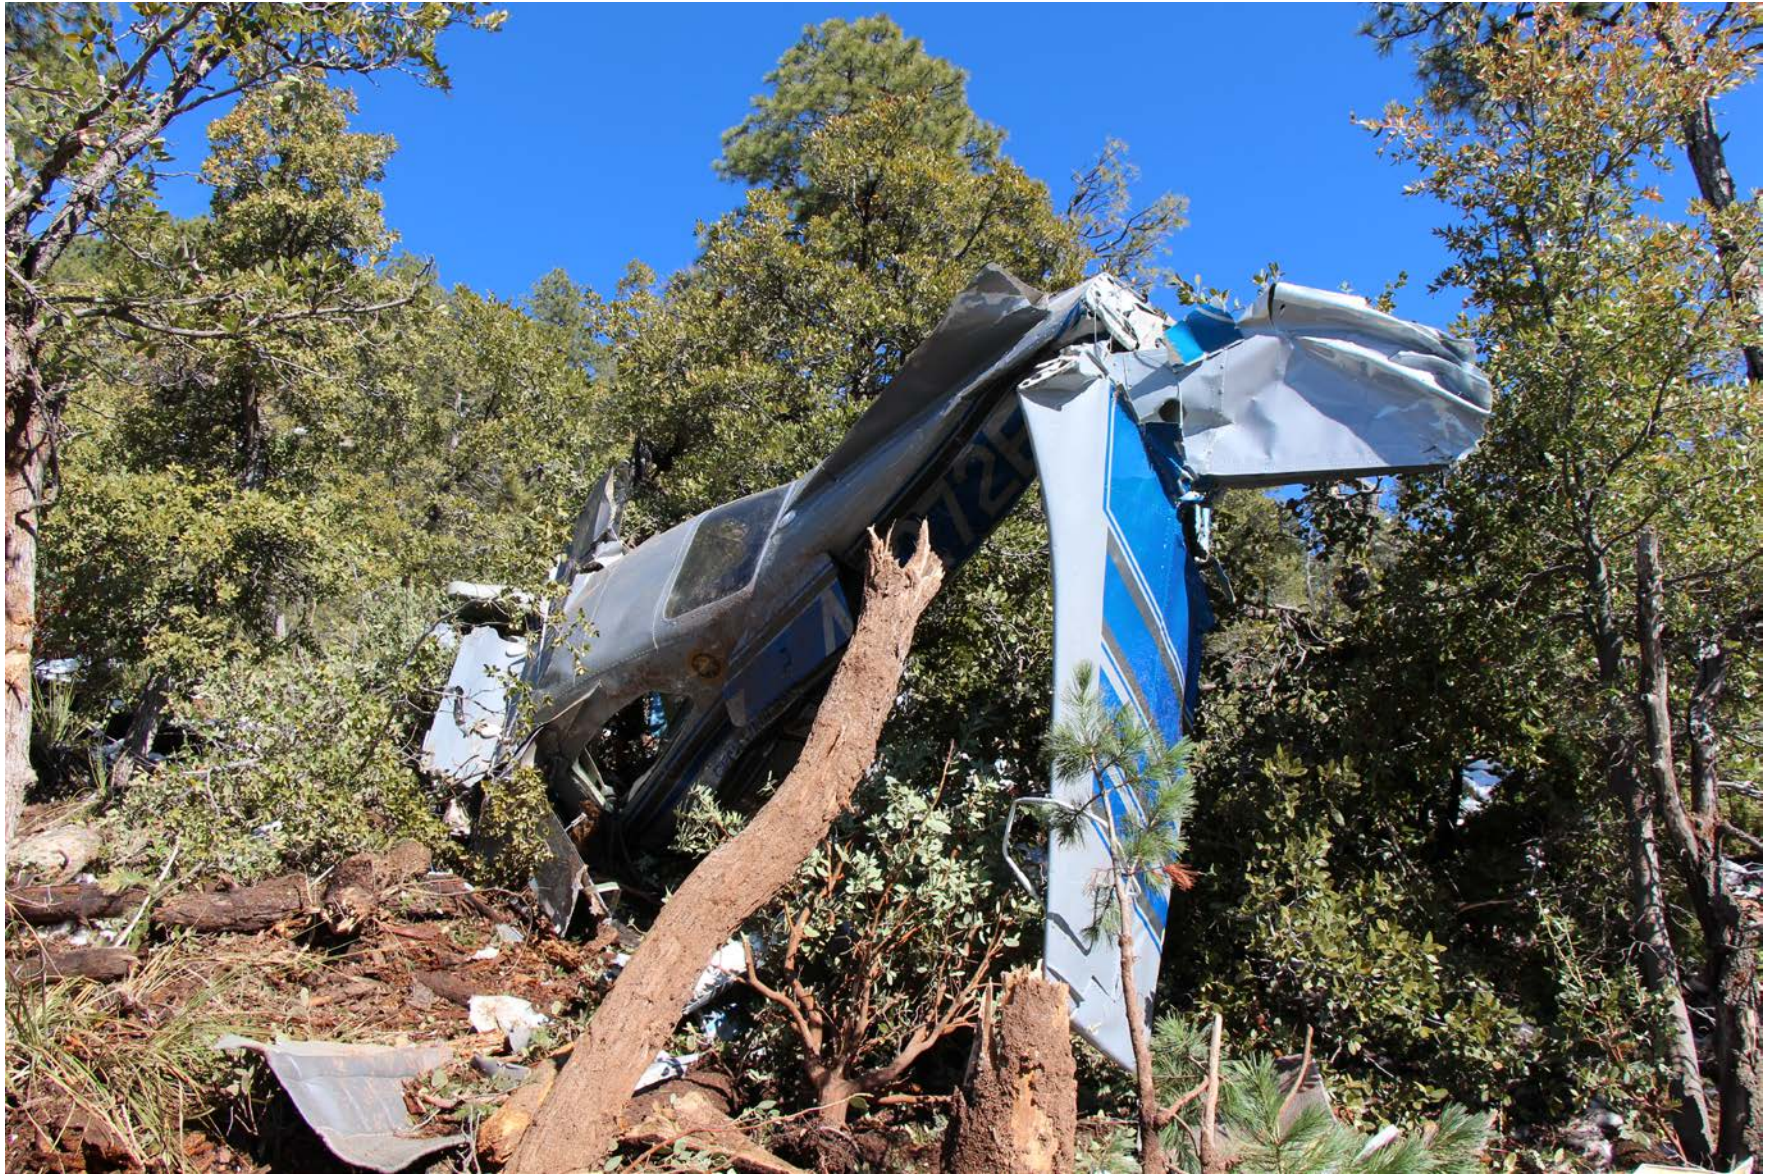
Photo 4 – View of Main Wreckage from Tail

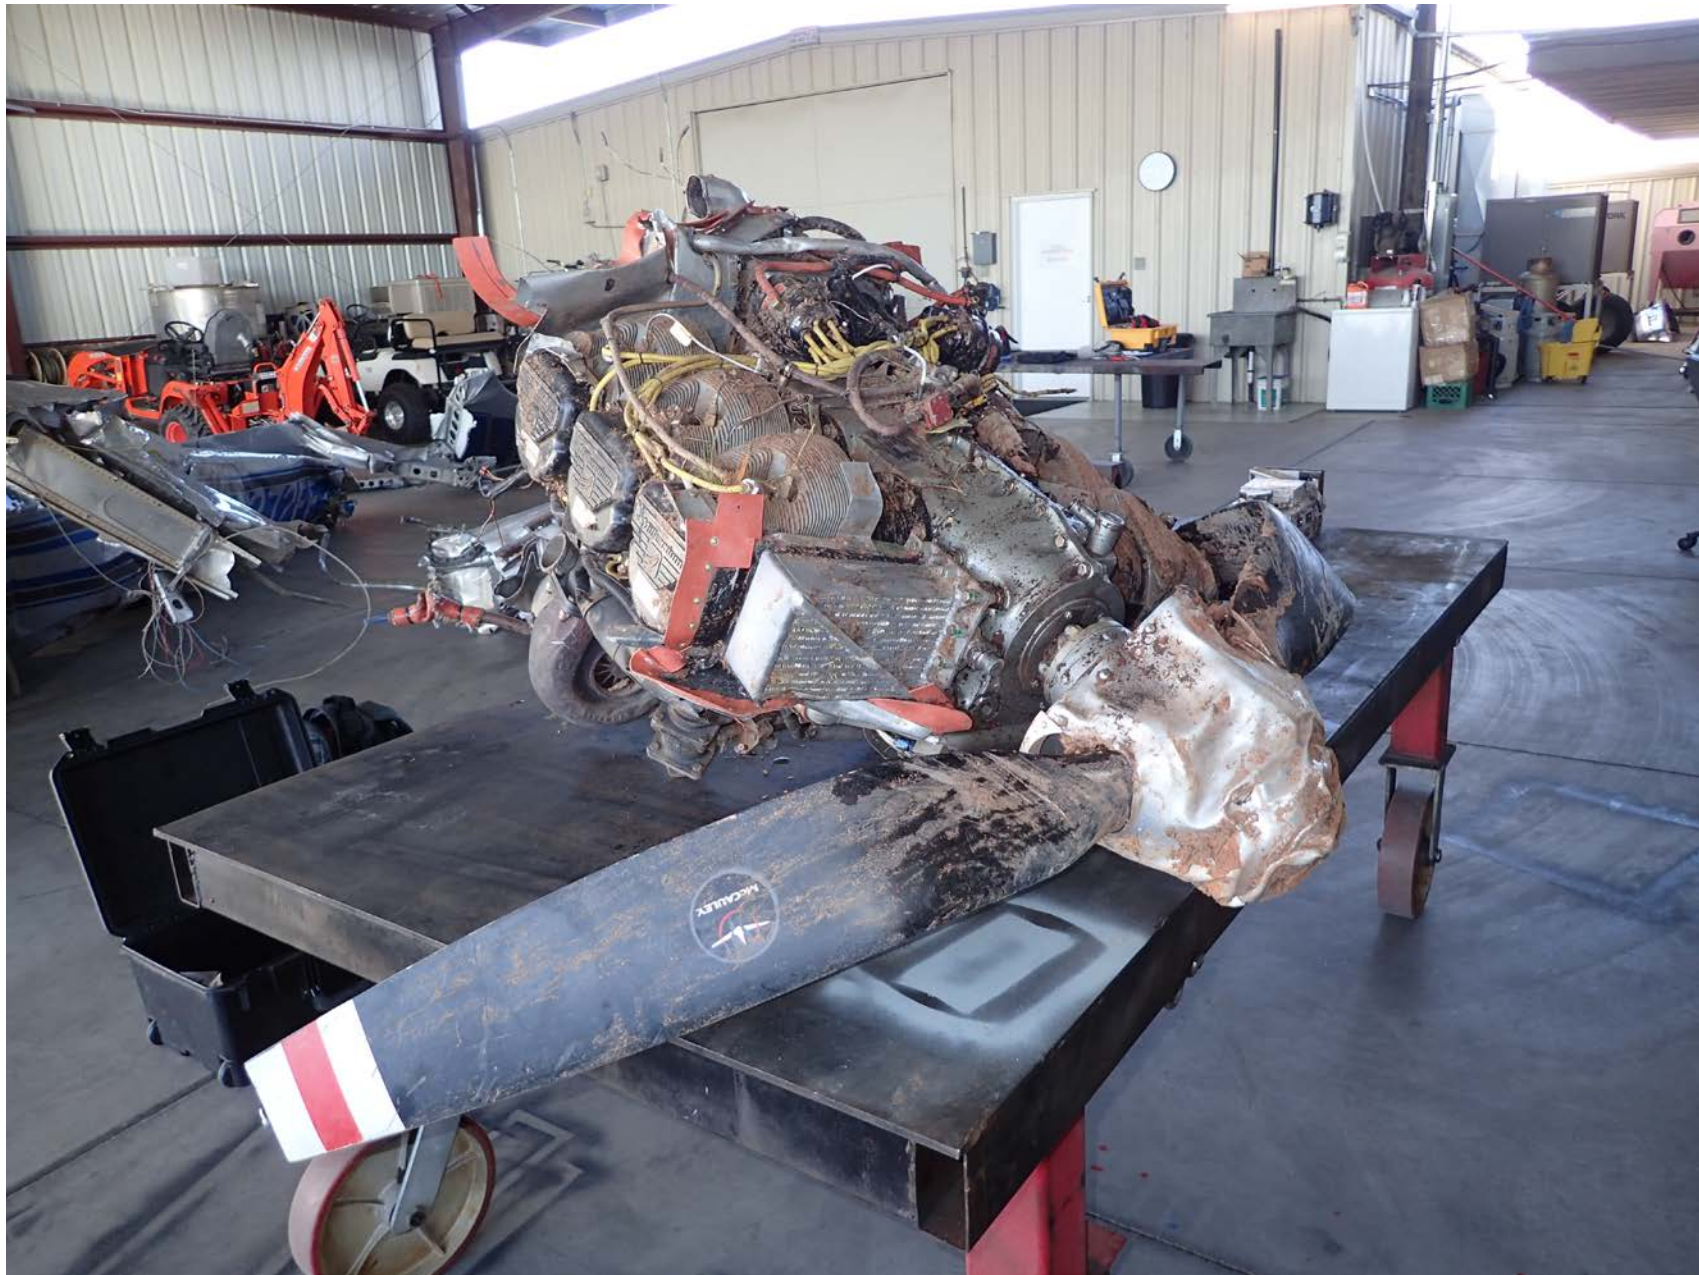
Photo 5 – View of Engine and Propeller on Examination Table

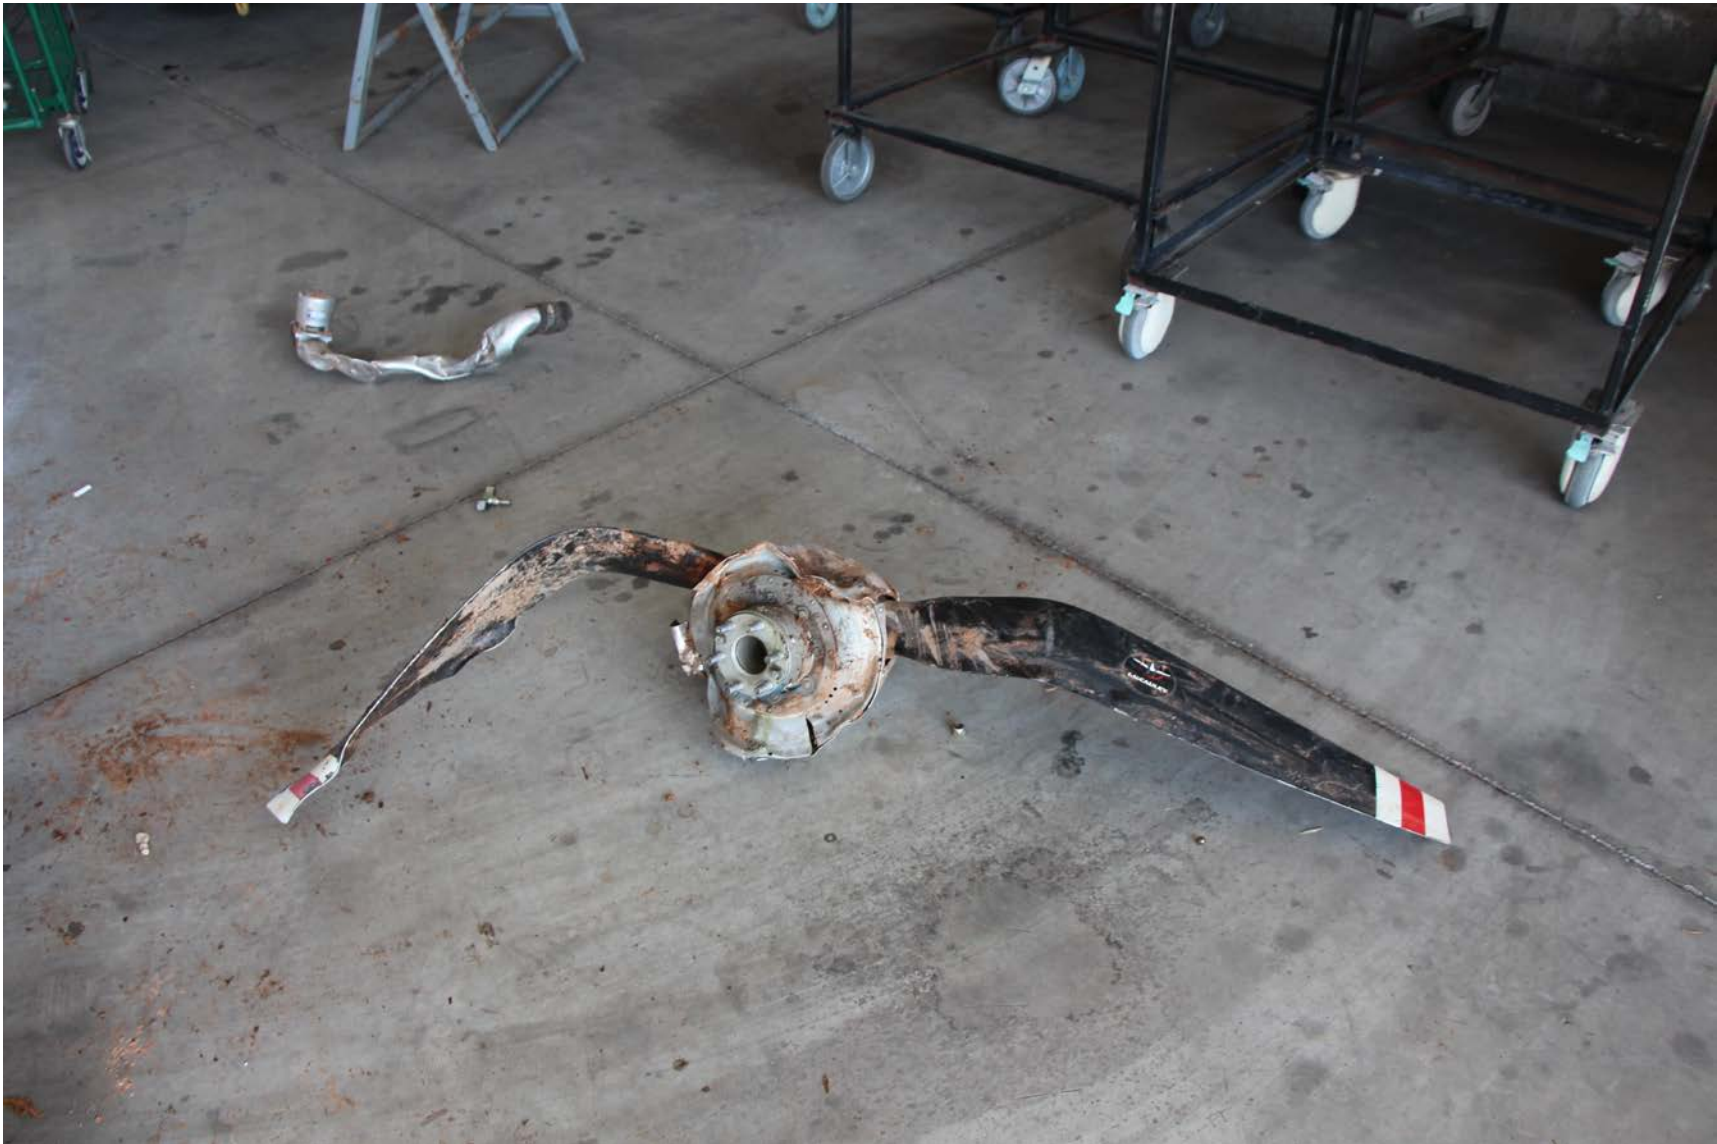
Photo 6 – 2-bladed Propeller at Examination Facility
