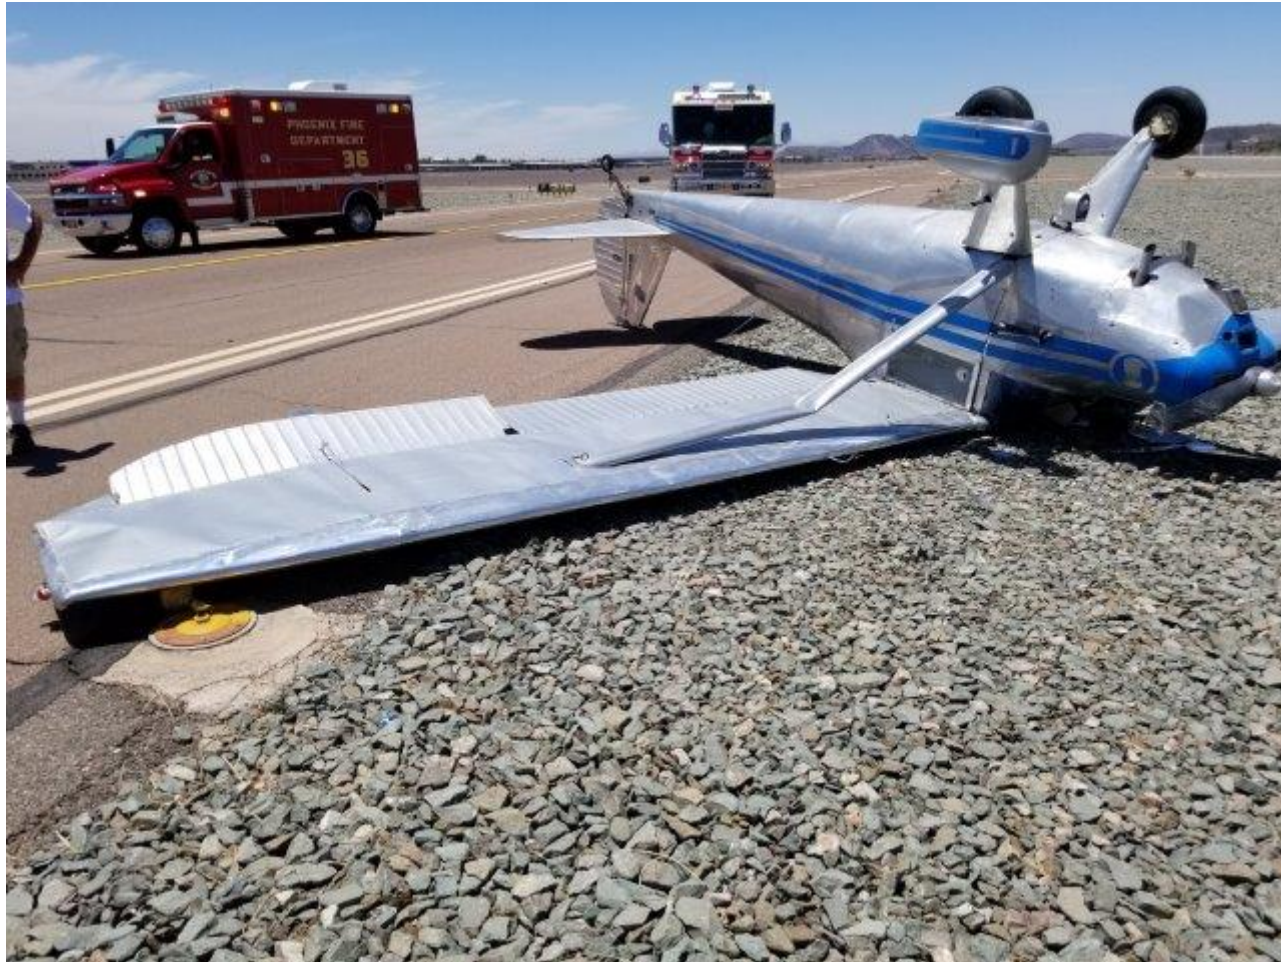
Photo 1 – View of damaged left wing lift strut (Photo courtesy of Airport Supervisor)

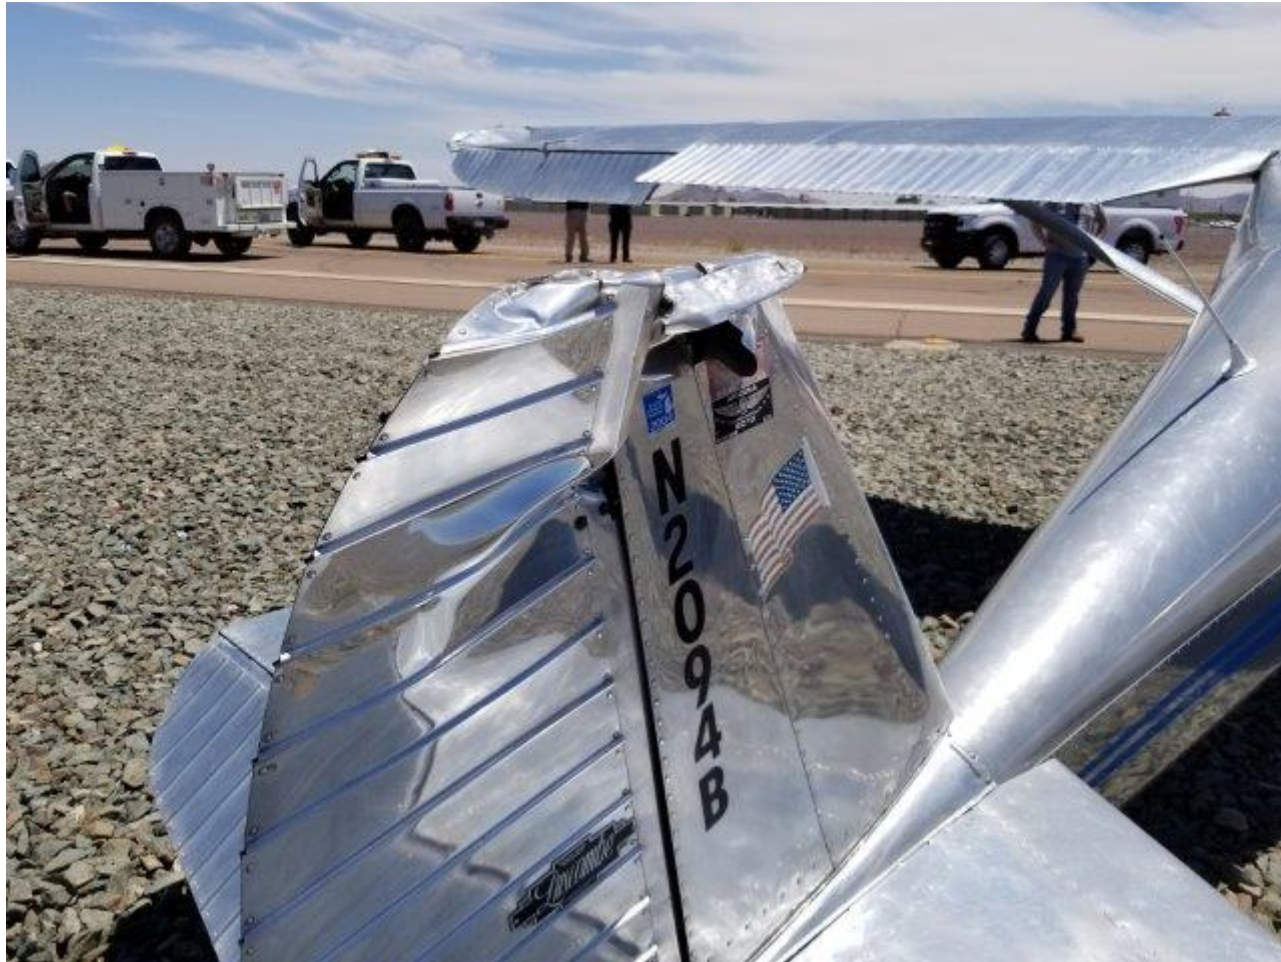
Photo 2 – View of damaged rudder (Photo courtesy of the Airport Supervisor)
