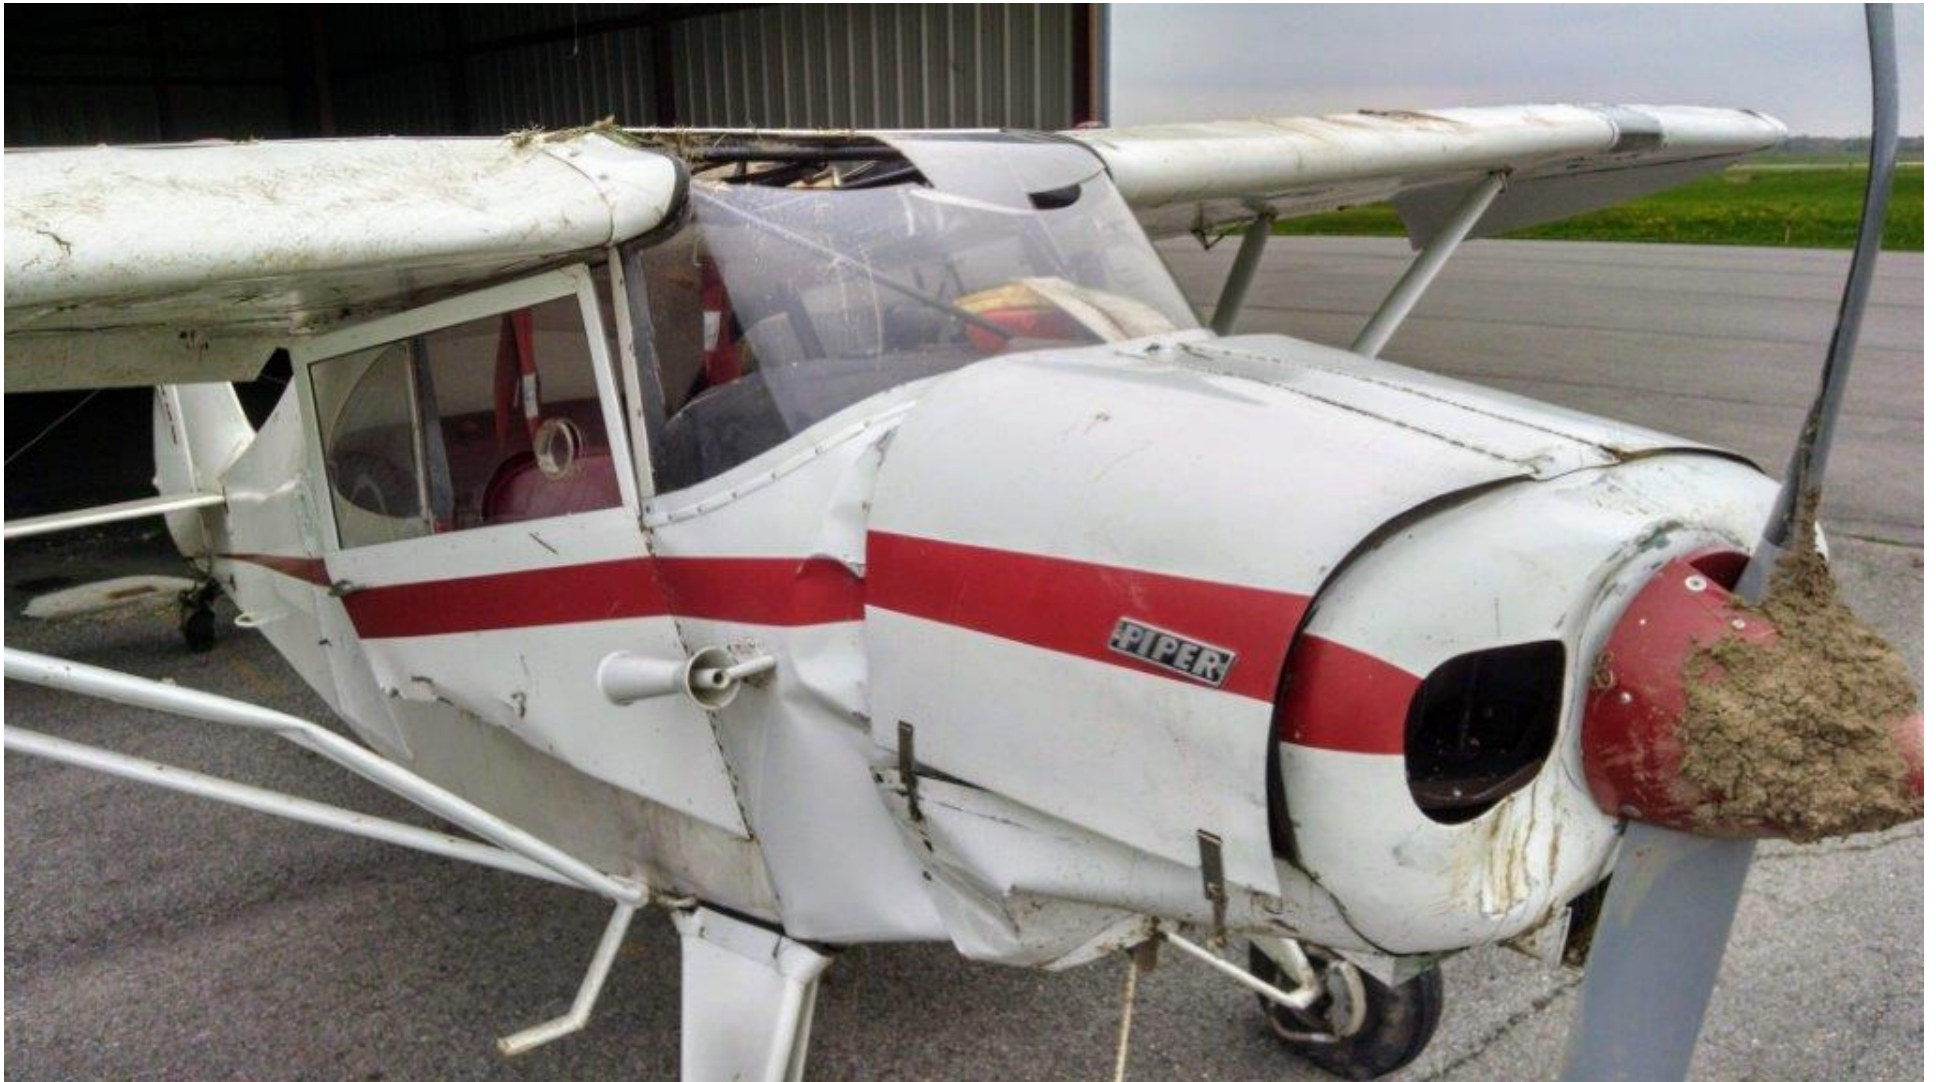
Photo 1 – View of damaged right wing lift strut and fuselage (Photo courtesy of insurance adjuster)

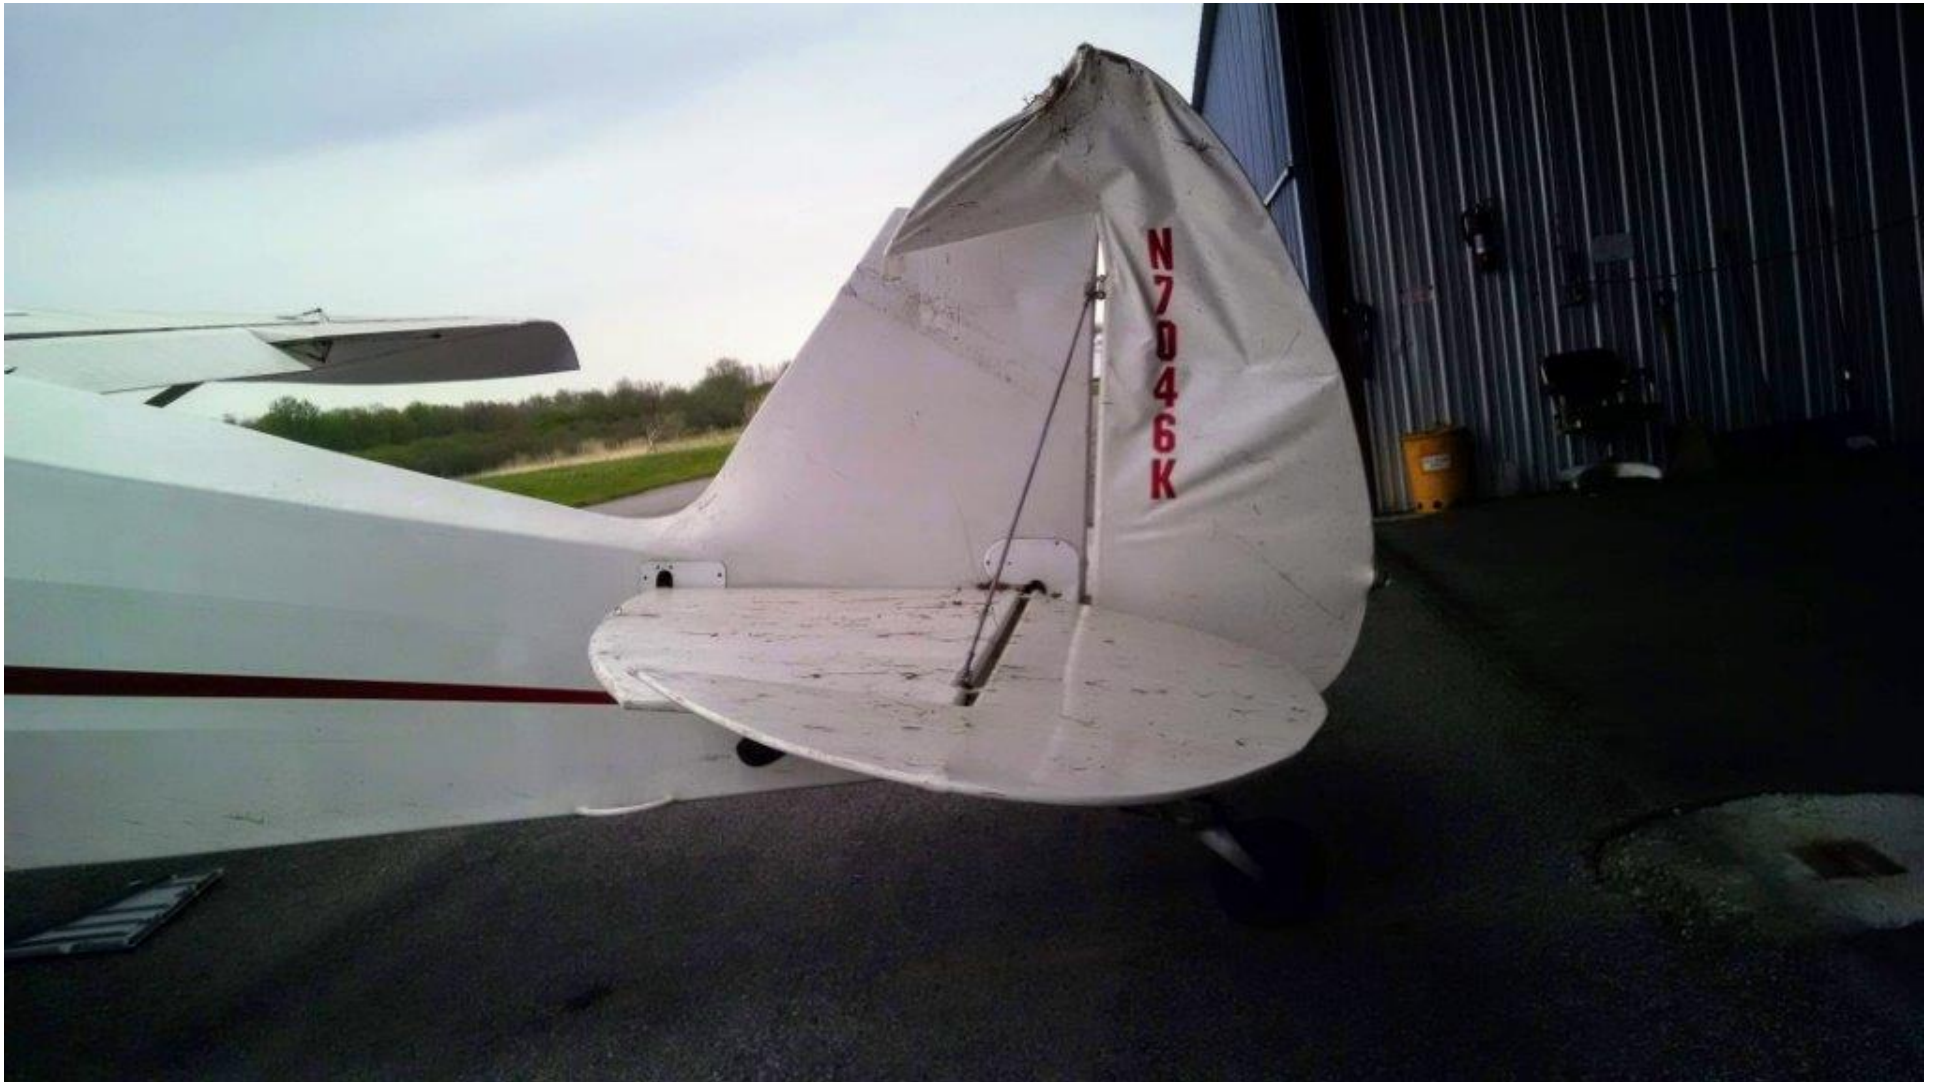
Photo 2 – View of damaged rudder (Photo courtesy of the insurance adjuster)
