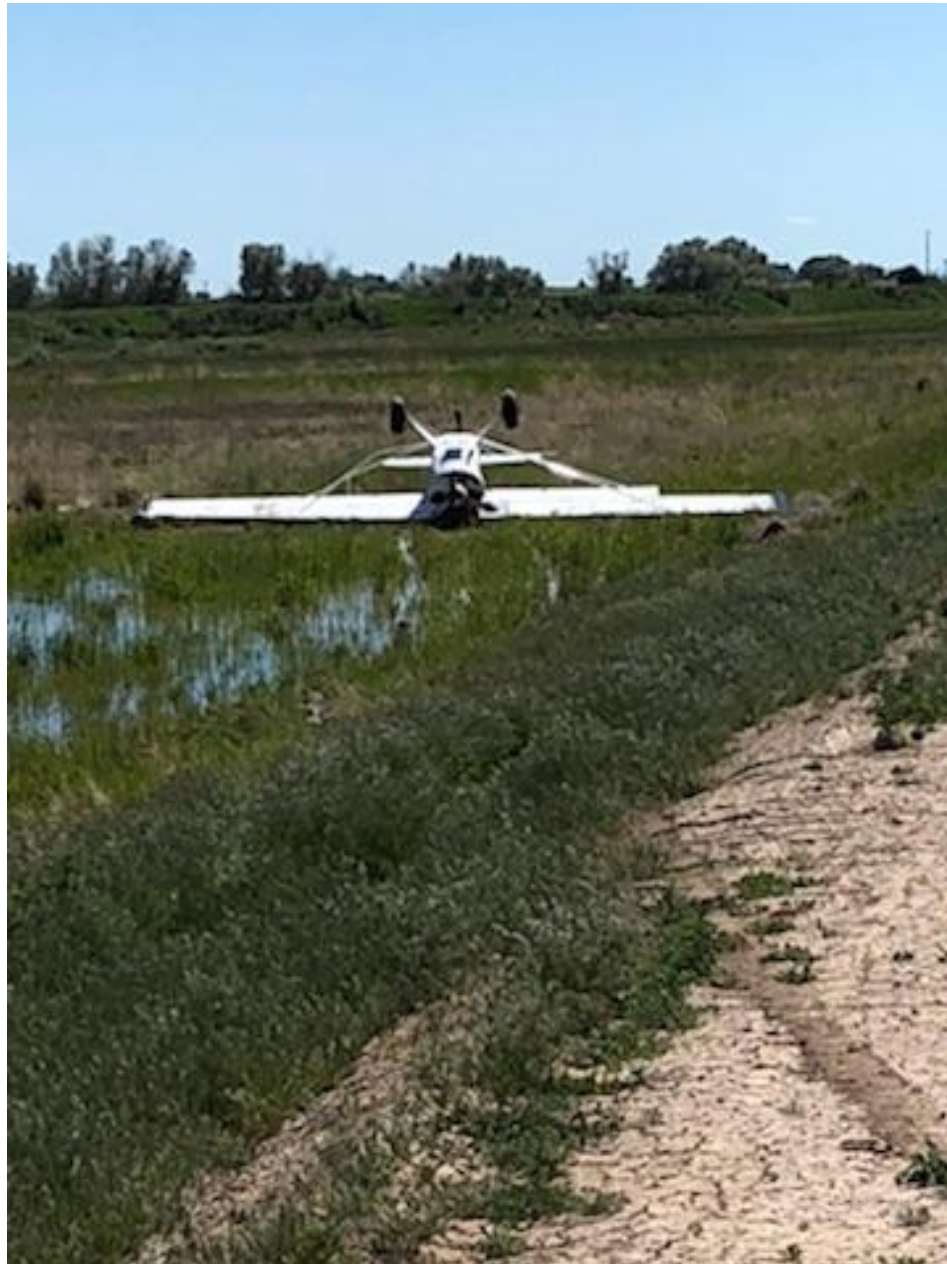
Photo 1 - Front view of inverted airplane (photo courtesy of the pilot)

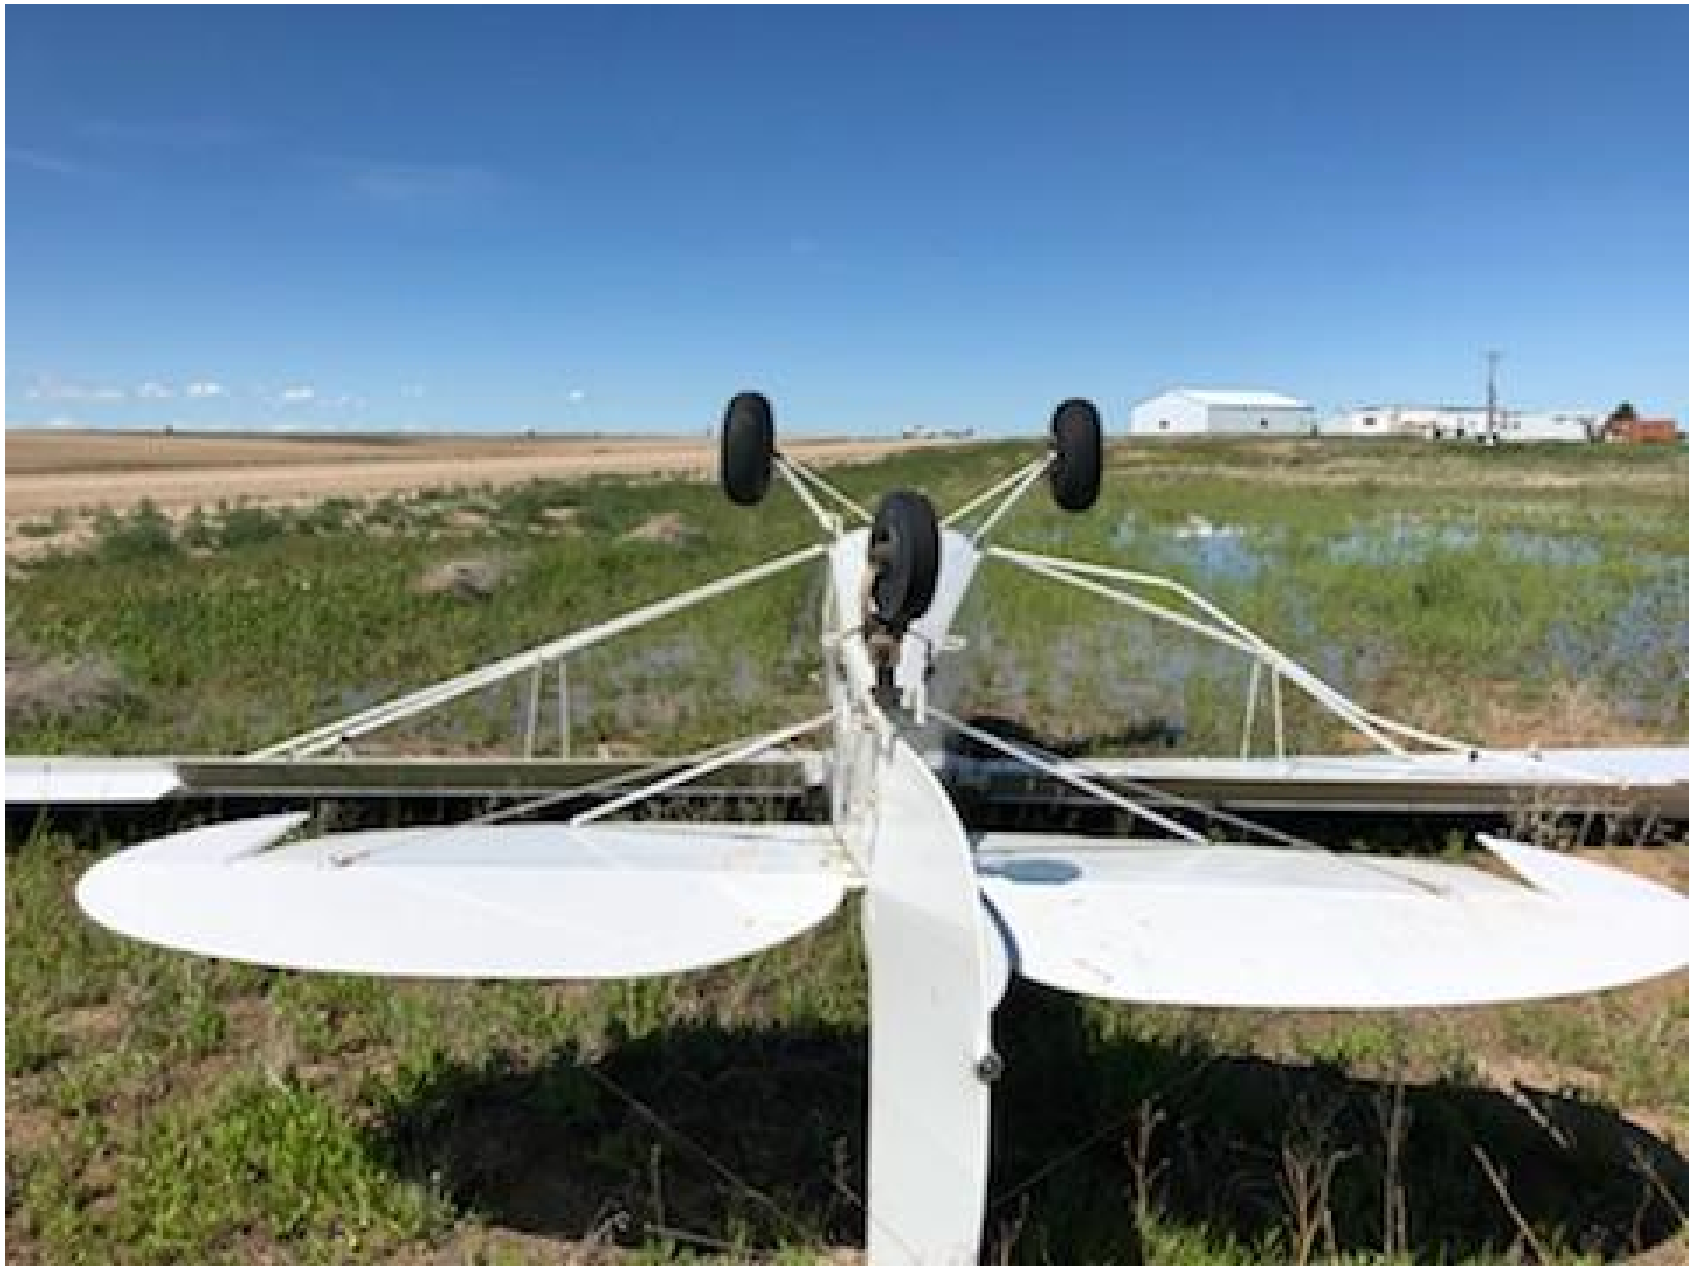
Photo 2 - View of left wing lift strut damage (photo courtesy of the pilot)
