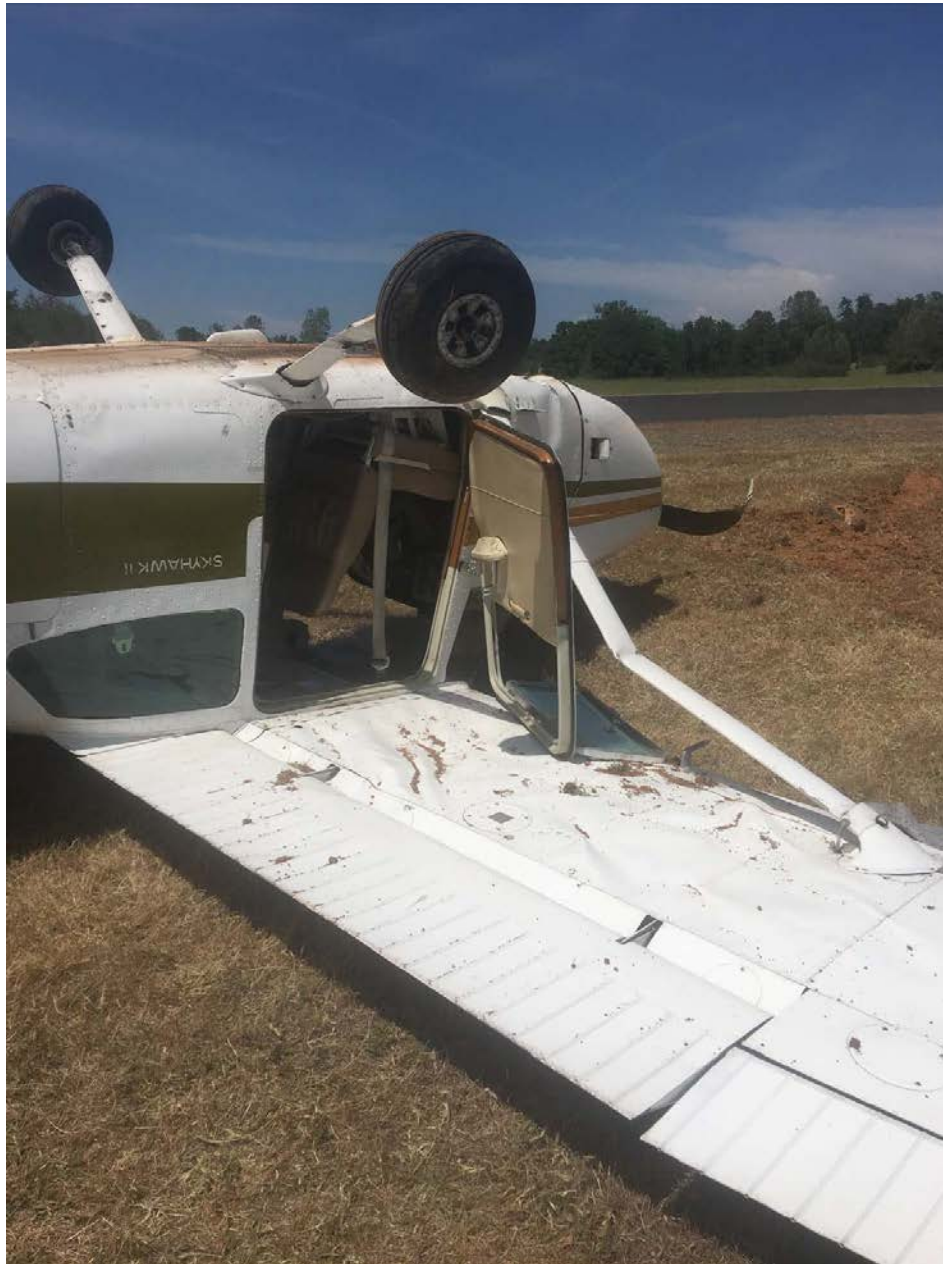
Photo 1 – View of damage to left-wing lift strut (courtesy of the FAA)

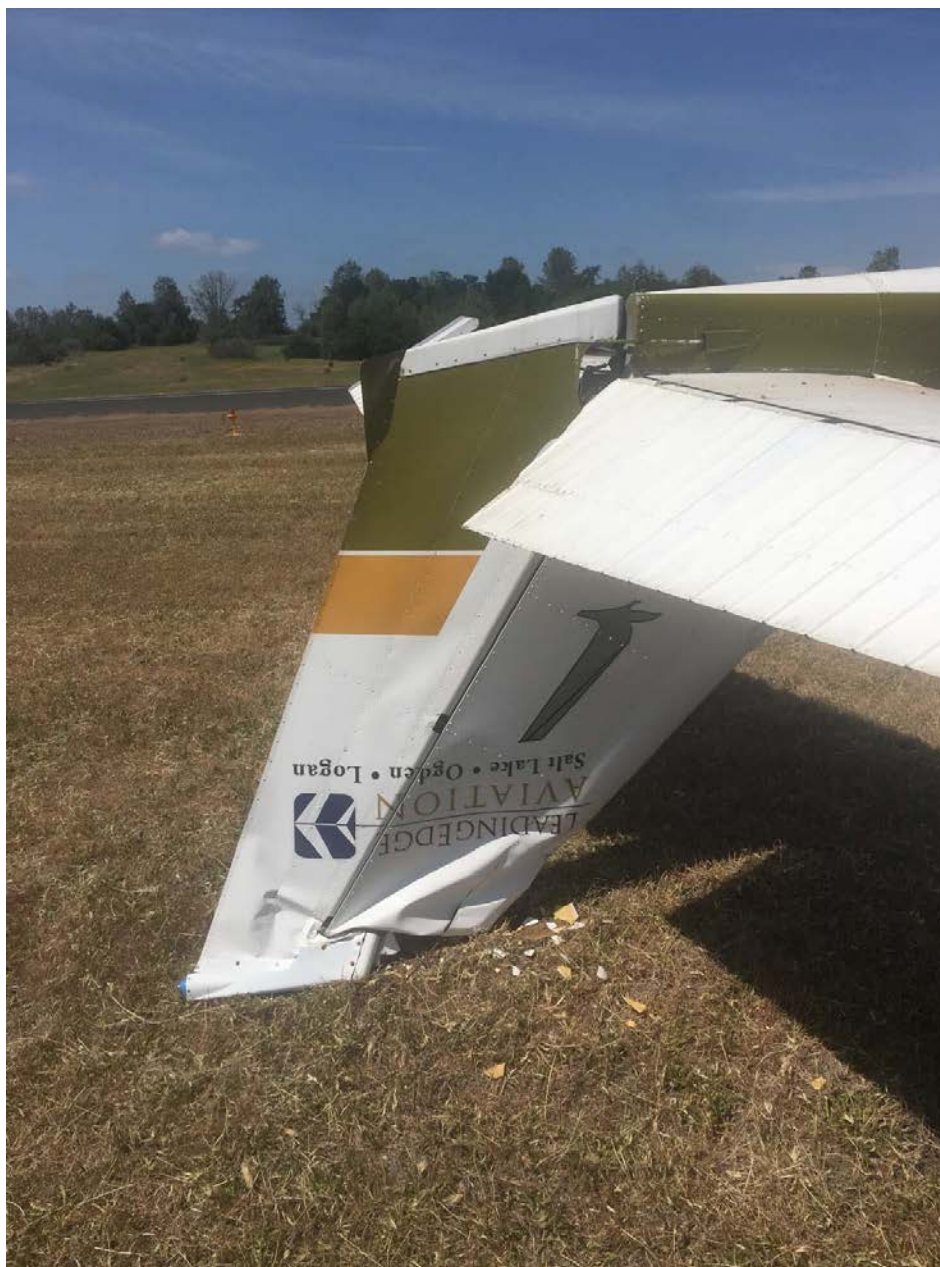
Photo 2 – View of damage to empennage (courtesy of the FAA)
