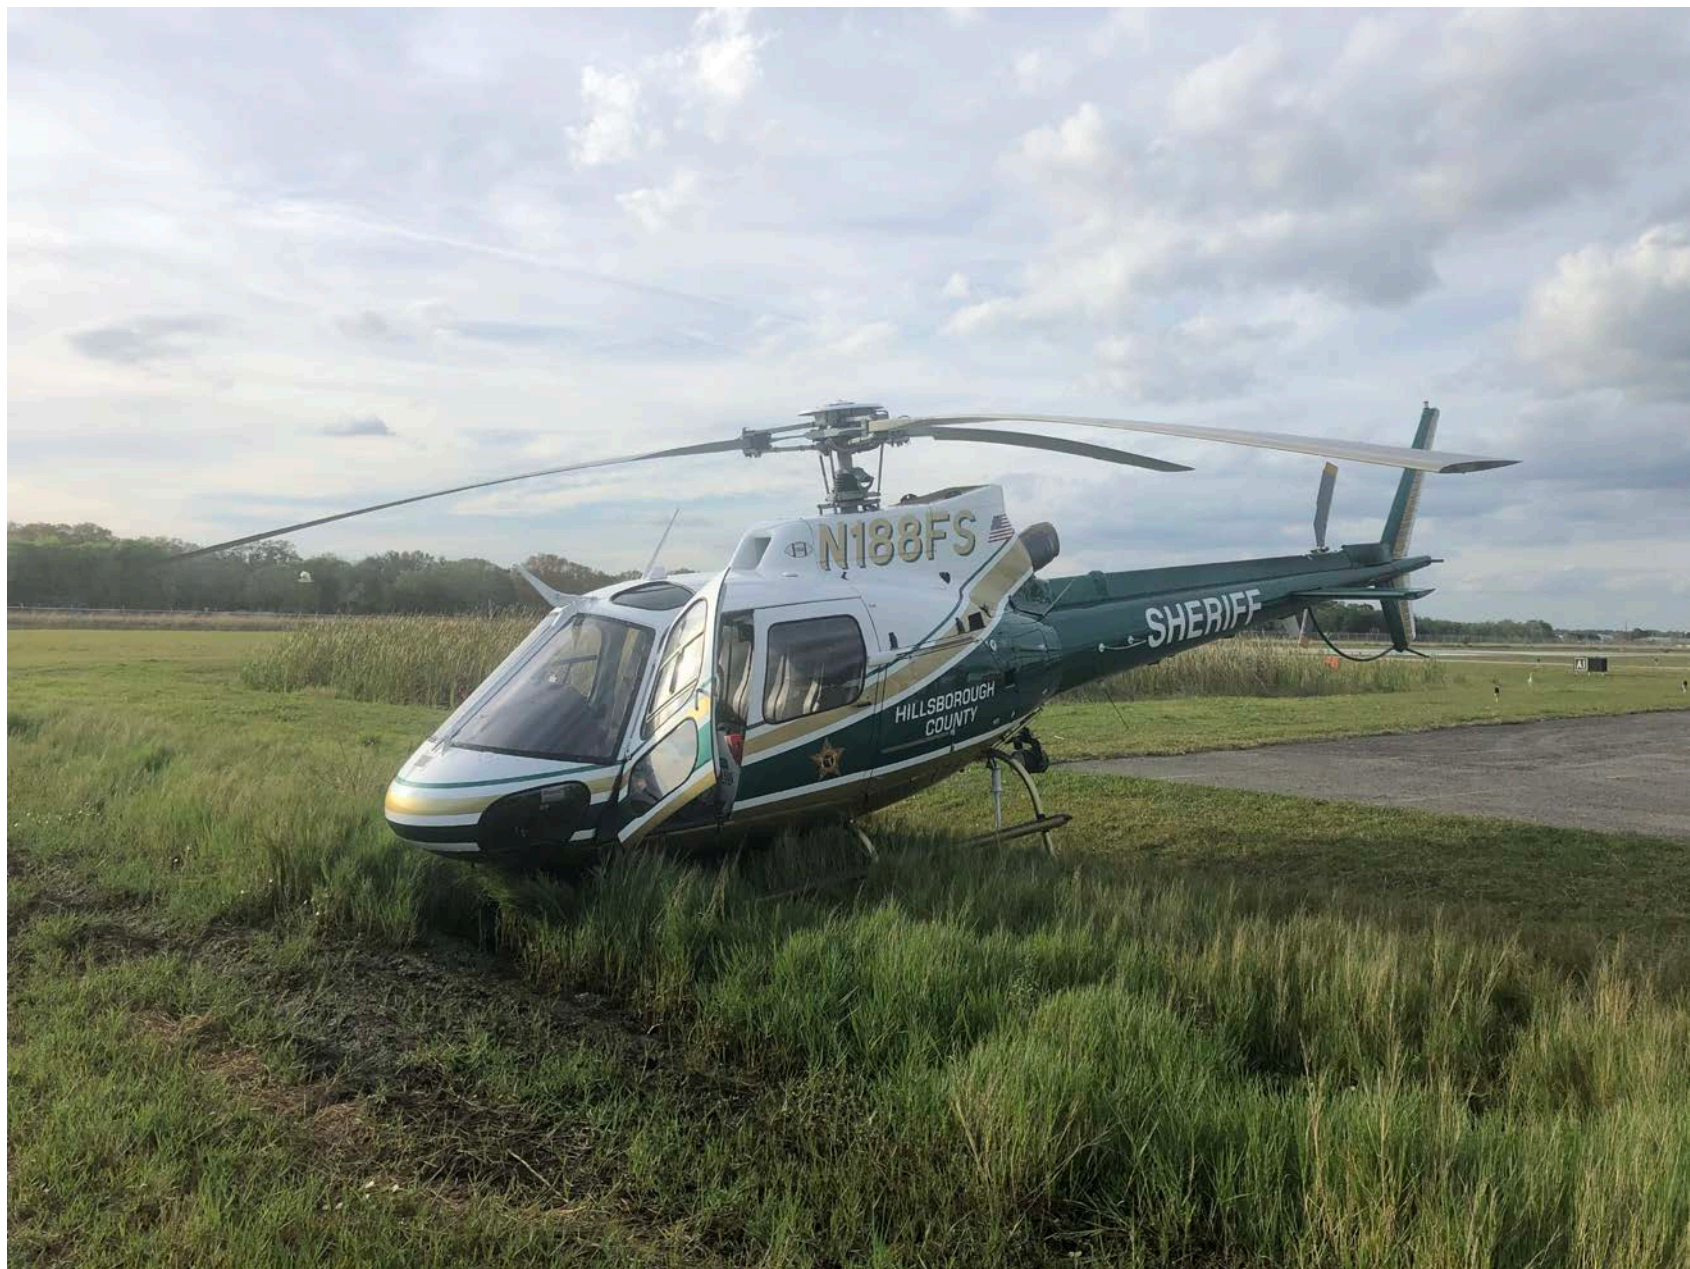
Photo 1 – View of helicopter in grass adjacent taxiway (photo courtesy of the FAA)

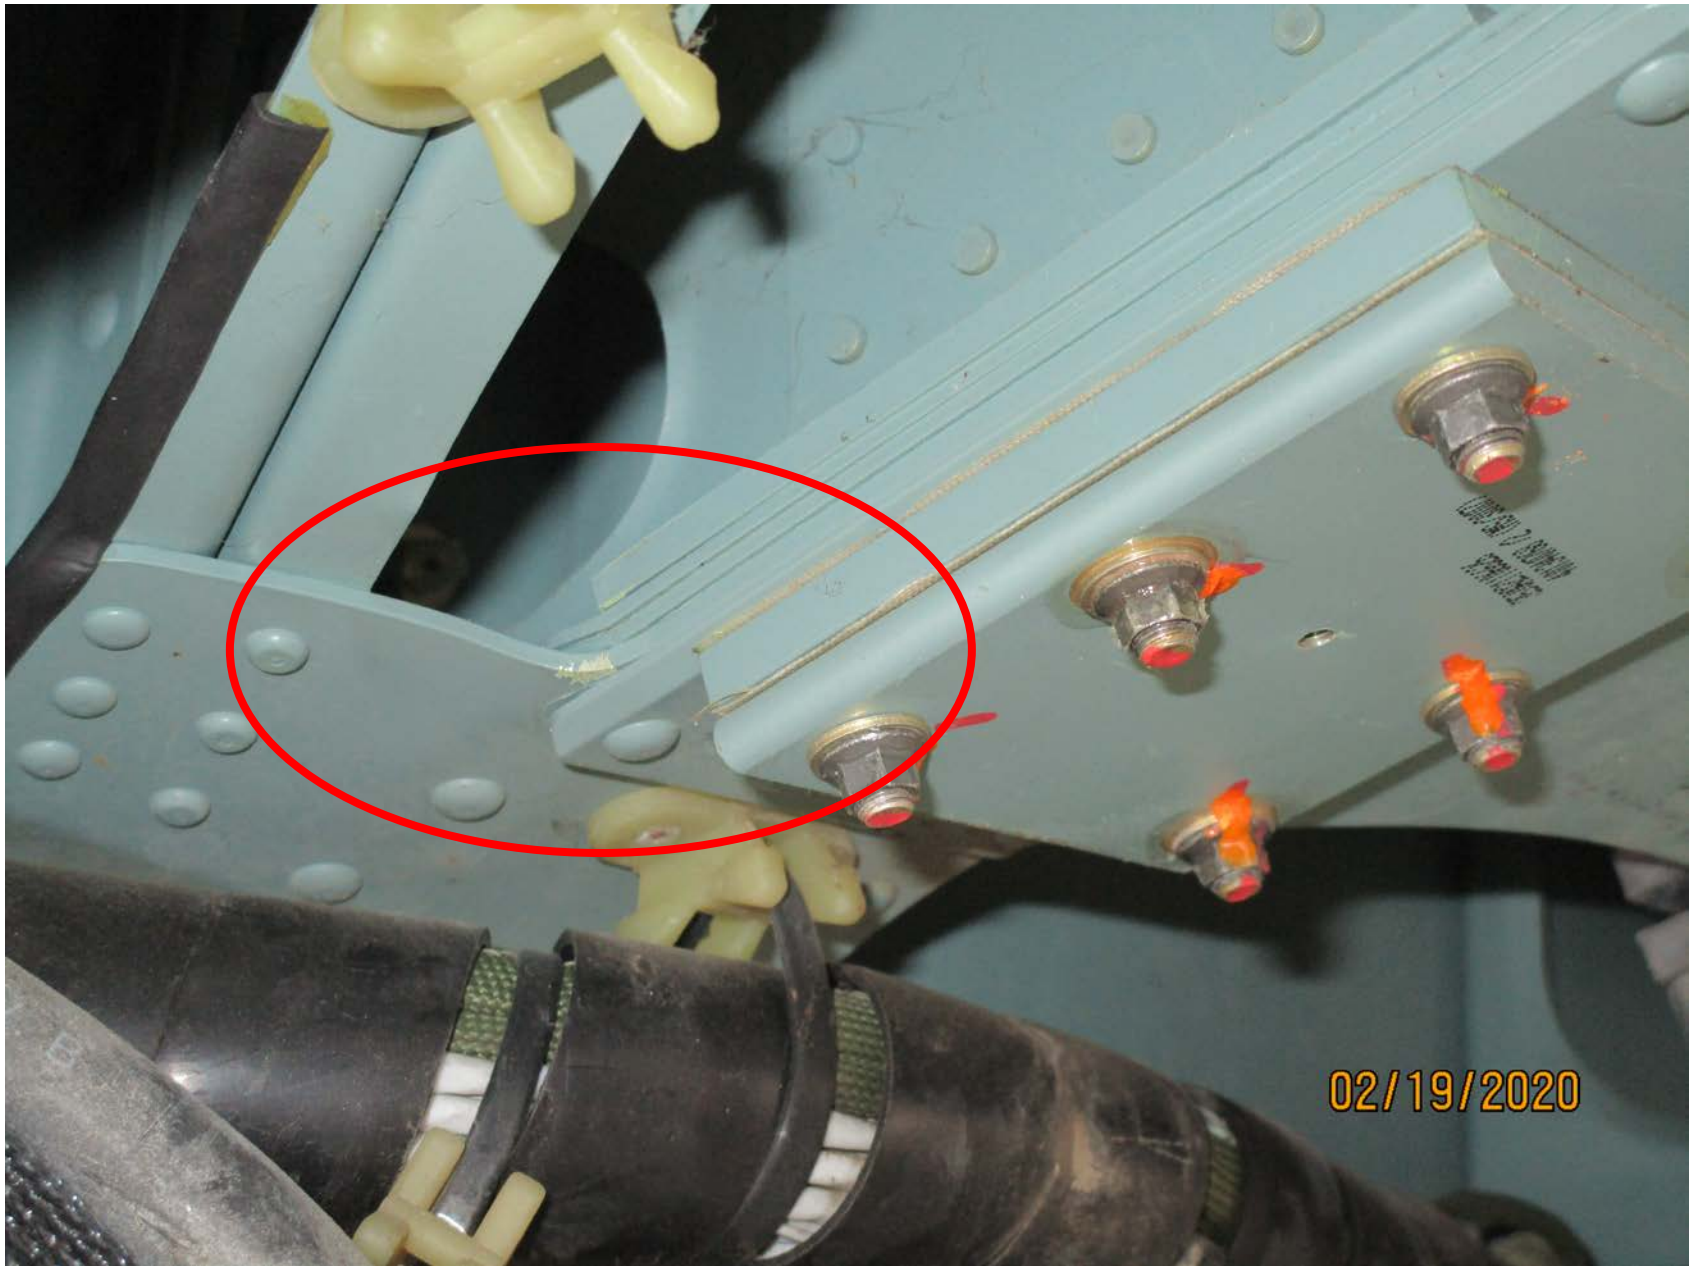
Photo 2 - View of left-hand anti-vibrator mount beam damage (photo courtesy of the FAA)
