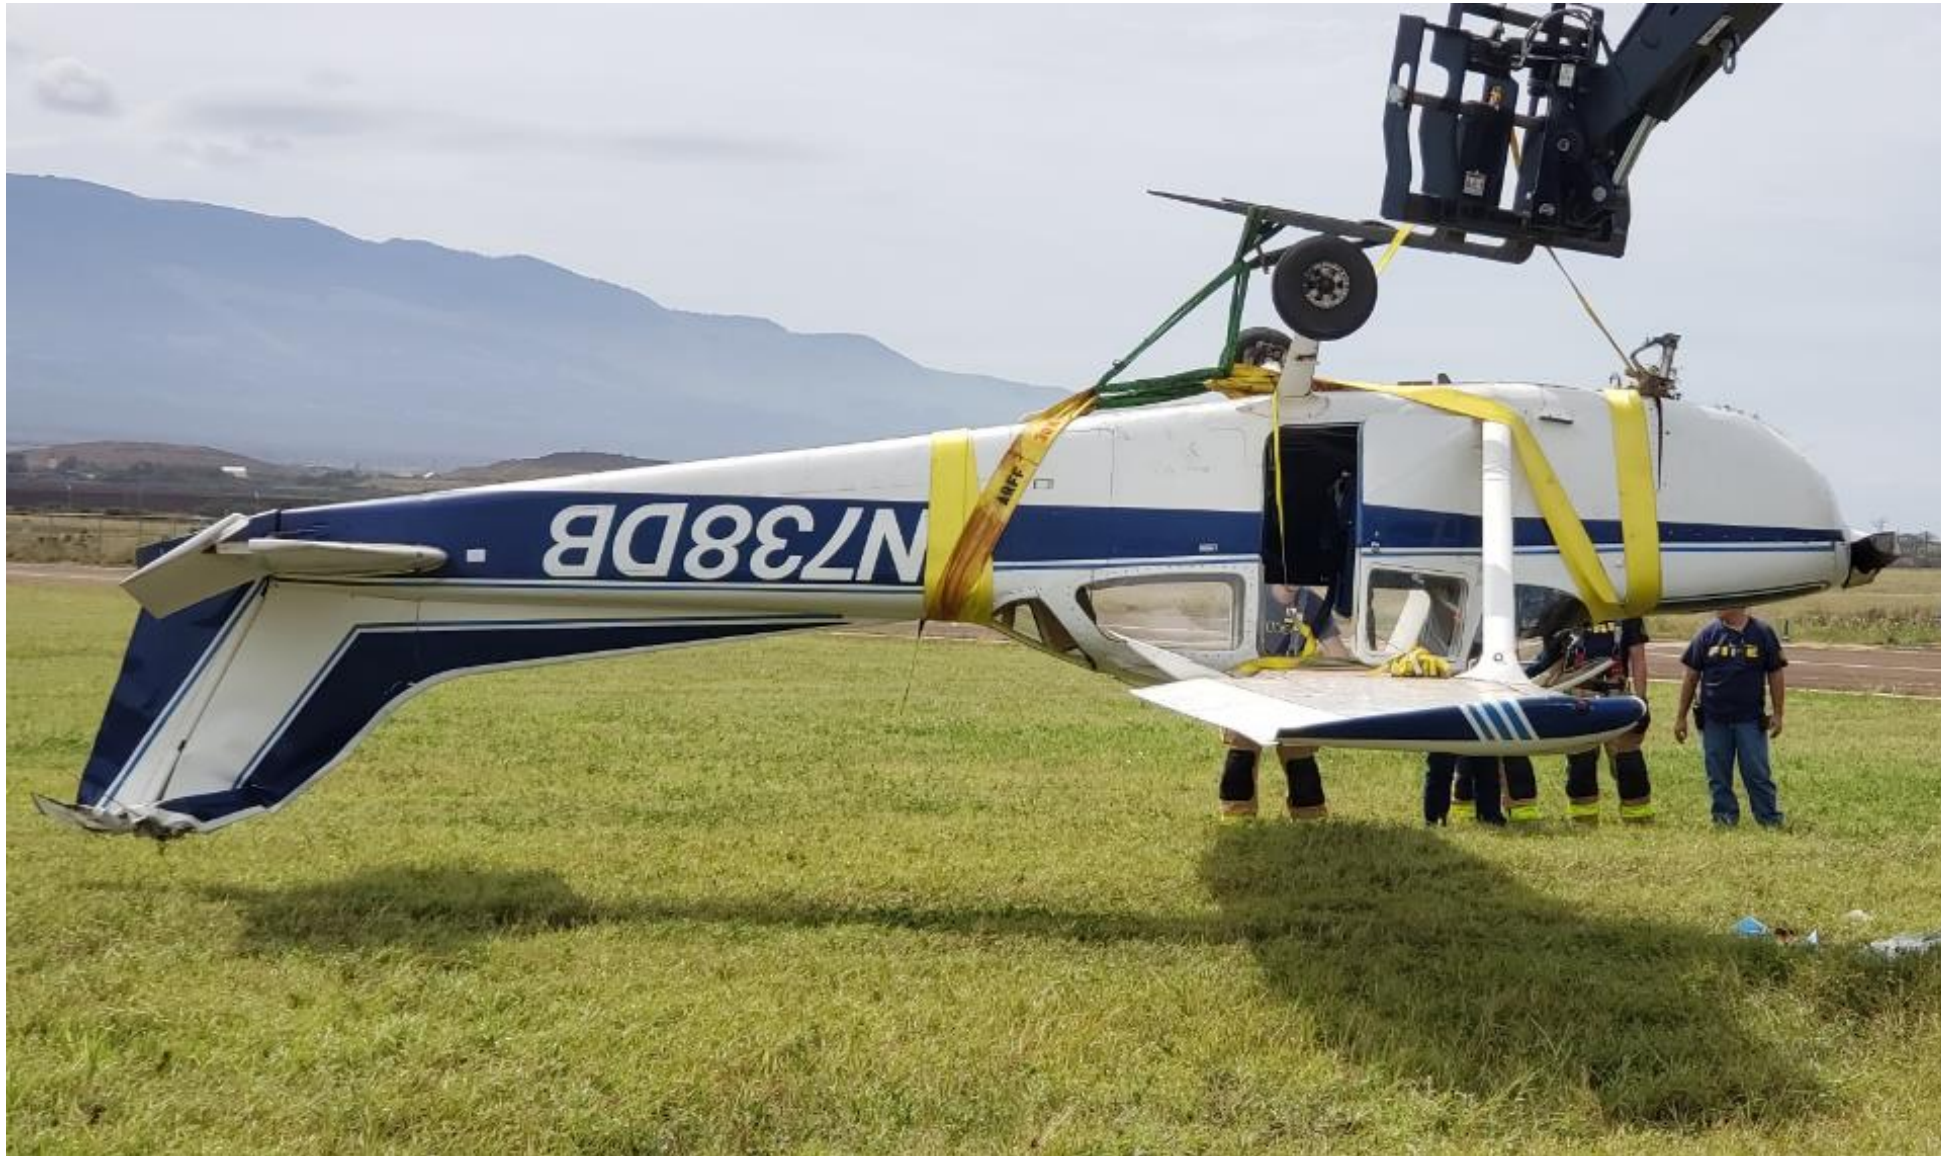
**Photo 1 – View of damaged empennage (Photo courtesy of the airport manager)**
