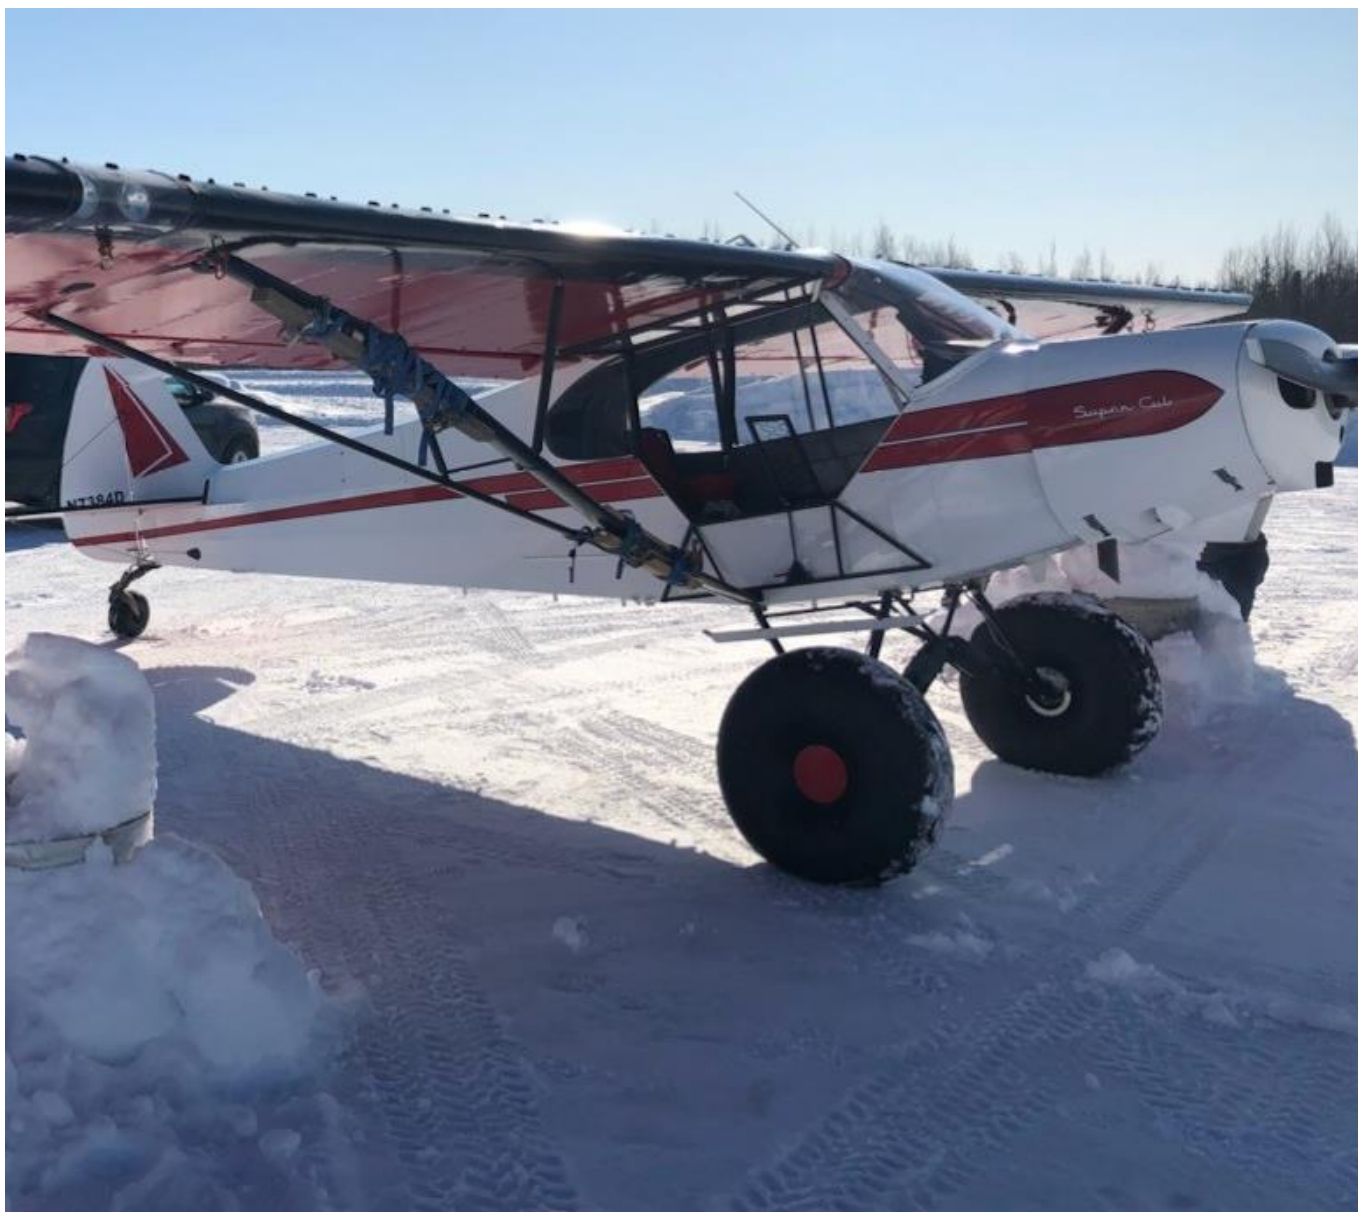
Photo 1 – View of damaged lift strut (Photo courtesy of the NTSB)

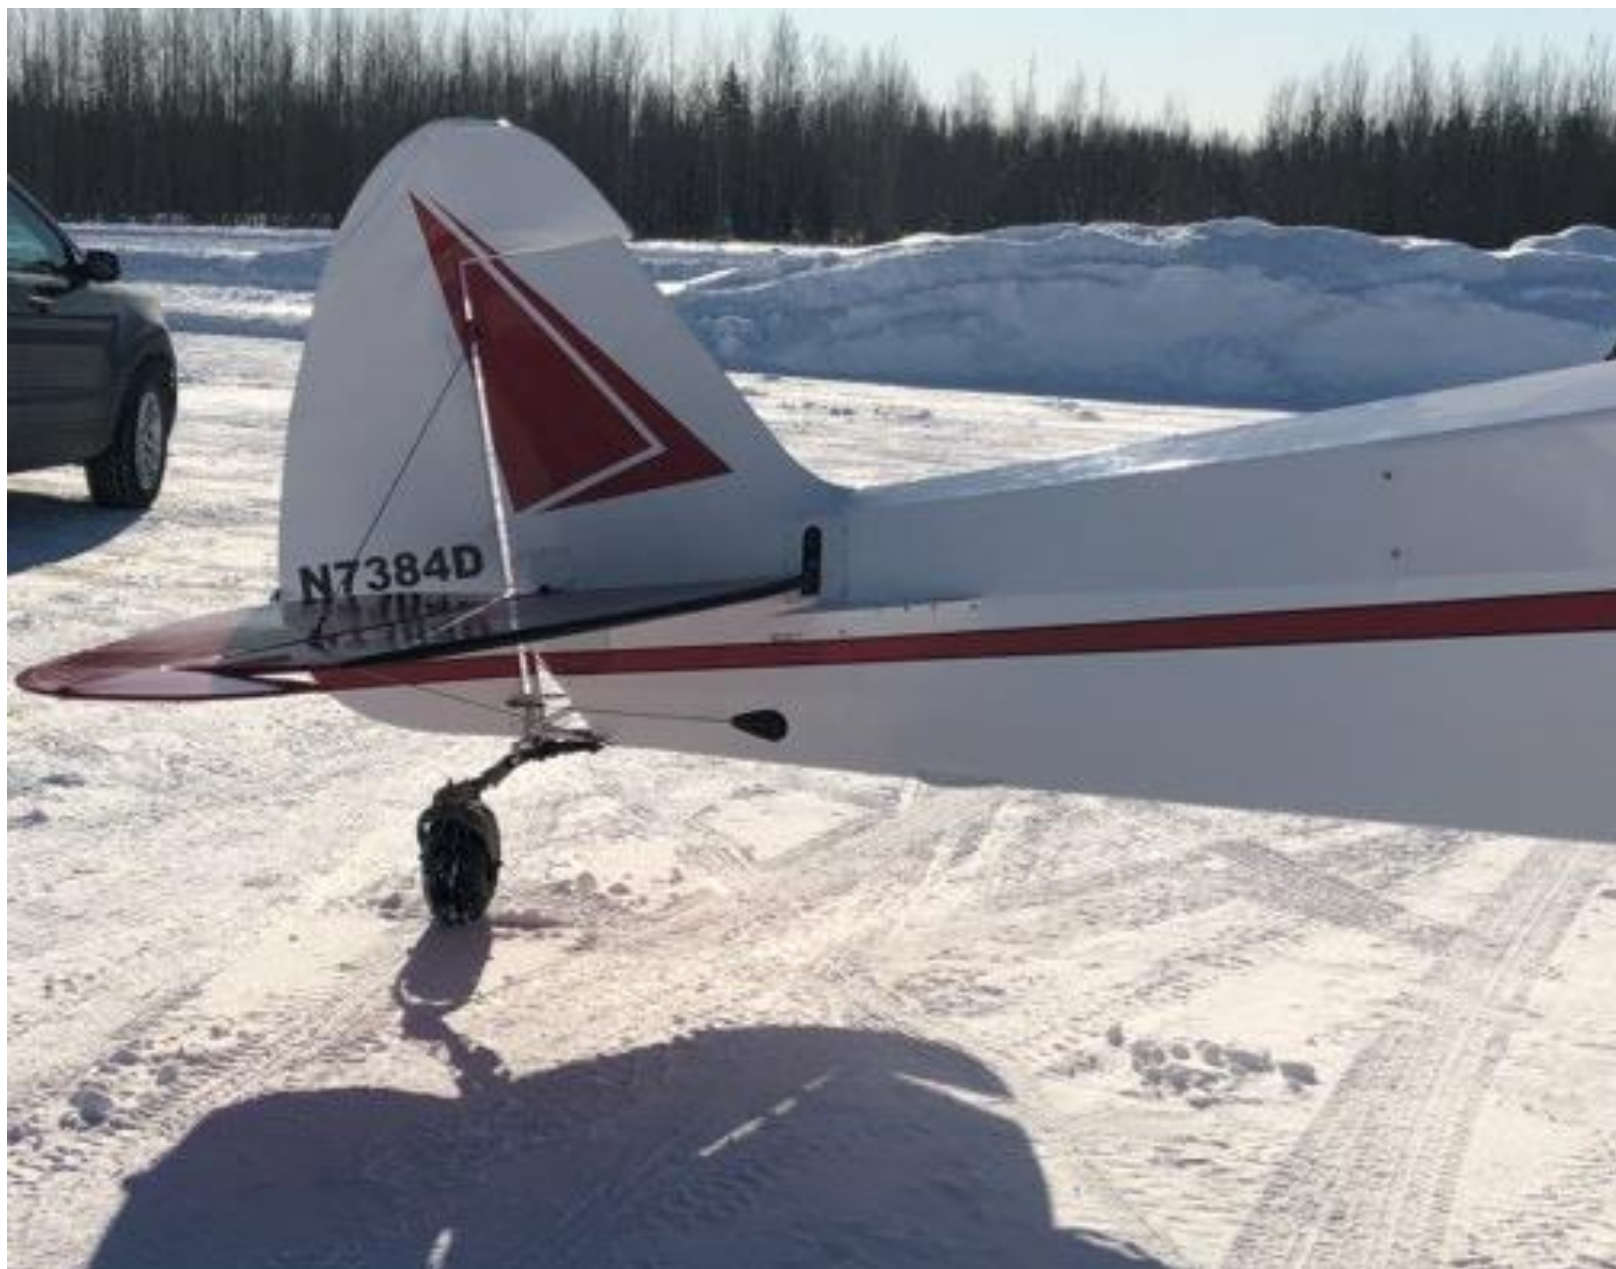
Photo 2 – View of damaged empennage (Photo courtesy of the NTSB)
