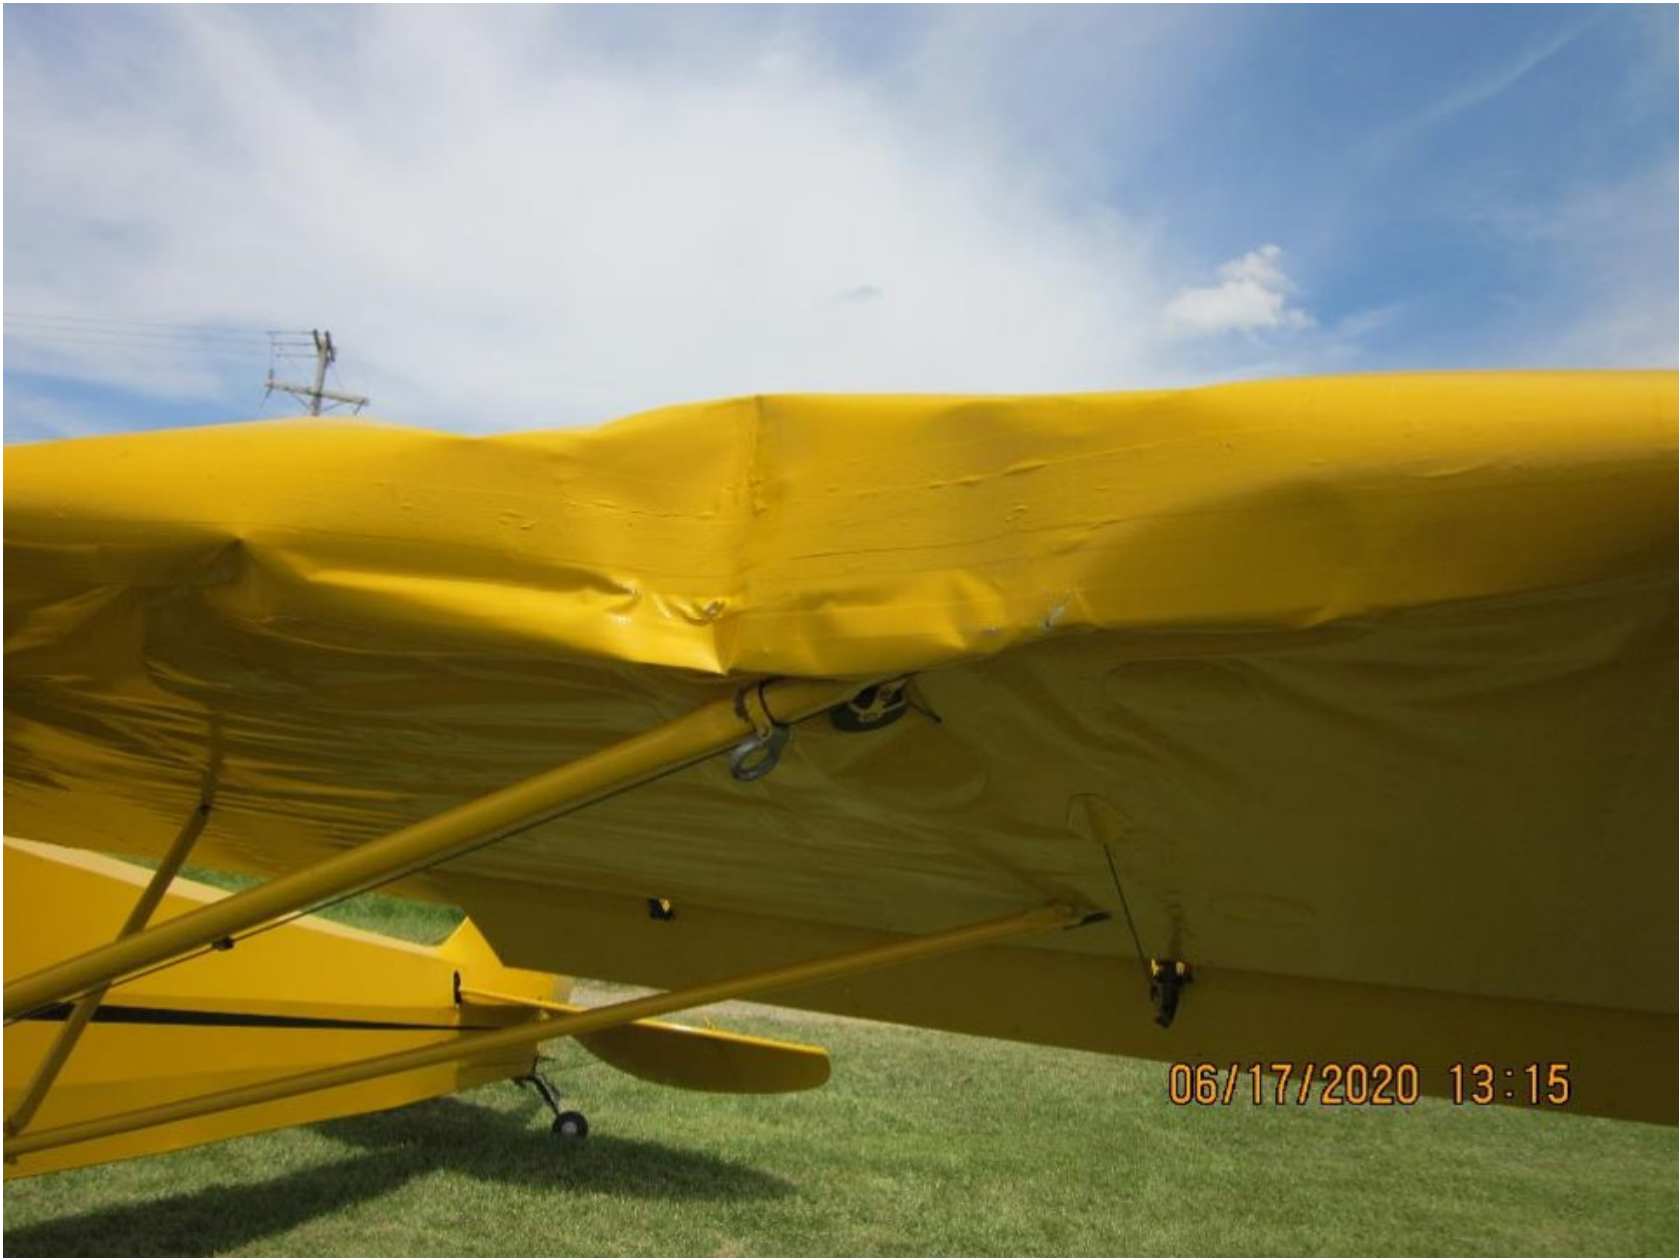
Photo 1 – Left wing leading edge damage (FAA photo)

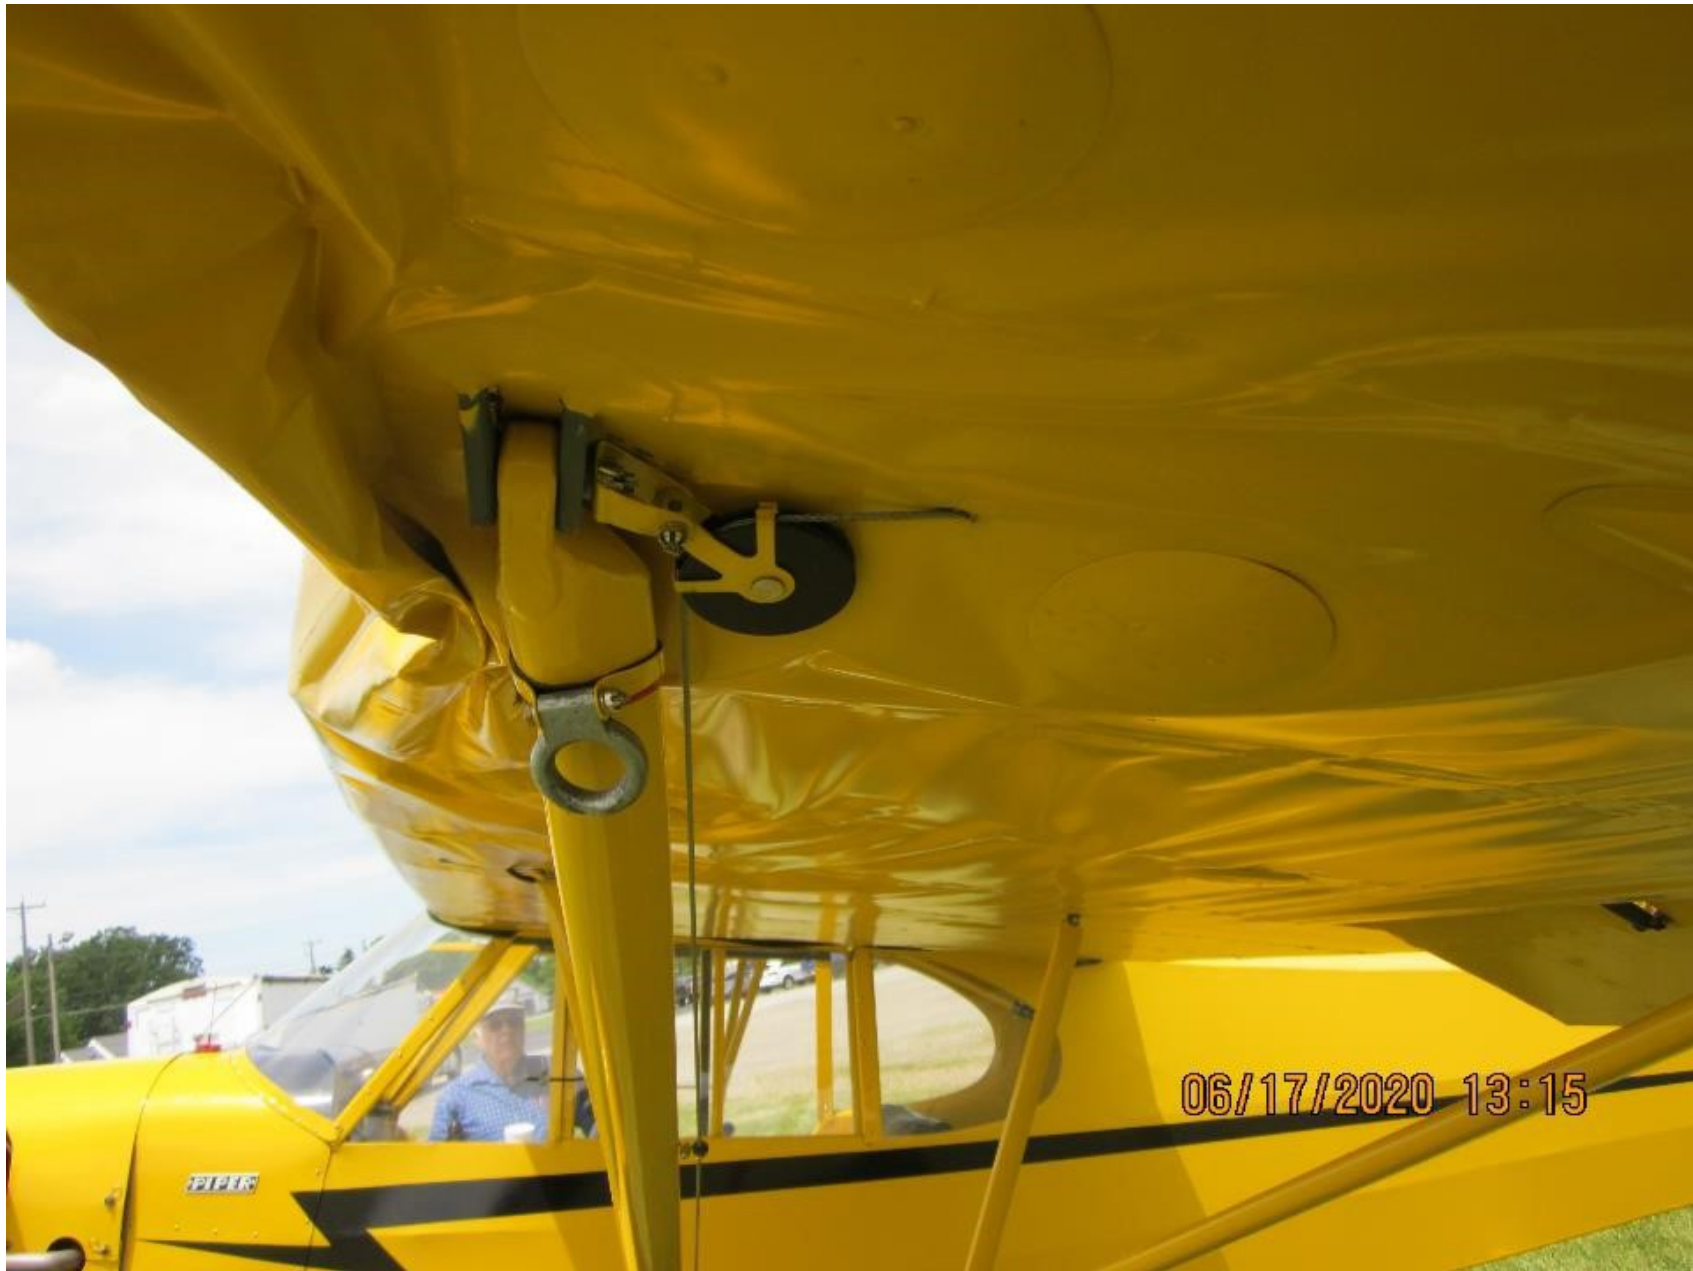
Photo 2 – Damage to underside of left wing (FAA photo)

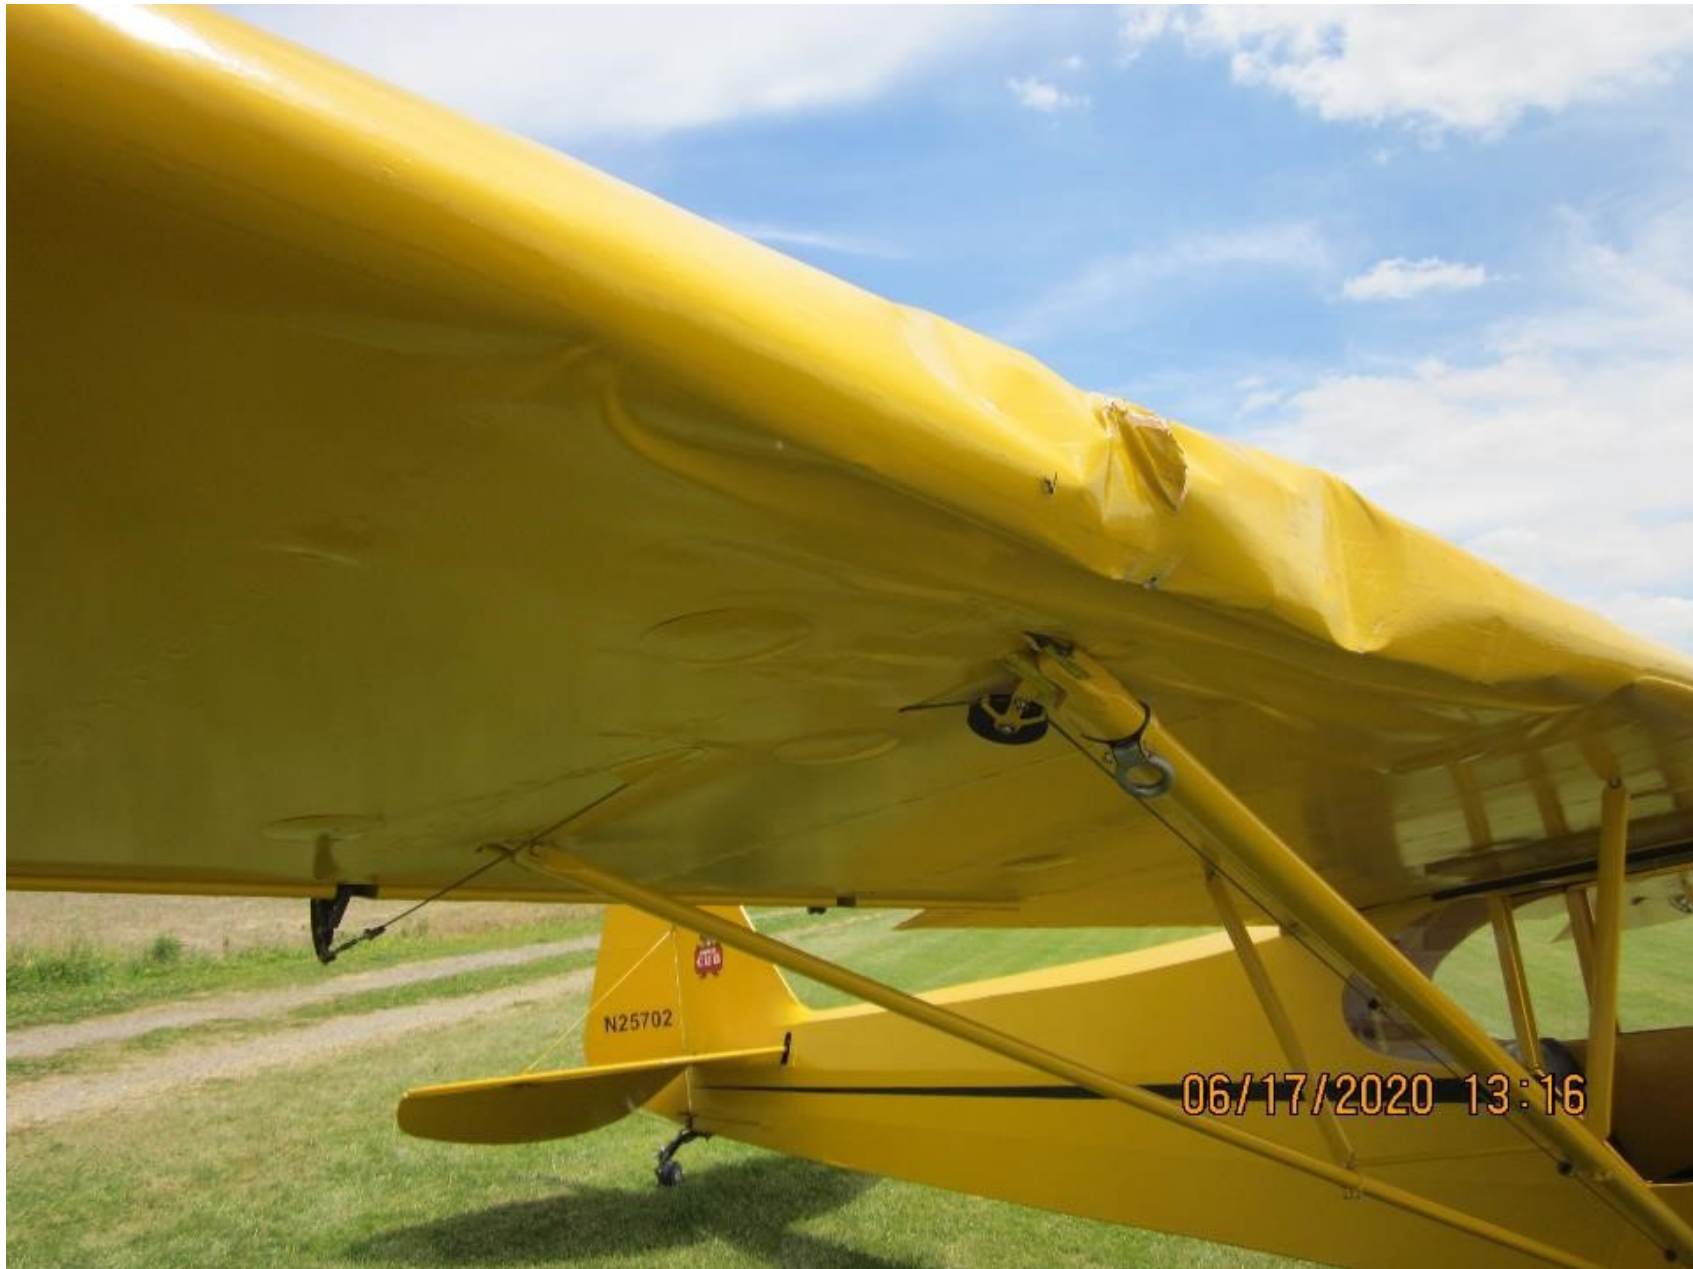
Photo 3 – Right wing leading edge damage (FAA photo)

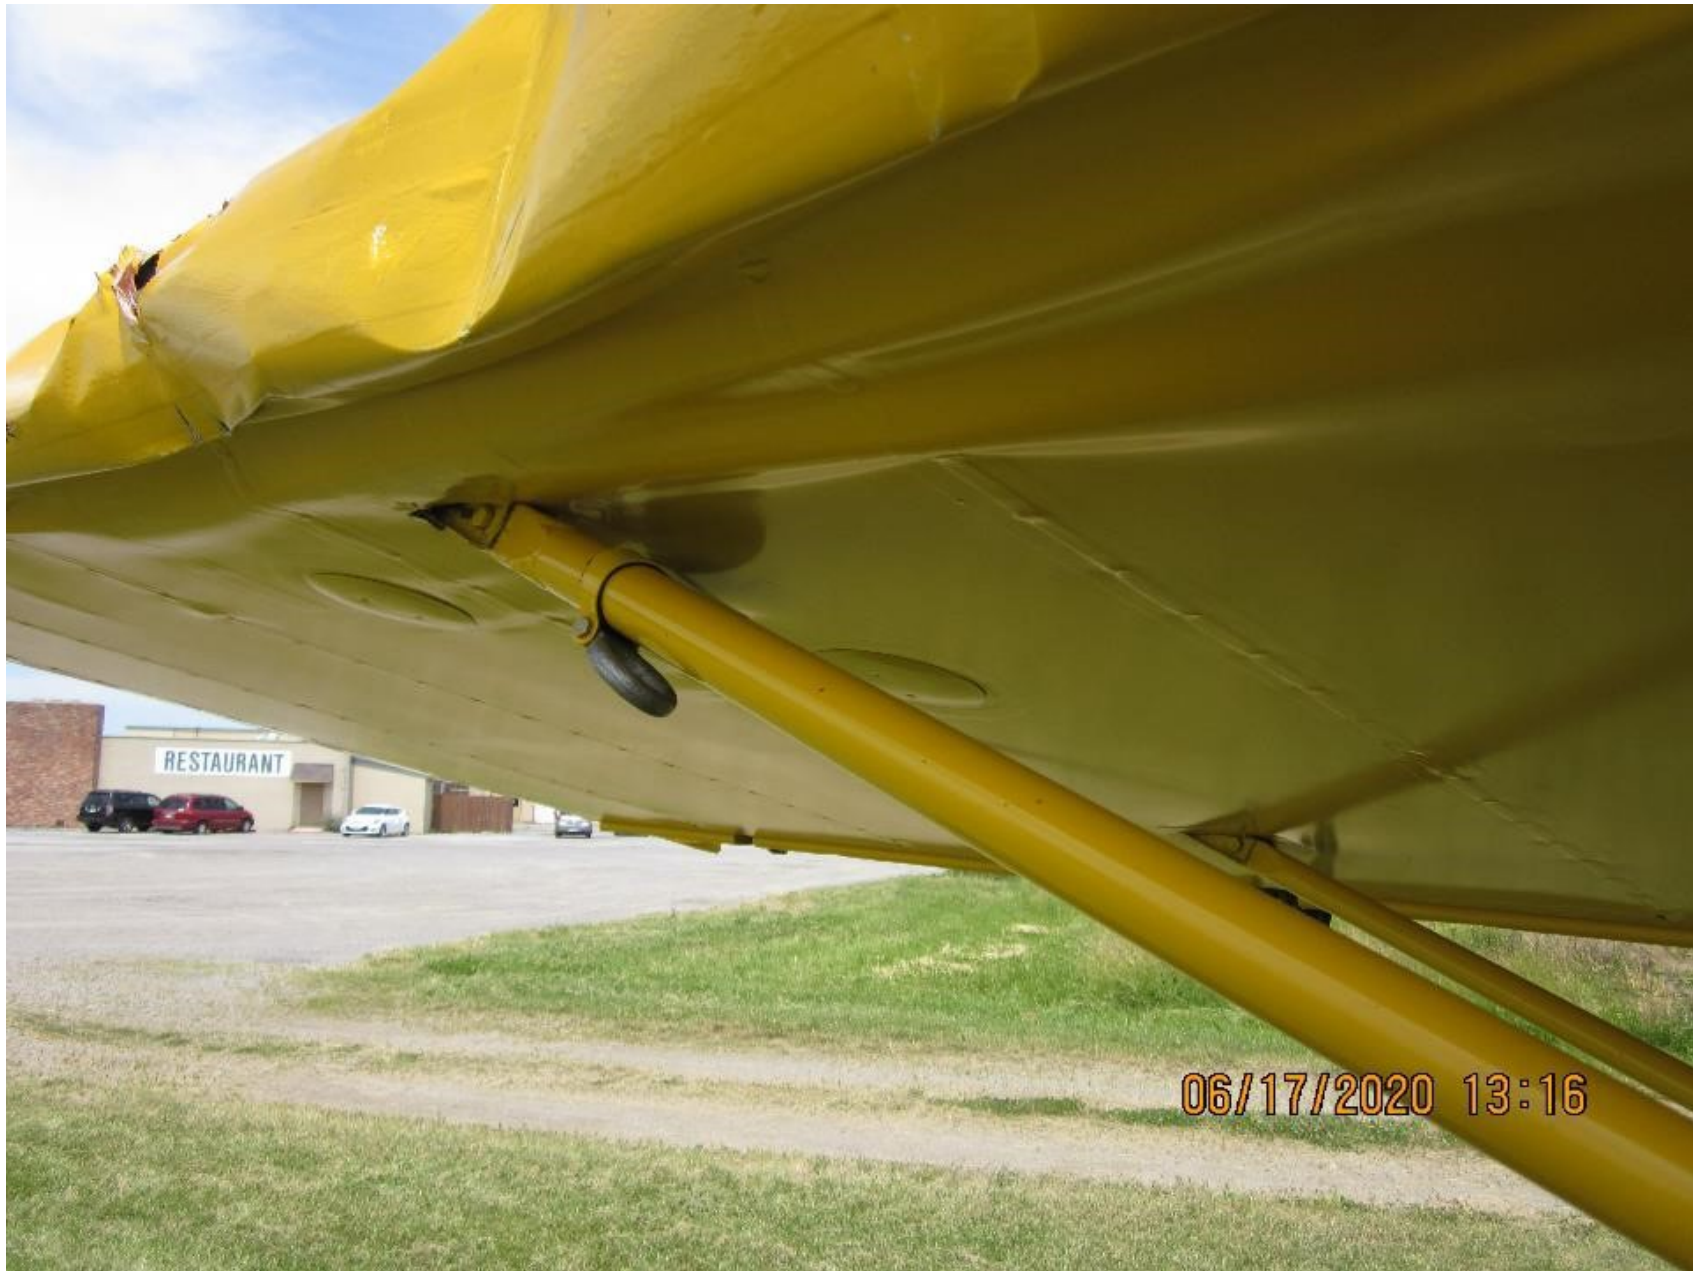
Photo 4 – Another view of right wing leading edge damage (FAA photo)

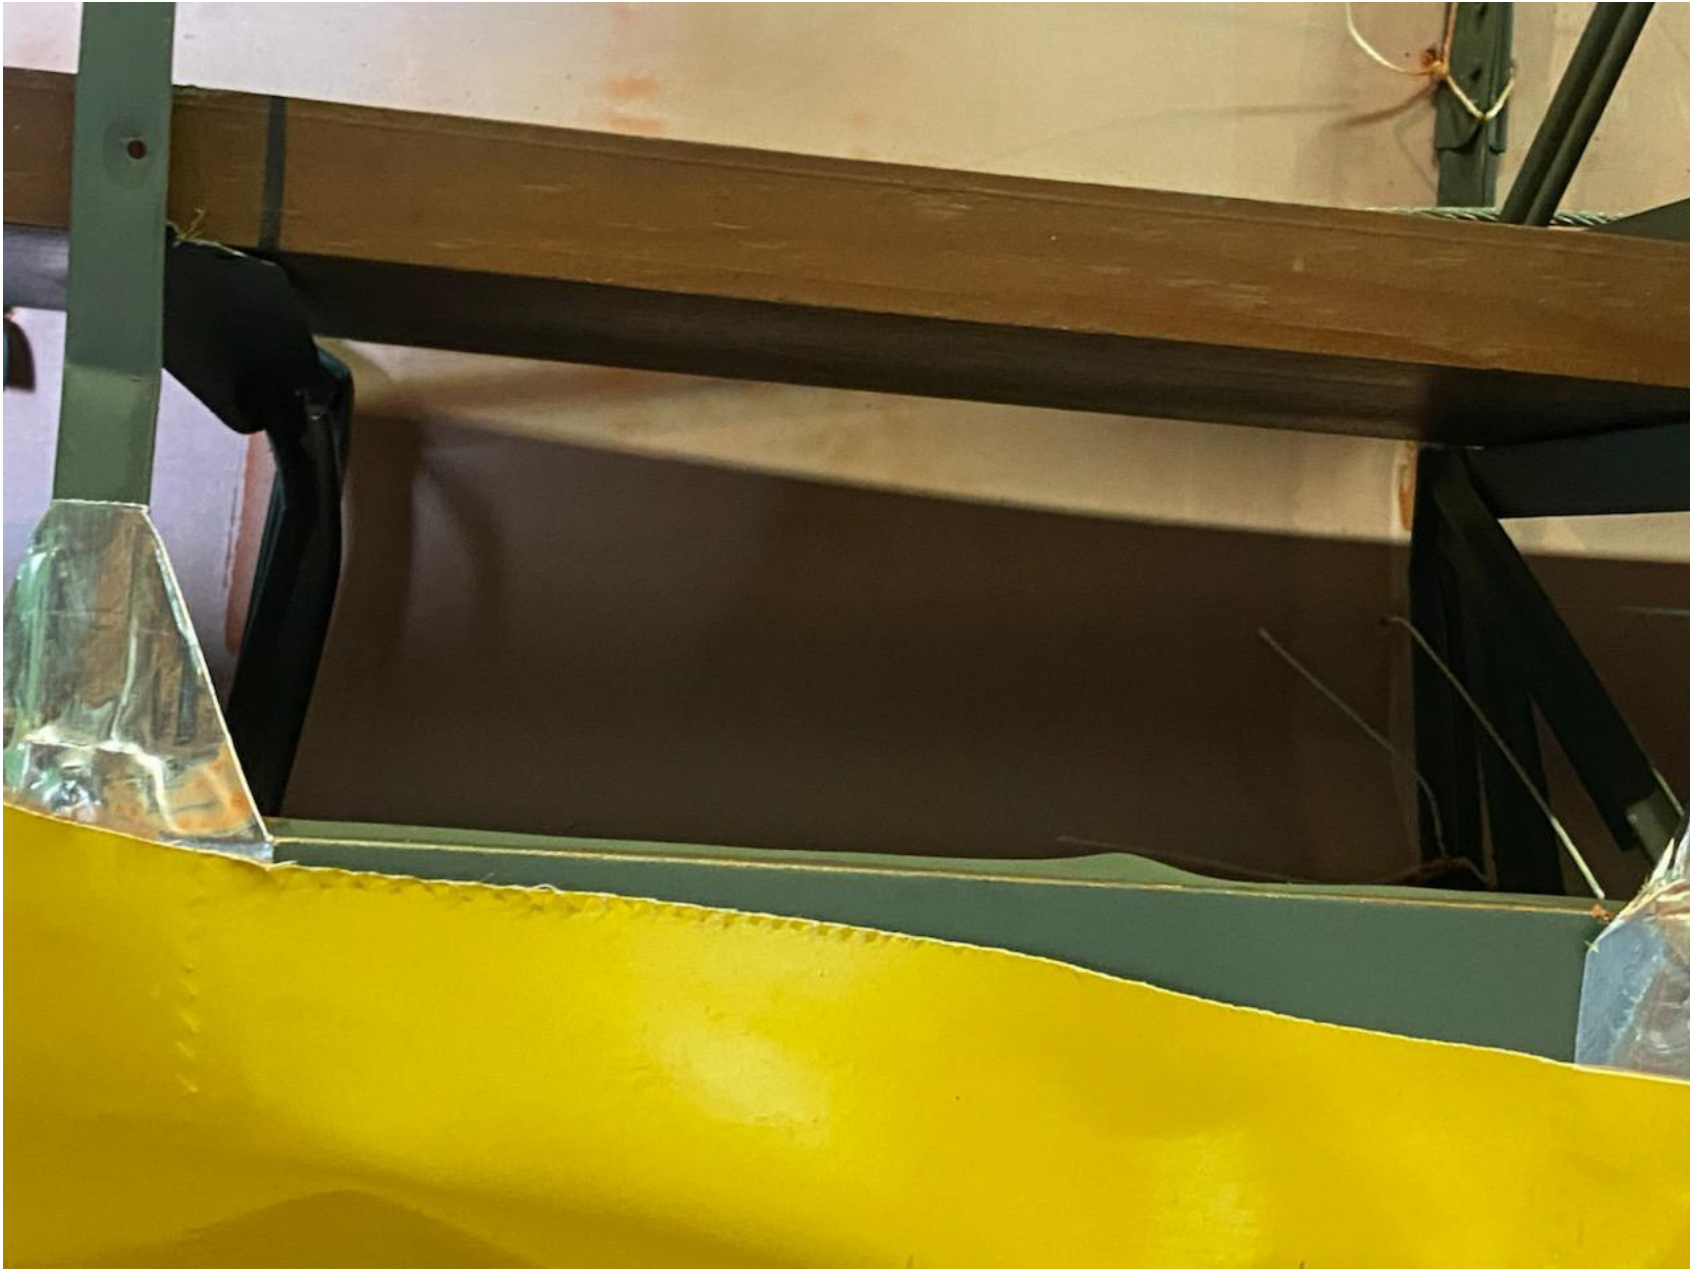
Photo 5 – No damage to right wing main spar (FAA photo)

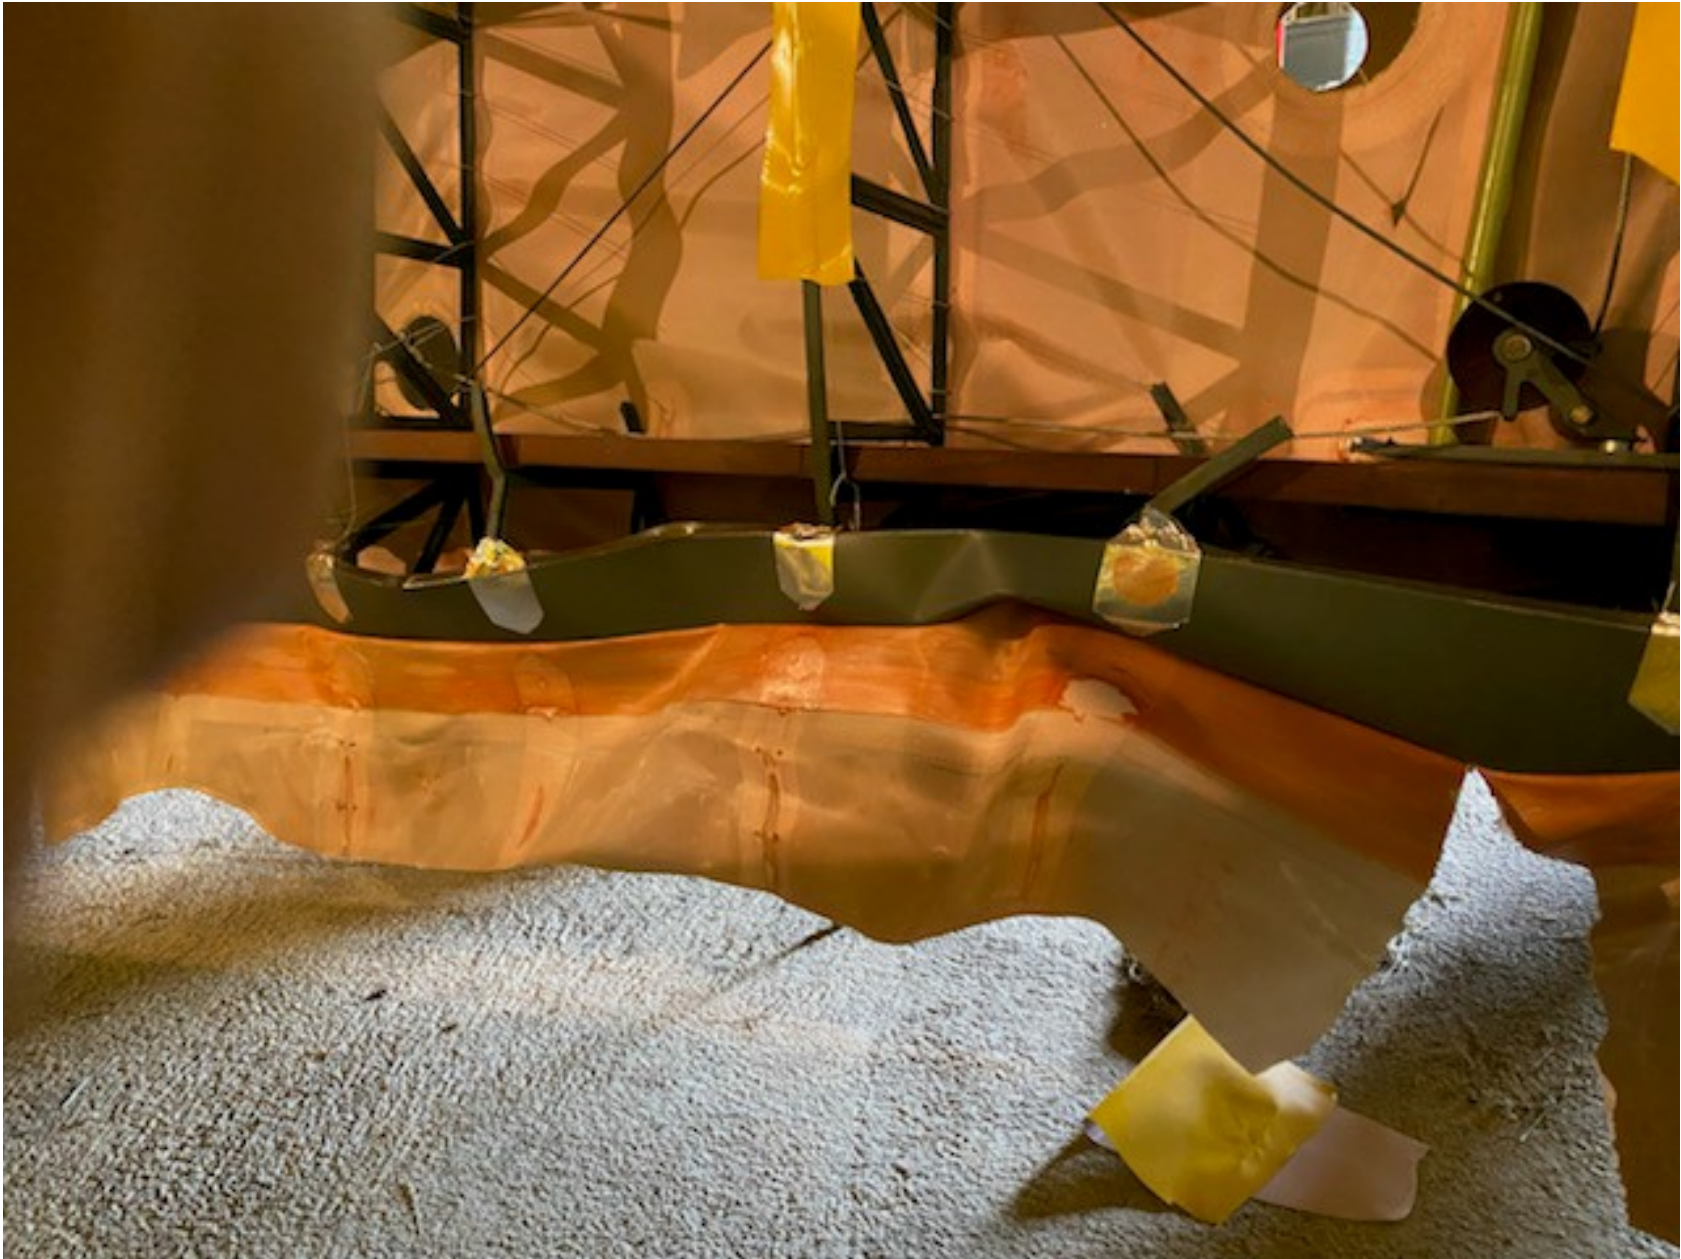
Photo 6 – No damage to left wing main spar, but leading edge is bent and crushed, breaking one rib and buckling another (FAA photo)
