Photo 1 – Pre-accident photograph of N118G

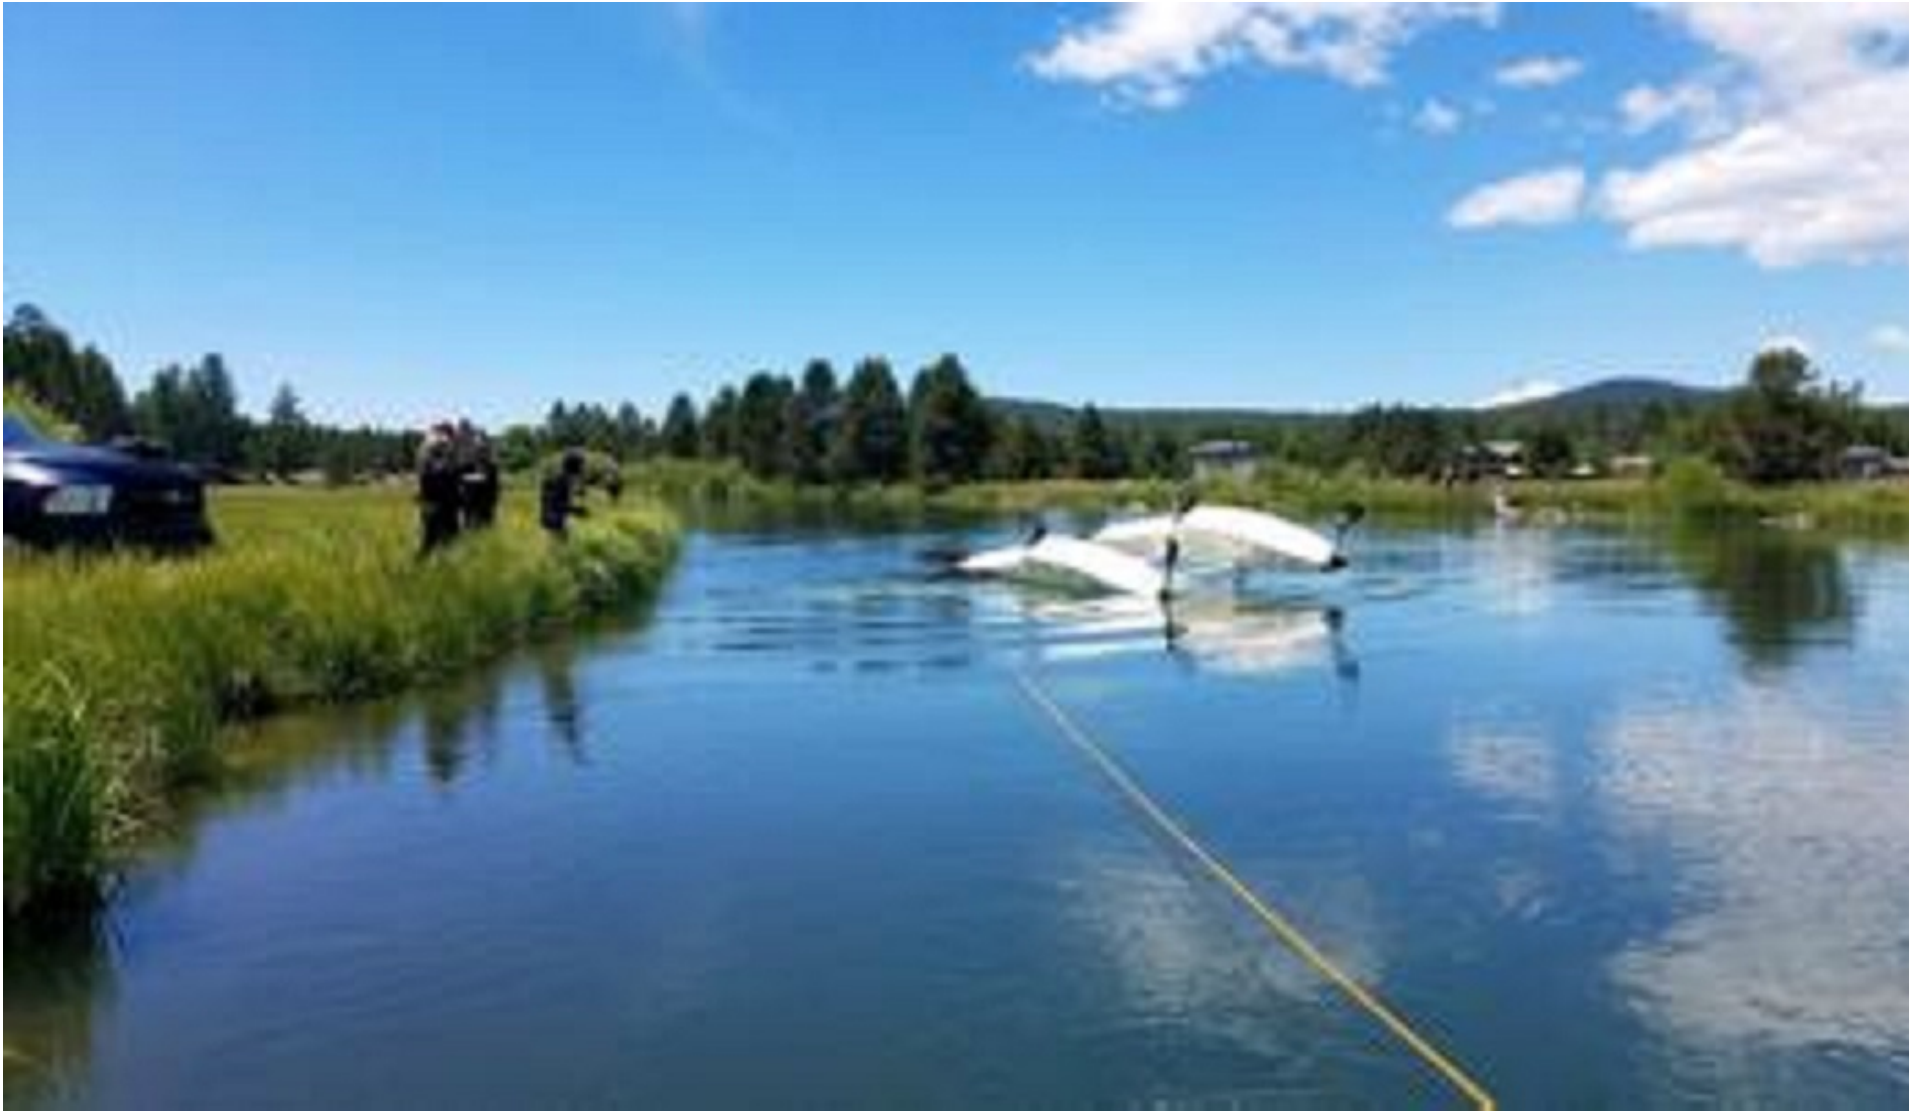
Photo 2 – N118G inverted in the Deschutes Rover shortly after the accident

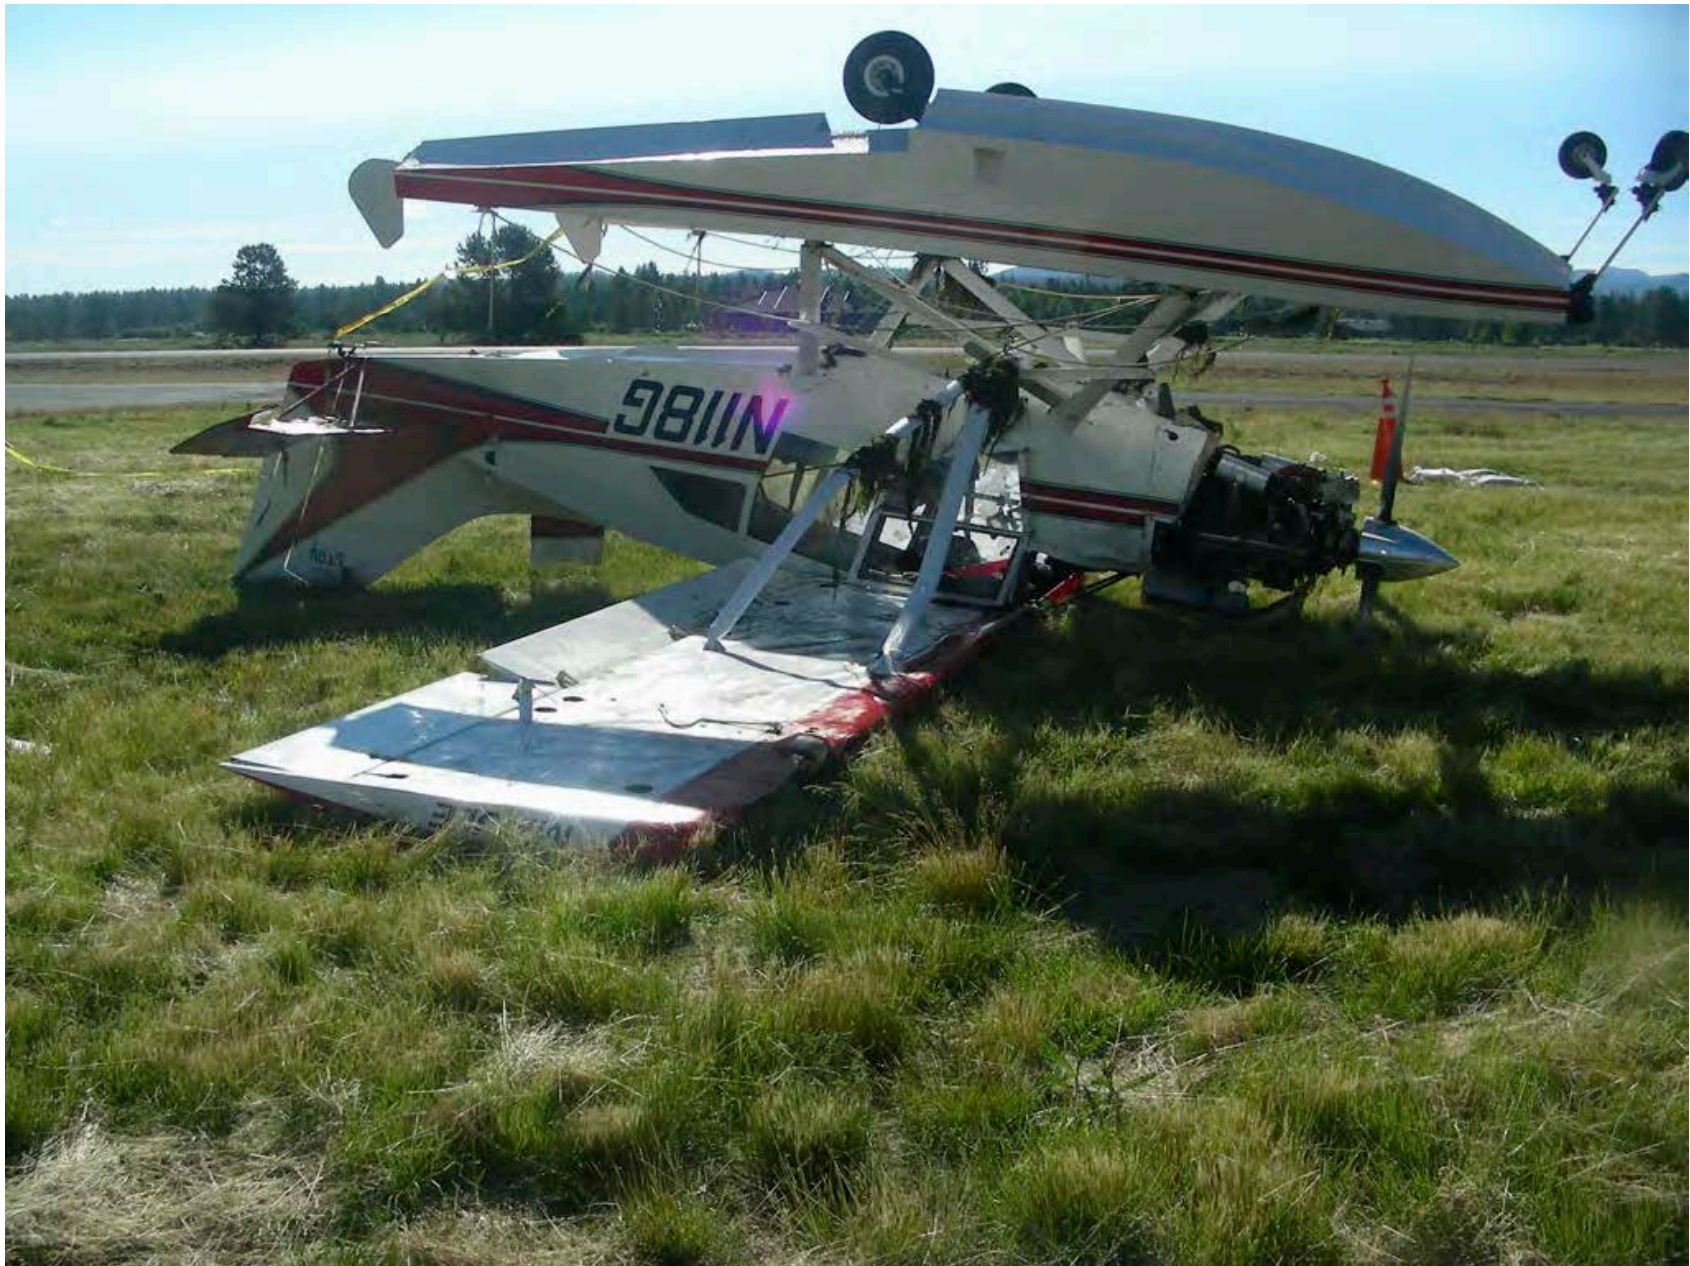
Photo 3 – N118G after recovery from the Deschutes River. Note landing gear is extended

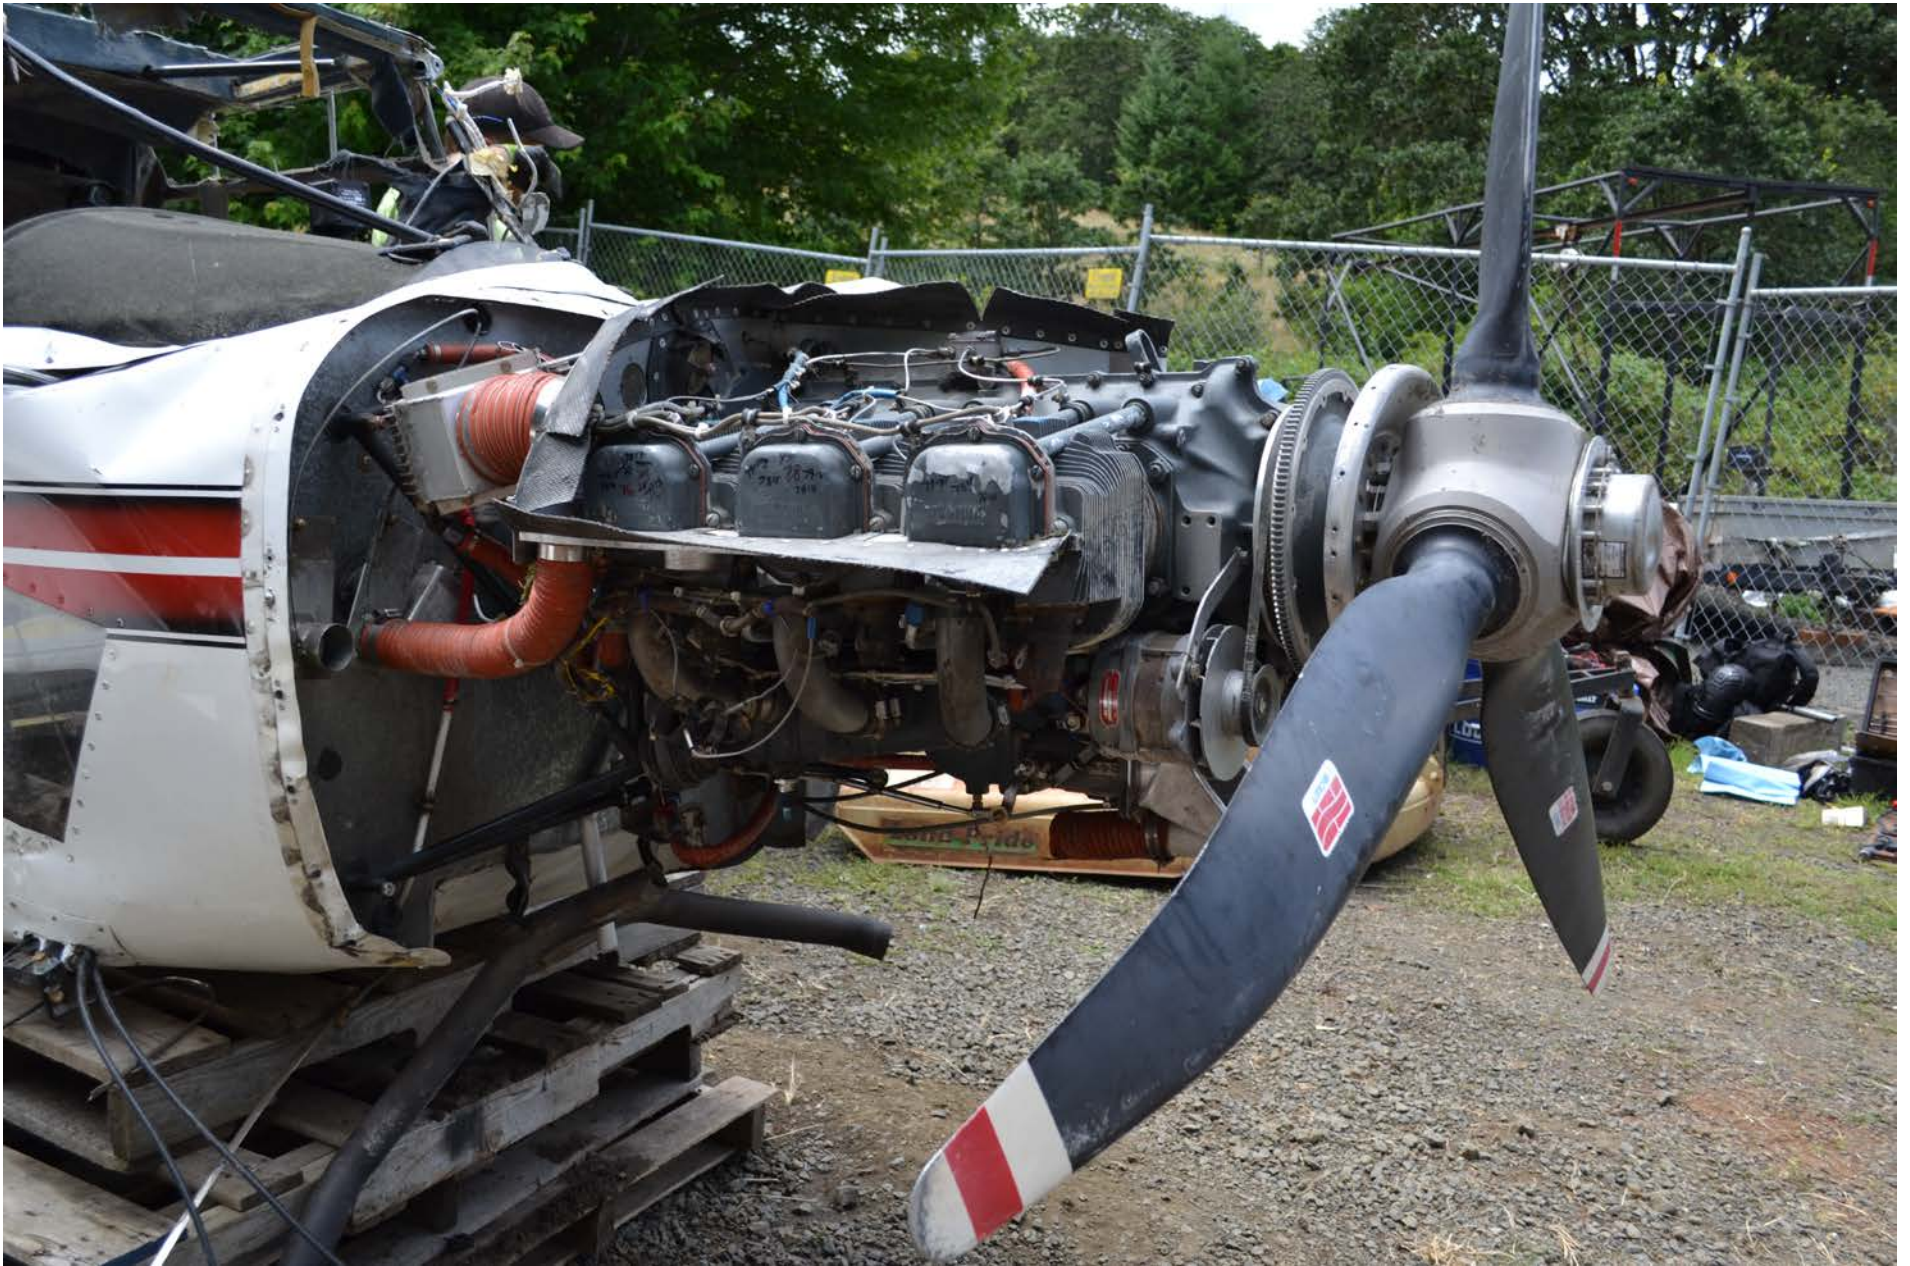
Photo 6 – The engine and propeller

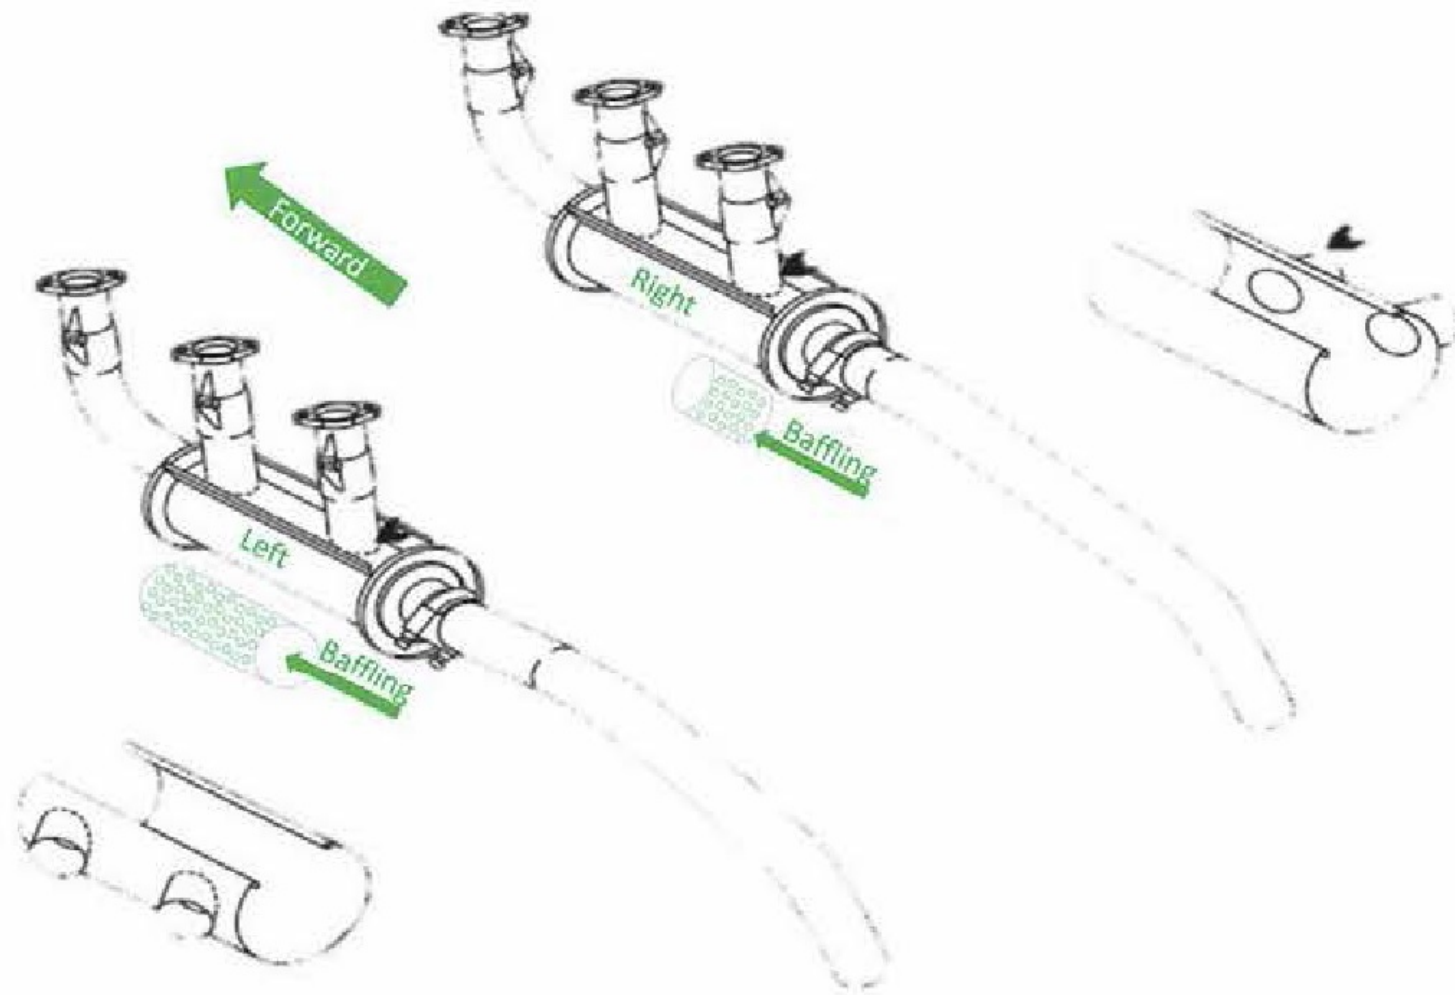
Photo 7 – The exhaust system

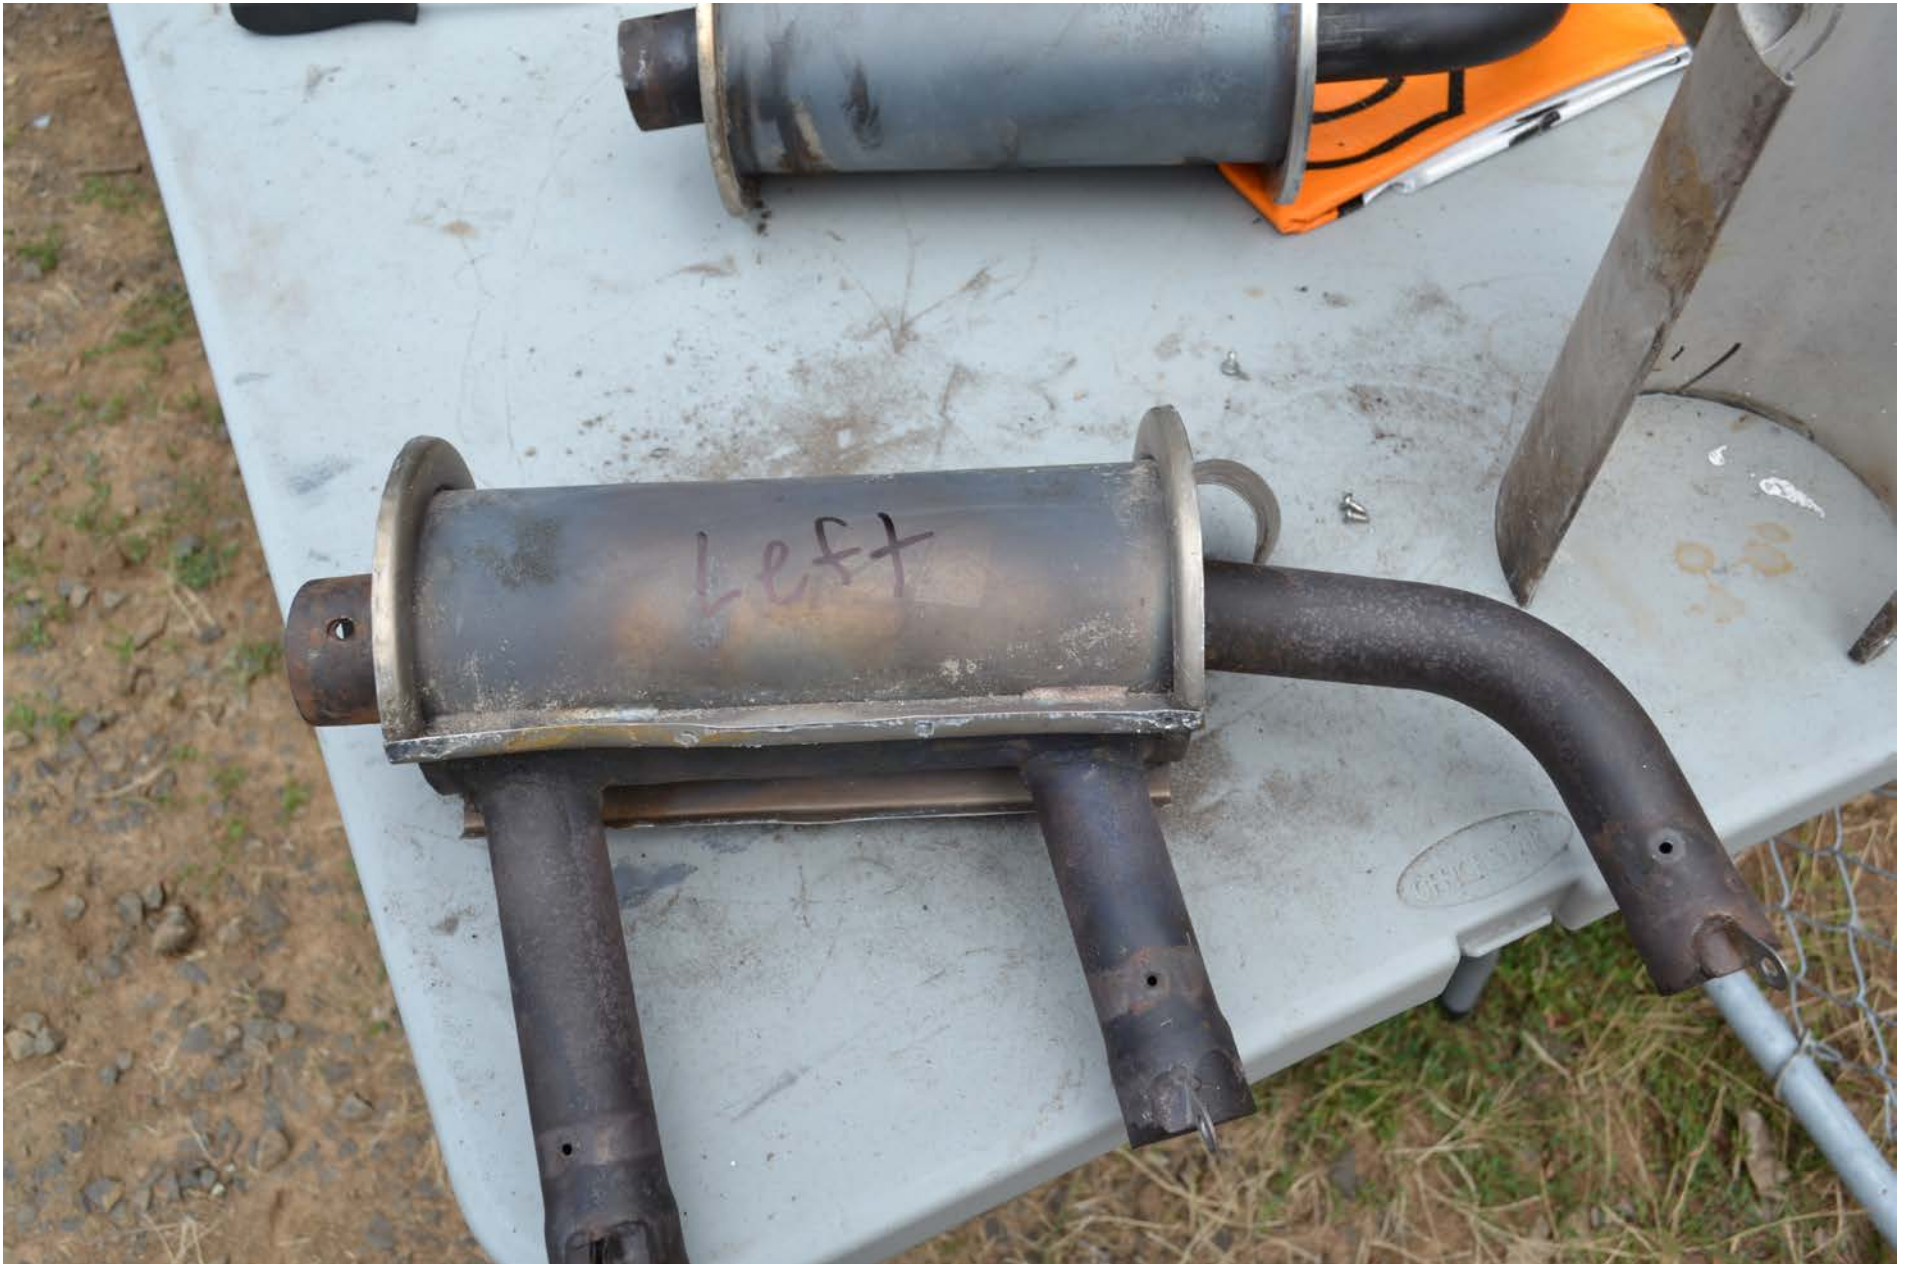
Photo 8 – The left and right (top) mufflers

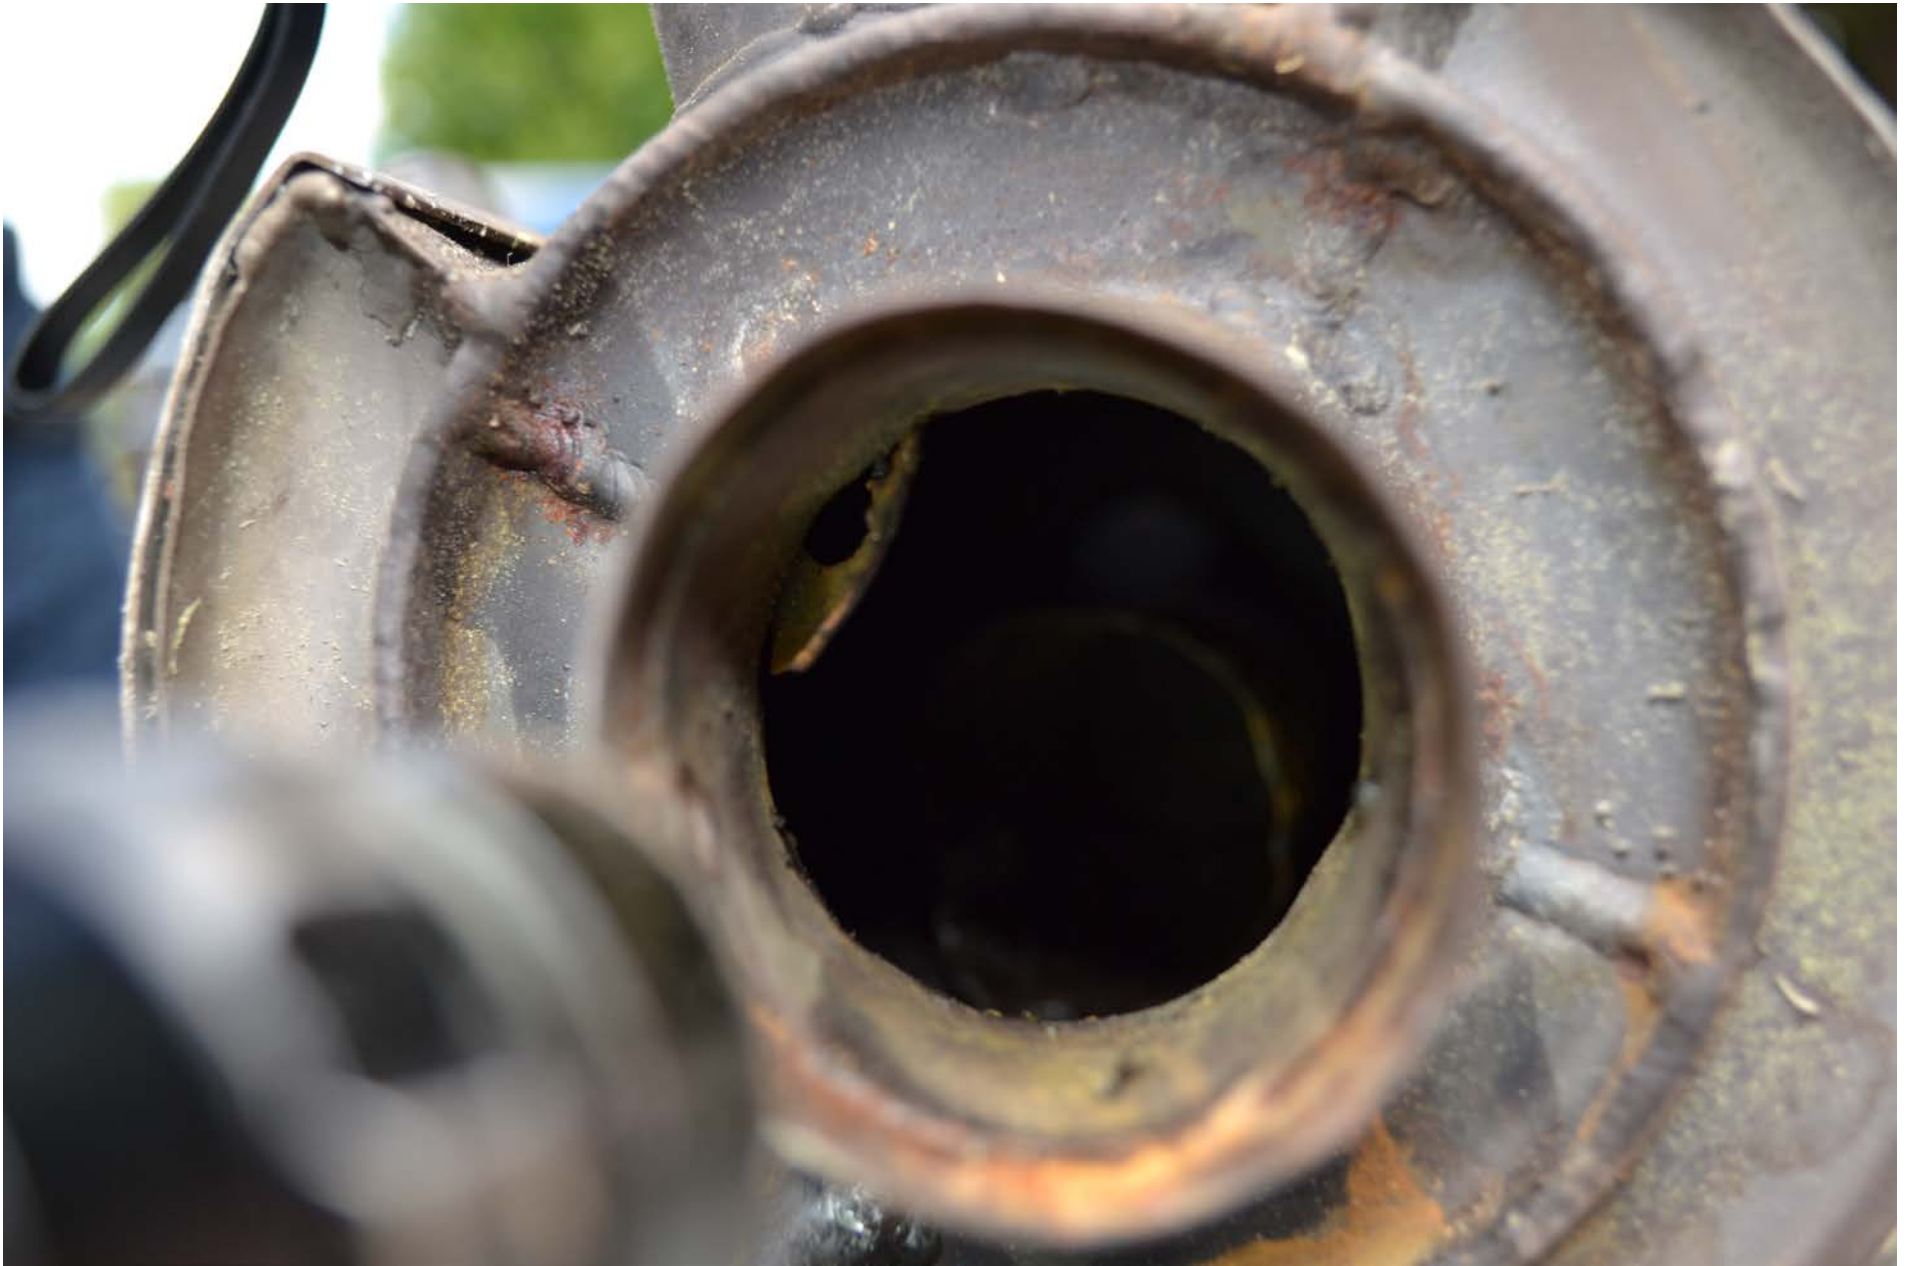
Photo 9 - Looking inside the left muffler

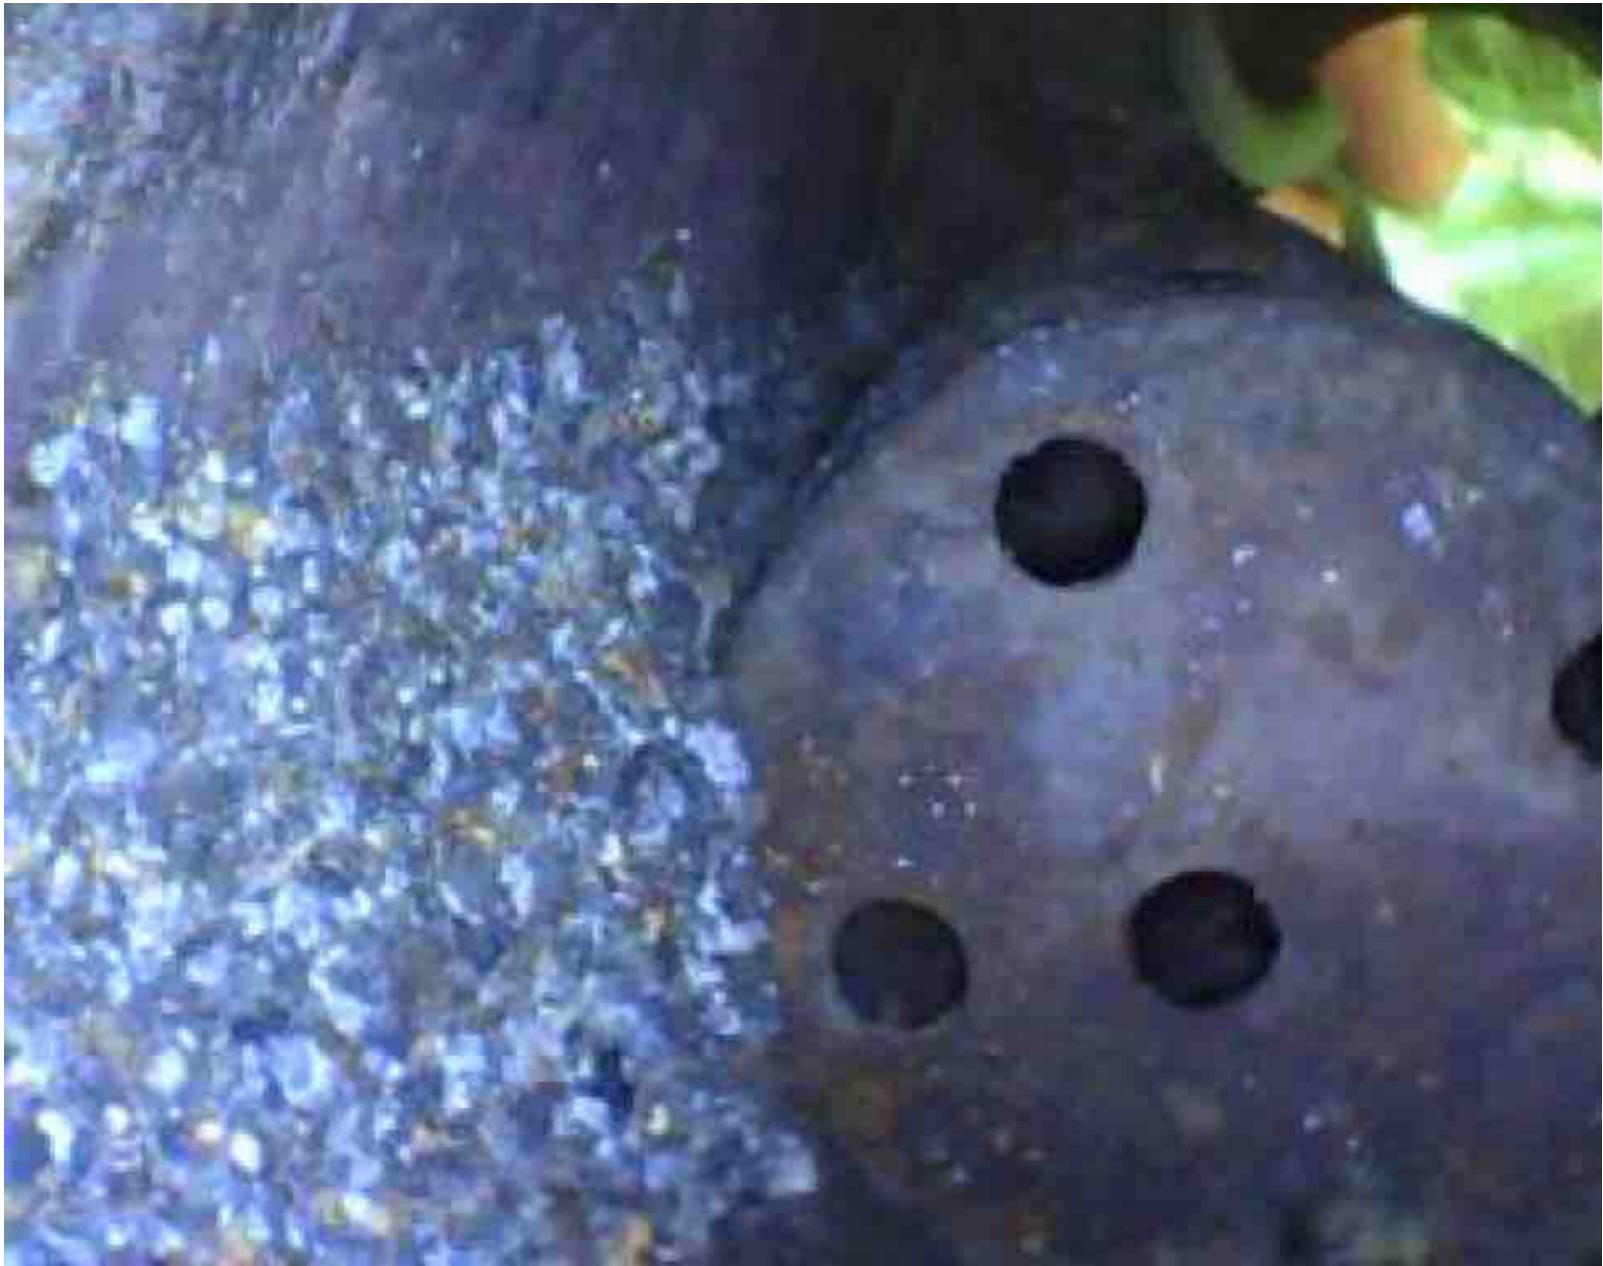
Photo 10 - Boroscoping the left muffler

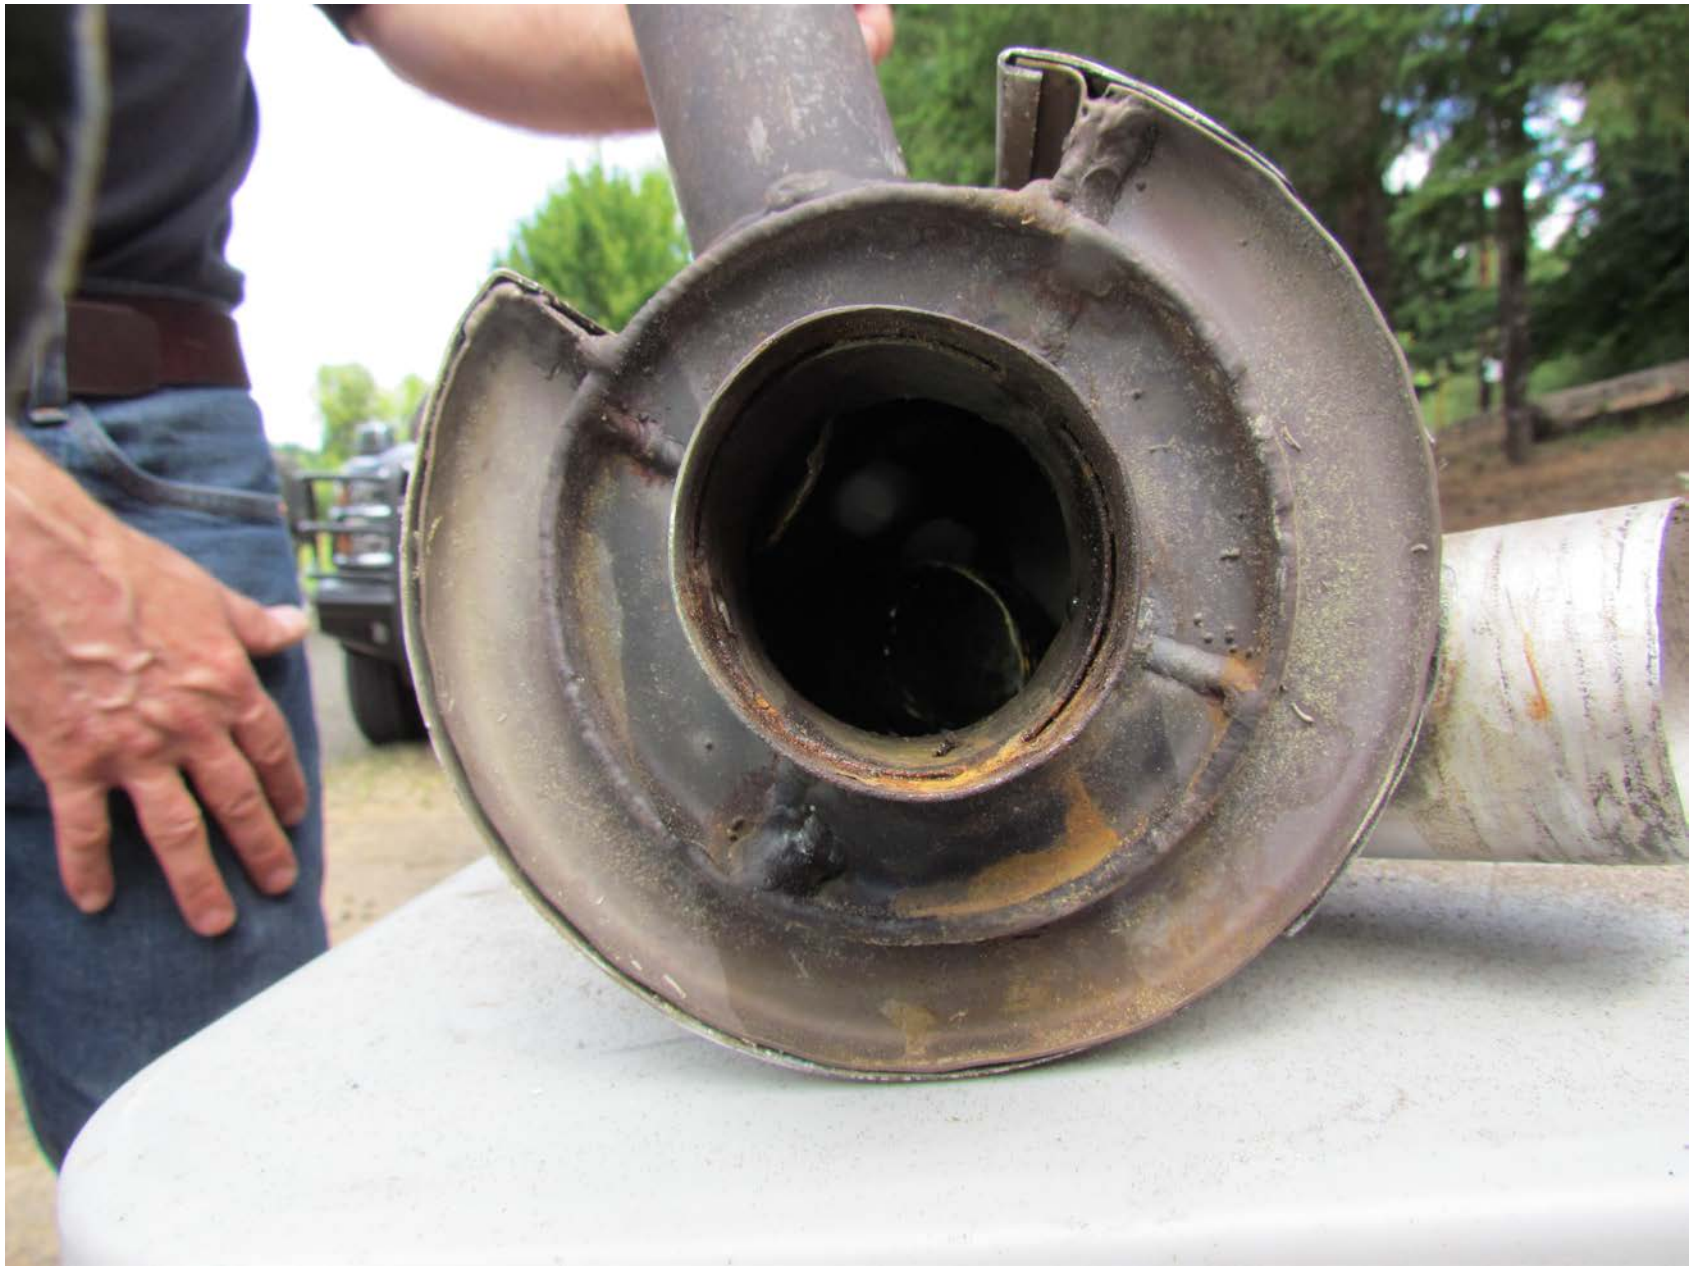
Photo 11 - Looking inside the right muffler

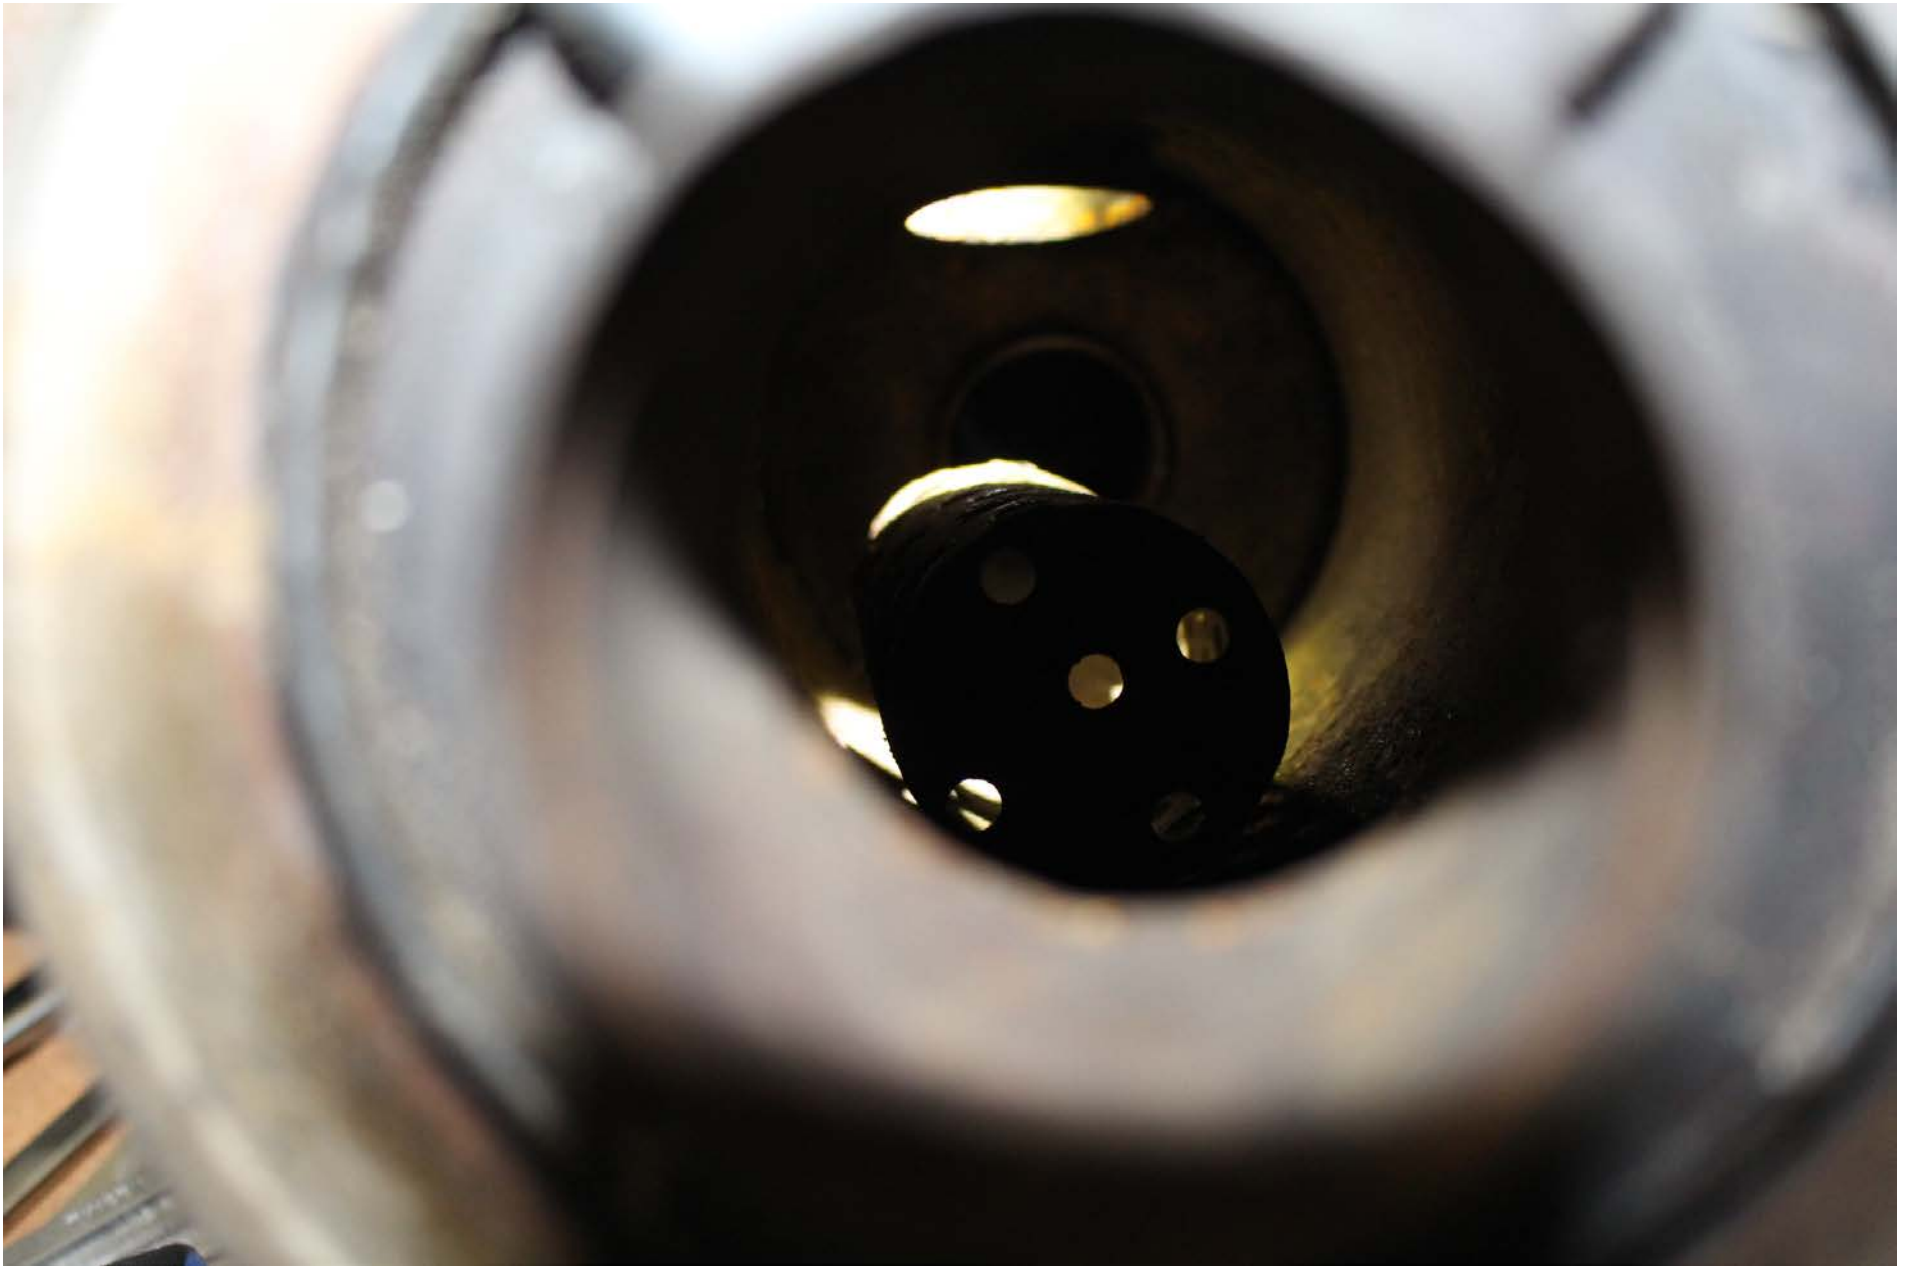
Photo 12 - Boroscoping the right muffler

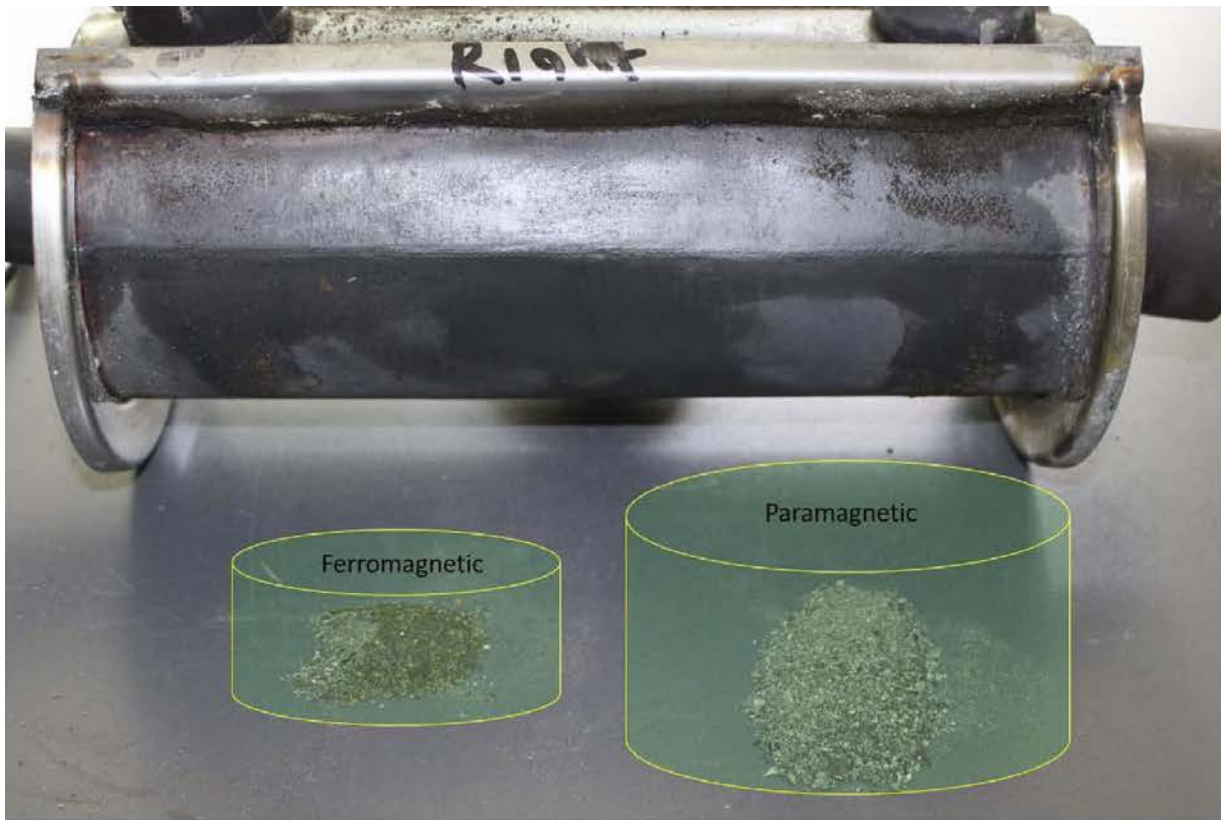
Photo 13 - Debris in the right muffler. About 1-12 tablespoons of debris was removed from the muffler, of which about 1/2 tablespoon was comprised of ferromagnetic debris. Machining was noted on most surfaces.

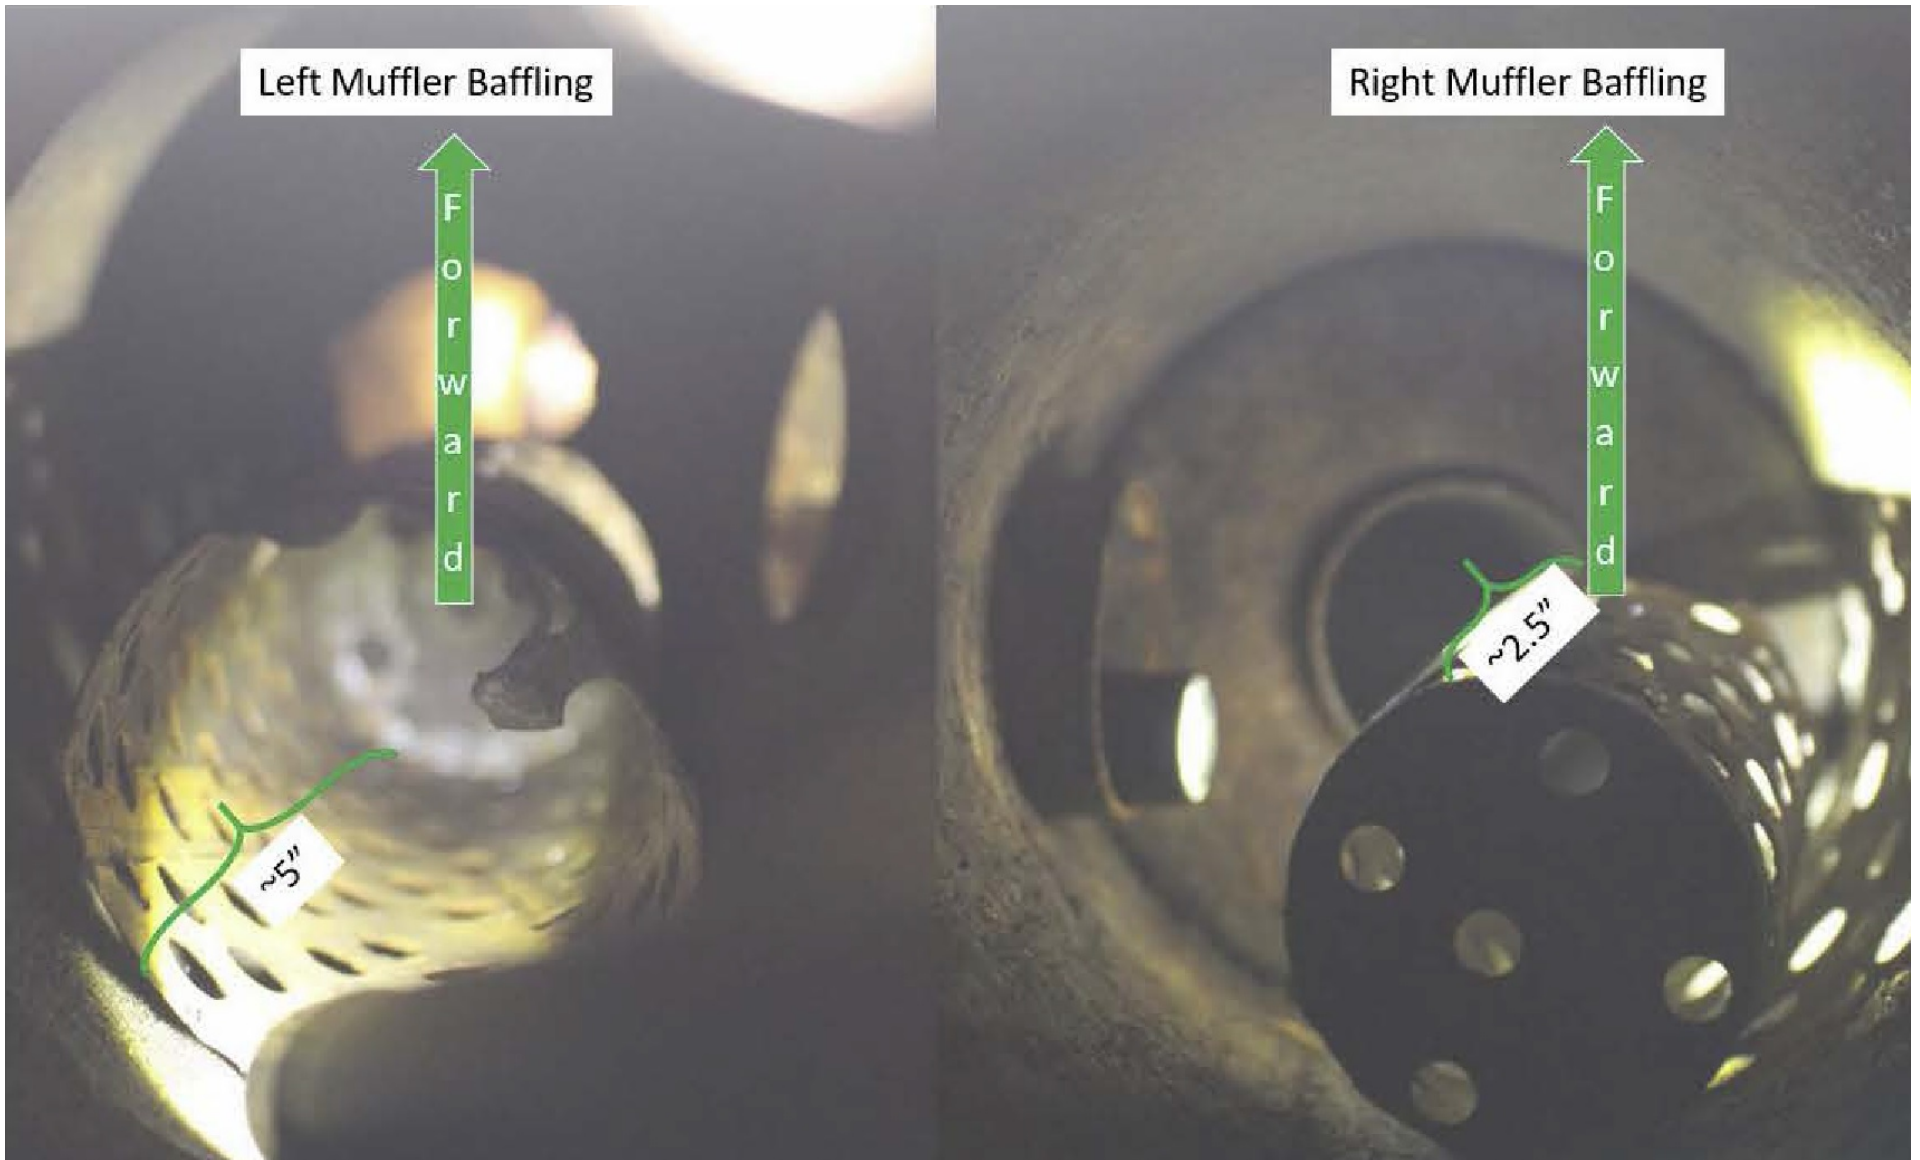
Photo 14 – Left and right muffler baffling
