Photo 1 – Pre-accident photograph of N118G

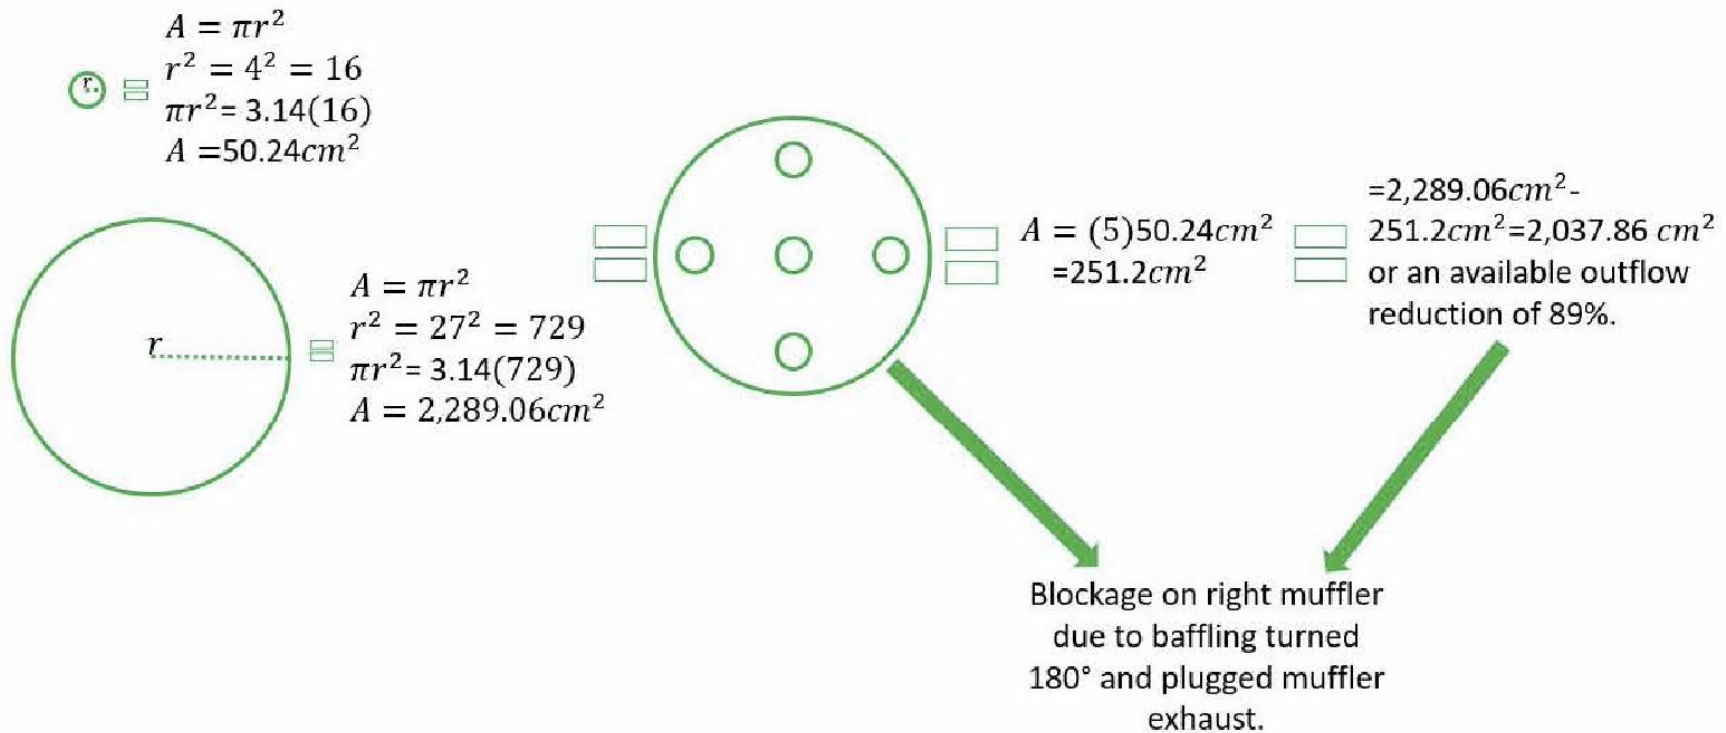
Photo 15 – Reduction in outflow calculations
