NATIONAL TRANSPORTATION SAFETY BOARD

ACCIDENT SITE EXAMINATION

WPR16FA131

Location: Coeur d'Alene, Idaho
Date: June 25, 2016
Aircraft: Cessna A185F N4585F,
Serial 1851092
NTSB IIC: Albert Nixon

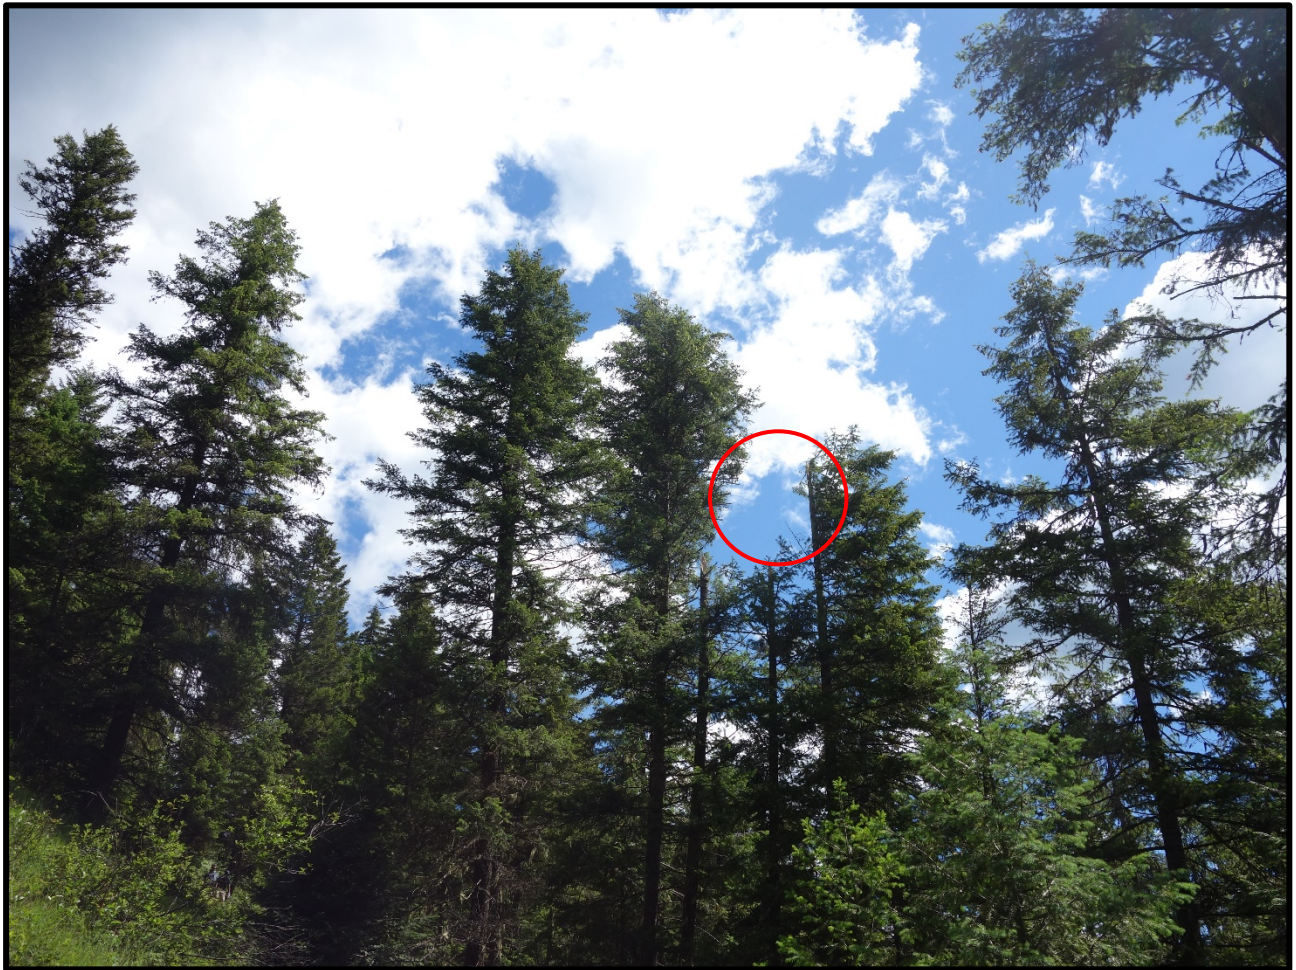
The debris path was about 150 ft long on a heading of about 220° magnetic and began with an initial impact to a tree top about 100 ft in height. The second point of impact was a group of 4 trees about 50 ft west of the initial impact point. The last portion of the debris path was a disturbed area of dirt, that was observed about 25 ft in length, 3 ft wide, and 2 inches in depth, that led to the main wreckage. All major components of the airplane were located in the debris path. Flight control continuity was established to the empennage. One personal electronic device was recovered from the wreckage.

Figure 2: Impacted Trees.

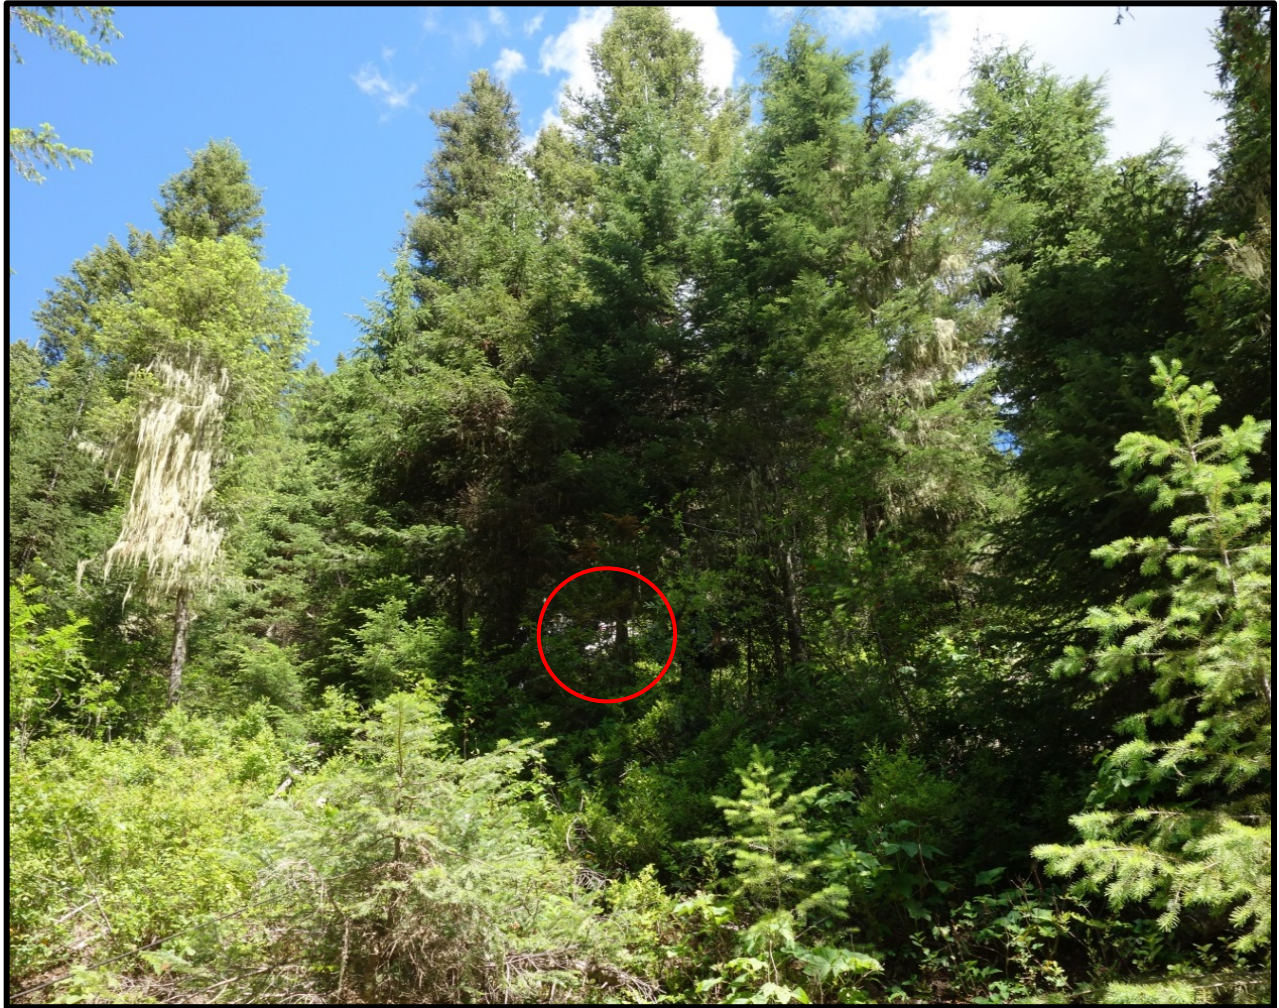
Examination of the accident site by investigators from the National Transportation Safety Board (NTSB), Continental Motors, and Textron Aviation, revealed that the airplane impacted heavy wooded terrain on a canyon hillside at an elevation of about 3,133 ft. The wreckage came to rest inverted on a hillside, with a slope of about 45°, about 1-mile northeast of the Horse Haven airstrip. The area surrounding the impact site consisted of a canyon valley surrounded by mountainous terrain with approximately 3,500 ft in distance between the closest ridgelines surrounding the accident site. The canyon ridgelines were about several hundred ft above the accident site elevation. The canyon narrowed ahead, with the distance between ridgelines decreasing to about 2,200 ft in distance, about a 1/3 of a mile northeast of the accident site, and the canyon valley elevation increased by several hundred ft. Further, the canyon continues to narrow a couple miles further ahead, with the canyon base floor elevation increasing by several hundred ft, and the ridgeline's high terrain about 1,500 ft higher in elevation than the accident site.

Figure 3: View of Airplane Wreckage from the Road.
