NATIONAL TRANSPORTATION SAFETY BOARD

ACCIDENT SITE EXAMINATION SUMMARY

WPR16FA144

Location: Logan, UT
Date: July 18, 2016
Aircraft: Diamond DA-40, N419FP
NTSB Investigator-in-Charge: Maja Smith

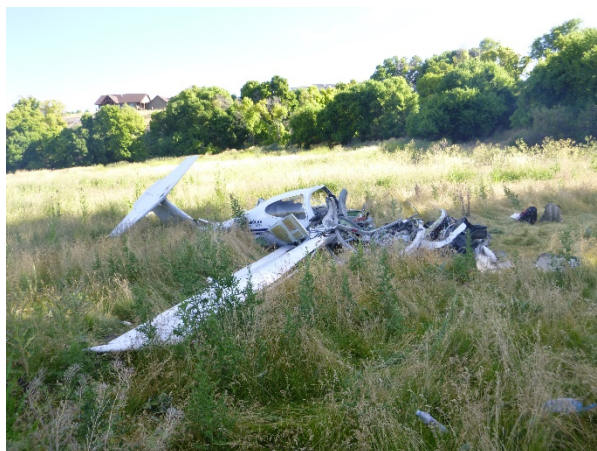
Photo 1. Airplane wreckage

Examination of the accident site revealed that it was located on the side of a hill at an elevation of 4,714 ft msl. The airplane impacted terrain in a near vertical attitude and came to rest upright on a heading of about 093 degrees magnetic. A near vertical descent angle was determined by the compact nature of the wreckage footprint. The wreckage was contained to an area of 36 feet in width and 32 feet in length.

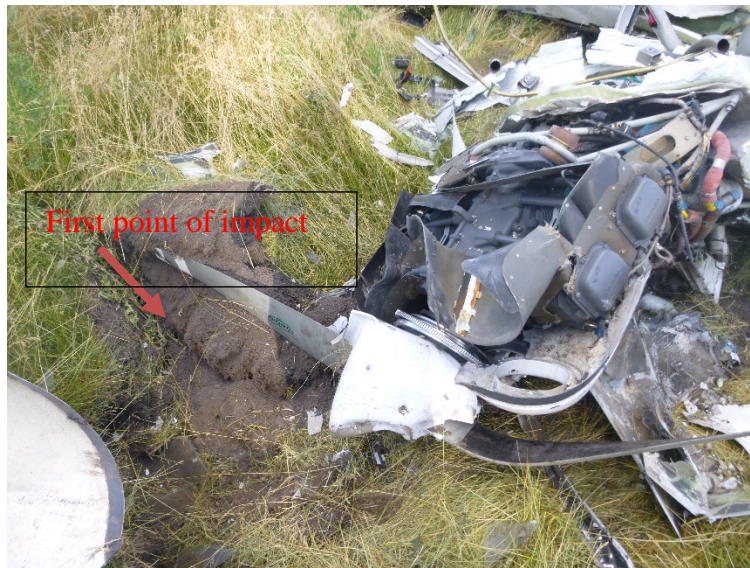
Photo 2. First point of impact

The first point of impact was identified as a crater created by the propeller impact and it was about 1.5 feet deep. A ground impression about 3 feet in length was observed about 8 feet from the first point of impact. The left door was located 87 feet away from the main wreckage and oriented on about 230 degrees magnetic bearing from the wreckage. The main wreckage consisted of the engine, cockpit, fuselage, and empennage.

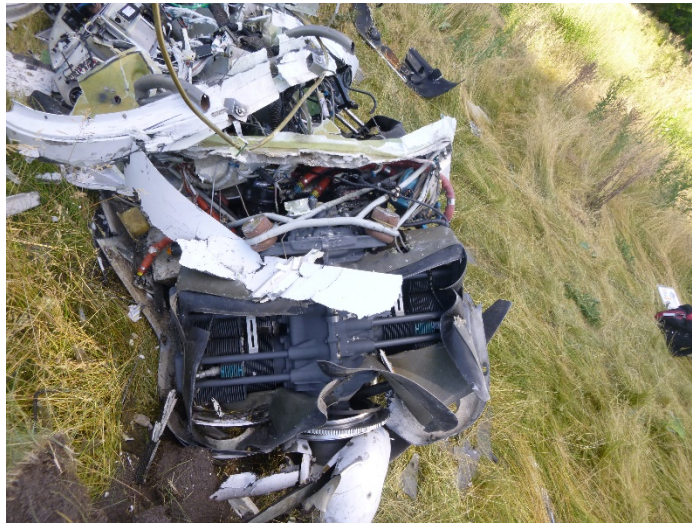
Photo 3. Engine

The engine remained attached to the firewall and it was resting upwards on the ground. The nose landing gear was crushed under the engine. The instrument panel remained partially attached to the firewall and was mostly destroyed as a result of impact forces. The ELT light was found blinking. The avionics master switch was found in on position.
