NATIONAL TRANSPORTATION SAFETY BOARD

ACCIDENT SITE EXAMINATION SUMMARY

WPR17FA139

Location: Chelan, WA
Date: July 1, 2017
Aircraft: N492XB; Scout XC Light Sport
NTSB Investigator-in-Charge: Maja Smith

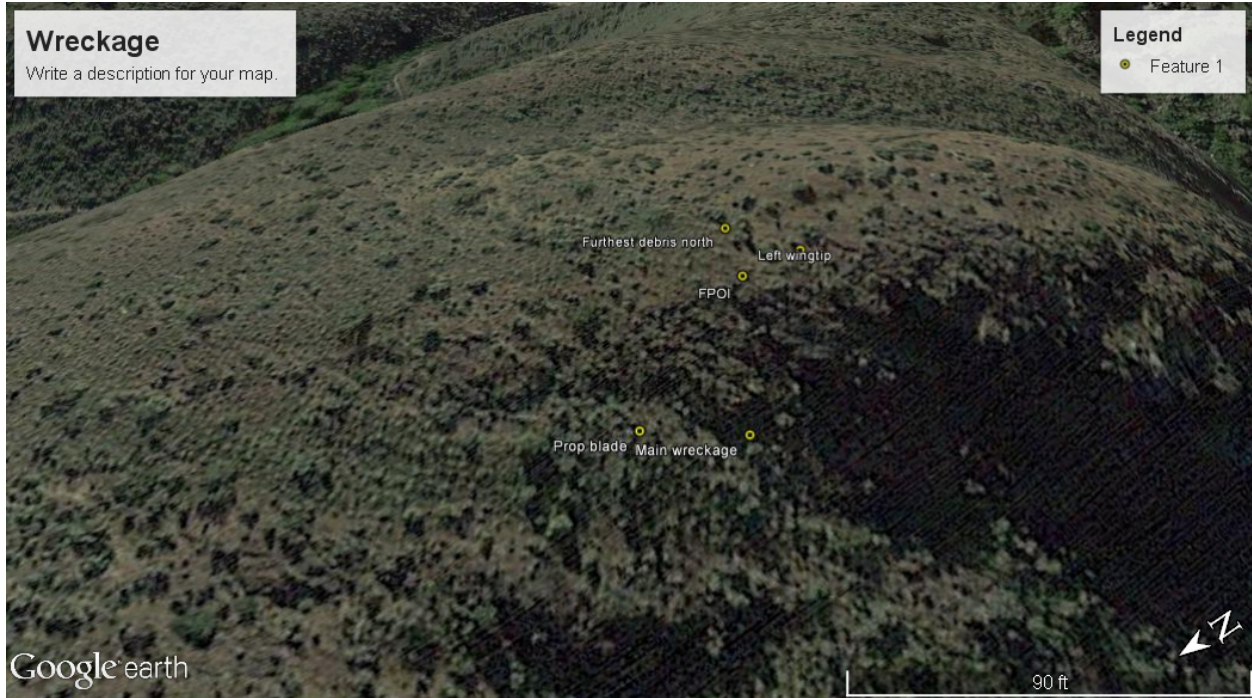
Figure 1-Wreckage Diagram

Examination of the accident site revealed that the airplane impacted near the top of a hill in mountainous rocky terrain.

The airplane had been destroyed by high impact forces and spread out in a linear pattern.

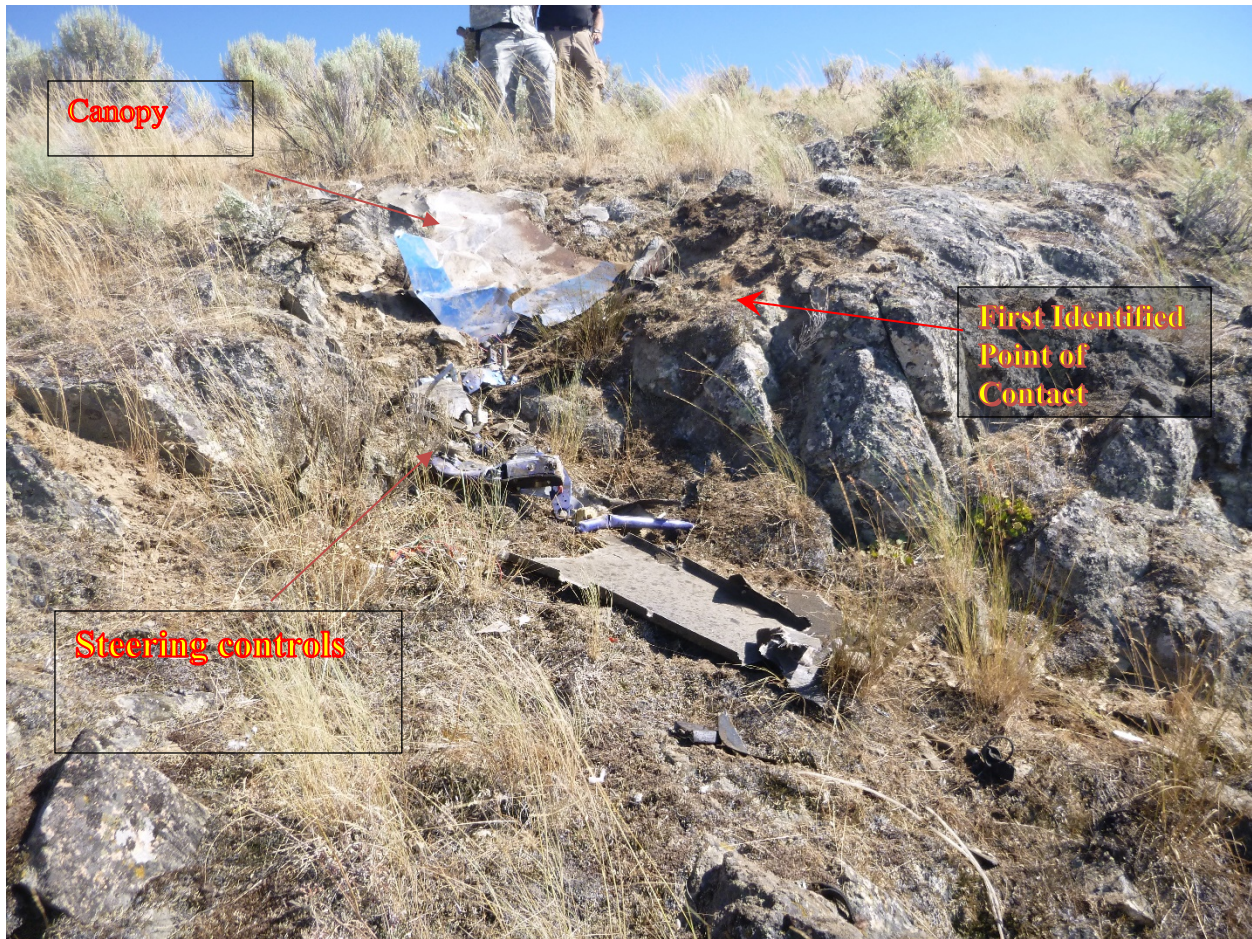
Figure 2-First Identified Point of Contact

The direction of the wreckage debris path was oriented a heading of about 130 degrees magnetic. The first identified point of contact (FIPC) was a rock located on a side of the hill about 25 feet from the top of the hill. The FIPC was characterized by an area of disturbed ground on the rock and surrounded debris which included the front steering fork, and the brake reservoir. A portion of the canopy was located left of the FIPC. The main wreckage was located about 50 feet from the FIPC on a heading of 320 degrees indicating that, following the impact, it rolled down the hill.

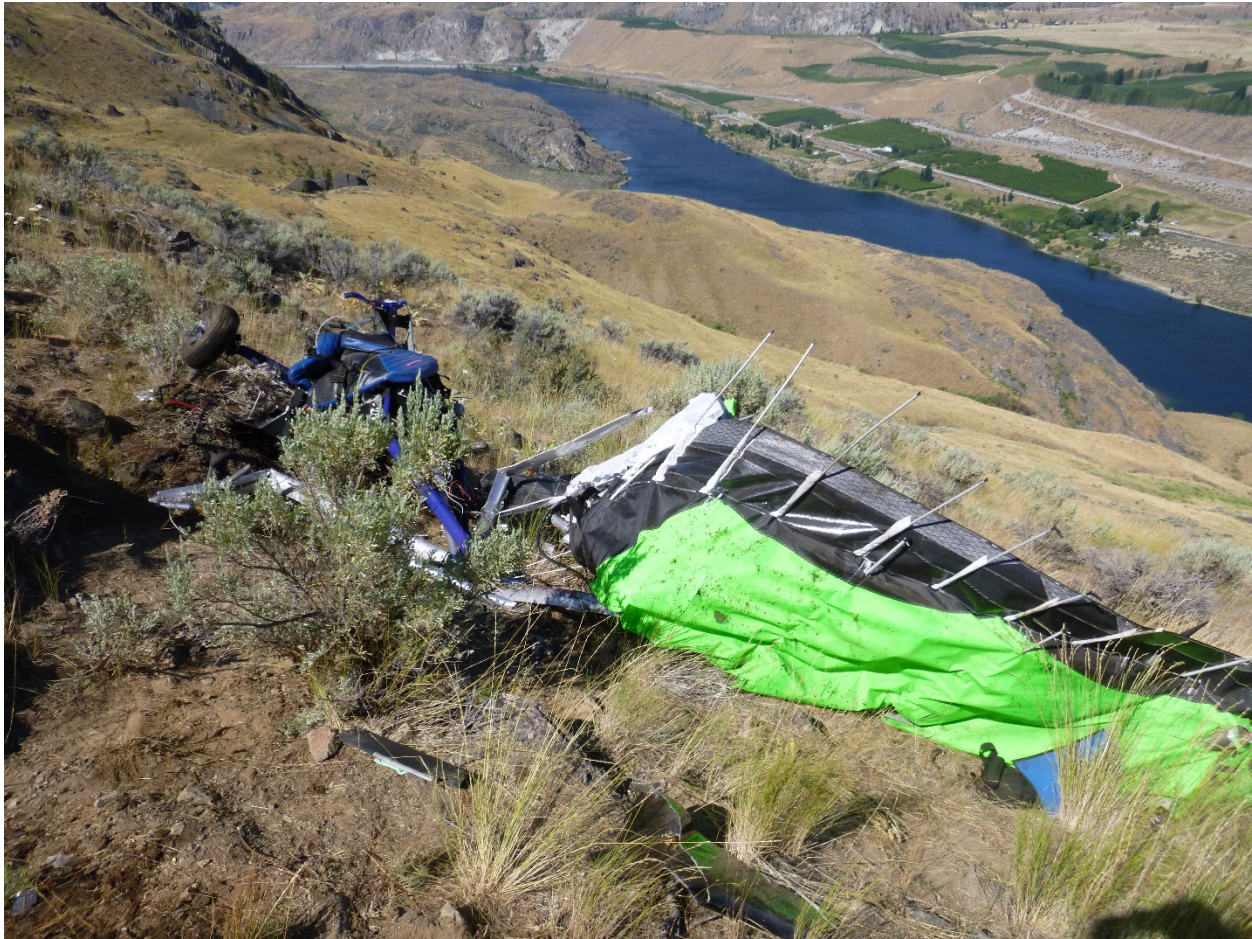
Figure 3-Main Wreckage

The main wreckage consisted of majority of the airframe, engine, both wings, main landing gear and a three-blade propeller. One propeller blade broke off and was located 30 feet north from the main wreckage. The back seat was located within the main wreckage; the front seat was located along the debris path.
