NATIONAL TRANSPORTATION SAFETY BOARD

ACCIDENT SITE EXAMINATION

WPR14FA316

Location: Lolo Pass, Idaho
Date: July 28, 2014
Aircraft: Experimental Meyer-Legacy Lancair
N29MM, Serial L2K-197
NTSB IIC: Albert Nixon

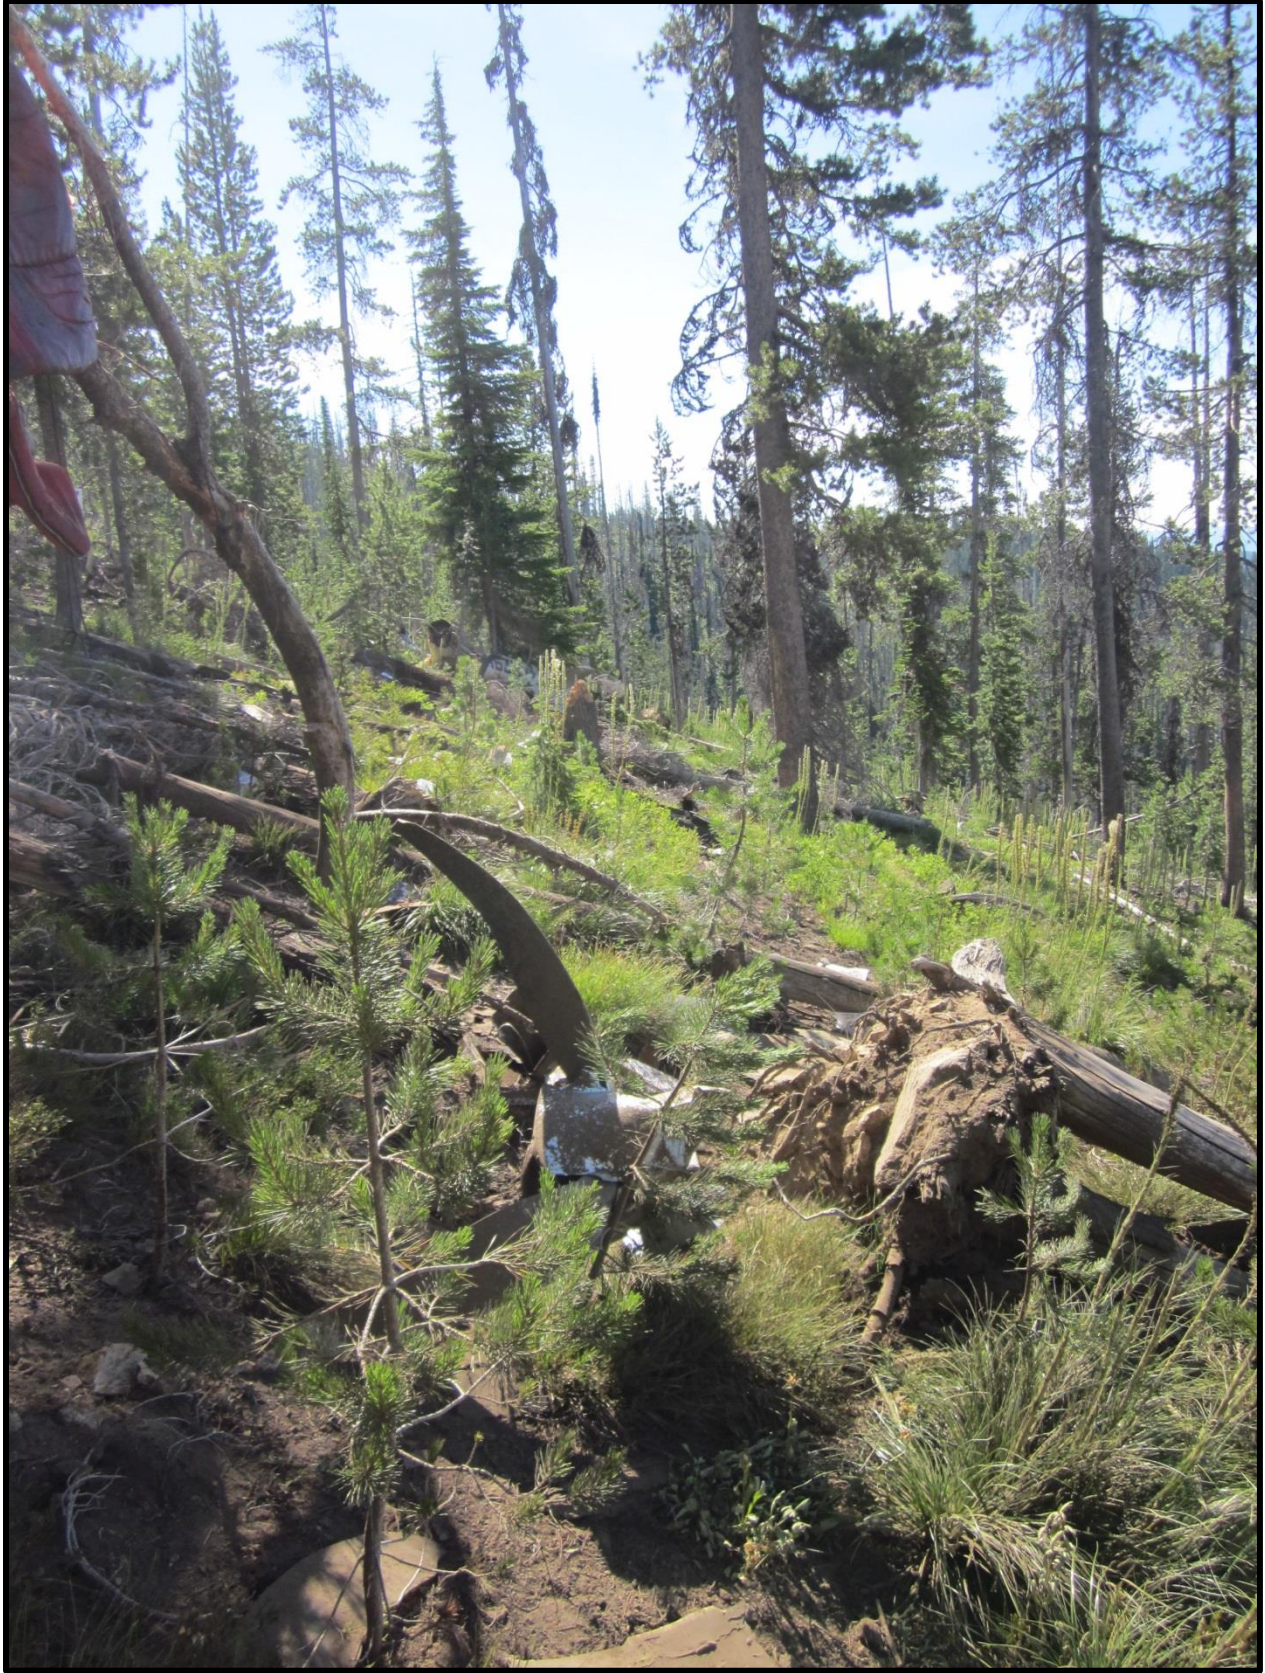
Figure 1: View of Ground Scars at Accident Site

A disturbed portion of the ground was observed that started about 75 feet behind the main fuselage and continued to lead right up to it. The ground scar was about 1.5 feet in width and about a couple of inches in depth. The airplane's fuselage came to rest on a heading of about 180 degrees magnetic. The empennage separated from the fuselage and was situated about 180 degrees off the fuselage heading, inverted, and with two trees between them. It was partially attached to the fuselage only by cables. The nose gear and main landing gear were extended. The windshield fragments located had some oil smearing observed.

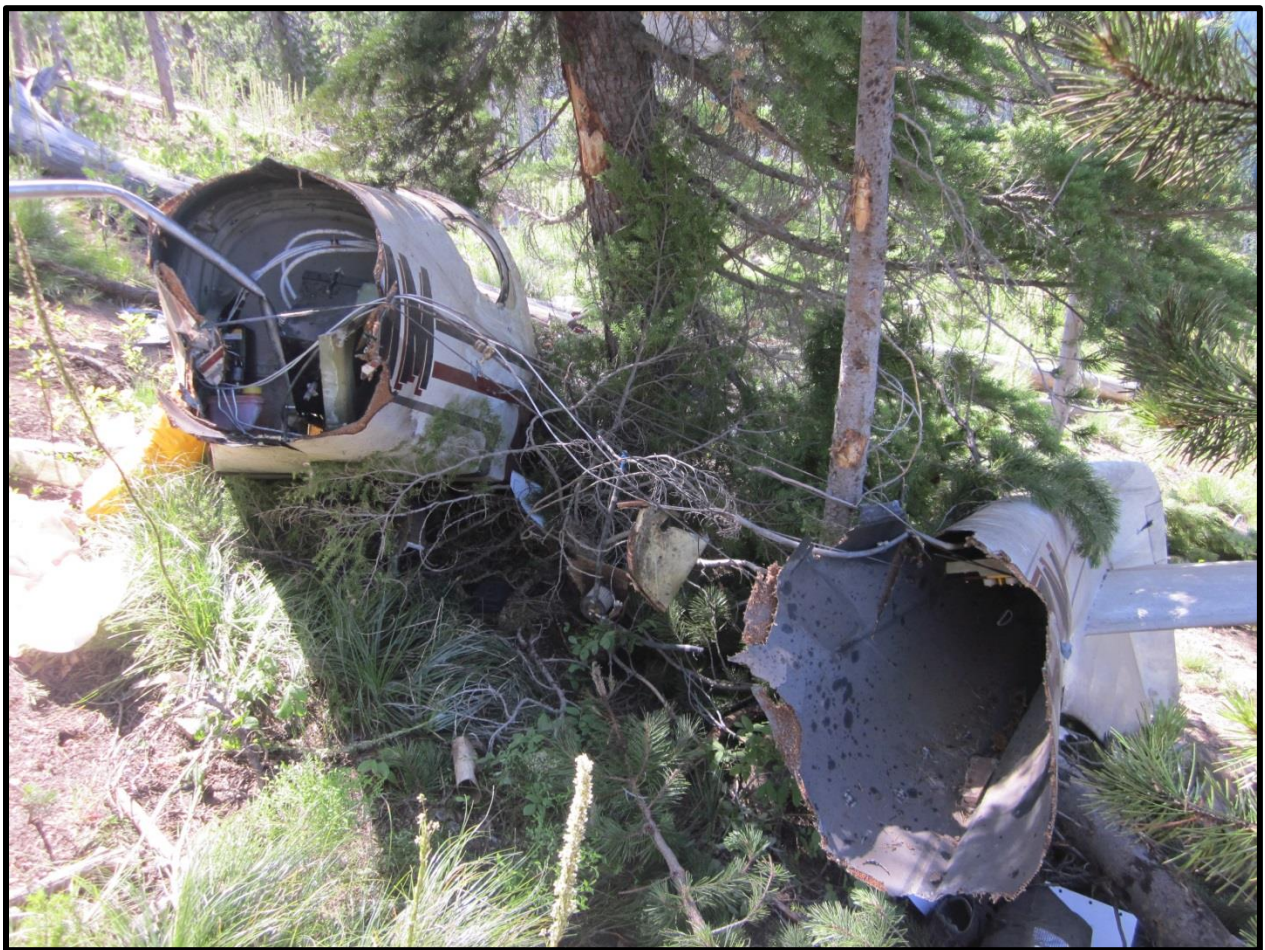
The rudder and elevators remained attached at all their respective mounts. Flight control continuity established with the rudders and elevators to the cockpit controls.

Figure 2: Aft View of Main Fuselage.

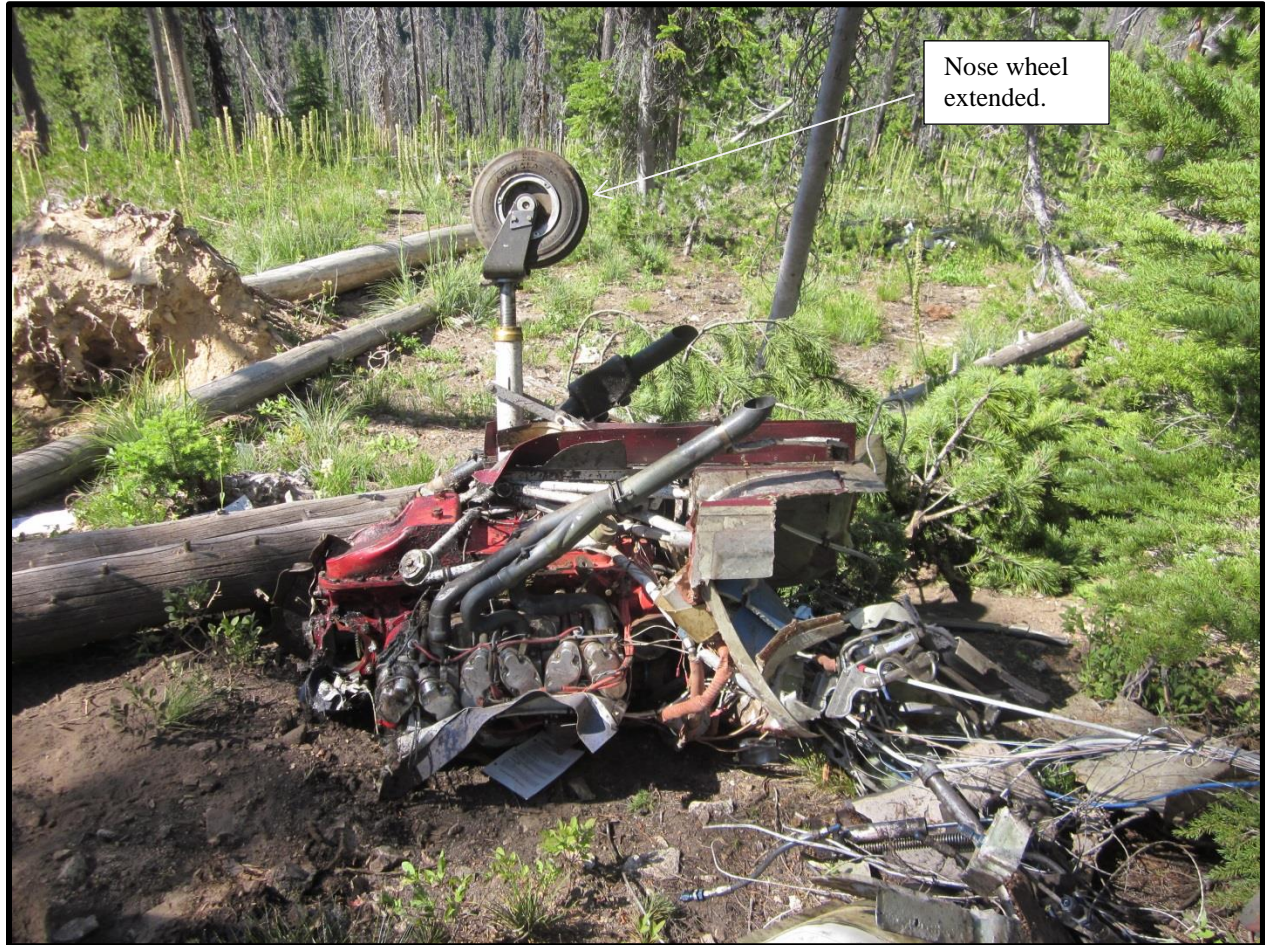
4.0 The engine was separated from the airplane and came to rest inverted at about 10 feet in front of the fuselage. A small amount of oil was observed on the engine exhaust. The

Figure 3: View of Engine Inverted on the Ground.

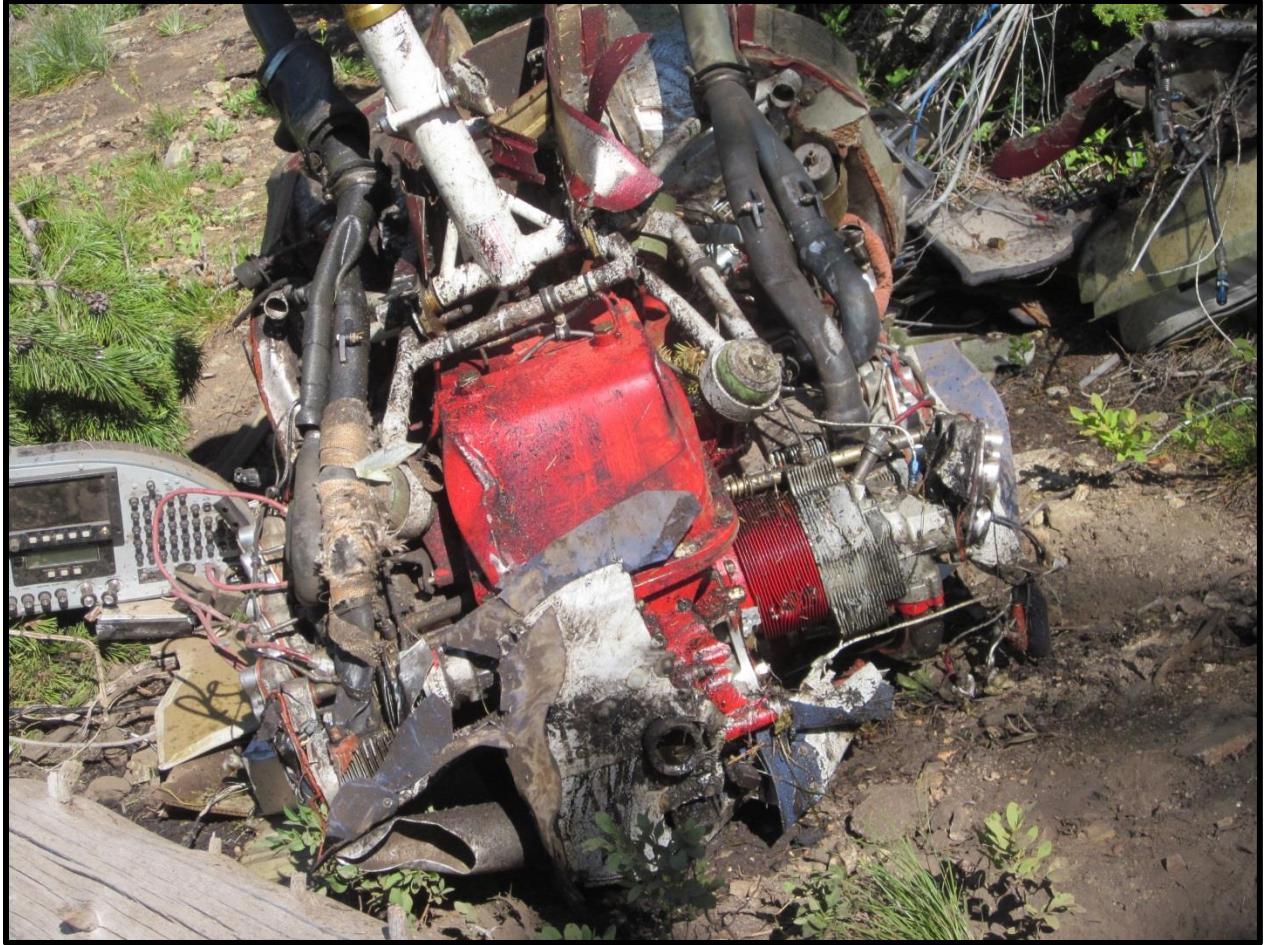
Figure 4: View of (inverted) Engine from a Top View.
