NATIONAL TRANSPORTATION SAFETY BOARD

ACCIDENT SITE EXAMINATION SUMMARY

WPR17FA085

Location: Harrisburg, OR
Date: April 7, 2017
Aircraft: Piper PA-46-310P, N123SB
NTSB Investigator-in-Charge: Maja Smith

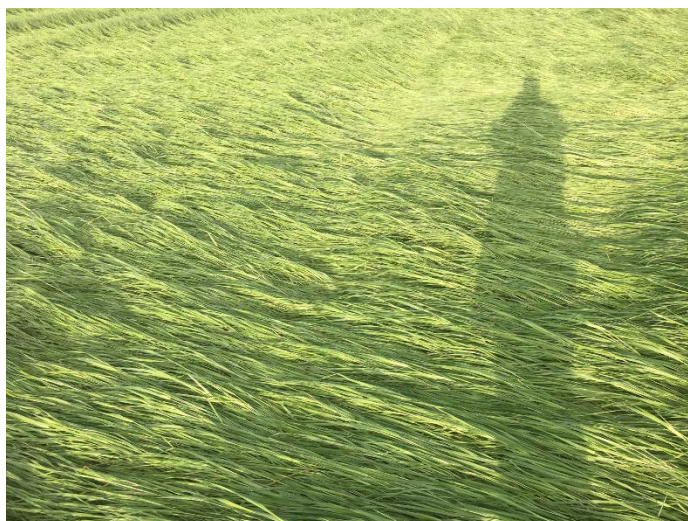
Image 2-View of disturbed grass area

A 140 feet by 150 feet area of disturbed grass was located south of the FPIC. A center mass was about 250 feet from the FPIC. Within the area, the grass was lying flat on a ground oriented in a northerly direction. The grass outside that area was standing straight up.

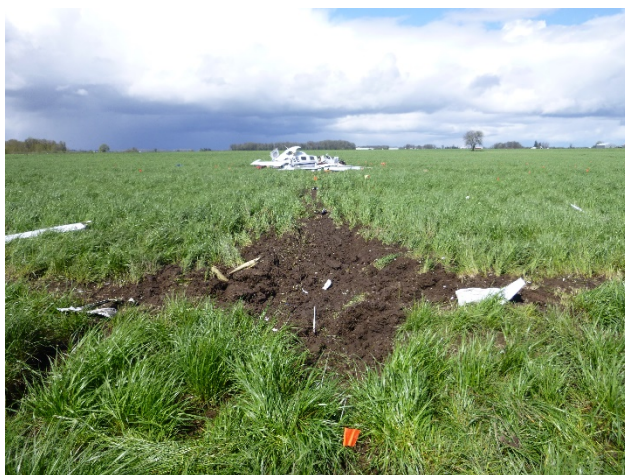
Image 3-First identified point of contact

The first identified point of contact (FIPC) was characterized by 22 feet by 35 feet area of disturbed soil that resembled a silhouette of an airplane. Such imprint indicated that the airplane most likely impacted the terrain in a level altitude. Visible evidence of a landing gear impact mark was present, as well as an outline of both wings and the fuselage. Both the left and right ailerons were separated from the fuselage and located within the area of FIPC. The left, right and nose landing gear were separated; both left and right landing gear were located resting adjacent to each other on their respective side of the fuselage, along the wreckage debris, about 75 feet from the FIPC.

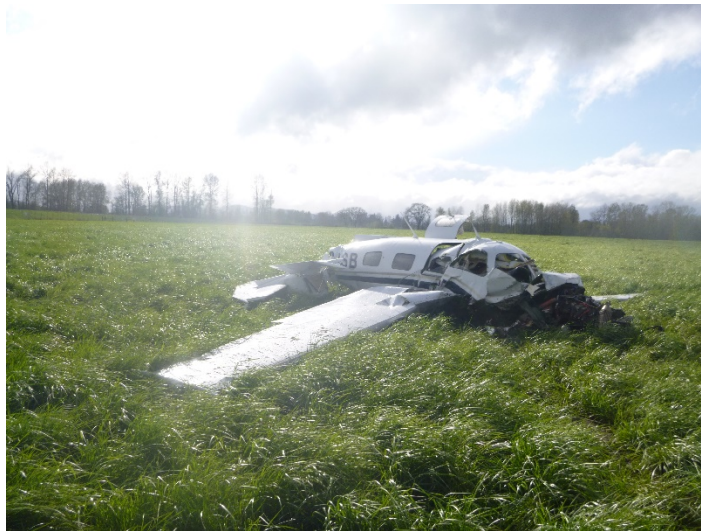
Image 4-Wreckage

The wreckage was located about 93 feet from the FIPC. It consisted of an engine, fuselage, both wing, and an empennage. The wreckage exhibited significant impact damage along its fuselage, wings and the empennage. As a result of the impact, the cabin area was displaced, with significant compression of the fuselage structure into the area of the two front seats. The engine cowling was found open and crushed backwards toward the windshield. Both the forward and side windows were shattered.

The propeller was found attached to the engine. One blade was straight, the other one bent backwards about 90 degrees which is consistent with the blade impact to the ground. The engine was covered with the dirt and soil which is consistent with a forward motion of the airplane moving along the ground.

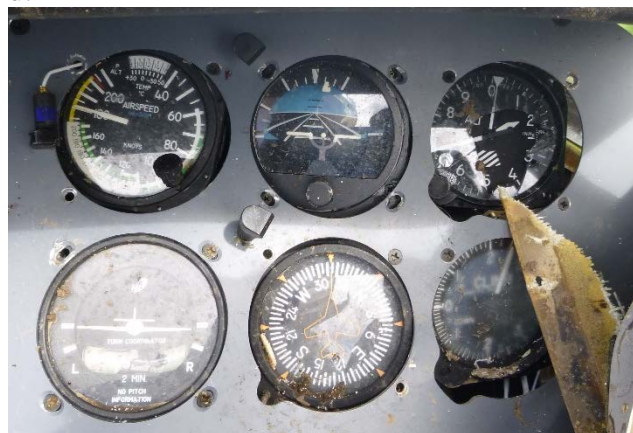
Image 5 – Instrument panel

The instrument panel exhibited impact damage with multiple instruments displaced from the panel. Flight instruments on the right side of the instrument panel were readable; the airspeed indicator indicated 100 knots, the altimeter indicated about 2,700 feet with a kollsman setting of 29.5 inches, the vertical speed indicator indicated about 2,200 feet per minute climb, the heading indicator indicated 312 degrees, and the inclinometer on a turn-and-slip indicator was on the right. Throttle, propeller and mixture levers were found in a full forward position.
