NATIONAL TRANSPORTATION SAFETY BOARD

ACCIDENT SITE EXAMINATION SUMMARY

WPR18FA119

Location: Scottsdale, Arizona
Date: April 9, 2018
Aircraft: N7376Y; Piper PA-24-260
NTSB Investigator-in-Charge: Maja Smith

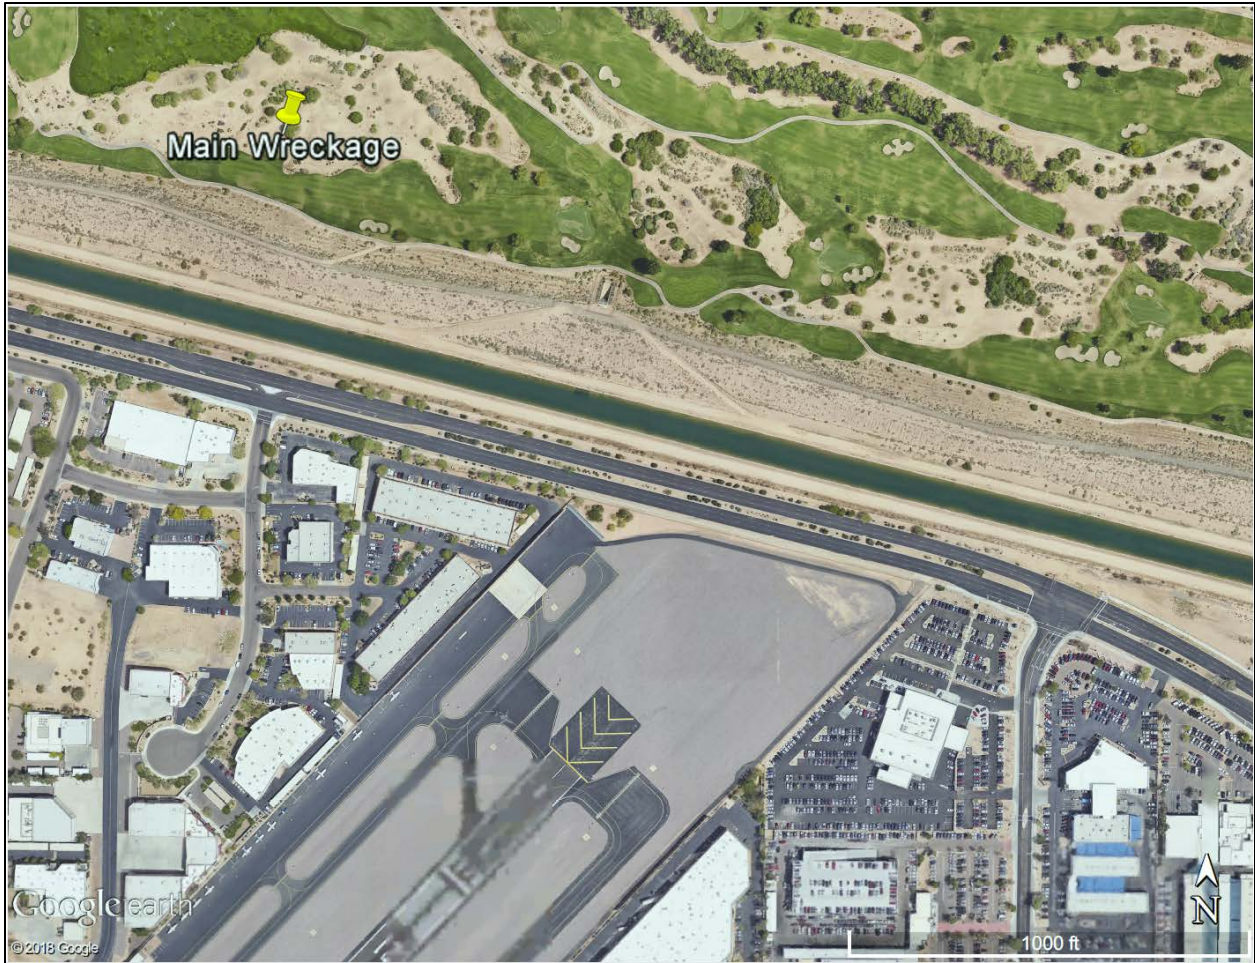
Figure 1-Aerial View of the Airport (SDL) and Accident Site

Main Wreckage: N33° 38.121', W-111° 54.208' – Elevation: 1,484 feet
Accident site was about 1/4-mile northwest of the departure end of SDL

Examination of the accident site was conducted on April 9-10, 2018, by the National Transportation Safety Board (NTSB), and the Federal Aviation Administration (FAA). The accident site was found adjacent to the No. 2 fairway of the Champions Course of the Tournament Players Club (TPC), 1/2 mile northwest of SDL. A water canal traveling east to west and a 50-foot embankment was located between the golf course and airport property. The main wreckage was substantially damaged by impact forces and postimpact fire.

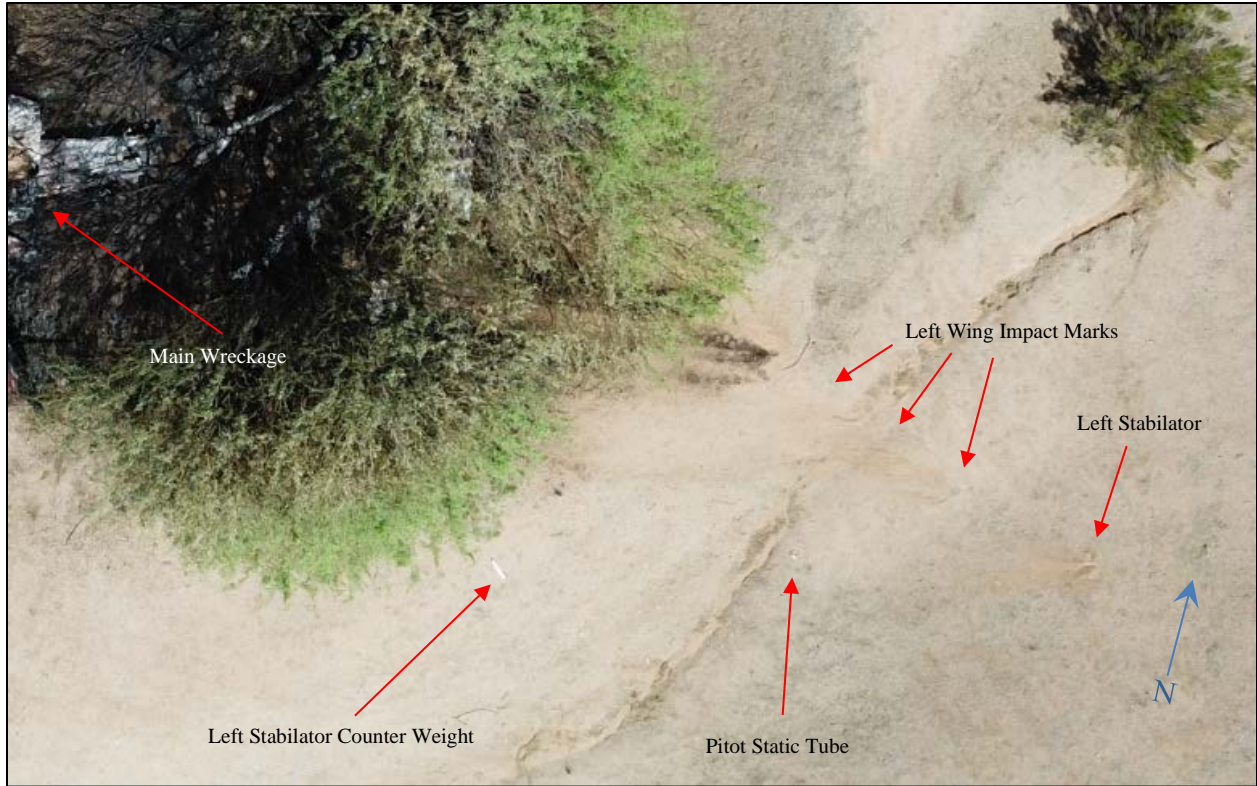
Figure 2-Aerial View of FIPC

The main wreckage was contained within a debris field of about 180 ft in length and 40 ft wide. The direction of the debris field was oriented on a magnetic heading of a about 245° from the first identified point of contact (FIPC) to the electric motor housing found on the fairway. The direction of the main wreckage was found on a magnetic heading of 335°. A large mesquite tree is located in the middle of the debris field. Its canopy is about 45 ft in diameter. The FIPC in the debris field was a small elongated divot on the east side of the tree. About 4 ft further was an area of disturbed ground measuring about 12 ft in length extending towards the main wreckage. The small divot and disturbed ground is consistent with the airplane impacting the ground in a left wing down attitude. Extending from the area of disturbed ground was a shallow crater about 8 ft in diameter, and about 3 inches deep, and contained sooty streaking residue across the ground.

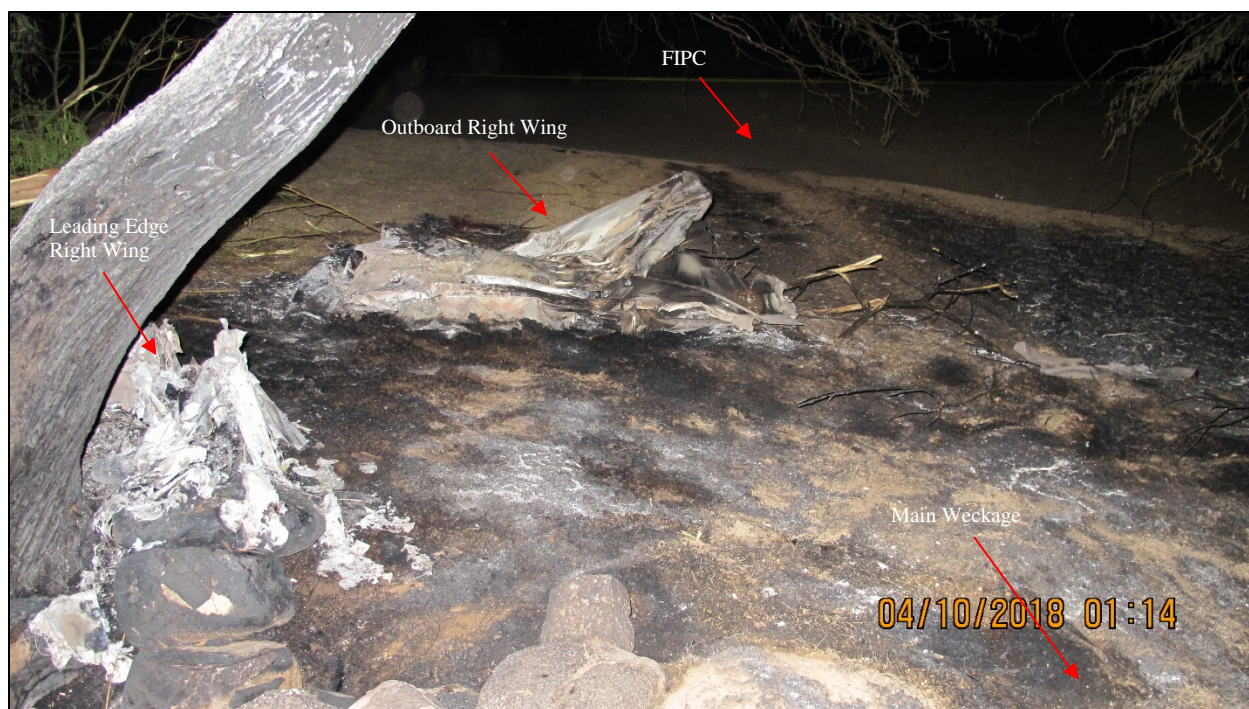
Figure 3-Left Wing Sections

A large section of the northeast side of the tree canopy separated and was located near the base of the tree. The outboard 4-foot section of the right-wing tip was found near the base of the tree. The right-wing leading edge and auxiliary tank was found wrapped around the base of the tree. A section of left wing spar was found underneath the tree canopy.

The left wing outboard section and wing skin was found about 10 ft further down the debris field. The left main tank was found 20 ft down the debris field. Multidirectional scratches were visible on the lower surface of the left main tank. A motor housing was the furthest piece of wreckage in the debris field and was found about 90 ft from the left main tank.

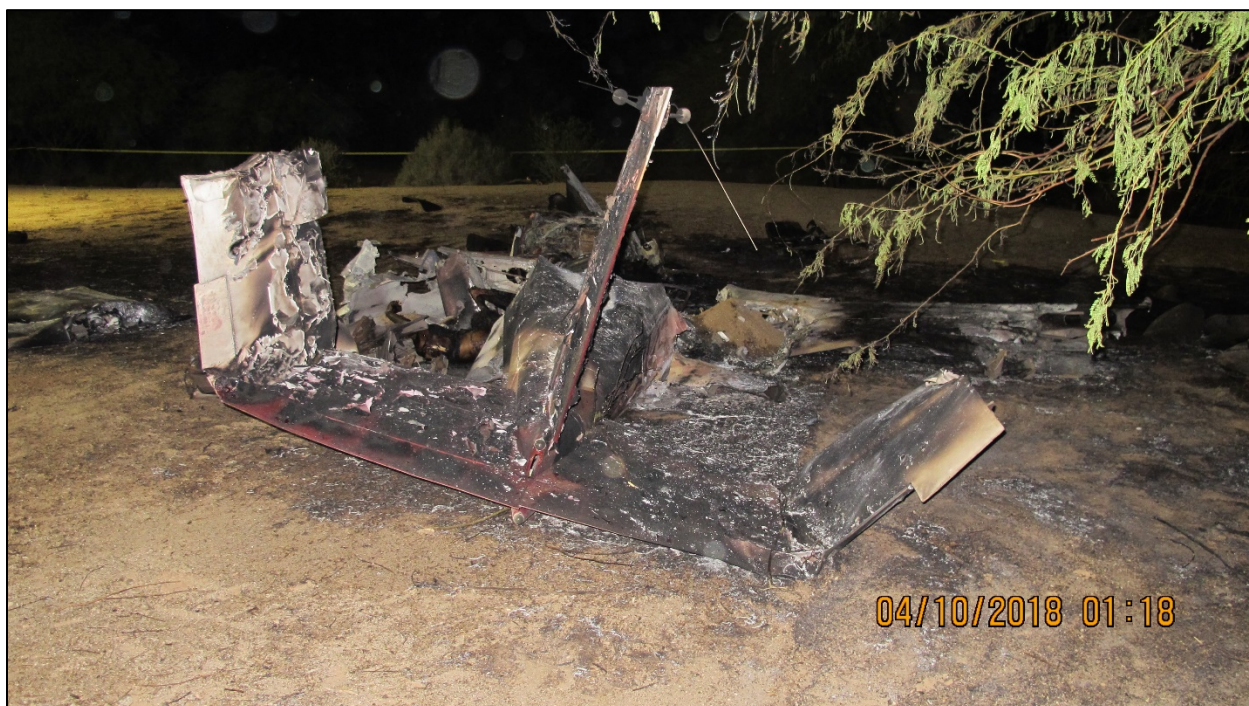
Figure 4-Main Wreckage, Empennage

The empennage remained attached to the main wreckage and had impact damage and thermal discoloration. The rudder counter weights remained attached to the rudder and the vertical stabilizer cap fairing was missing. The stabilator and stabilator trim tab was bent upwards about 70° at both midsections of each side. Both stabilator counterweights separated and were found in the debris field.
