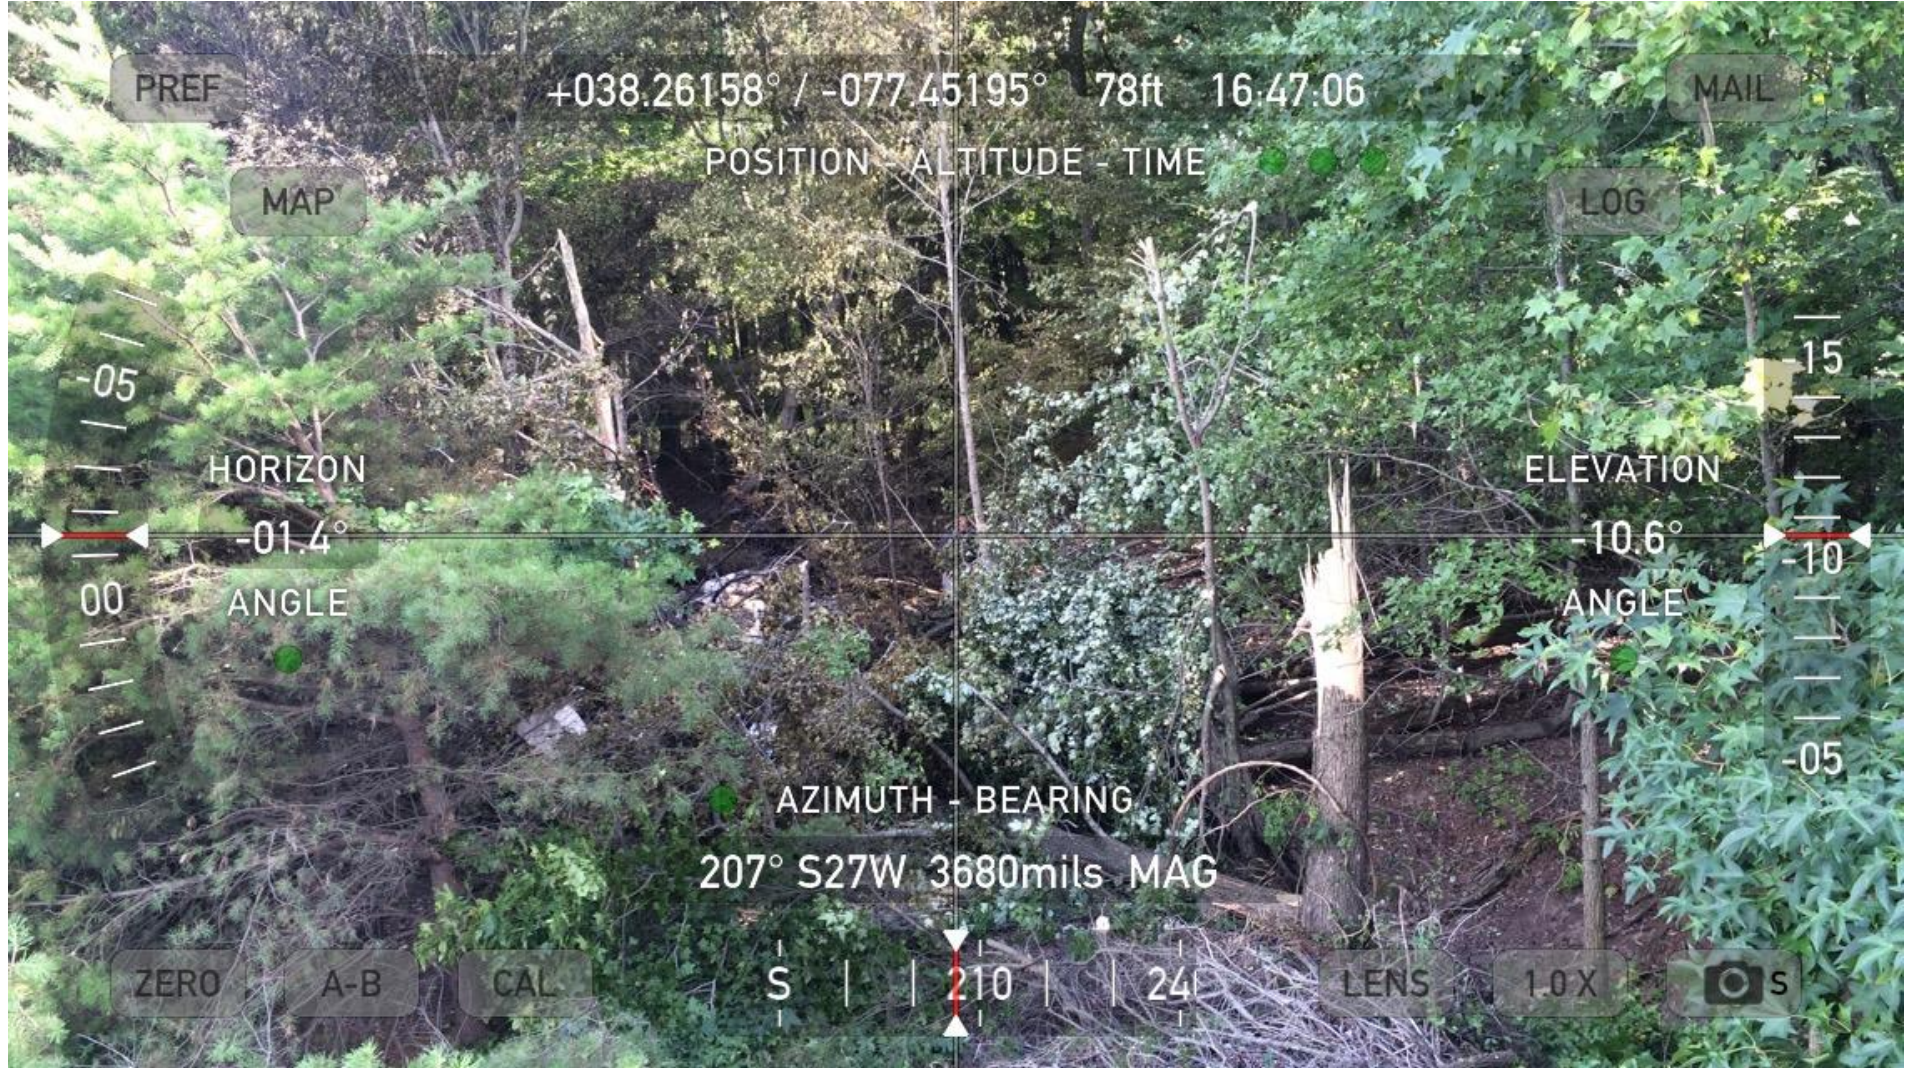
**Photo 1 –View and location of accident site showing surrounding tree impact damage.**

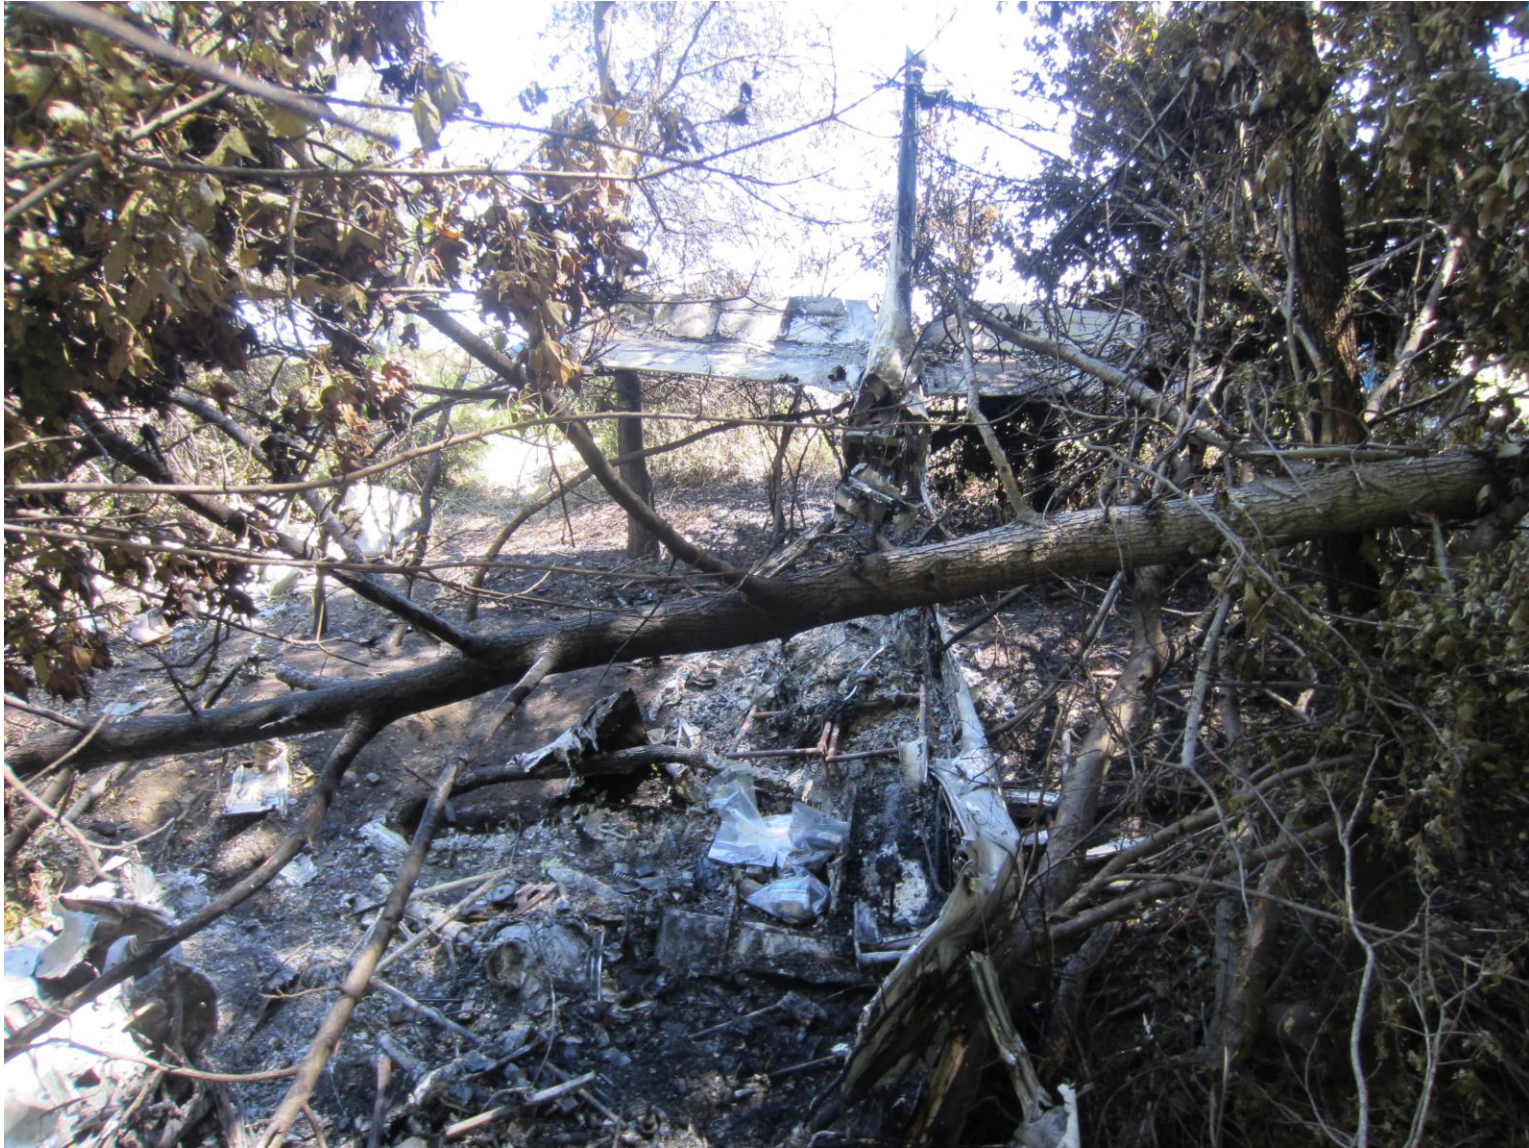
**Photo 2 –View of fuselage damage looking aft towards tail.**

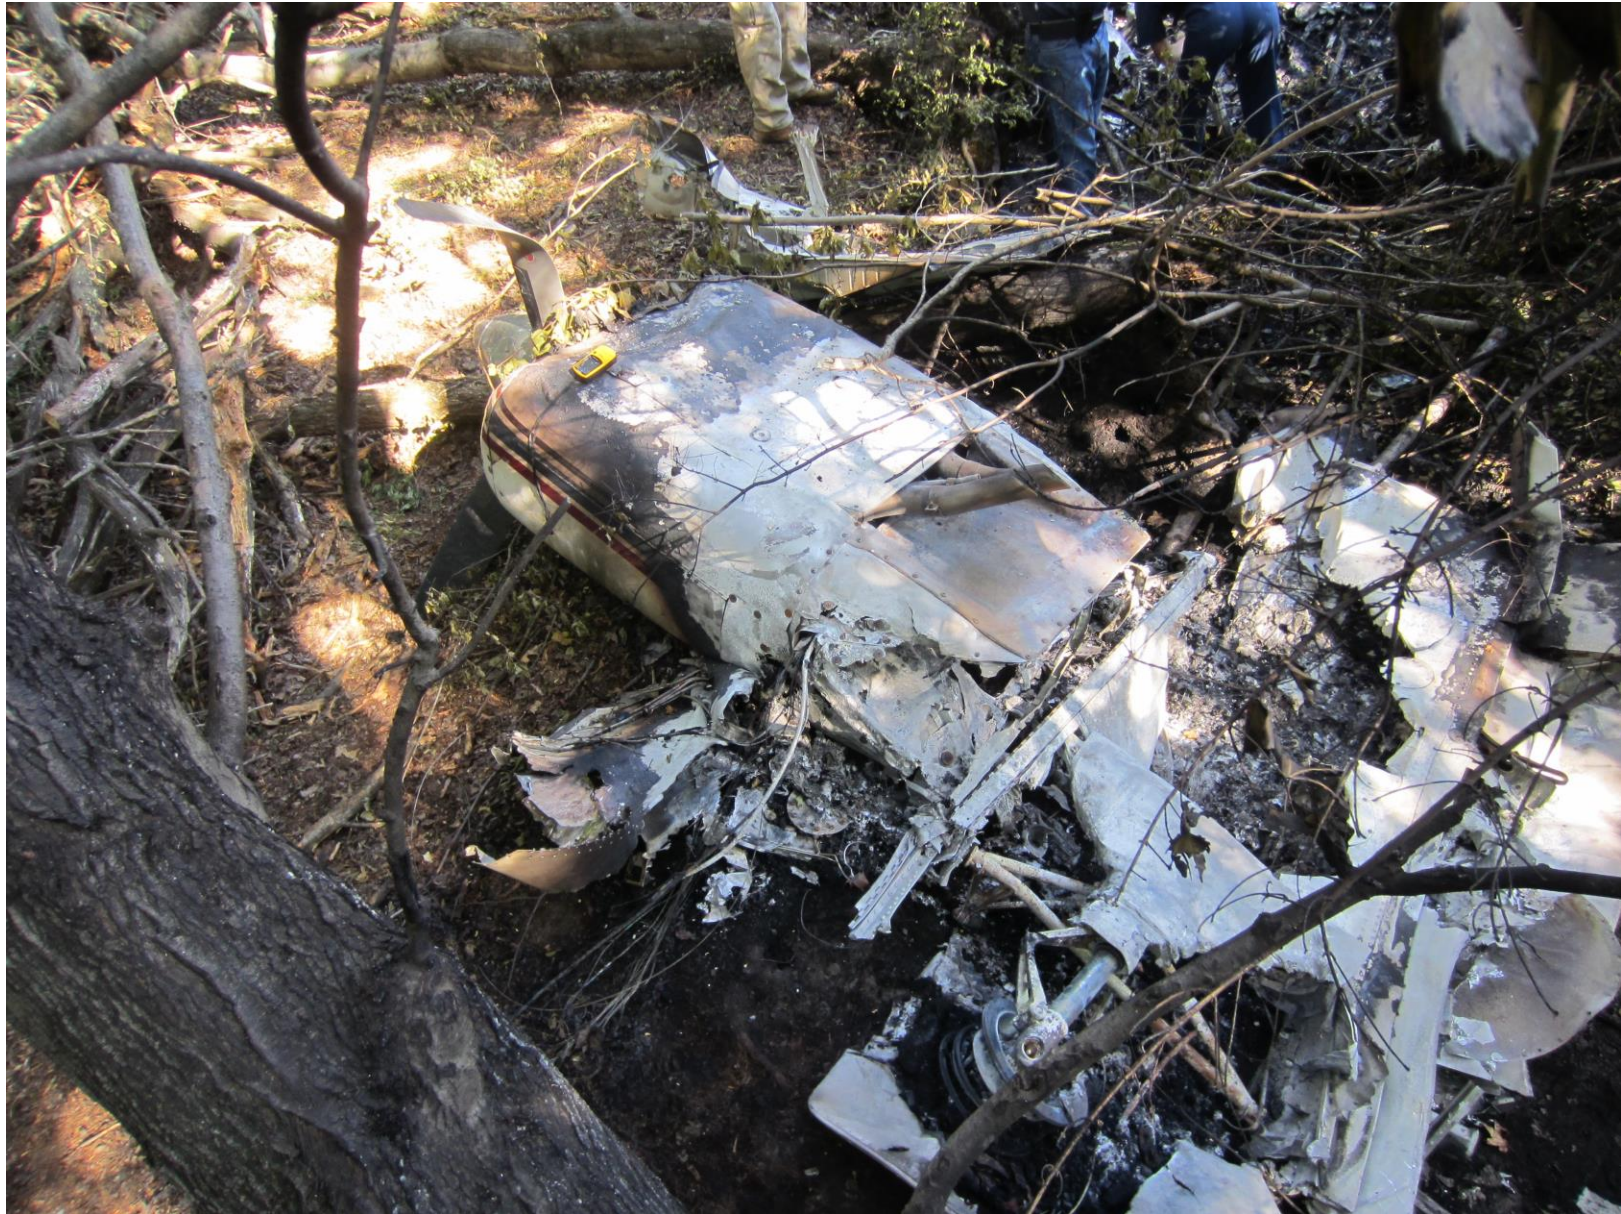
**Photo 3 – Left engine, propeller and wing damage. The entire assembly is upside down.**

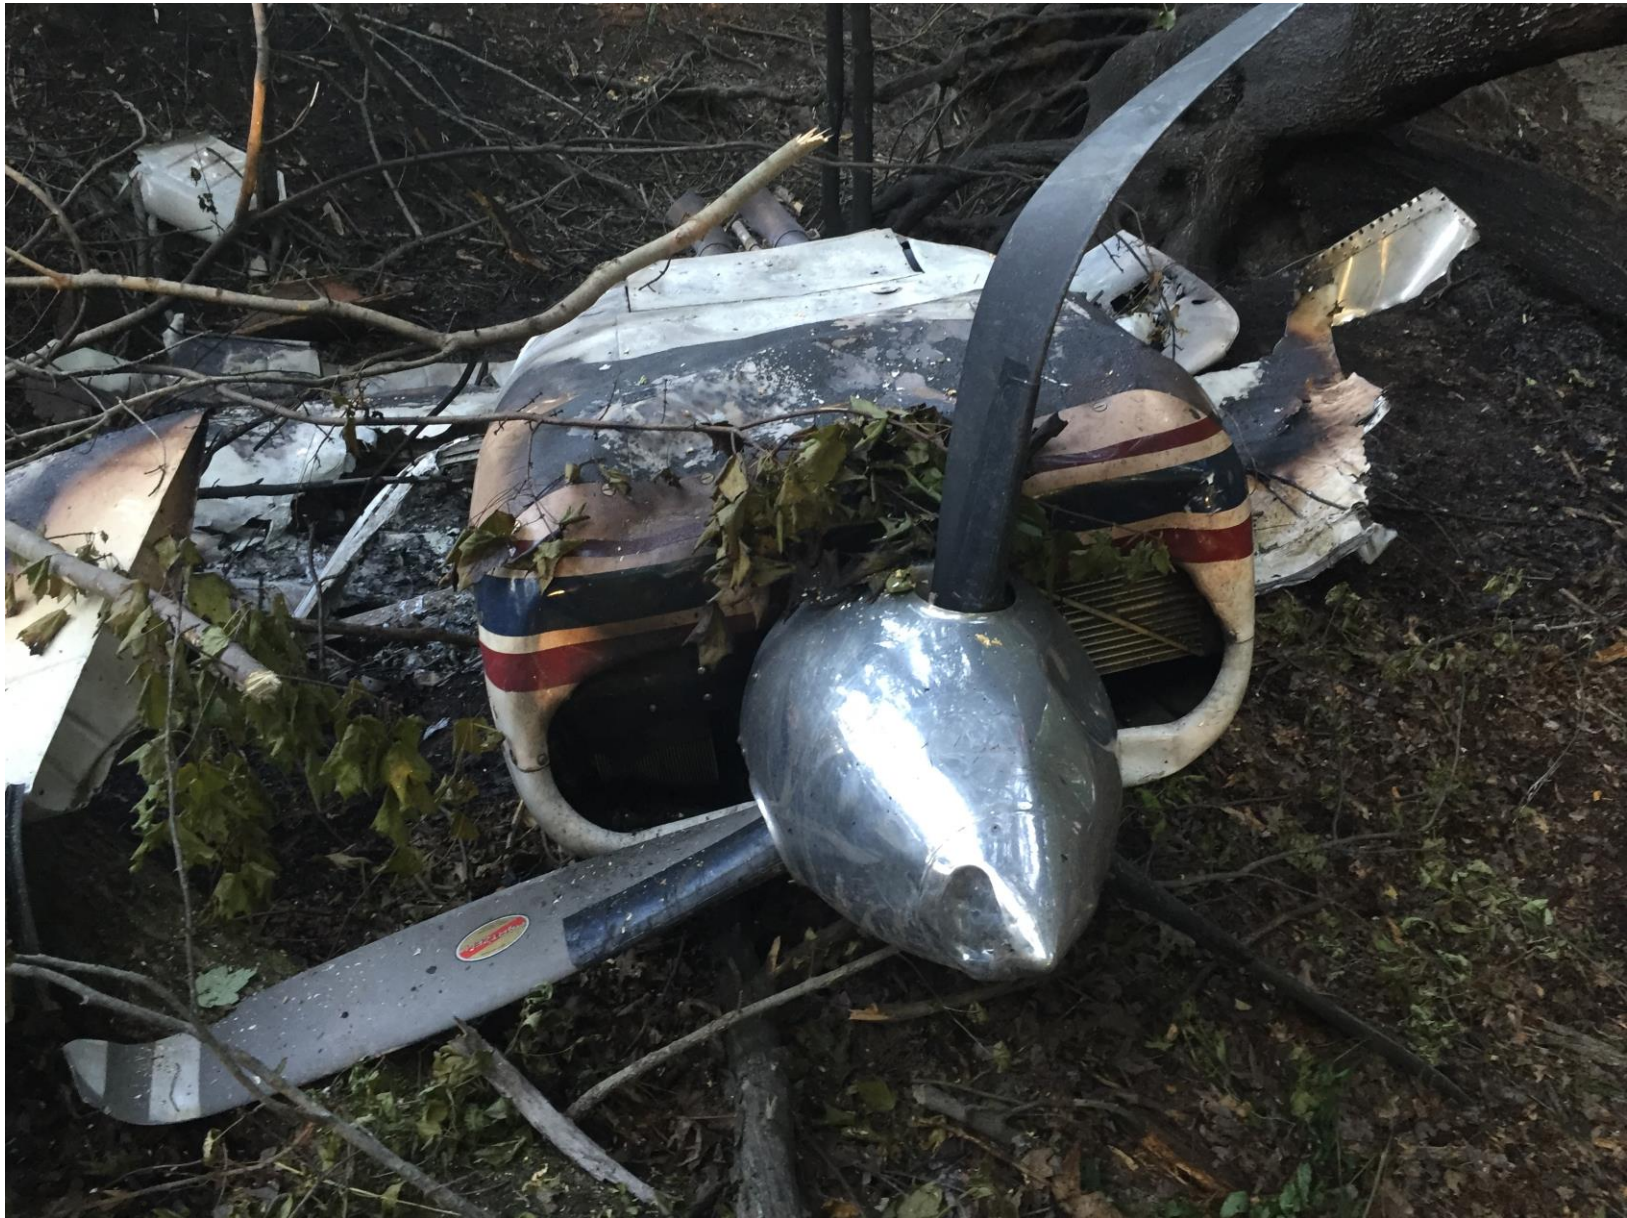
**Photo 4 –Close up view of left propeller and engine damage.**

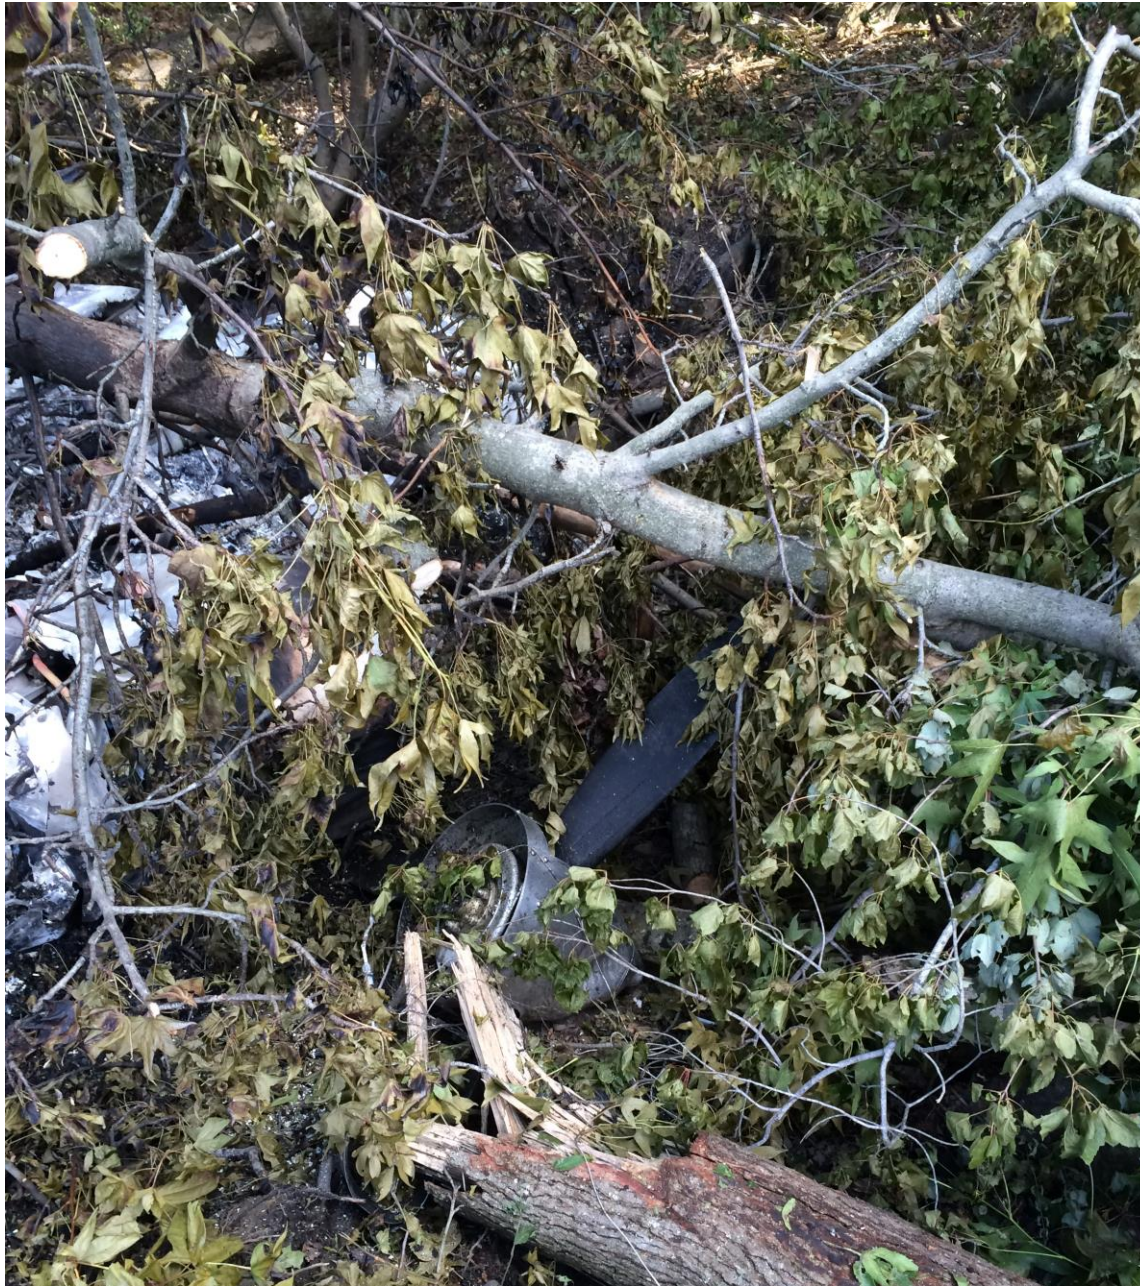
**Photo 5 -Right propeller hub separated from engine. All blades remained attached.**

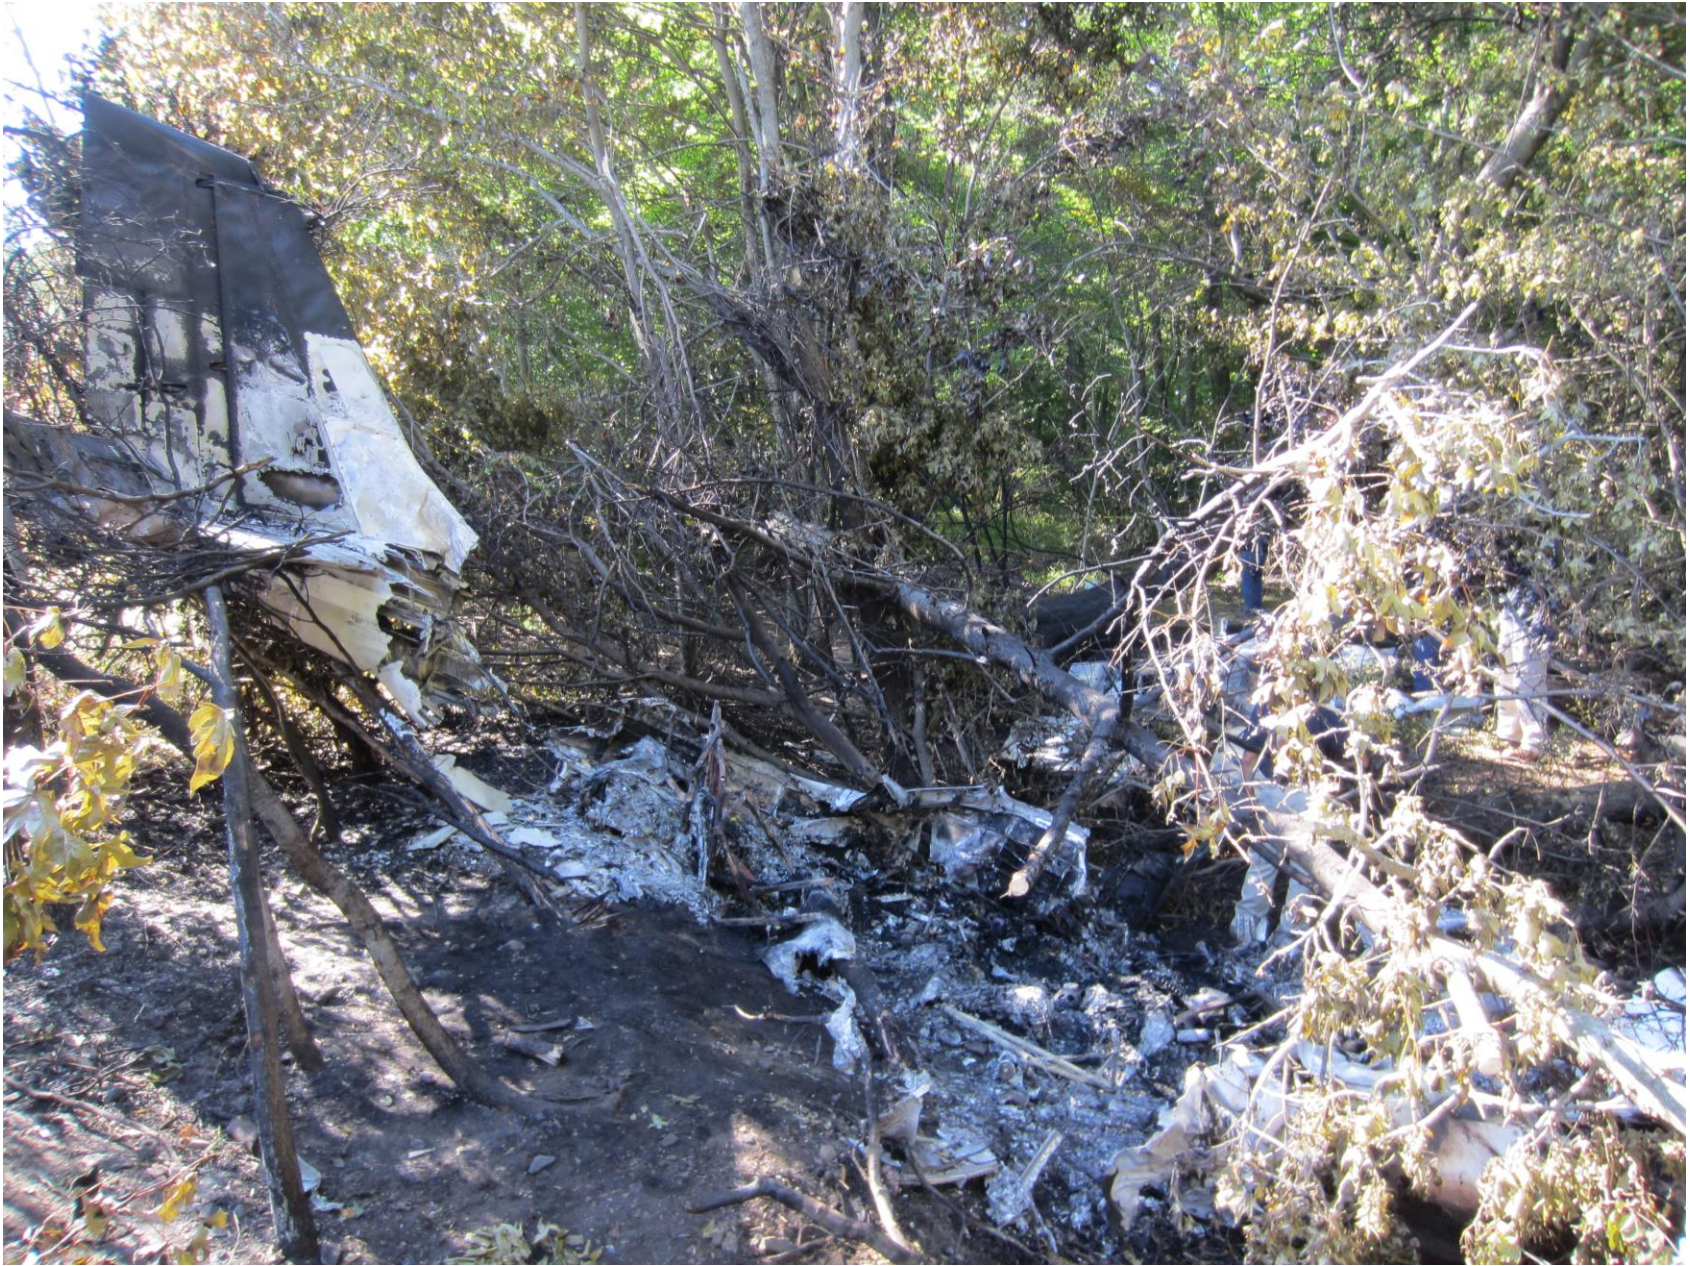
**Photo 6 -Right profile view of fuselage and tail.**
