CRASH SUMMARY FACTUAL REPORT

Valhalla, NY

DCA15MR006

DCA15MR006 Crash Summary

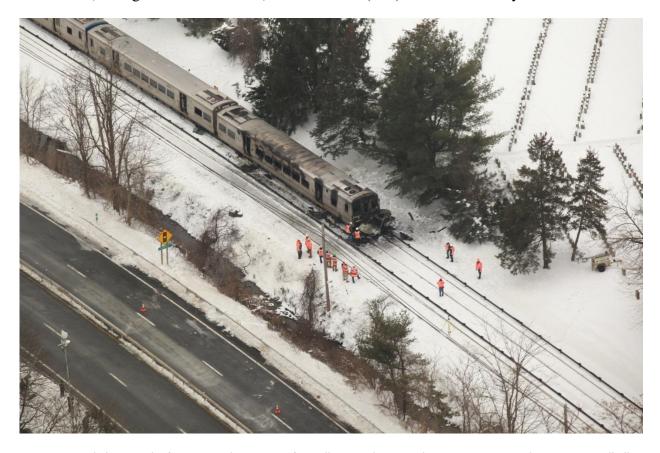
Figure 1-Aerial photograph of Metro North train 659 after collision with SUV at the Commerce St. grade crossing in Valhalla, NY

Event recorder data indicates the train slowed from 58 mph to 49 mph in 4 seconds. The train and SUV came to rest about 665 feet from the point of collision. The movement resulted in damage to the electrified 3rd rail. The 3rd rail detached, pierced the SUV, entering the first railcar in two locations from the underside at the aft end of the left side passenger doorway.

An estimated 386 feet of 3rd rail was damaged, of which about 343 feet was located inside the lead car. Eleven sections of rail were found inside the first railcar and the entire railcar interior was consumed by fire. The train was occupied by 2 crew members and approximately 650 passengers at the time of the accident. The weather at the time of the accident was reported 20°F and with very light wind, clear skies, and good visibility. Damage has been estimated by MN at \$3.1M
