DOCKET NO. SA-510

Air France FDR/QAR Yaw Indicators

Subject: USAir 737-300 Accident, N513AU/PP033 Near Pittsburgh,
September 8, 1994 - AFA Rudder Related Events

AFA RUDDER KICK REPORTS

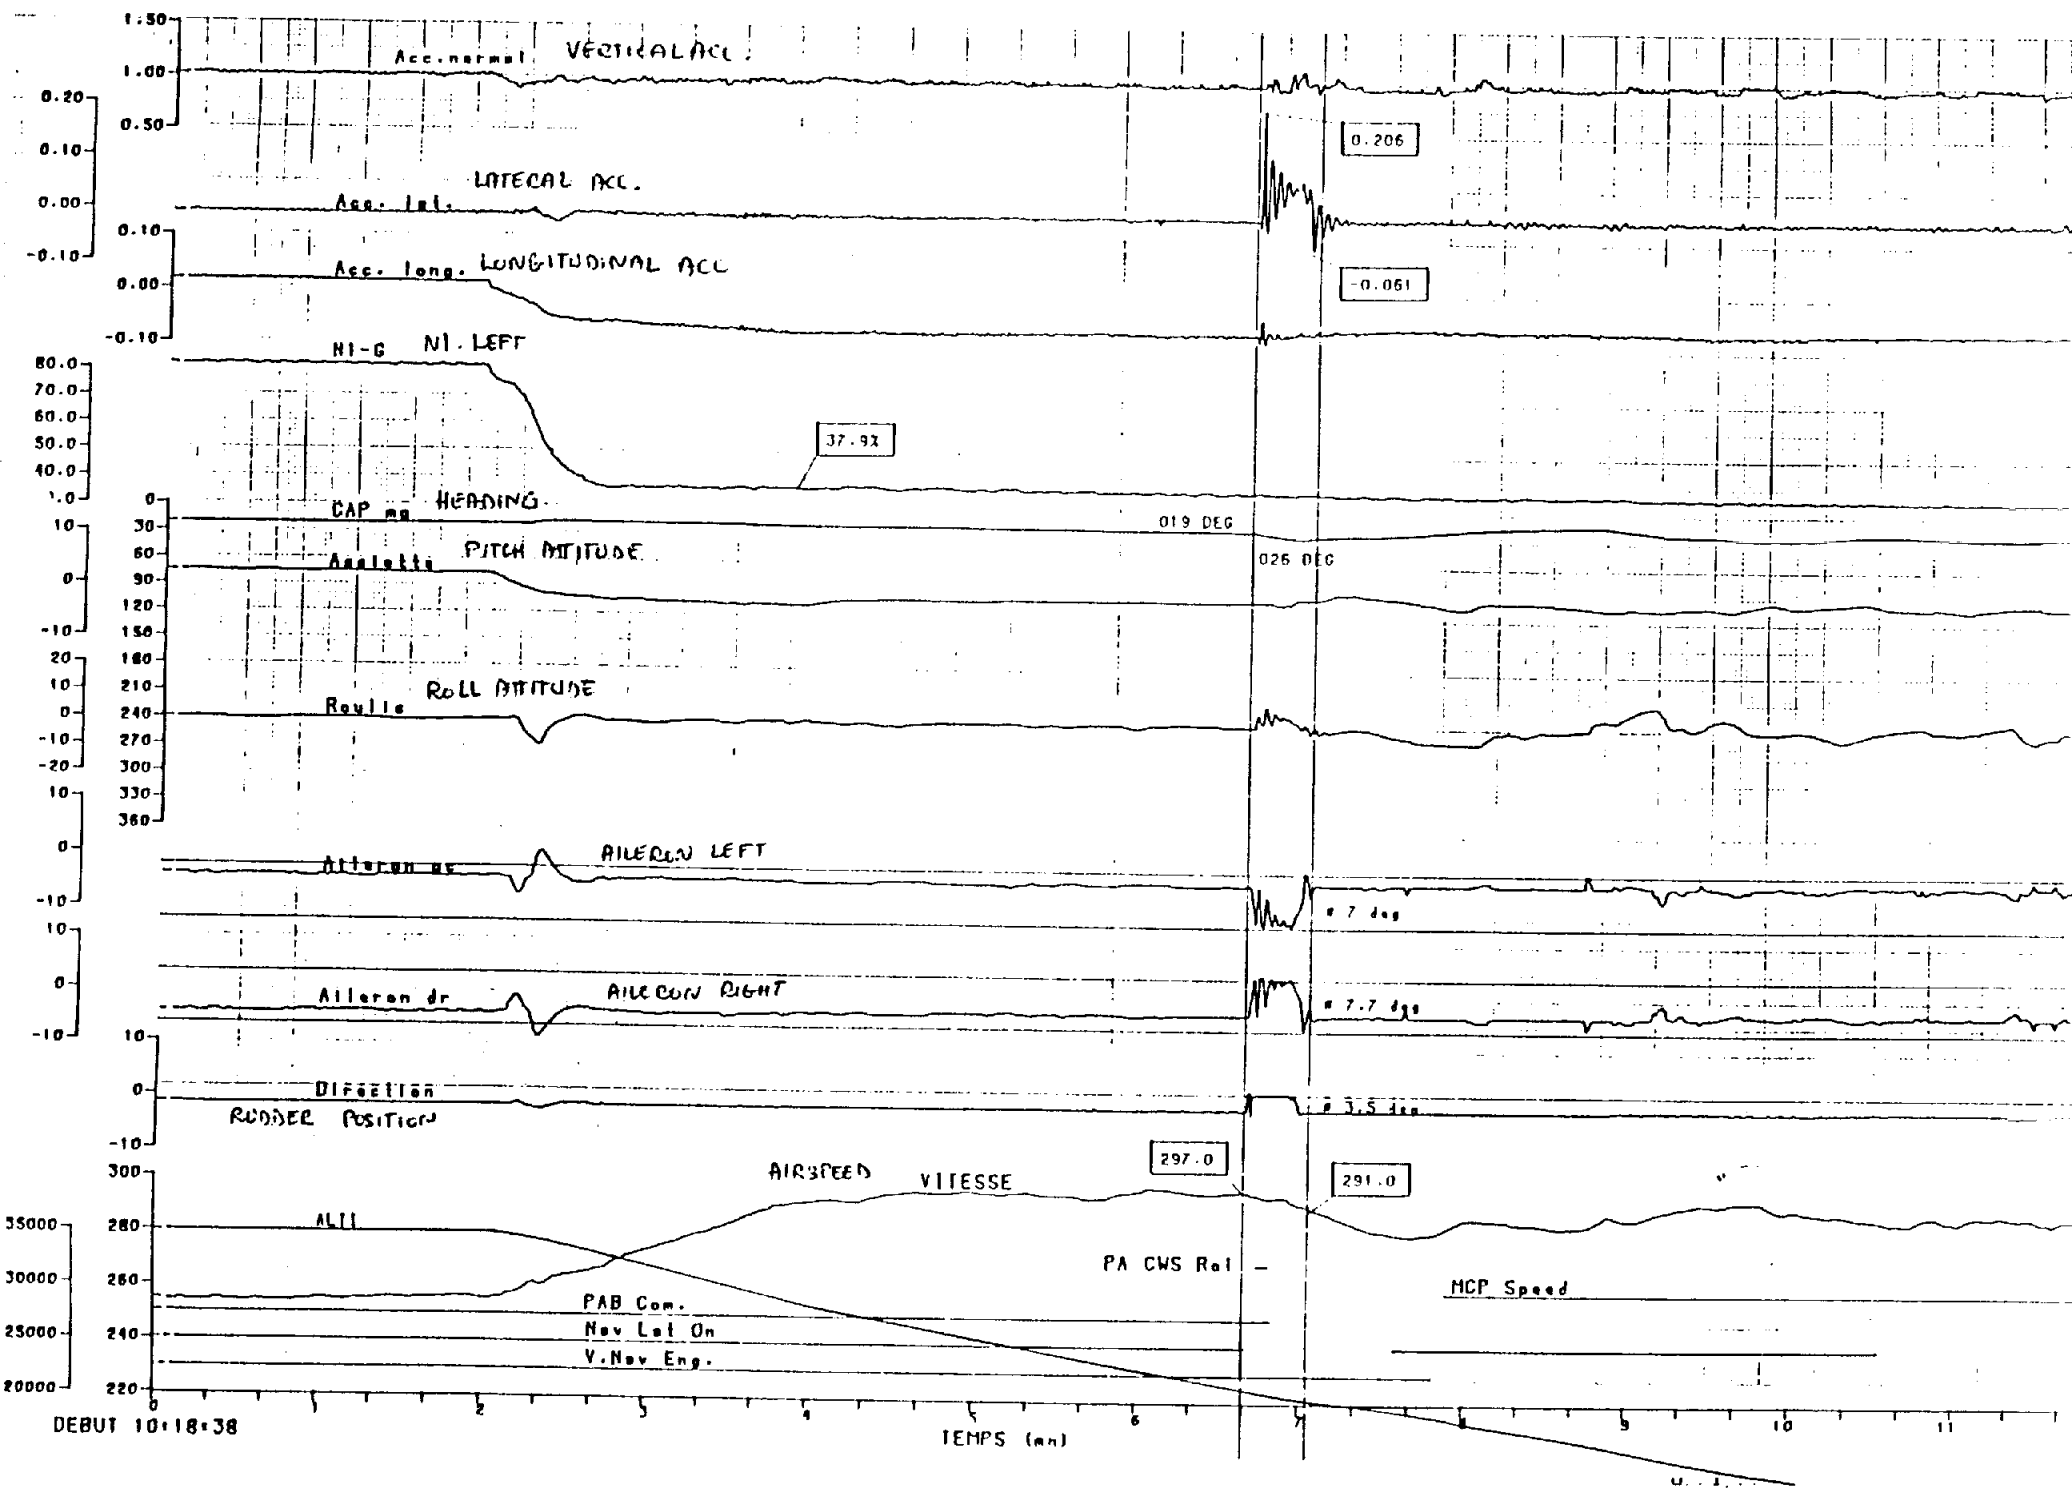
AIR FRANCE REPORTED THAT THE DATA AIRPLANE EXPERIENCED A RUDDER
KICK DURING DESCENT. THIS OCCURRED WHEN THE AIRSPEED WAS REDUCED
TO 290 KNOTS. THERE WERE NO TURBULENCES. THE AIRPLANE HAD A
SUDDEN YAW TO THE RIGHT. CONSEQUENTLY, THE AUTOPILOT WAS
DISENGAGED. AS A RESULT OF THIS CONDITION, TWO PASSENGERS WERE
REPORTED SLIGHTLY INJURED.AIR FRANCE REPLACED THE YAW DAMPER COUPLER, S/N OUT 88092861.
FURTHERMORE, THE DADC WAS ALSO REPLACED, S/N OUT 1095.AIR FRANCE ENGINEERING AND MAINTENANCE ARE INVESTIGATING THIS
CONDITION. REFERENCE /A/ PRESENTS THE DATA RECORDER IN THE DFDR
FOR YOUR INFORMATION.

During descent into Orly, at 290 knots, a sudden yaw movement was noted. The pilots noted full right yaw damper input on the yaw damper indicator. The yaw damper was disconnected and the problem went away.

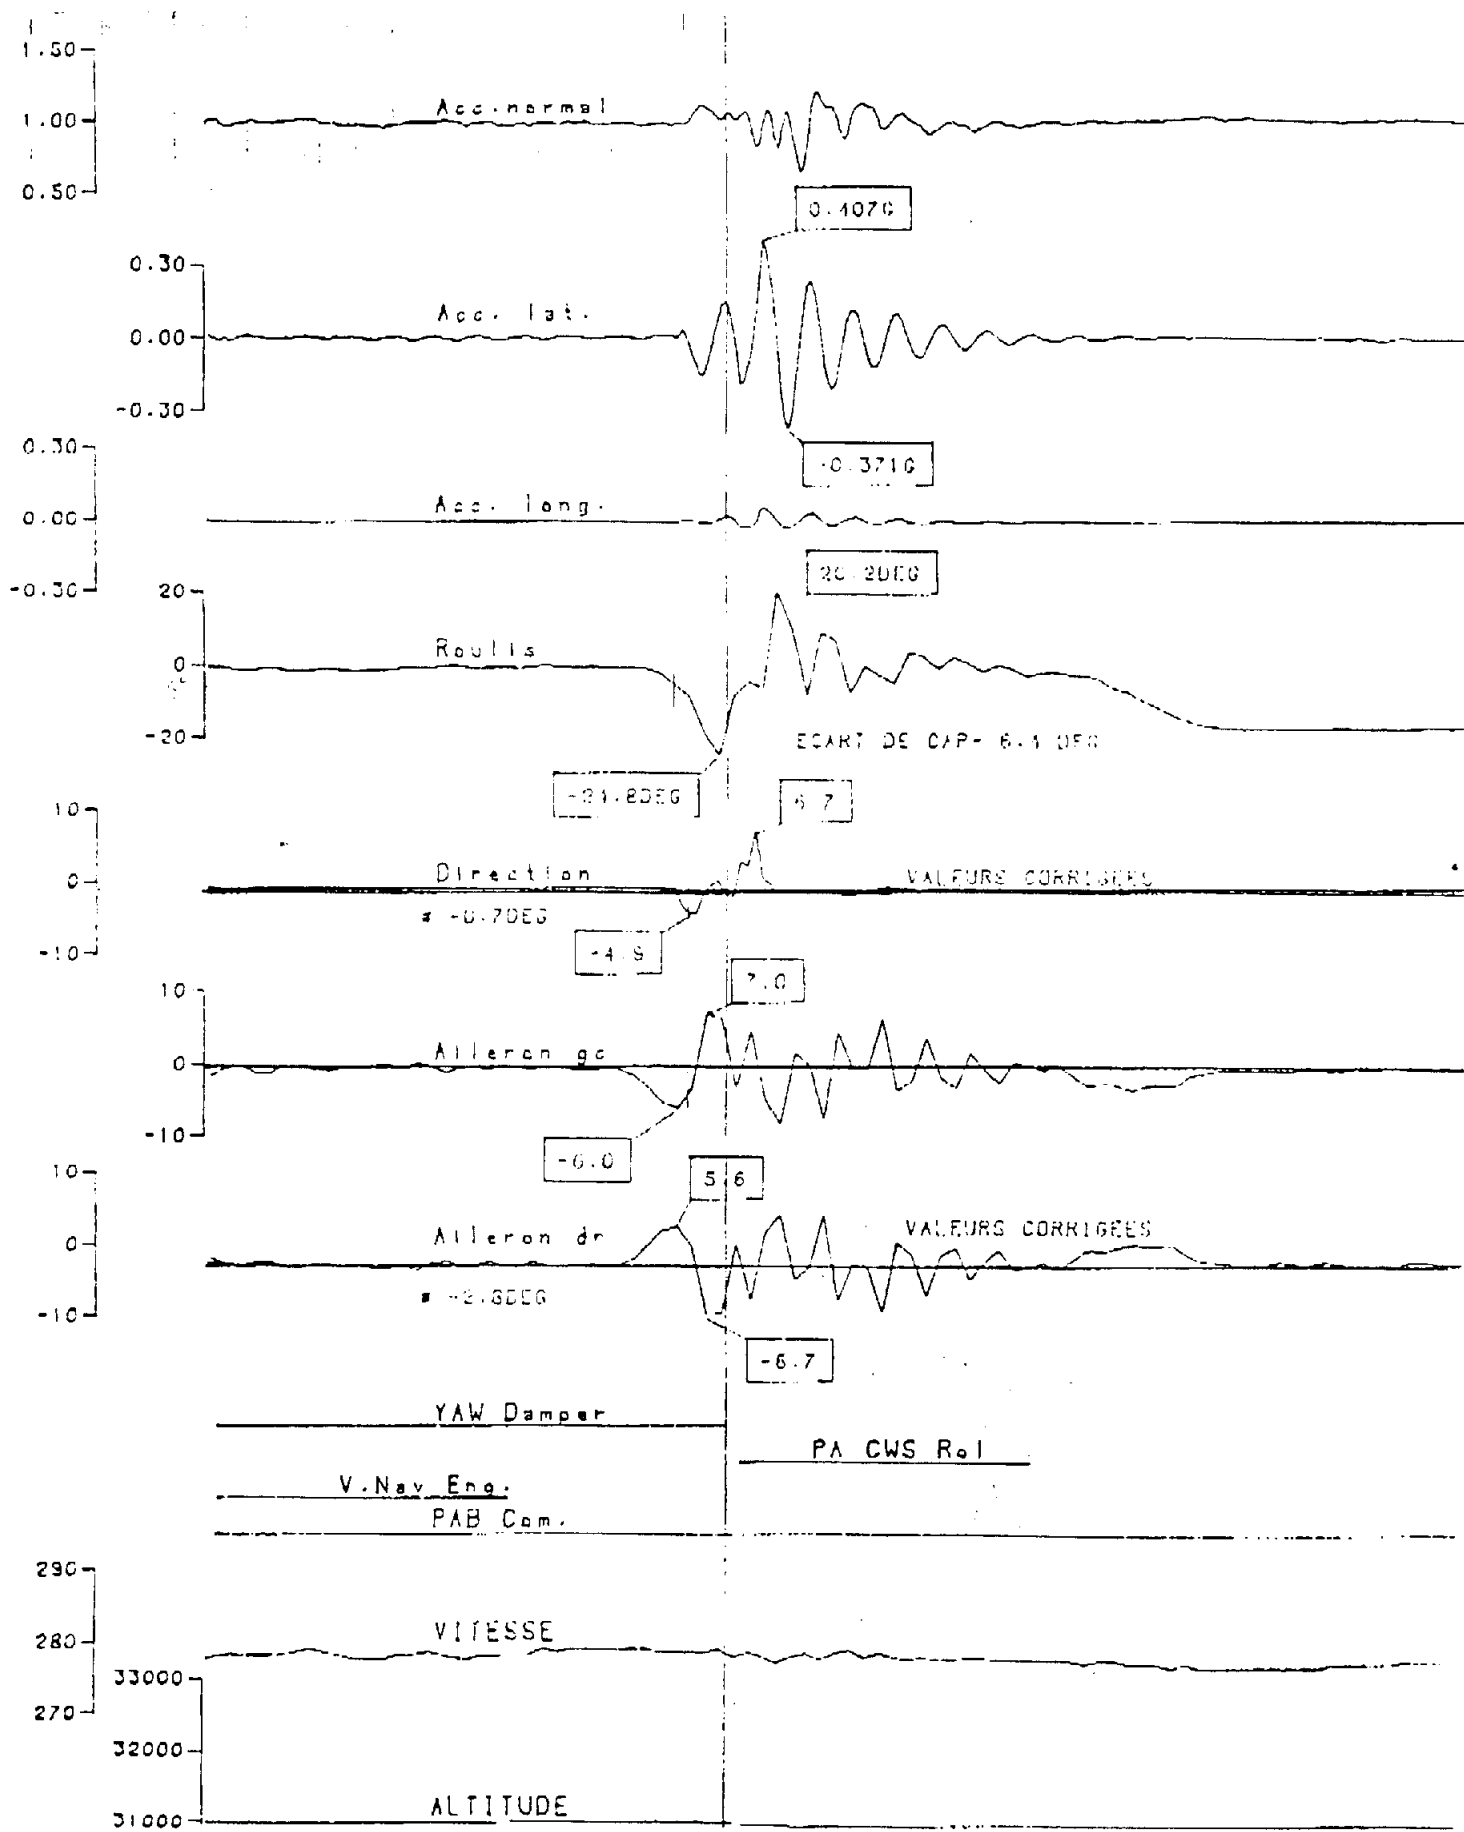
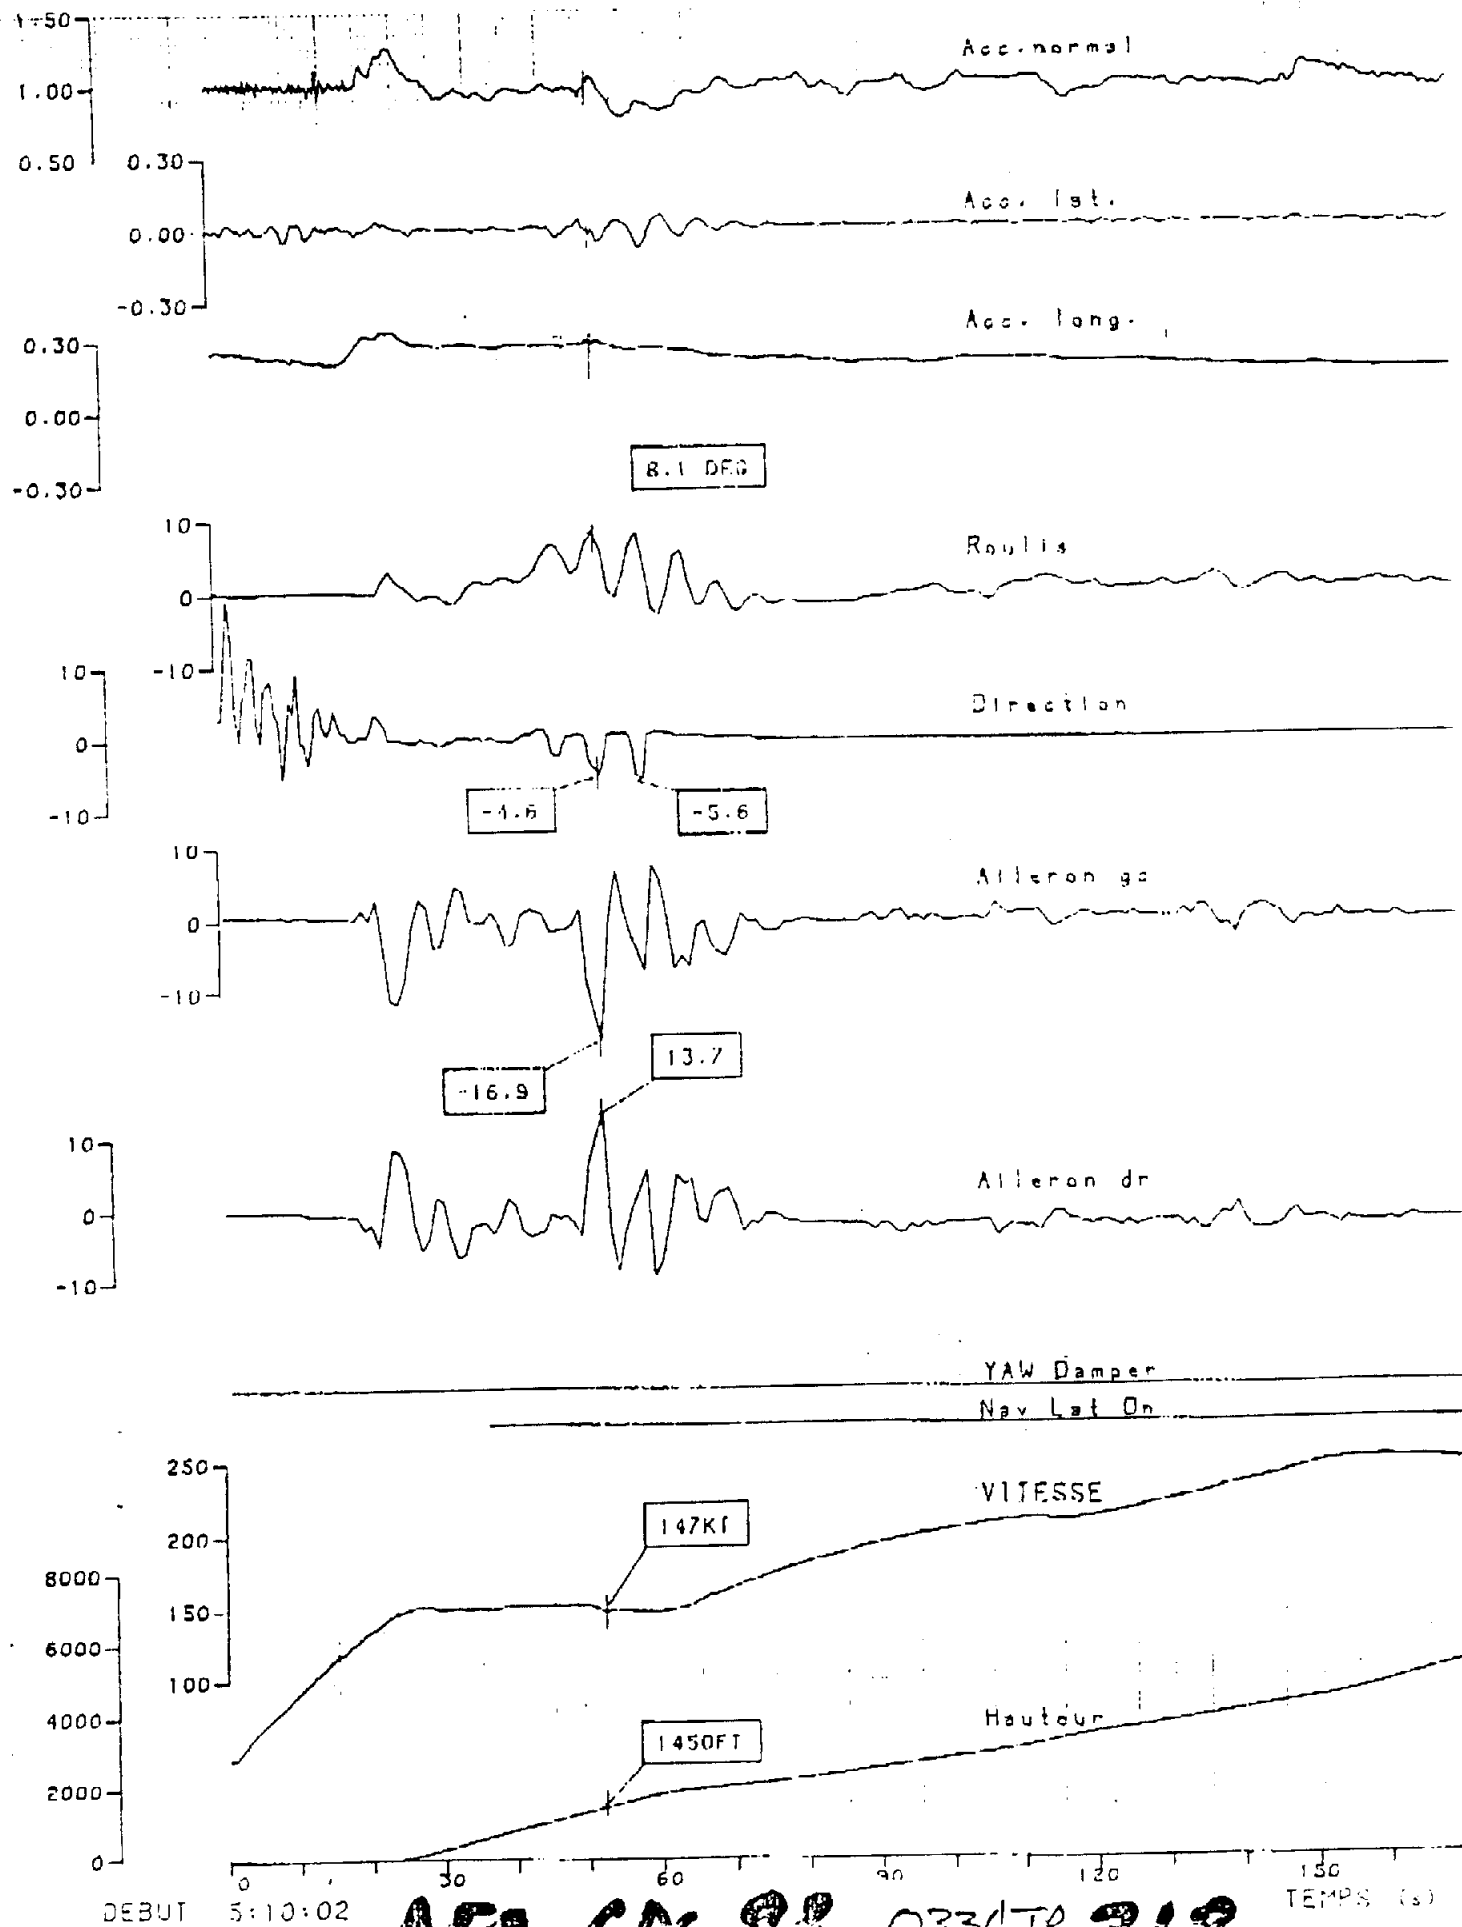
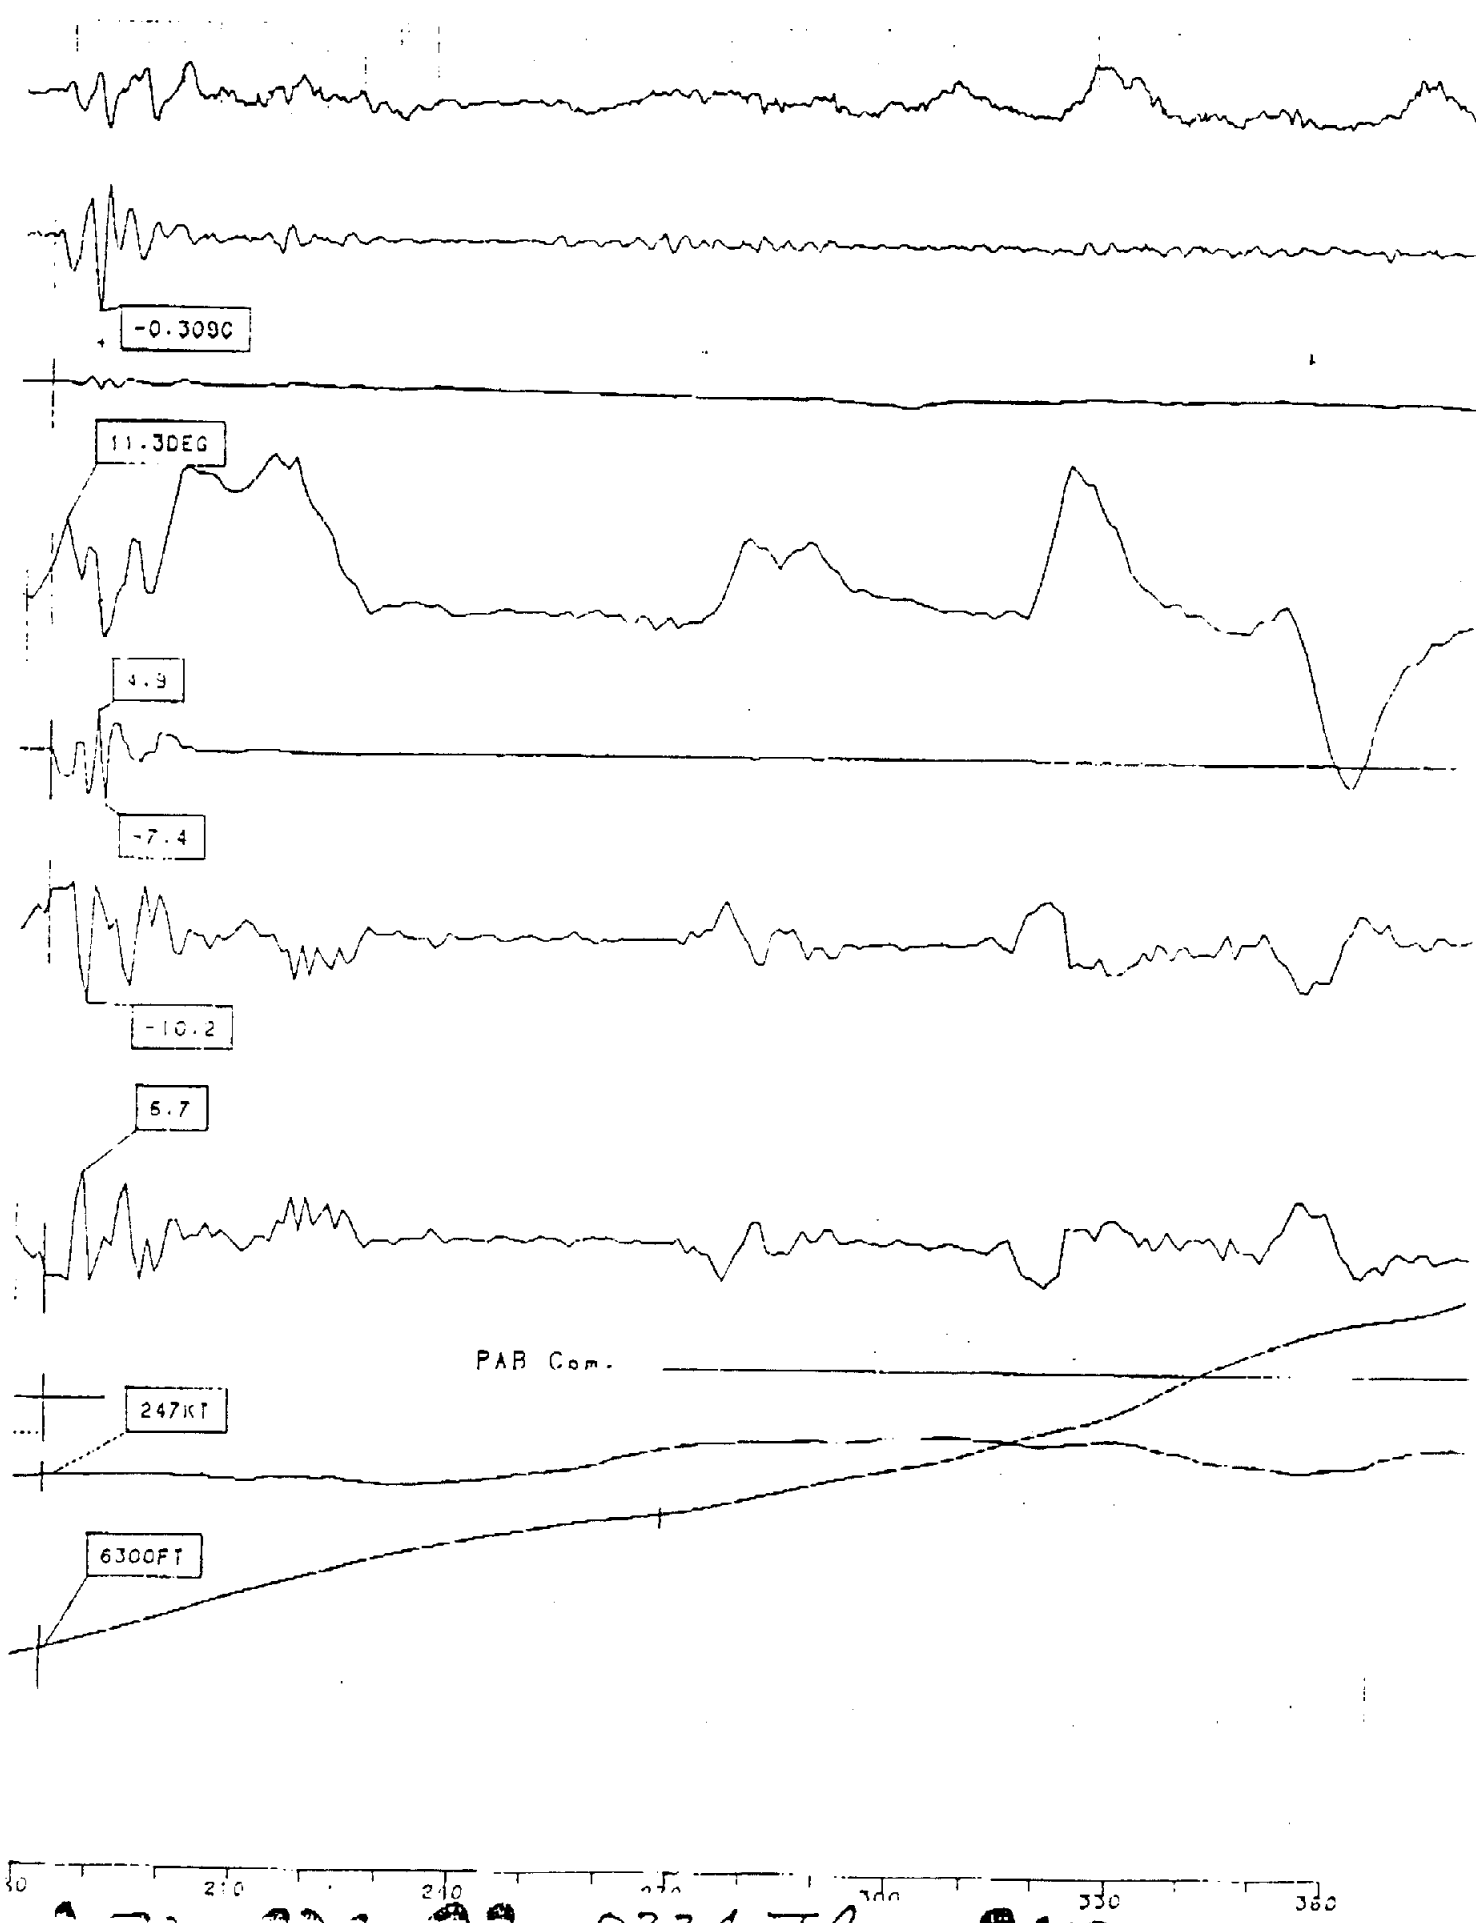
WE HAVE REVIEWED THE REF /A/ DETAILS AND THE FAXED FDR DATA FOR THE SECOND /AUG 20/ RUDDER ANOMALY REPORT DURING TAKEOFF ROLL. WE DO NOT BELIEVE THIS REPORT IS RELATED TO THE OTHER TWO REPORTS DUE TO THE MAGNITUDE OF THE RUDDER DISPLACEMENT /12.3 DEGREES/. WE BELIEVE THERE WAS A MANUAL INPUT TO THE RUDDER PCU FROM SOME SOURCE WHICH CAUSED THIS RUDDER DEFLECTION. IN ORDER TO FURTHER EVALUATE THIS REPORT, WE WOULD APPRECIATE IT IF AFA COULD PROVIDE THE FOLLOWING INFORMATION.

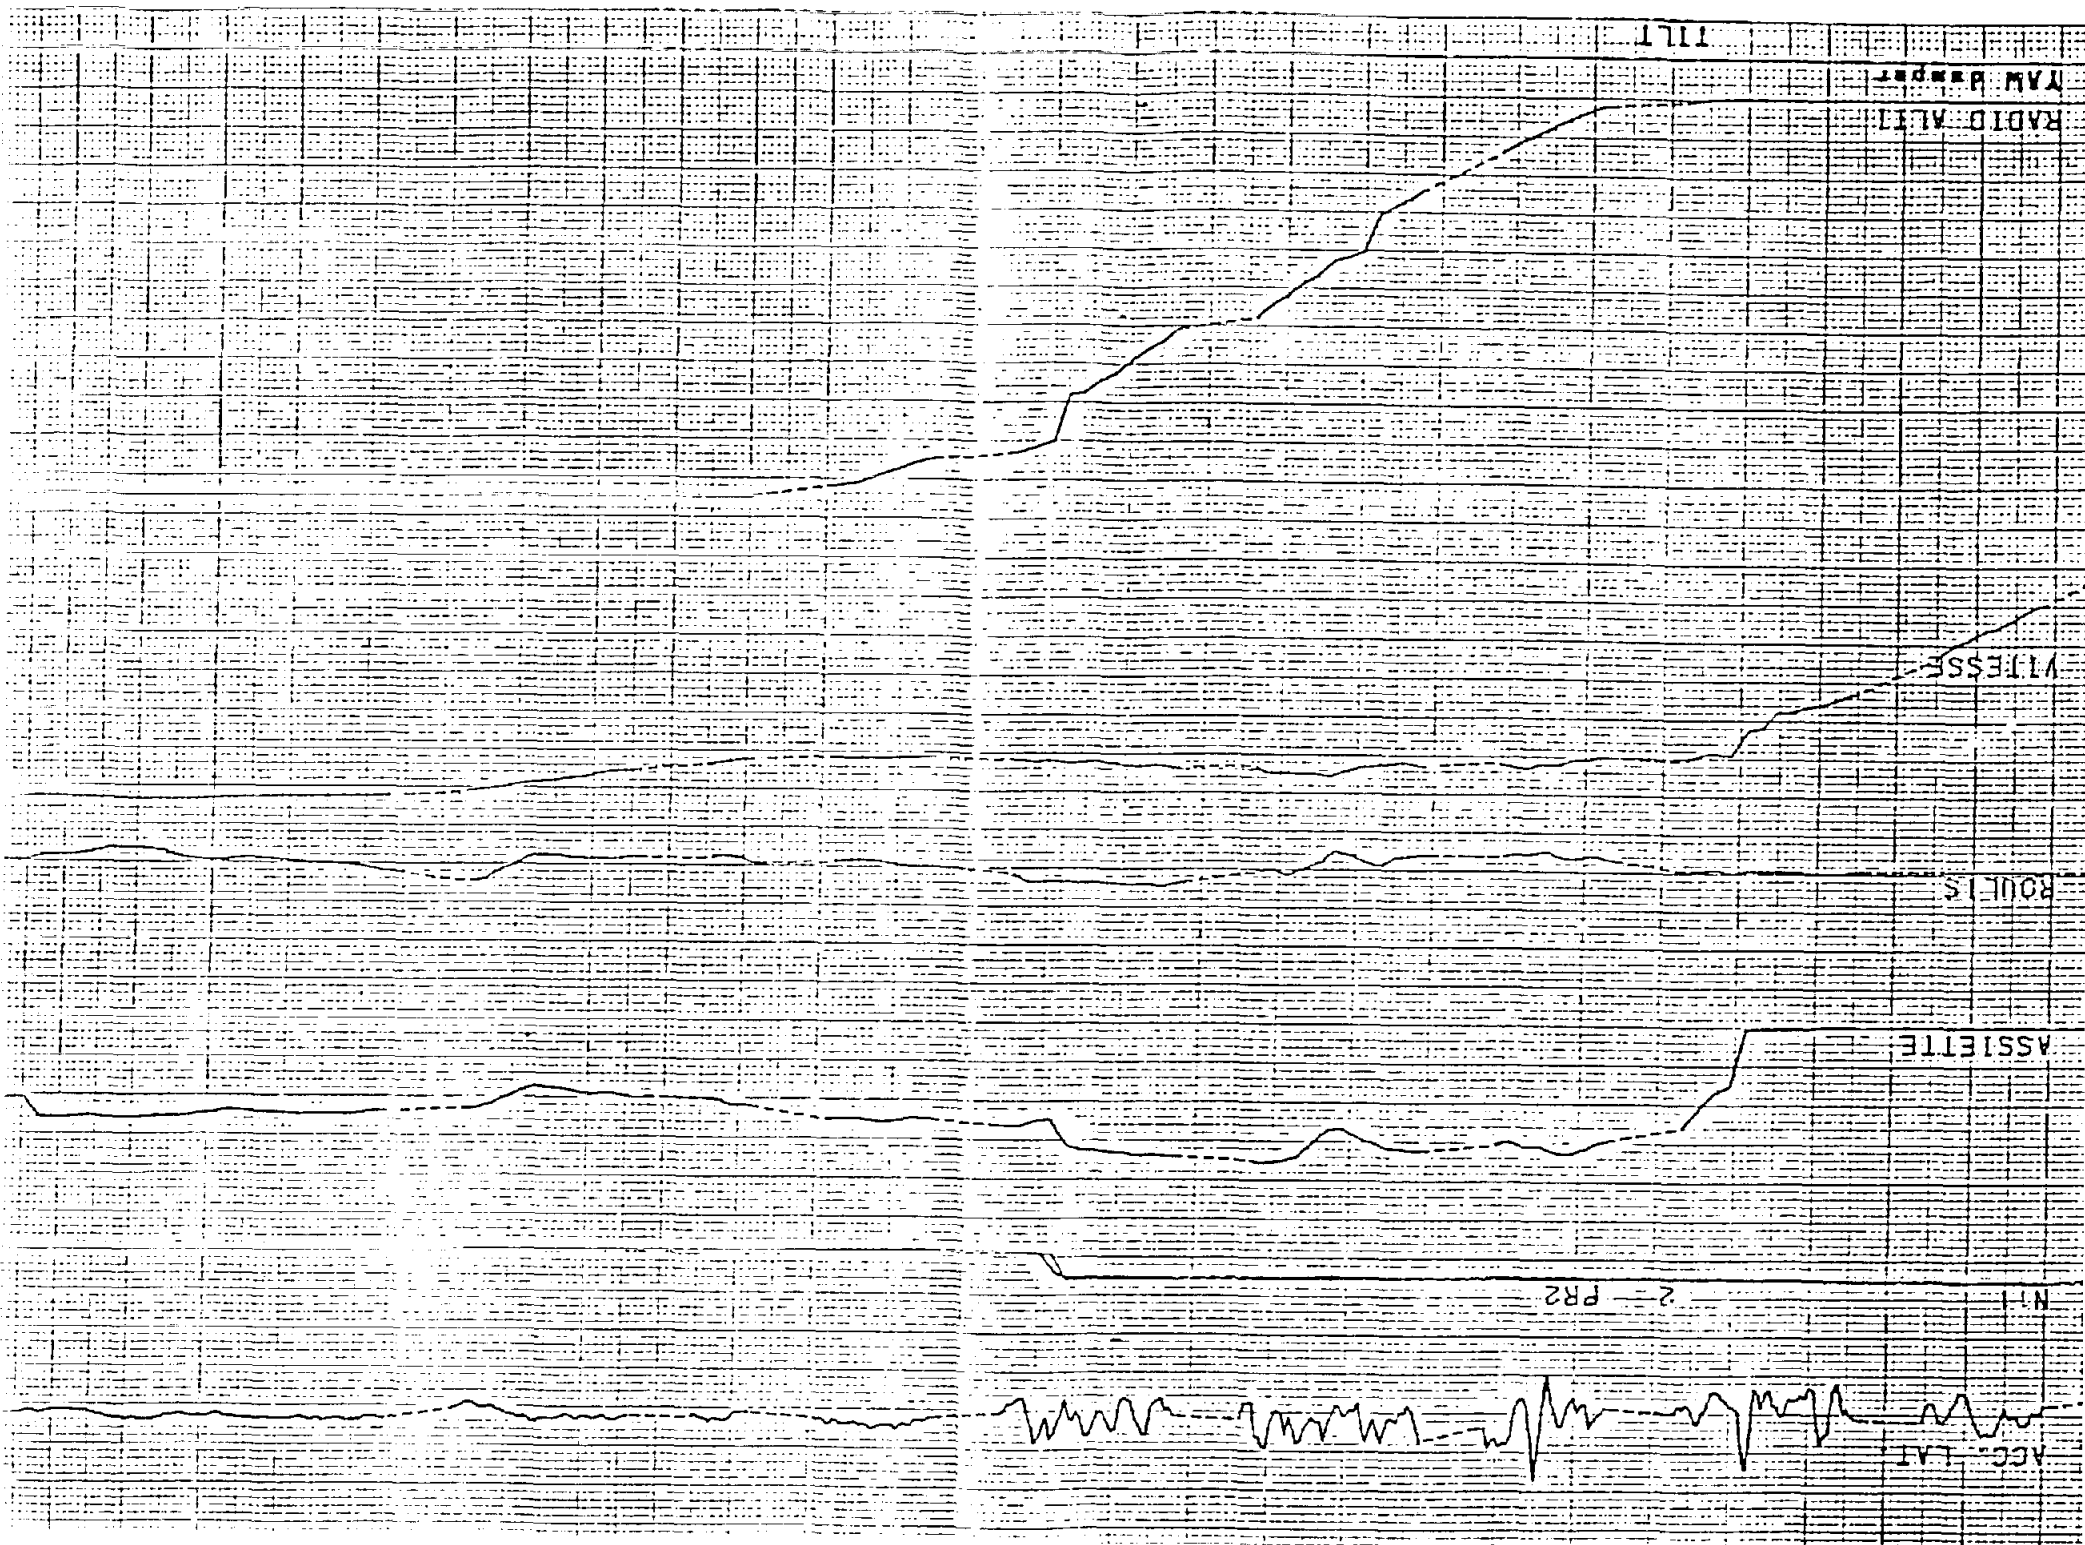
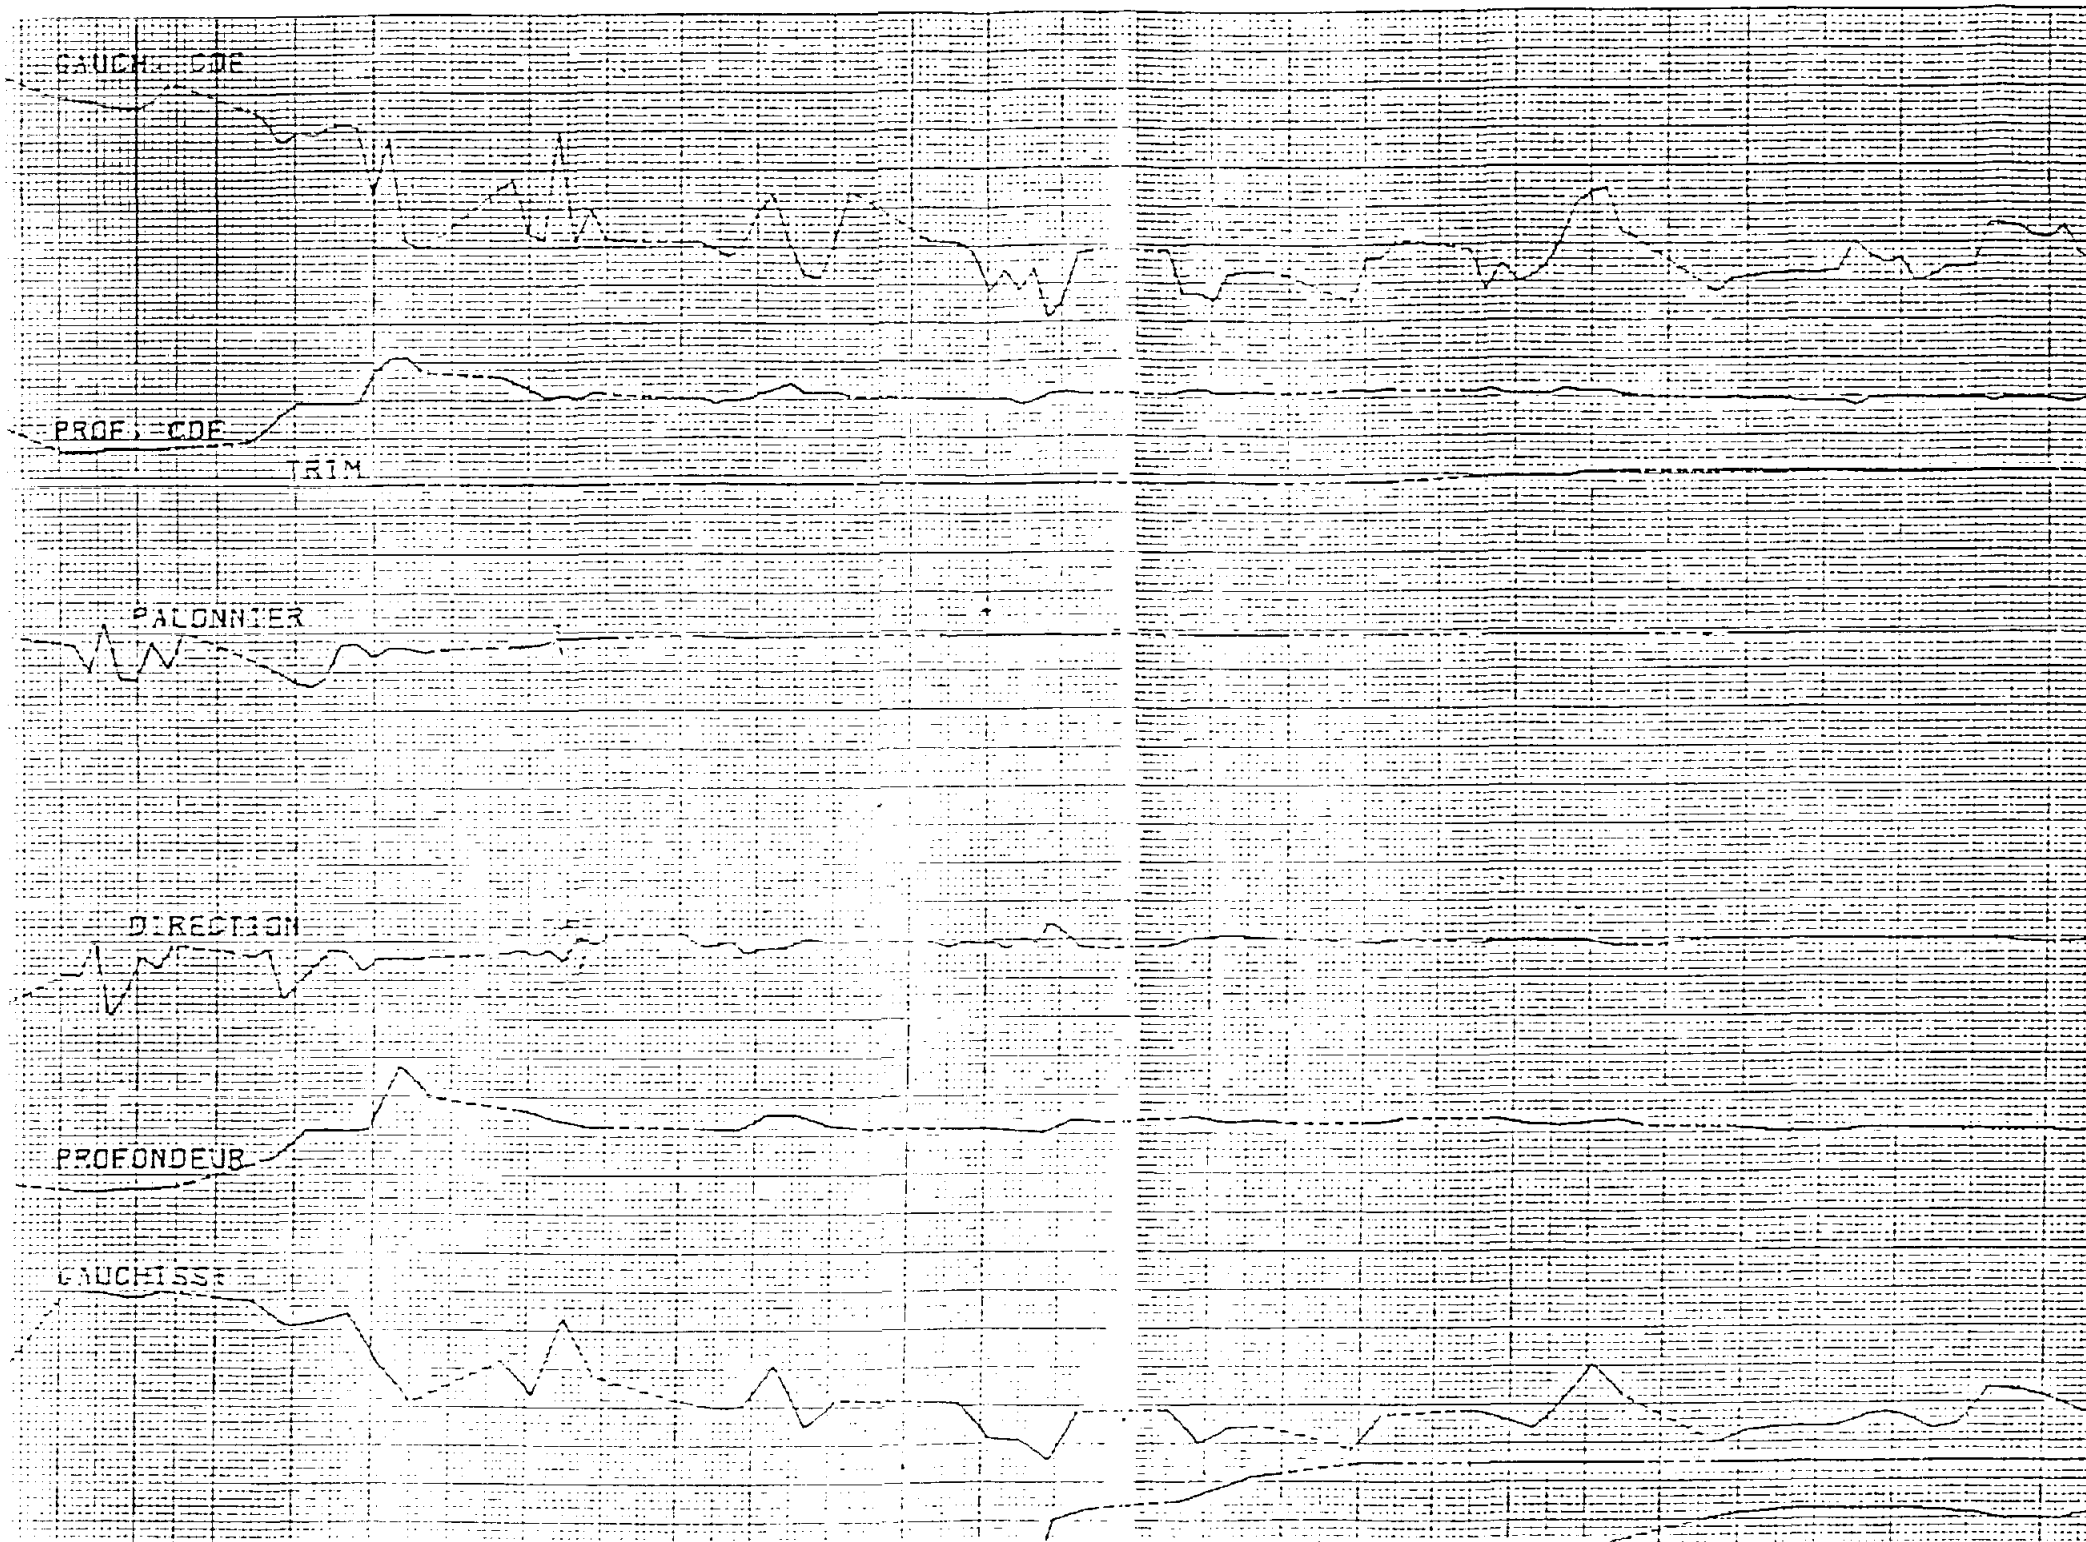
OUR REVIEW OF THESE FLIGHT DATA RECORDER GRAPHS HAS REVEALED NO
APPARENT RUDDER CONTROL OR YAW DAMPER ANOMALIES. THE DATA
INDICATES THAT RUDDER POSITION WAS WITHIN REASONABLE AGREEMENT
WITH RUDDER PEDAL POSITION AND/OR YAW DAMPER COMMAND AUTHORITY.
THE DATA ALSO INDICATES THAT YAW DAMPER COMMANDED RUDDER
DISPLACEMENTS WERE REACTIONS TO EXTERNAL CONDITIONS SUCH AS
LATERAL ACCELERATIONS OR AILERON COMMANDS. IT APPEARS FROM THE
FLIGHT DATA RECORDER GRAPHS THAT THE RUDDER CONTROL SYSTEM WAS
FUNCTIONING CORRECTLY ON THE DATA AIRPLANE. ACCORDINGLY, WE DO
NOT SUGGEST ANY FURTHER ACTION REGARDING THIS MATTER AT THIS
TIME.

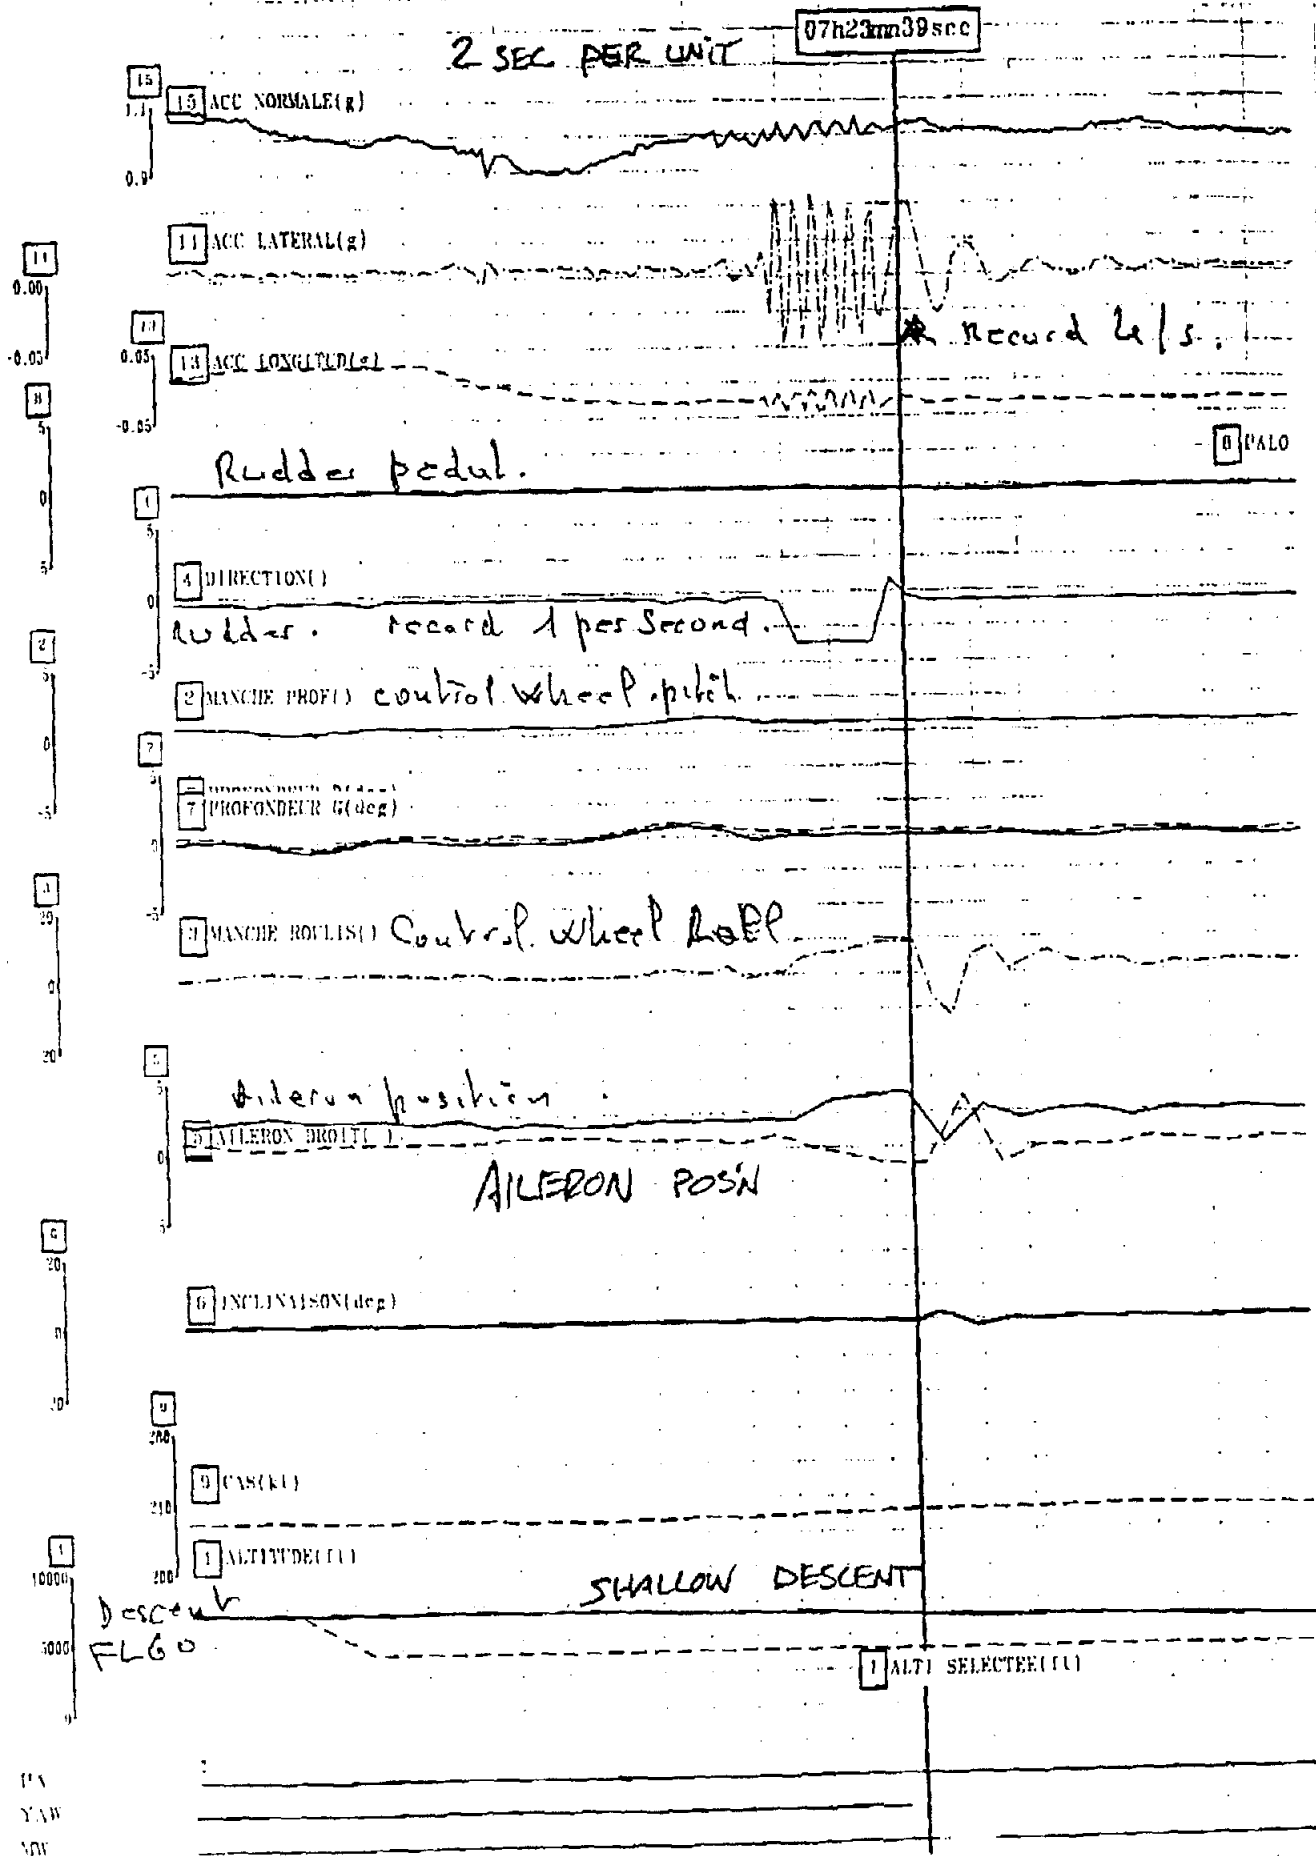
AFA-CDG-94-0334 TR

On 30 Sep 94, AFA—CDG reported rudder kicks on airplane PT510 (F—GJNJ) during descent on 16 Sep. AFA noted a rudder displacement of 1 Hz with *no rudder pedal displacement.* AFA believed this frequency is a characteristic of yaw damper input. Graphical QAR data was forwarded, and Boeing was requested to review this data. Boeing review of this data indicates that the rudder did displace to the yaw damper limit for approximately 3 seconds. However, Boeing advised AFA that the information provided in the forwarded QAR data was not sufficient to determine the cause of the rudder deflection, and that AFA should provide FDR data in raw form for a more complete analyses.

THE FOLLOWING INFORMATION IS PROVIDED IN RESPONSE TO THE REF /A/
TELEX REGARDING RUDDER //KICKS// DURING FLIGHT. AFA REQUESTED WE
REVIEW AND COMMENT ON FAXED FDR DATA FROM THE DATA AIRPLANE.
REPORTEDLY, WHILE DESCENDING FROM FL060, THE RUDDER //DISPLACED
AT A RATE OF 1 CYCLE PER SEC AND THIS APPARENTLY INDUCED A 4 HZ
LATERAL OSCILLATION//. AFA NOTED THAT THE RUDDER PEDALS DID NOT
MOVE AT THAT TIME.
