DOCKET NO. **SA-510**

**NATIONAL TRANSPORTATION SAFETY BOARD**

## **737 Rudder PCU Input Rod Summary**

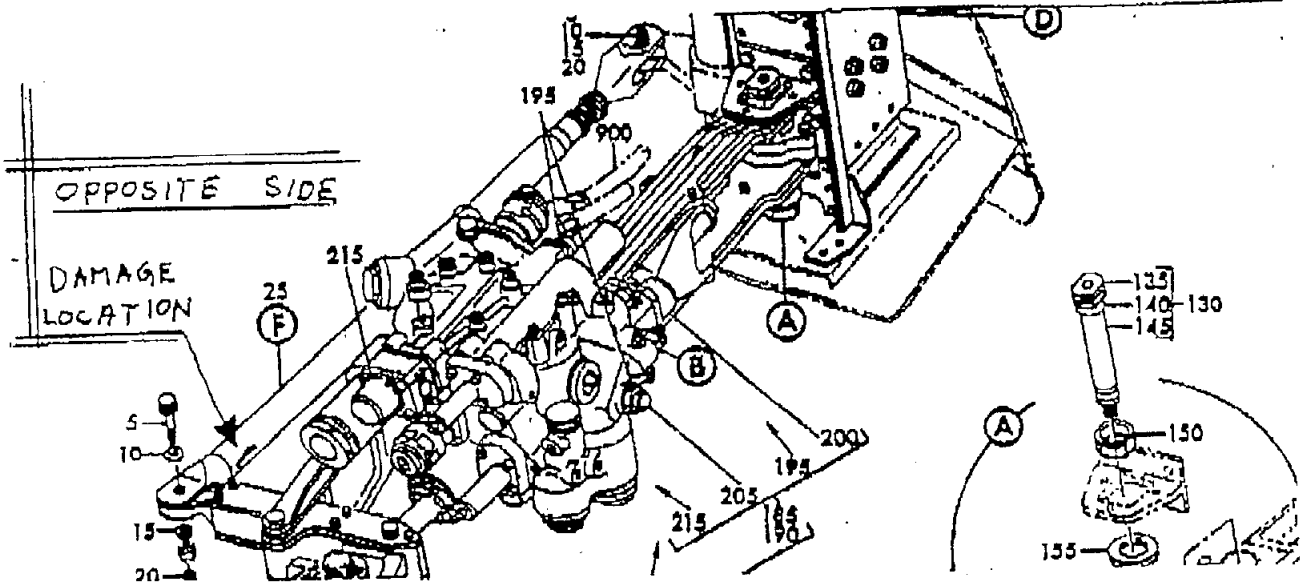
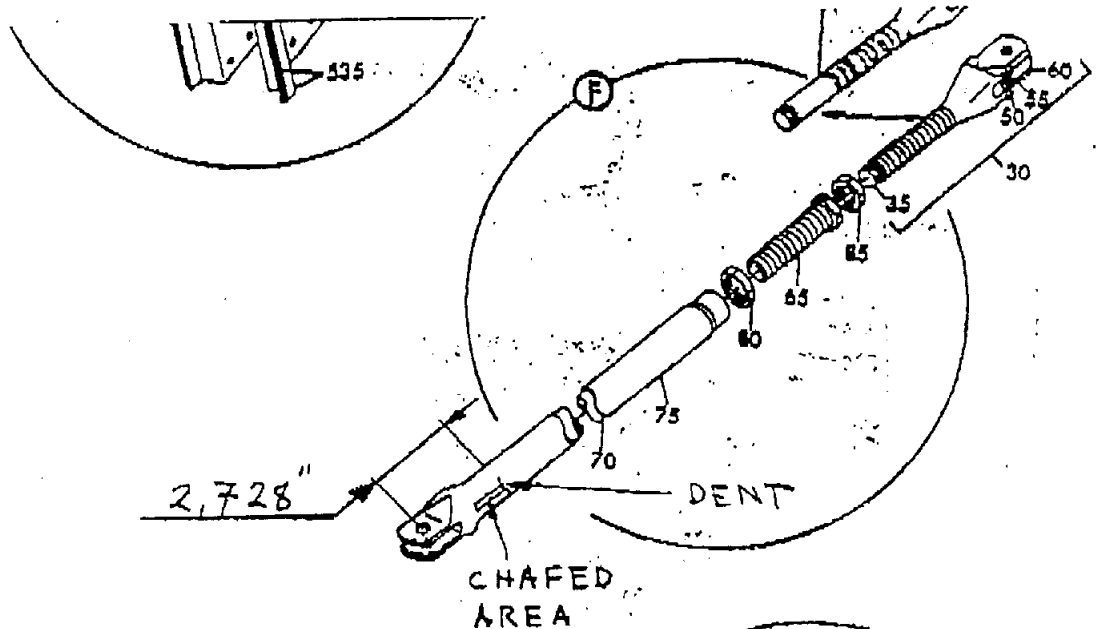
POWER UNIT INSTL-RUD CONT  
FIGURE 1 (SHEET 1)

PW571 IS CURRENTLY UNDERGOING ITS FIRST "4C" CHECK. DURING THIS MAINTENANCE PERIOD, BRAATHENS FOUND THE SUBJECT ROD WITH A DENT AND CHAFING. INSPECTION SHOWED THAT CONTACT HAD BEEN MADE DURING NORMAL OPERATION WITH THE VERTICAL STABILIZER STRUCTURE.

THE DENT IS APPROXIMATELY 0.027 INCH DEEP AND IS LOCATED 2.728 INCH FROM THE CENTER OF THE MOUNTING BORE. THE CHAFED AREA IS APPROXIMATELY 1.025 INCH LONG AND 0.120 INCH WIDE, THE DEPTH IS MINOR. PLEASE SEE THE REF (C) FAX (NOTE THAT THE FAX DEPICTS THE ROD WITH THE DENT AND CHAFING ON THE INBOARD SIDE OF THE ROD - IN FACT, THE DENT AND CHAFING ARE LOCATED ON THE OUTBOARD SIDE OF THE ROD).

BRAATHENS PLANS TO LOCALLY BLEND AND POLISH THE DENT AND CHAFING, EDDY CURRENT INSPECT, TREAT WITH ALODINE, AND PRIME WITH BMS 10-11.

1. OUR REVIEW OF THE REF /A/ AND REF /D/ INFORMATION INDICATES THAT IT IS STRUCTURALLY UNACCEPTABLE TO CONTINUE USE OF THE DAMAGED INPUT ROD DUE TO POTENTIAL COMPRISE OF THE DUAL LOAD PATH FUNCTION OF THIS ROD. ACCORDINGLY, WE SUGGEST THAT THE DAMAGED INPUT ROD BE REPLACED.

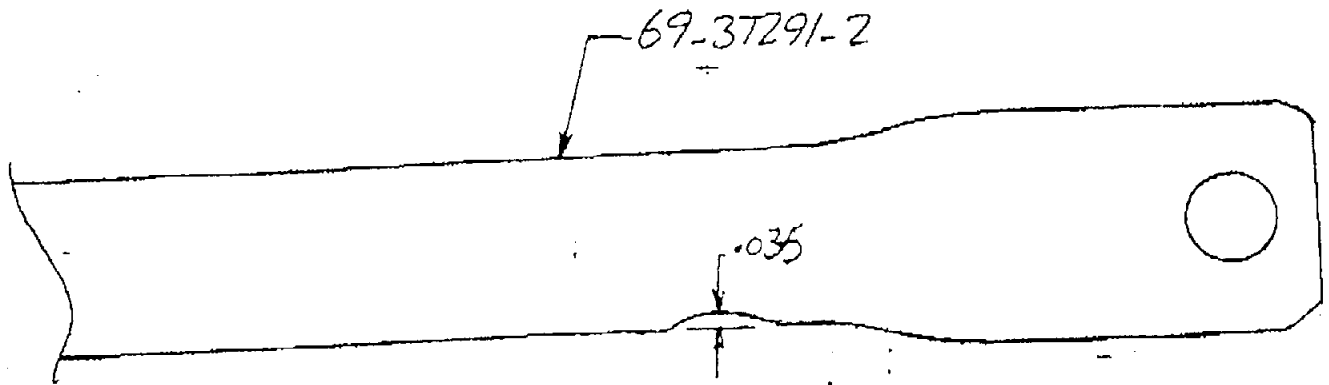
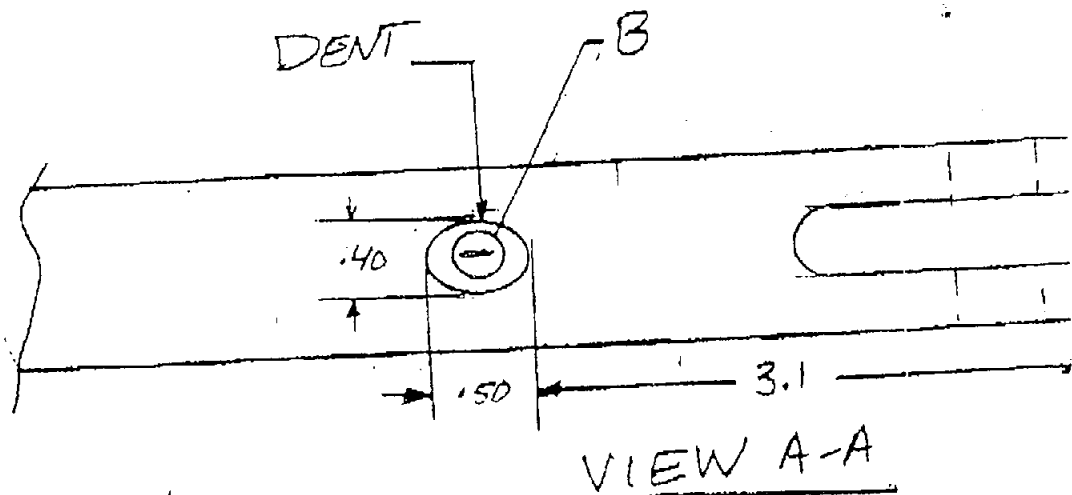
FIG 1  
TOP VIEW

THE OUTER ROD P/N 69-37291-2 WAS DENTED  
WHEN THE RUDDER ACTUATOR WAS ACCIDENTALLY OPERATED  
WHILE THE RUDDER WAS REMOVED FOR BALANCING.  
THE ROD WAS FORCED AGAINST AN ADJACENT STRUCTURE  
WHICH CAUSED A SMALL DENT AND A CRACK (Ref FIG 1)

IN THE REF /A/ FAX PEMCO REPORTED THE THAT OUTER RUDDER PCU INPUT ROD P/N 69-37291-2 BECAME DENTED WHEN THE RUDDER PCU WAS INADVERTENTLY OPERATED WHILE THE RUDDER WAS REMOVED FOR BALANCING. THE ROD WAS FORCED AGAINST AN ADJACENT STRUCTURE WHICH CAUSED A SMALL DENT. PEMCO ASKED WHETHER THE DAMAGED AREA IS REPAIRABLE OR THE ROD MUST BE REPLACED.

THE ROD IS STRUCTURALLY ACCEPTABLE IF REPAIRED PER THE FOLLOWING INSTRUCTIONS.

1/ BLEND-OUT THE DAMAGED AREA. THE MAXIMUM ALLOWABLE DEPTH OF MATERIAL REMOVAL IS 0.018 INCHES. MINIMUM RADIUS OF BLEND-OUT IS 0.25 INCHES.

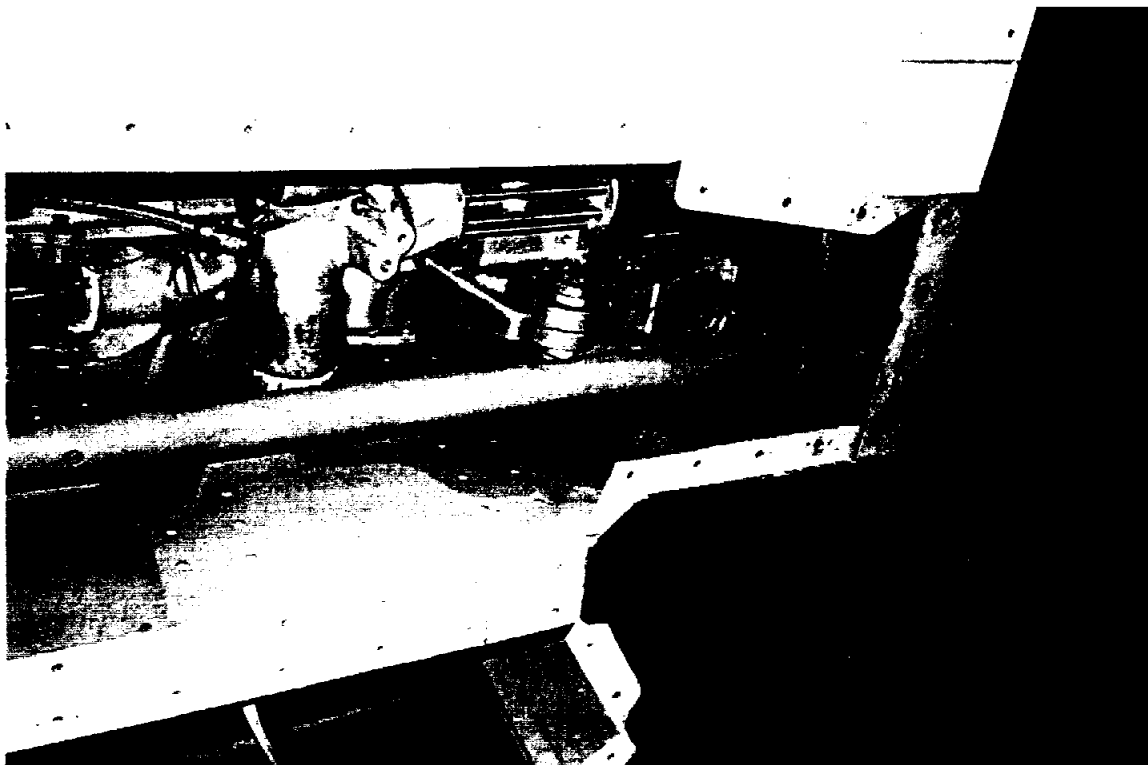
DELTA (DAL) REPORT (DAL-ATL-95-0114TR)

DURING THE PRESENT HMV OF THE DATA AIRPLANE, A DAMAGED INPUT ROD TO THE RUDDER PCU WAS DISCOVERED. DAMAGE HAS OCCURRED AT THE AFT END OF THE ROD WHERE THE ROD HAS BEEN STIKING THE LEFT AFT VERTICAL FRAME STRUCTURE OF THE STABILIZER. UPON NOTIFICATION, PICTURES WERE TAKE WITH ALL COMPONENTS IN PLACE. THE PICTURES HAVE BEEN SENT BY AIRBORNE EXPRESS AIRBILL 8770295332. THIS OFFICE HAS ASKED FOR THE INPUT ROD AND THAT THE RUDDER PCU BE MADE AVAILABLE IF BOEING REQUESTS. THE REF /B/ SKETCH SHOWS DAMAGE LOCATION. THE DENT IN THE INPUT ROD IS APPROXIMATELY 1/4 INCH DEEP AND IS SCRAPED REARWARD ABOUT 1 INCH. THERE IS A MINOR INDICATION OF SCRAPING ON THE VERTICAL RUDDER STRUCTURAL ELEMENT.
