NATIONAL TRANSPORTATION SAFETY BOARD
Vehicle Recorder Division
Washington, D.C. 20594

ADDENDUM – Sound Spectrum Study

Specialist's Factual Report By Sean Payne

Location: Zaleski, Ohio
Date: January 29, 2019
Helicopter: Bell 407
Registration: N191SF
Operator: Viking Aviation, LLC.
NTSB Number: CEN19FA072

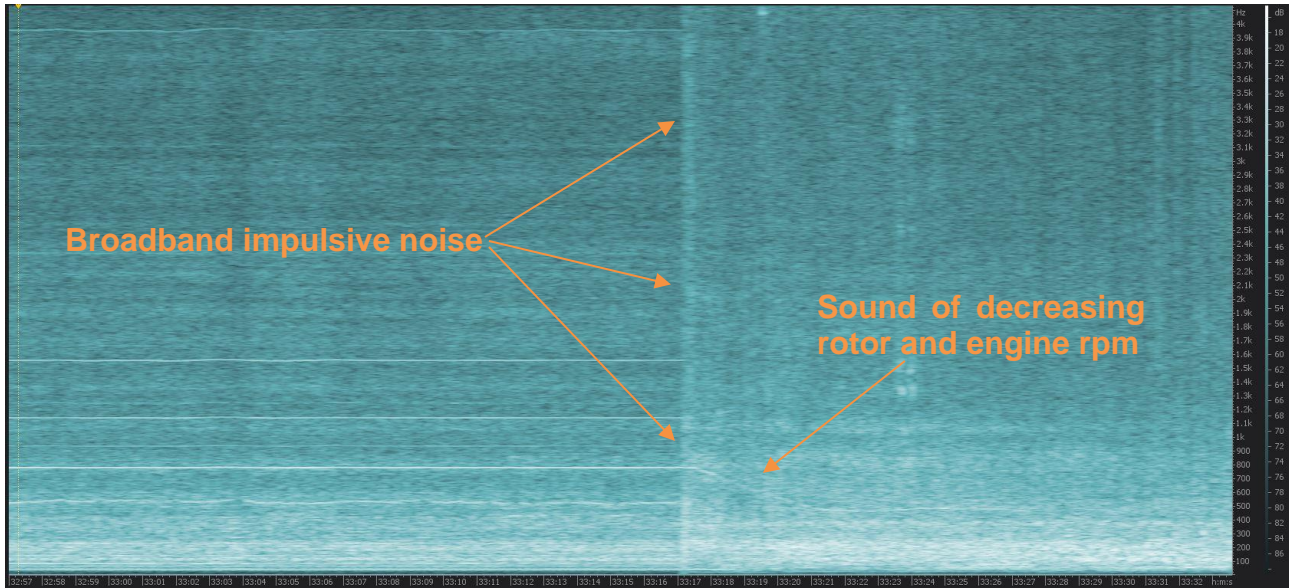
Referencing the CVR transcript for CEN09MA117, at 14:09:41.8 the transcript¹ describes: [sound of loud bang and air noise]. One tenth of second later at 14:09:41.9, the transcript describes: [sound of decreasing rotor and engine rpm].

Figure 1. The spectrograph of the audio recording from CEN09MA117 at the time of “[sound of bang and loud air noise].”

The spectrograph in figure 1 shows an impulsive broadband signal throughout the plotted frequency range that appears at the time of “[sound of bang and loud air noise.]”
