**NATIONAL TRANSPORTATION SAFETY BOARD
Office of Aviation Safety
Washington, D.C. 20594**

Airworthiness Group Chairman's Factual Report

NTSB ID No.: LAX08PA259

Location: Weaverville, California
Date: August 05, 2008
Time: About 7:41 PM Pacific Daylight Time (PDT)
Aircraft: Sikorsky S-61N Helicopter

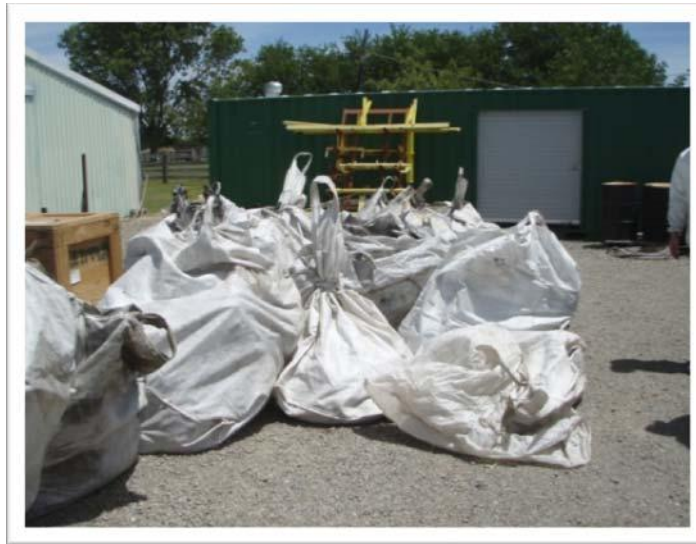
The helicopter contains two independent airframe fuel filters (one for each engine), which are secured to the lower fuselage fuel controls in the compartment immediately aft of the forward fuel tank. Both airframe fuel filters were located within storage bags containing the helicopter wreckage (Figure 1). Because both filter assemblies were thermally damaged, the Airworthiness group could not accurately determine their respective tank. For the purpose of this report, one filter was identified as filter "A" and the other filter was identified as filter "B".

Figure 1 Storage bags containing some of the helicopter wreckage

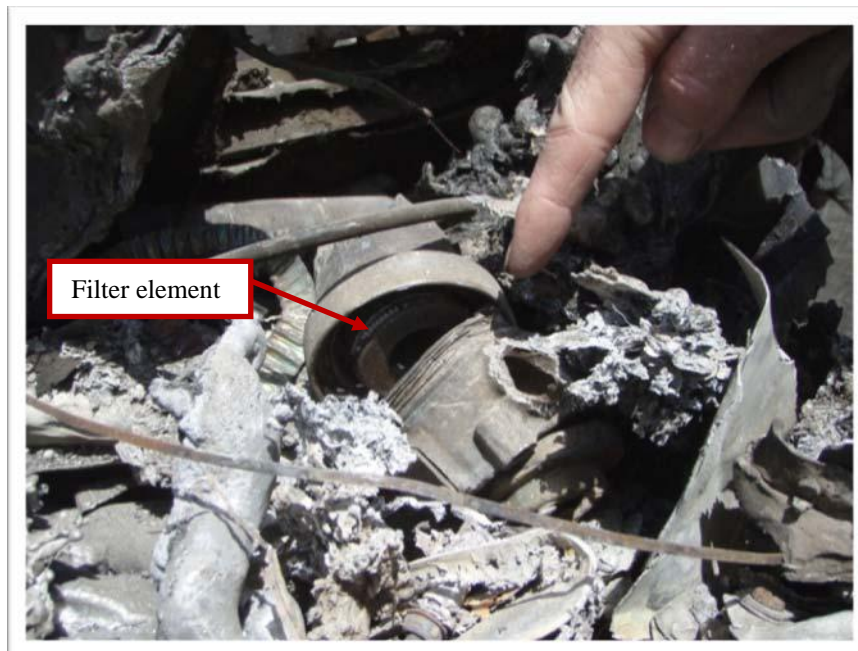
The filter assembly identified as filter “A” was found resting on top and within a storage bag containing a portion of the helicopter wreckage (Figure 2). As found, a visual examination of the filter assembly revealed that its filter housing sustained thermal and structural damage to the extent that its respective filter element was exposed. The filter assembly was removed from the bag and its filter element was removed. Visual inspection of the filter element revealed that it had a metal mesh screen indicating that the filter was rated at 40 microns (Figure 3).

Figure 2 View of the fuel filter assembly identified as filter “A” as found within the storage bag.

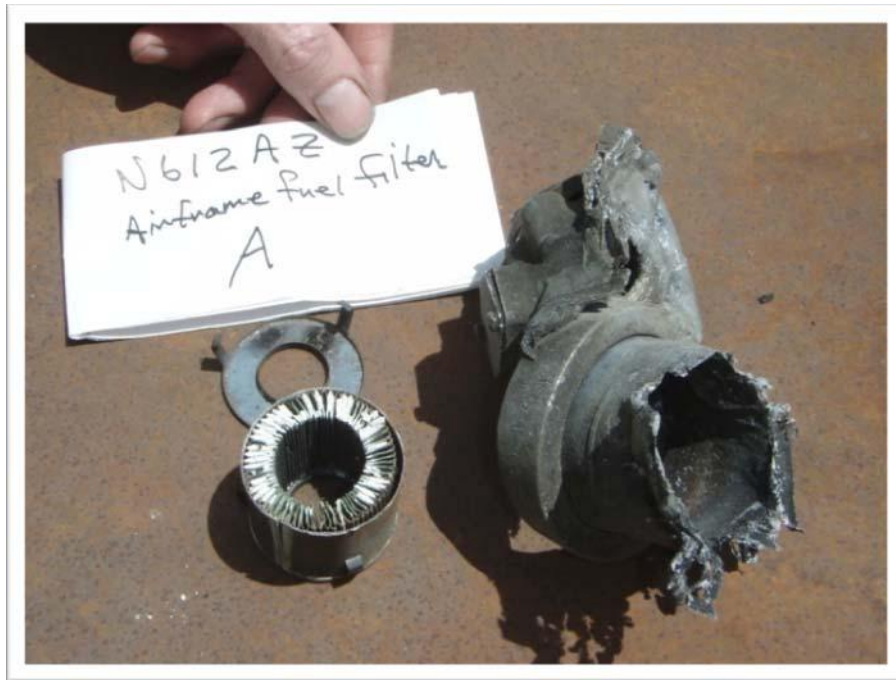
Figure 3 View of the fuel filter assembly identified as filter “A” showing the filter element removed from the filter housing

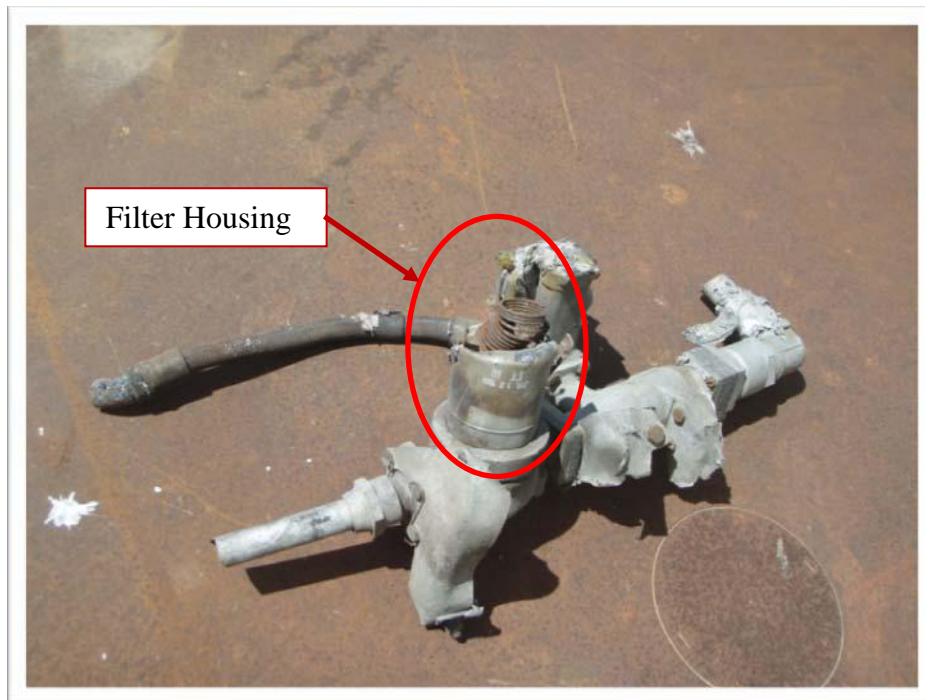
The filter assembly identified as filter “B” was found within the debris and wreckage contained within a storage bag separate from the bag that contained filter “A” (Figure 4). Visual examination of the filter assembly revealed that its filter housing sustained thermal and structural damage to the extent that its respective filter element was exposed (Figure 5). The filter element was removed and placed next to an exemplar 40 micron fuel filter for comparison. Visual inspection of the filter element revealed that it had a metal mesh screen indicating that the filter was rated at 40 microns (Figure 6 and Figure 7).

Figure 4 View of the fuel filter assembly identified as filter “B” as found within the wreckage.

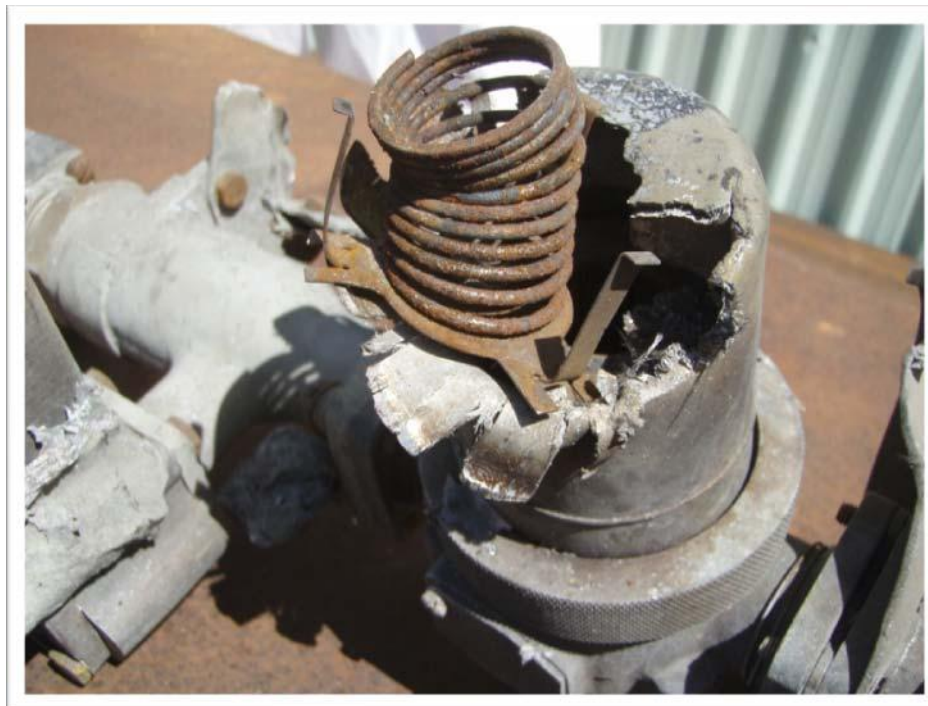
Figure 5 View of filter assembly “B” showing the fracture surface and thermal damage to the filter housing

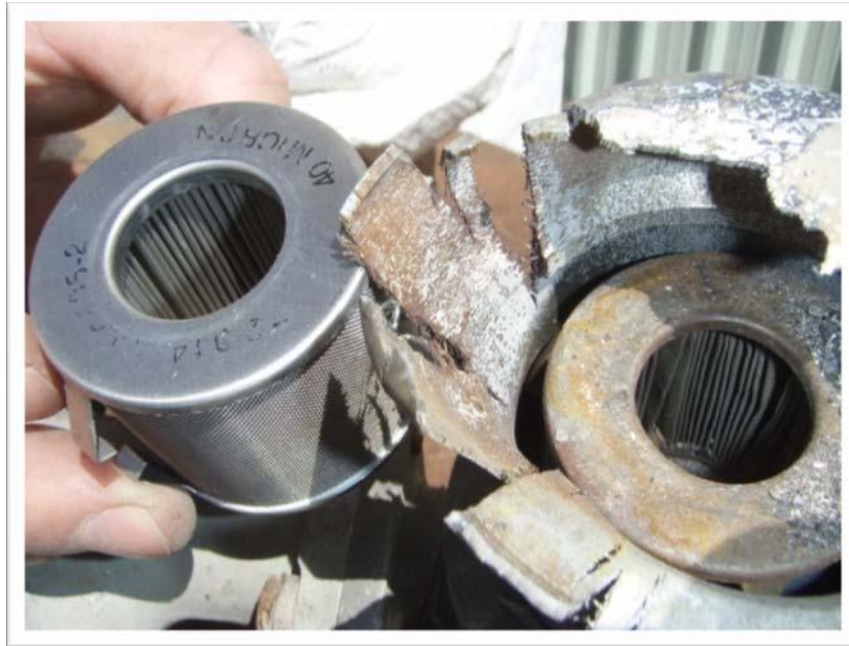
Figure 6 View of filter assembly “B” showing a comparison of the accident filter assembly to a new 40 micron filter element.

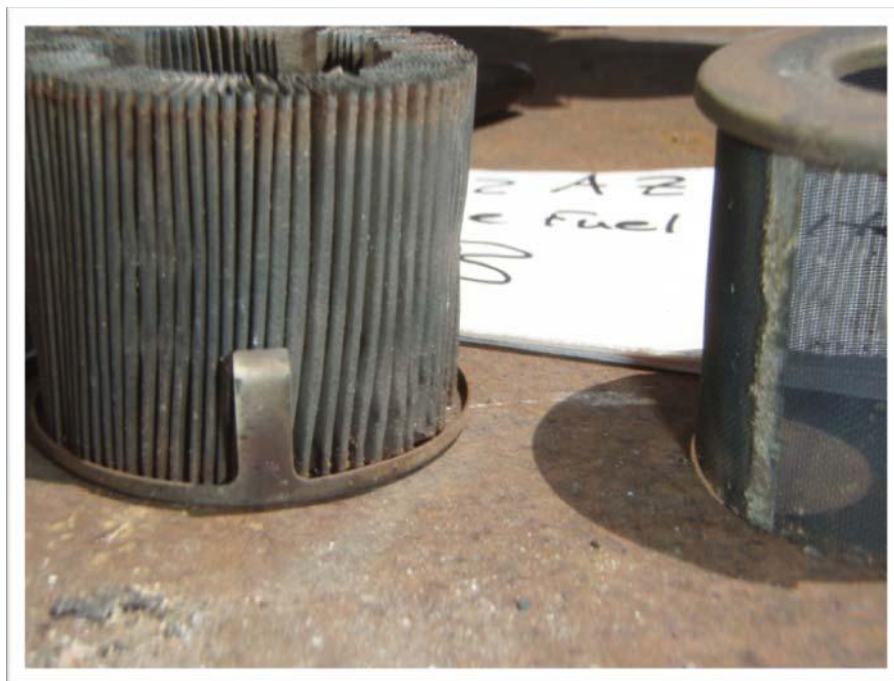
Figure 7 Close up view of the filter element “B” after being removed from the filter housing
