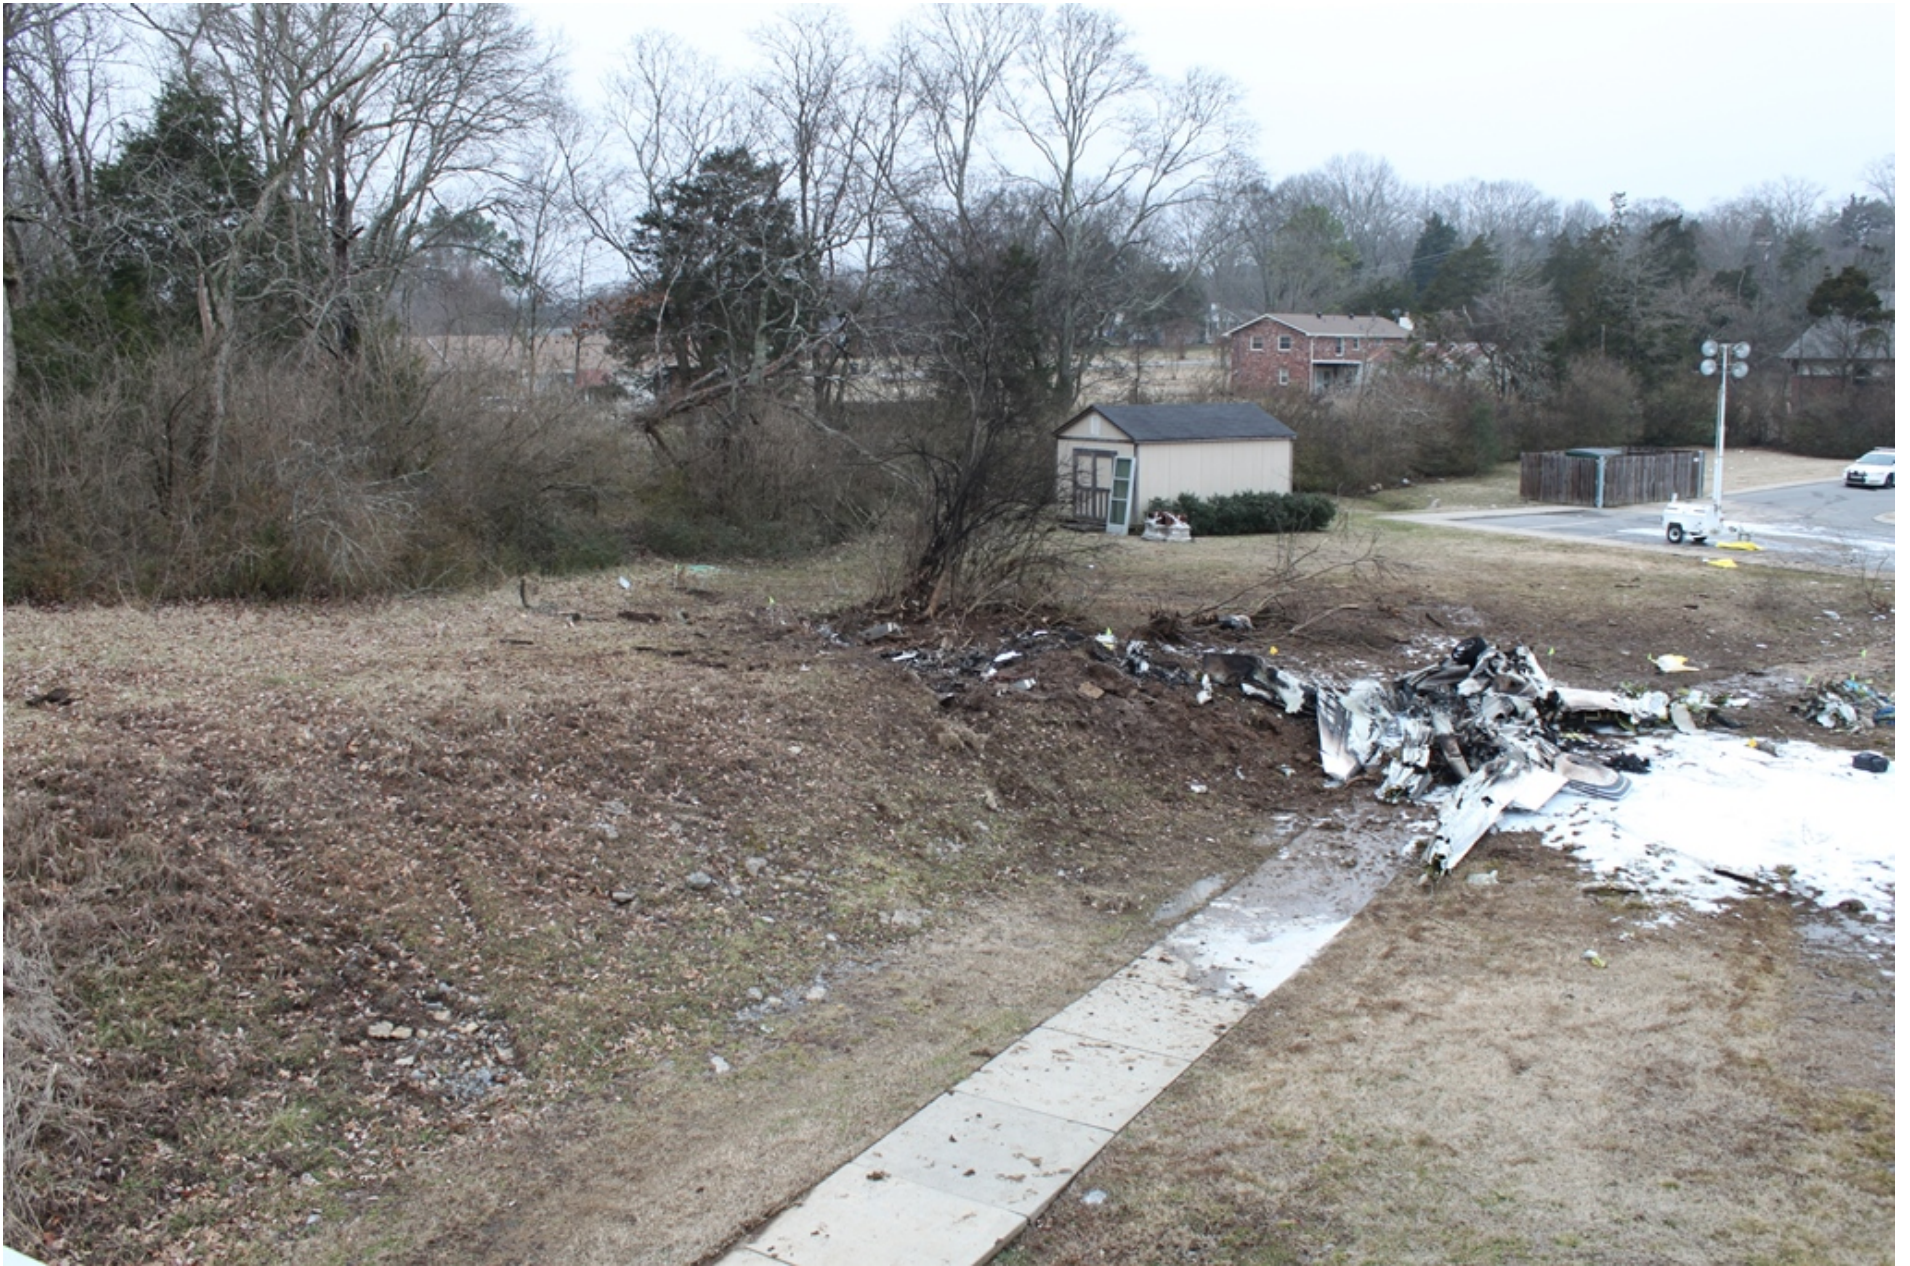
Photo 1 – View of main wreckage from rooftop of adjacent building

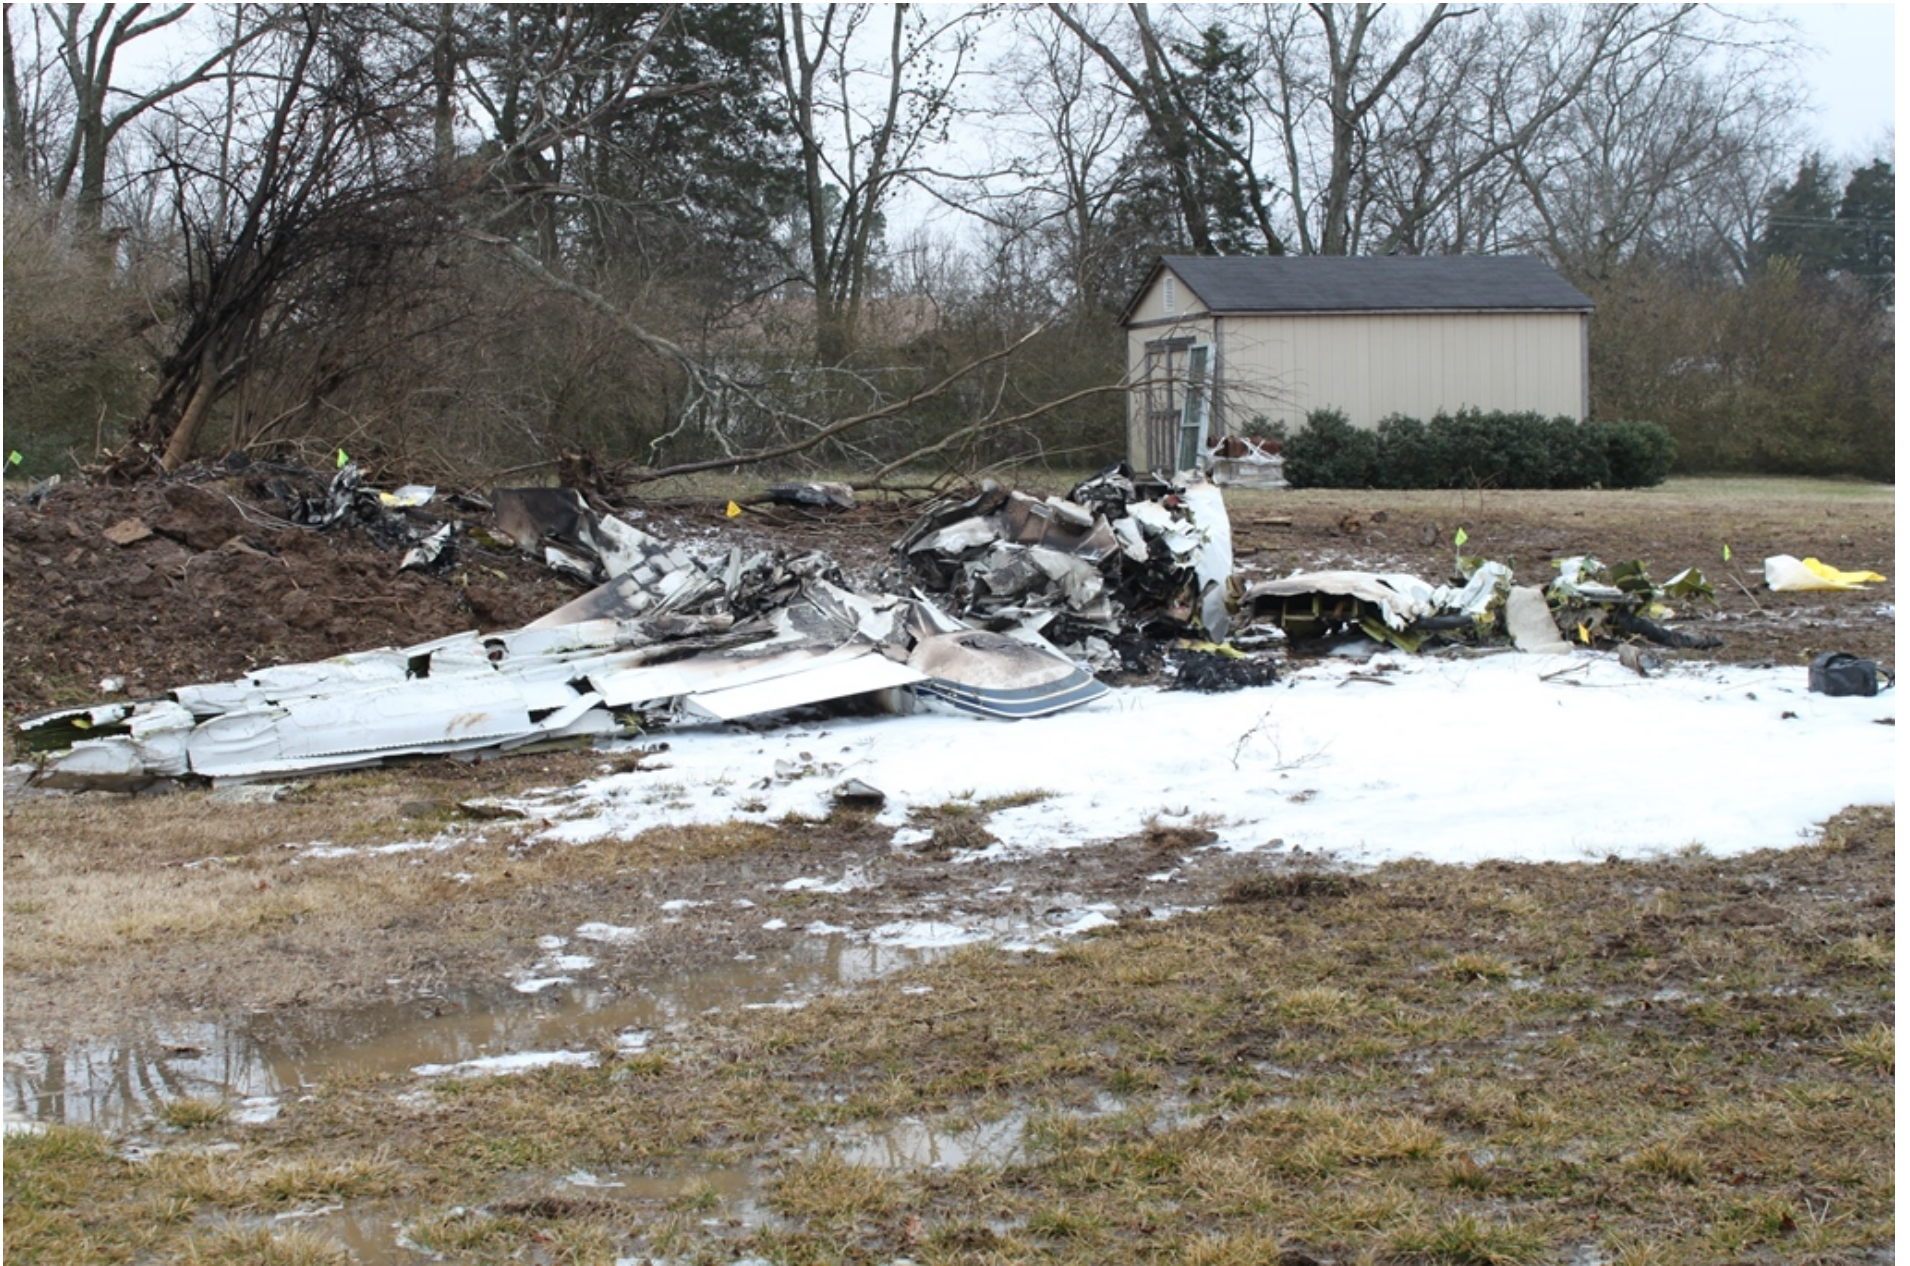
Photo 2 – View of main wreckage 1

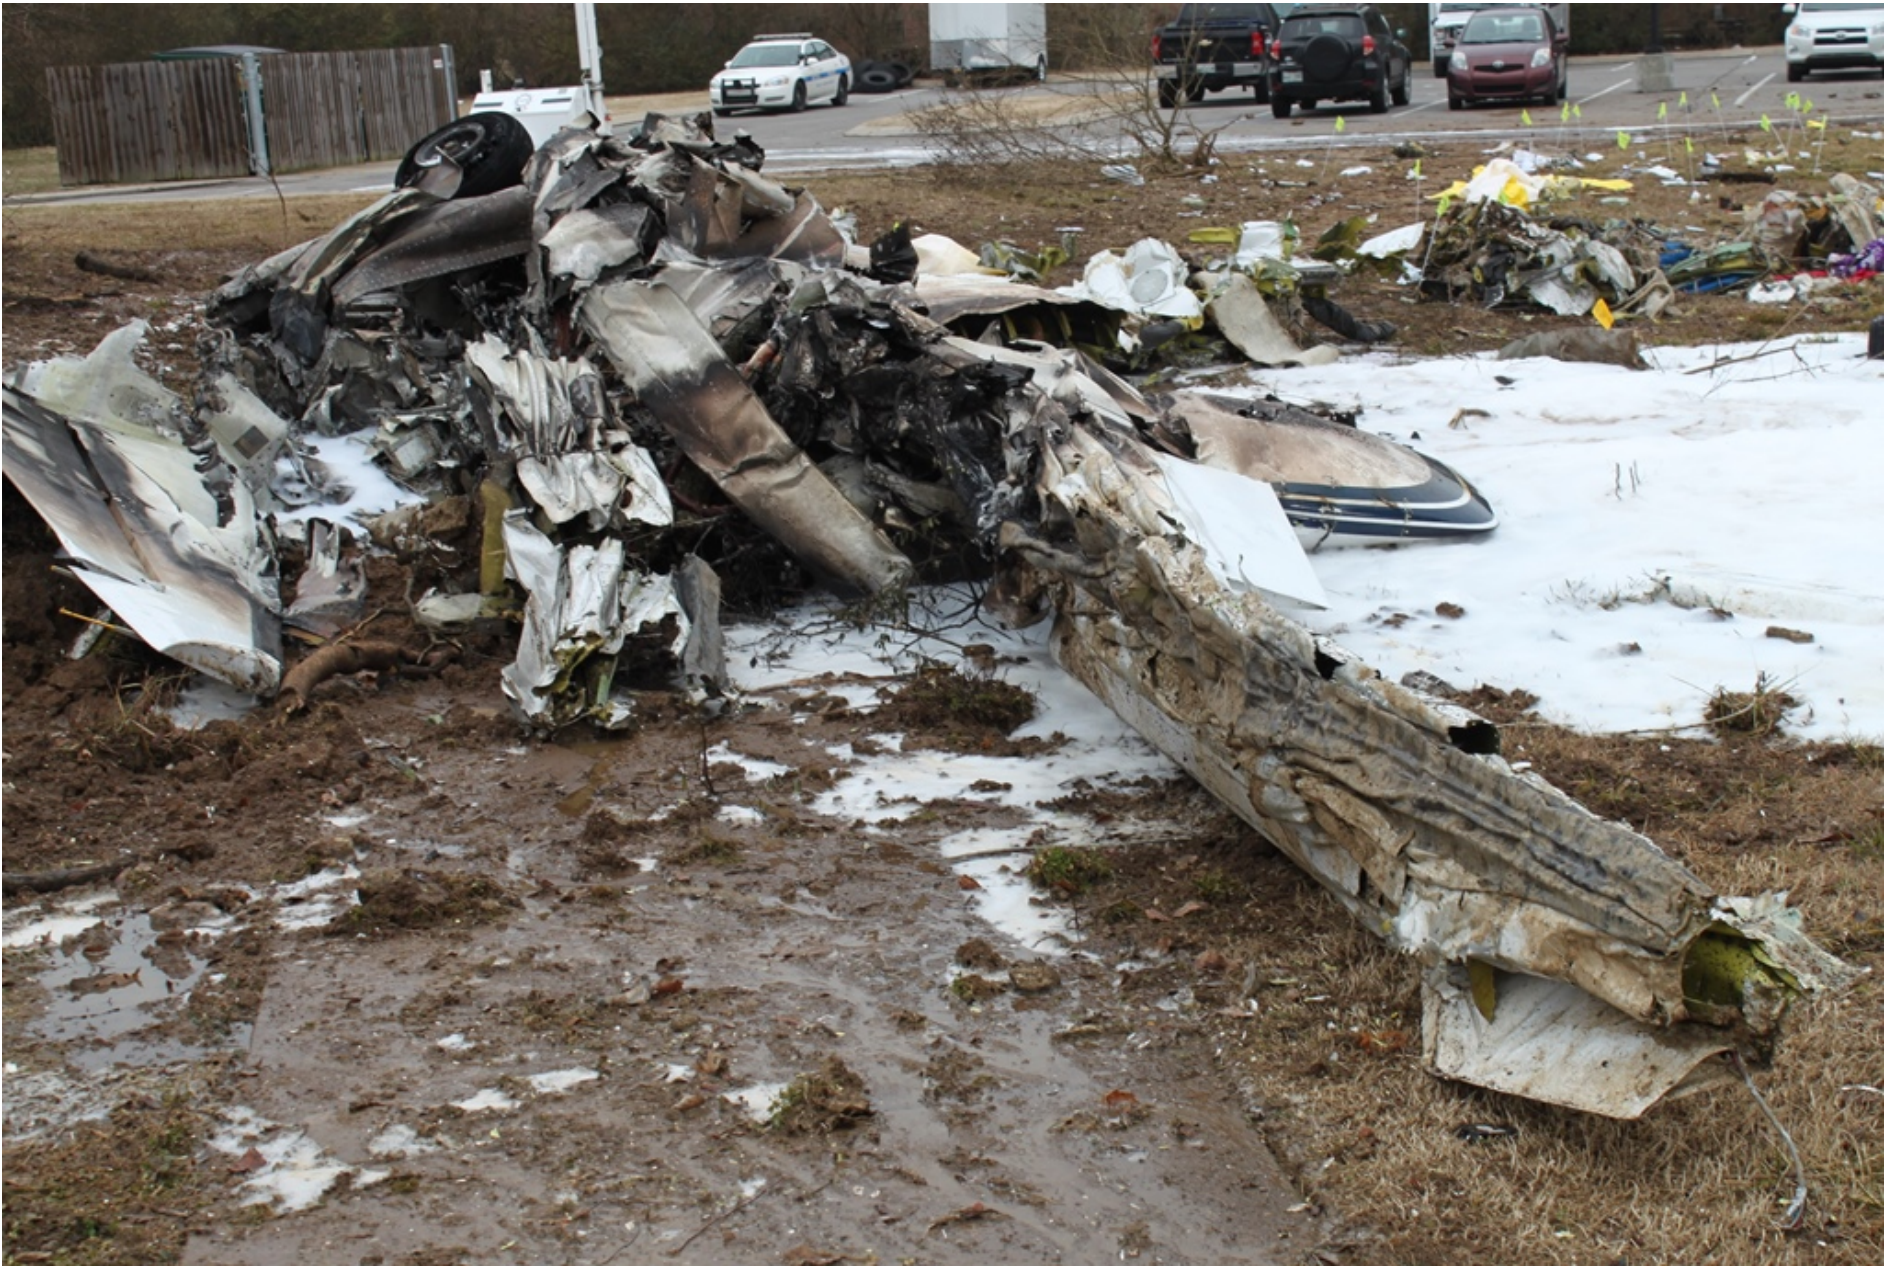
Photo 3 – View of main wreckage 2

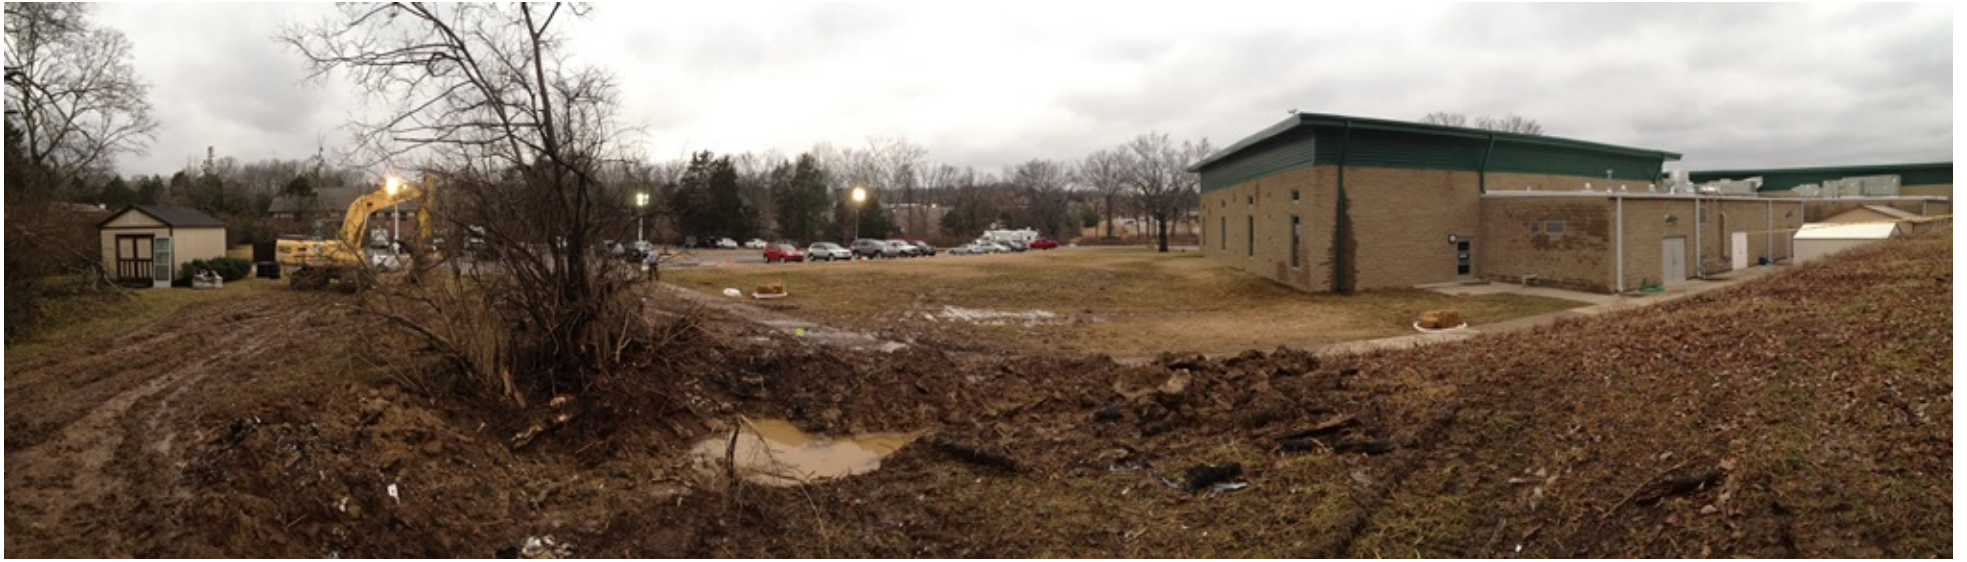
Photo 4 – Panoramic view of accident site from main impact crater after wreckage recovery (Honeywell Photograph)

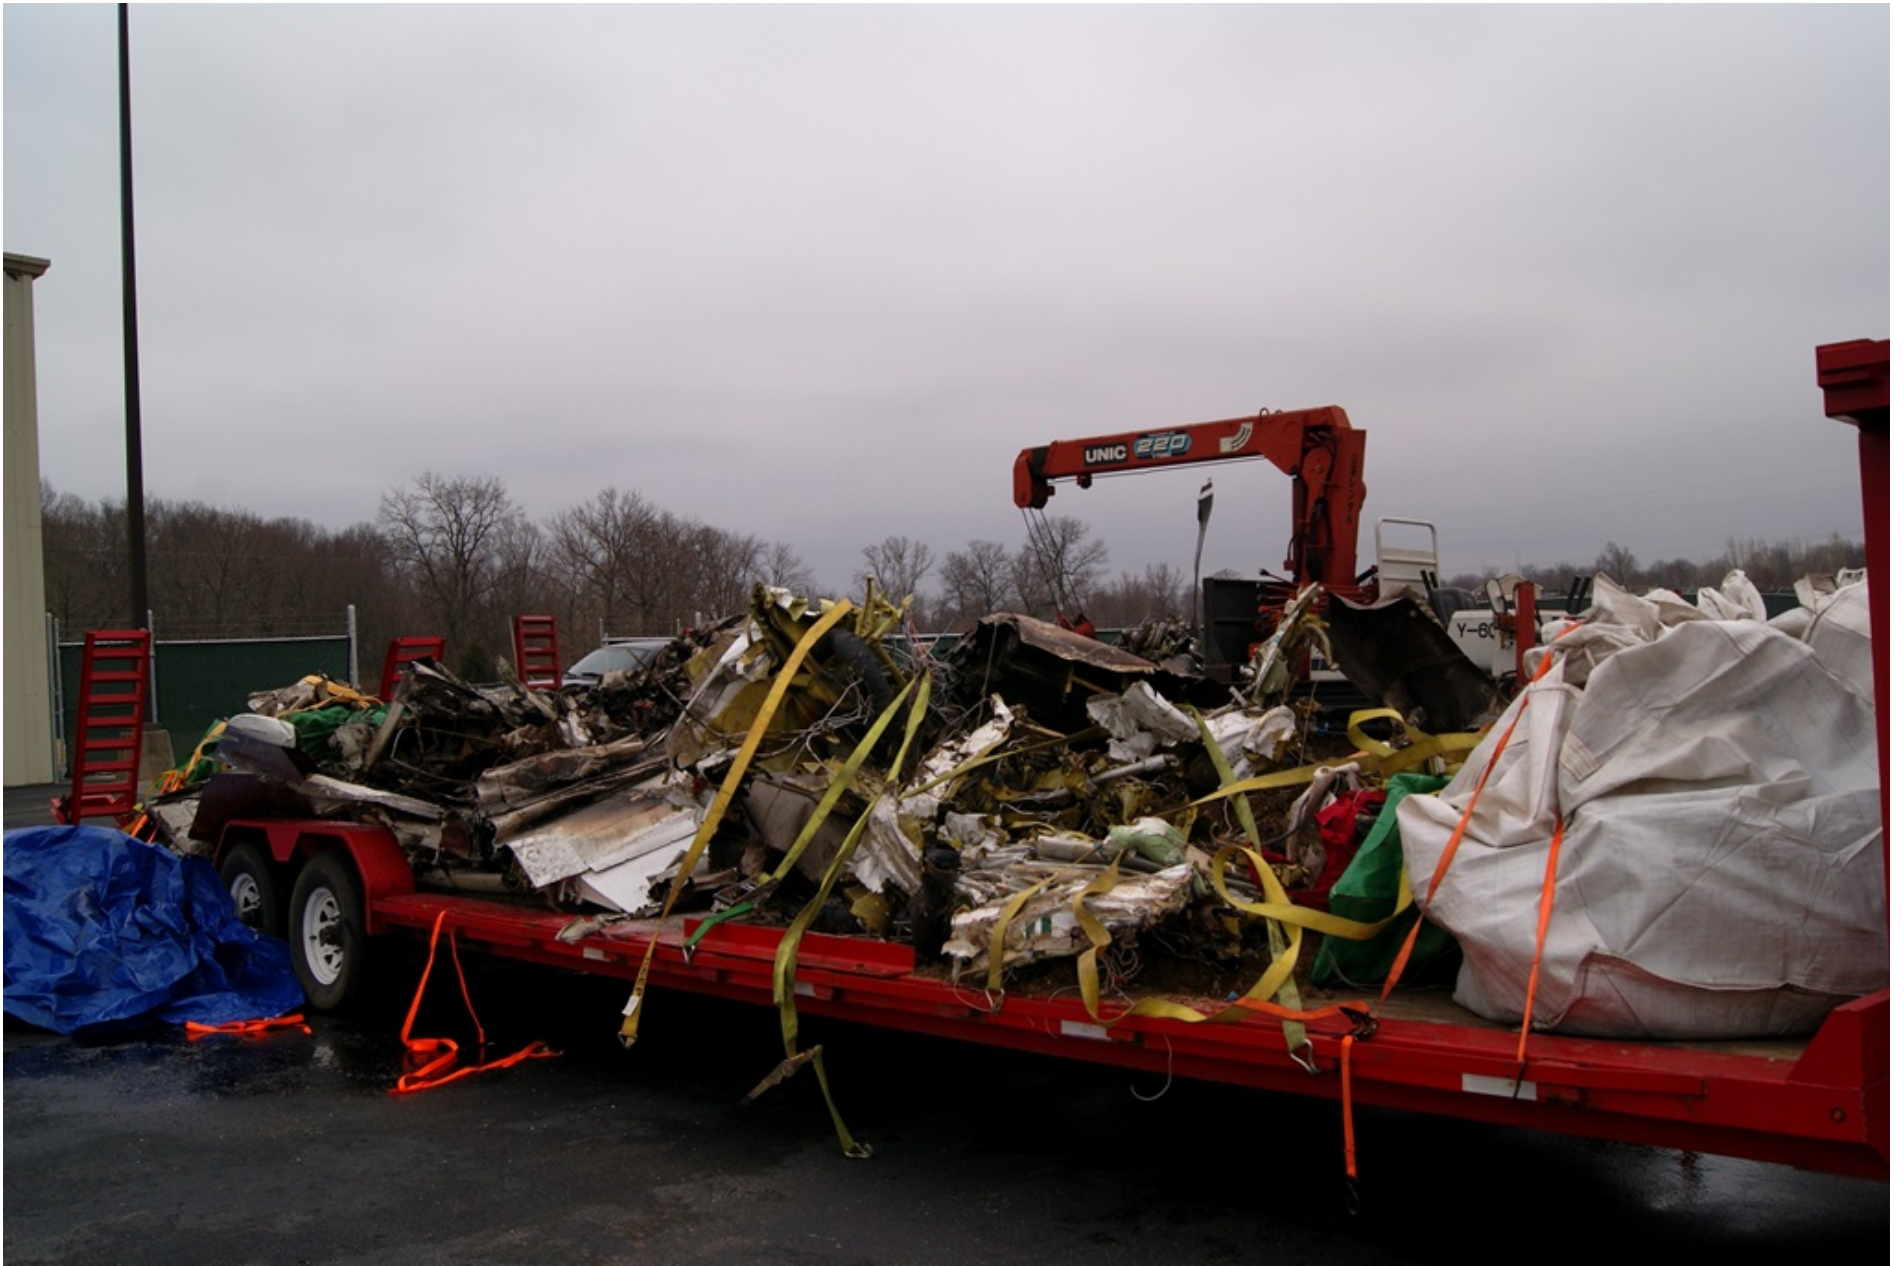
Photo 5 – View of recovered wreckage on trailer 1

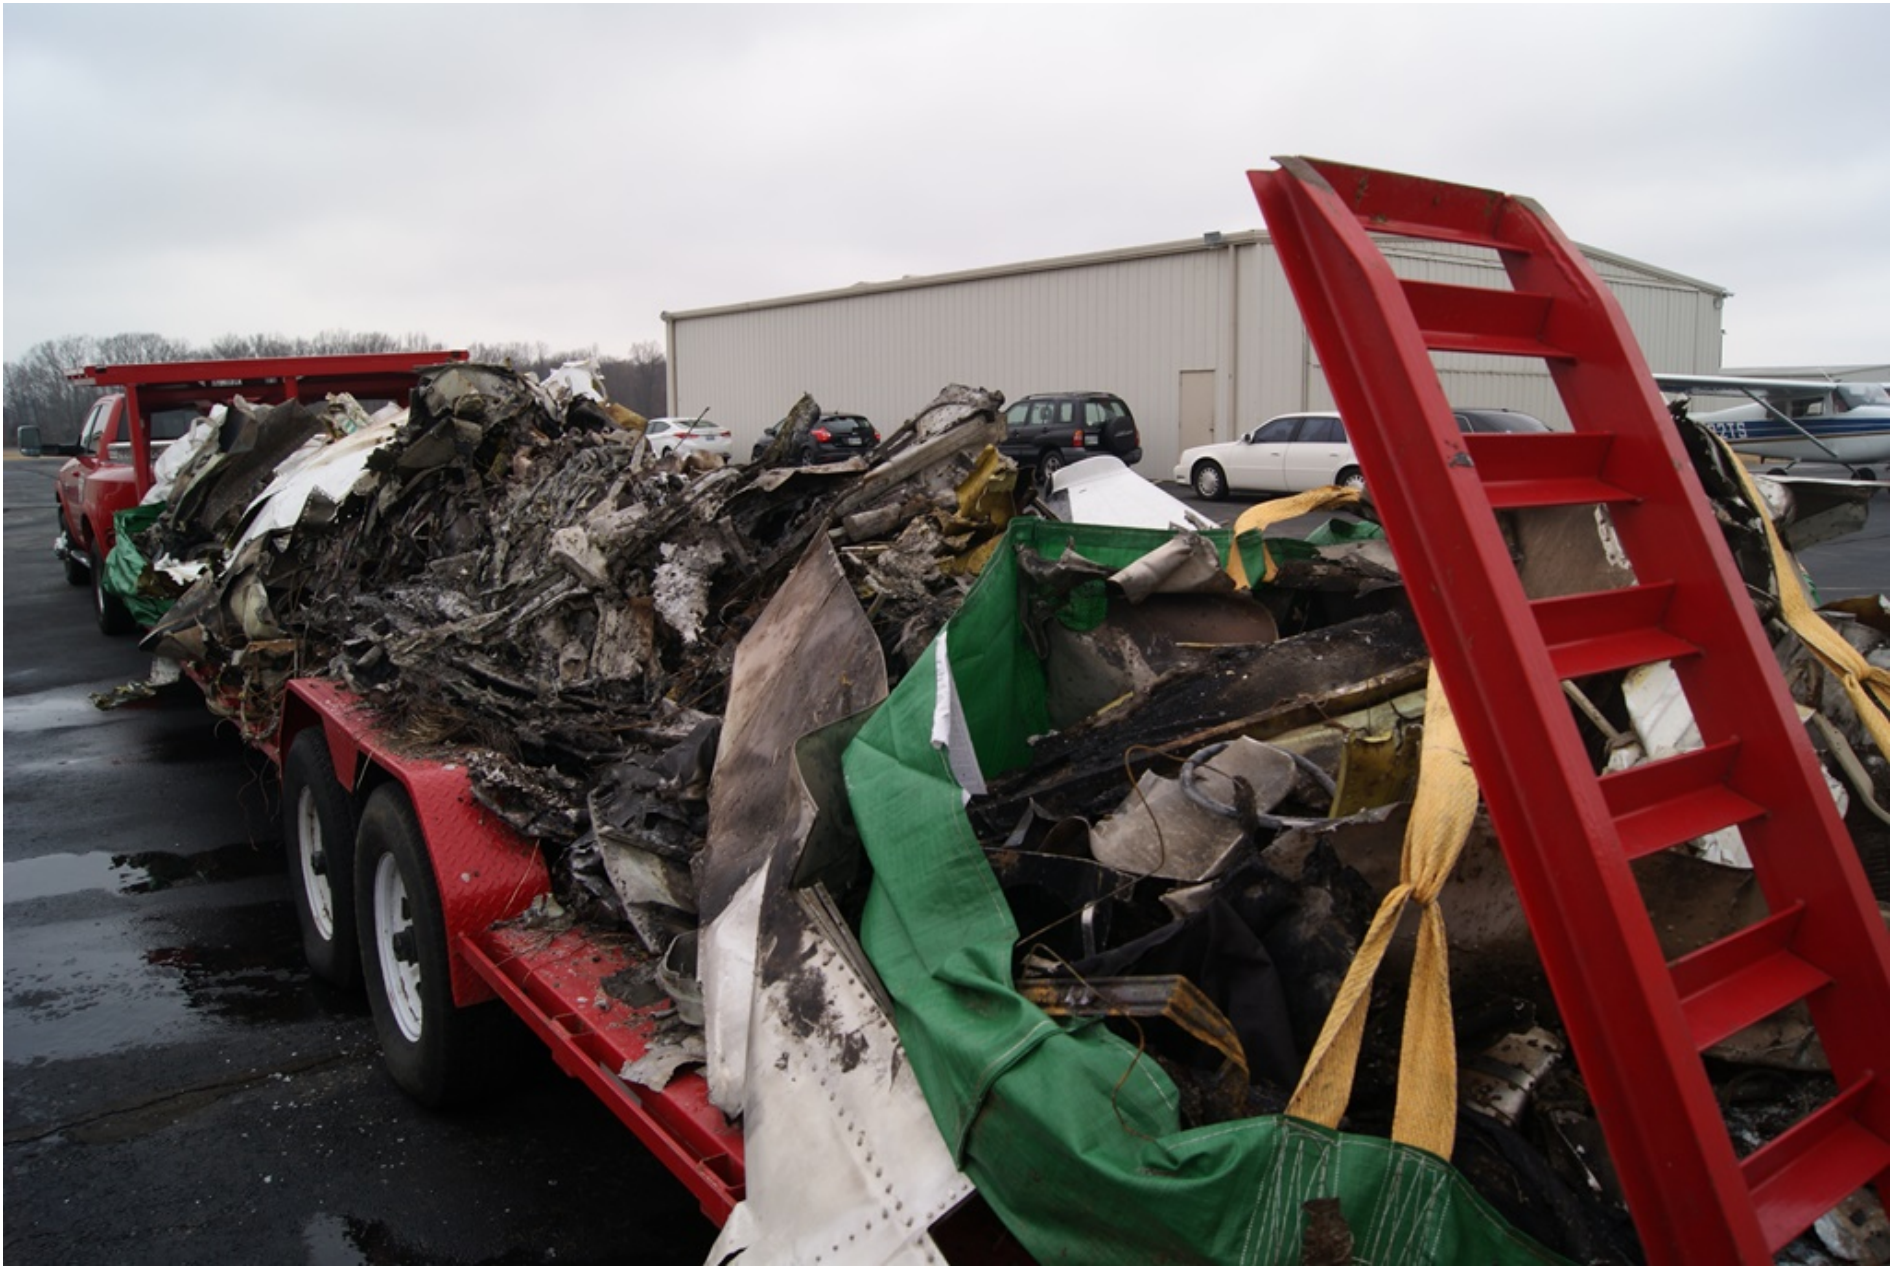
Photo 6 – View of recovered wreckage on trailer 2

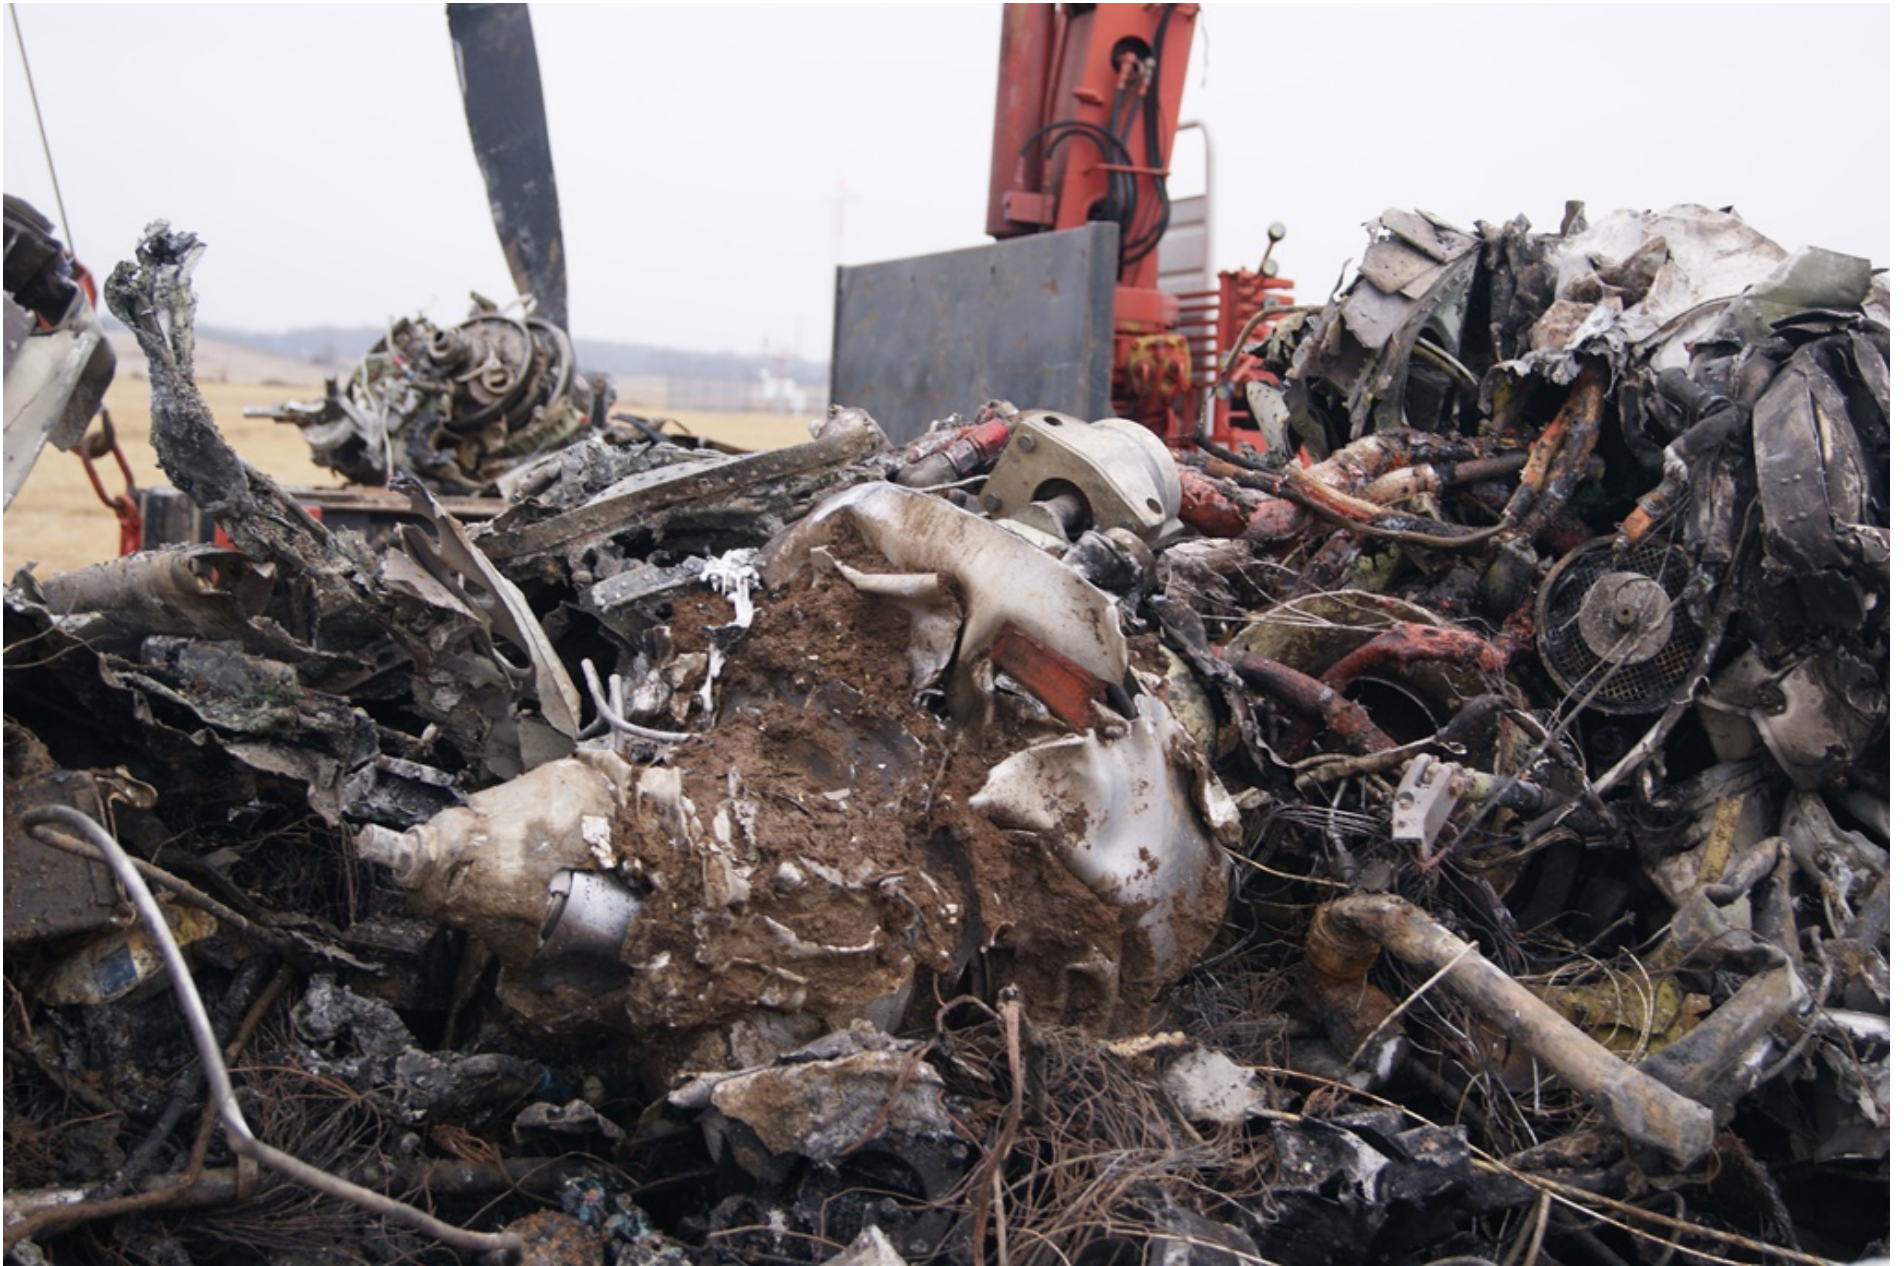
Photo 7 – View of left engine after recovery from the accident site

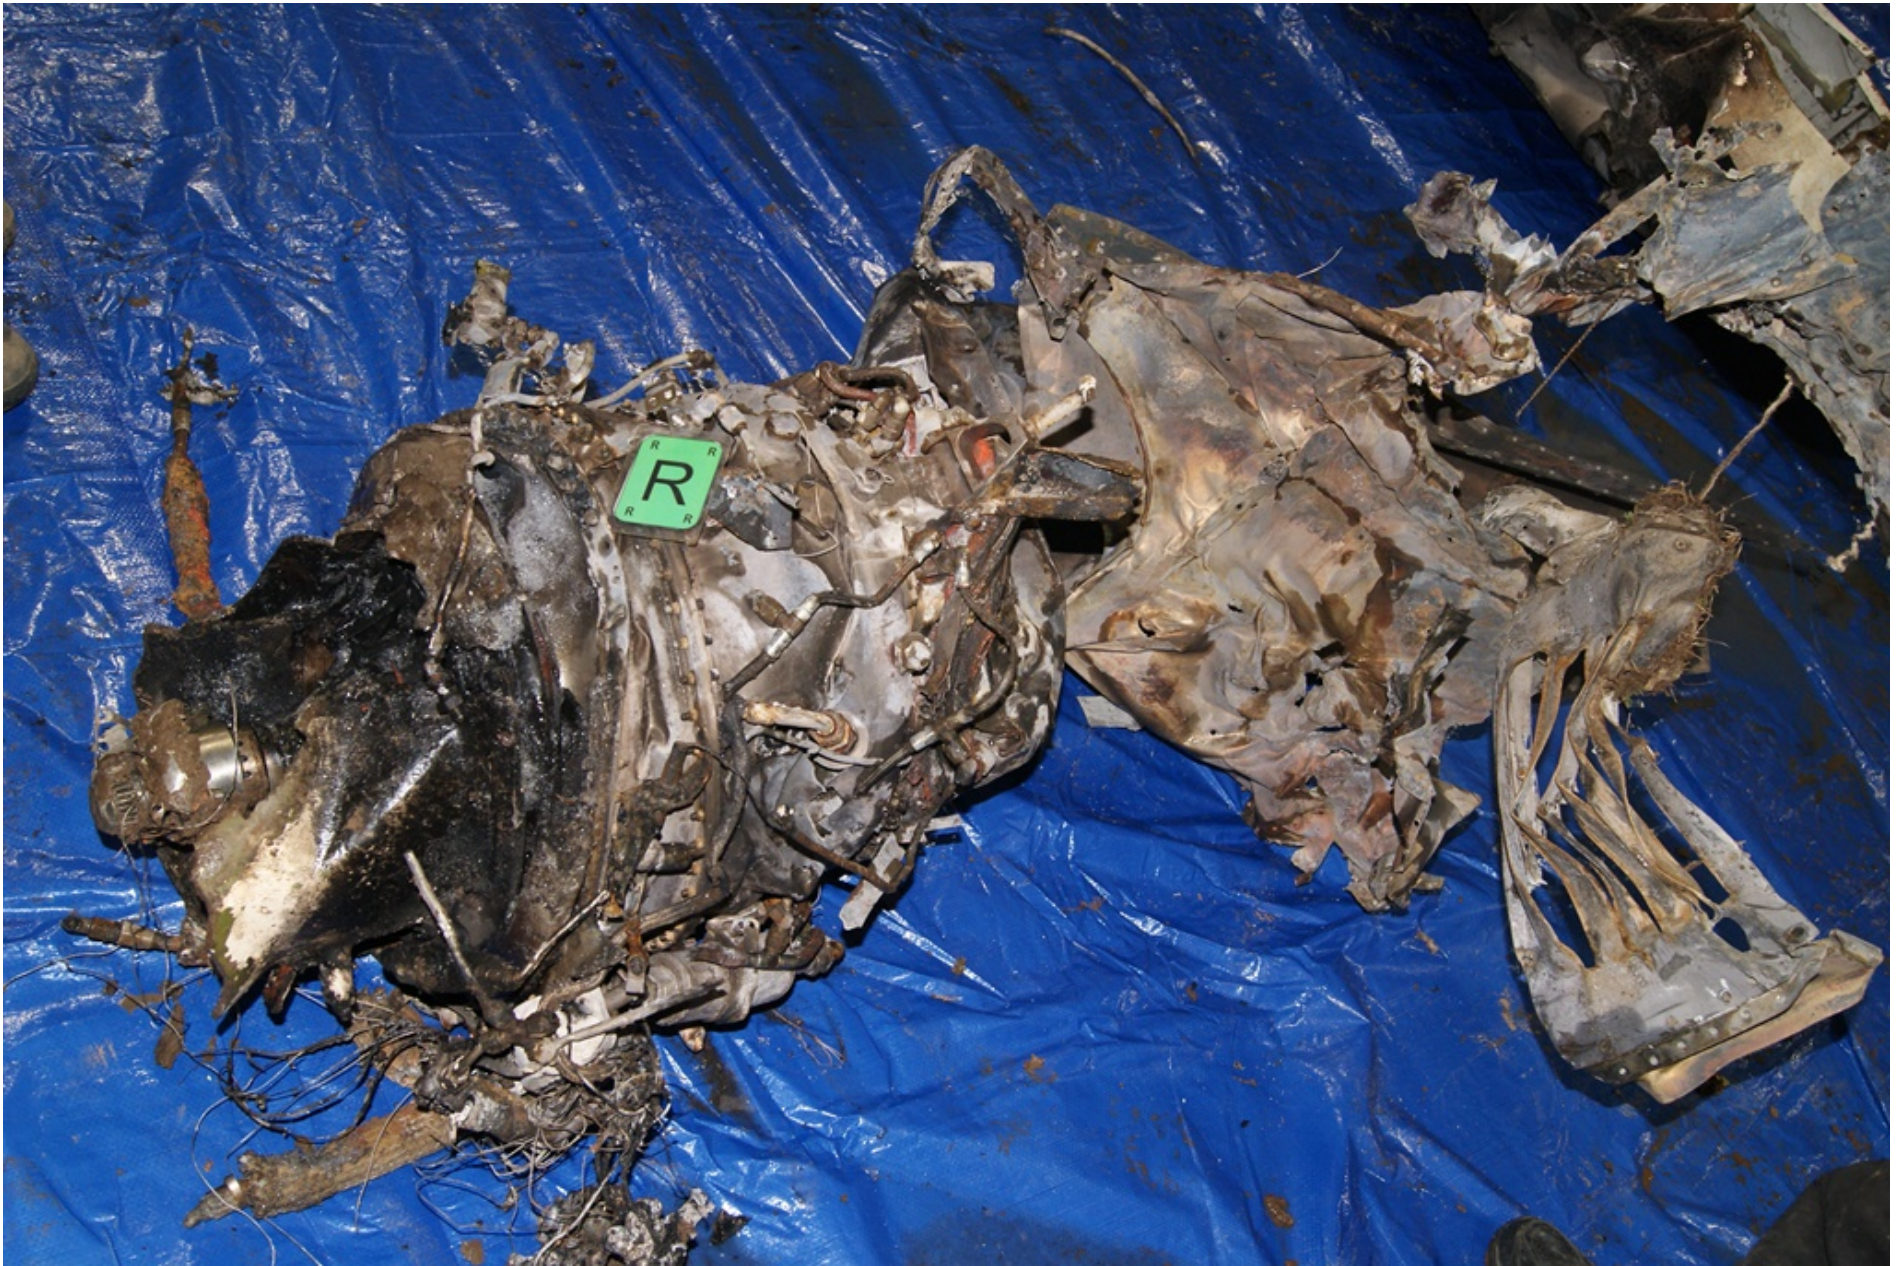
Photo 8 – View of right engine after recovery from accident site

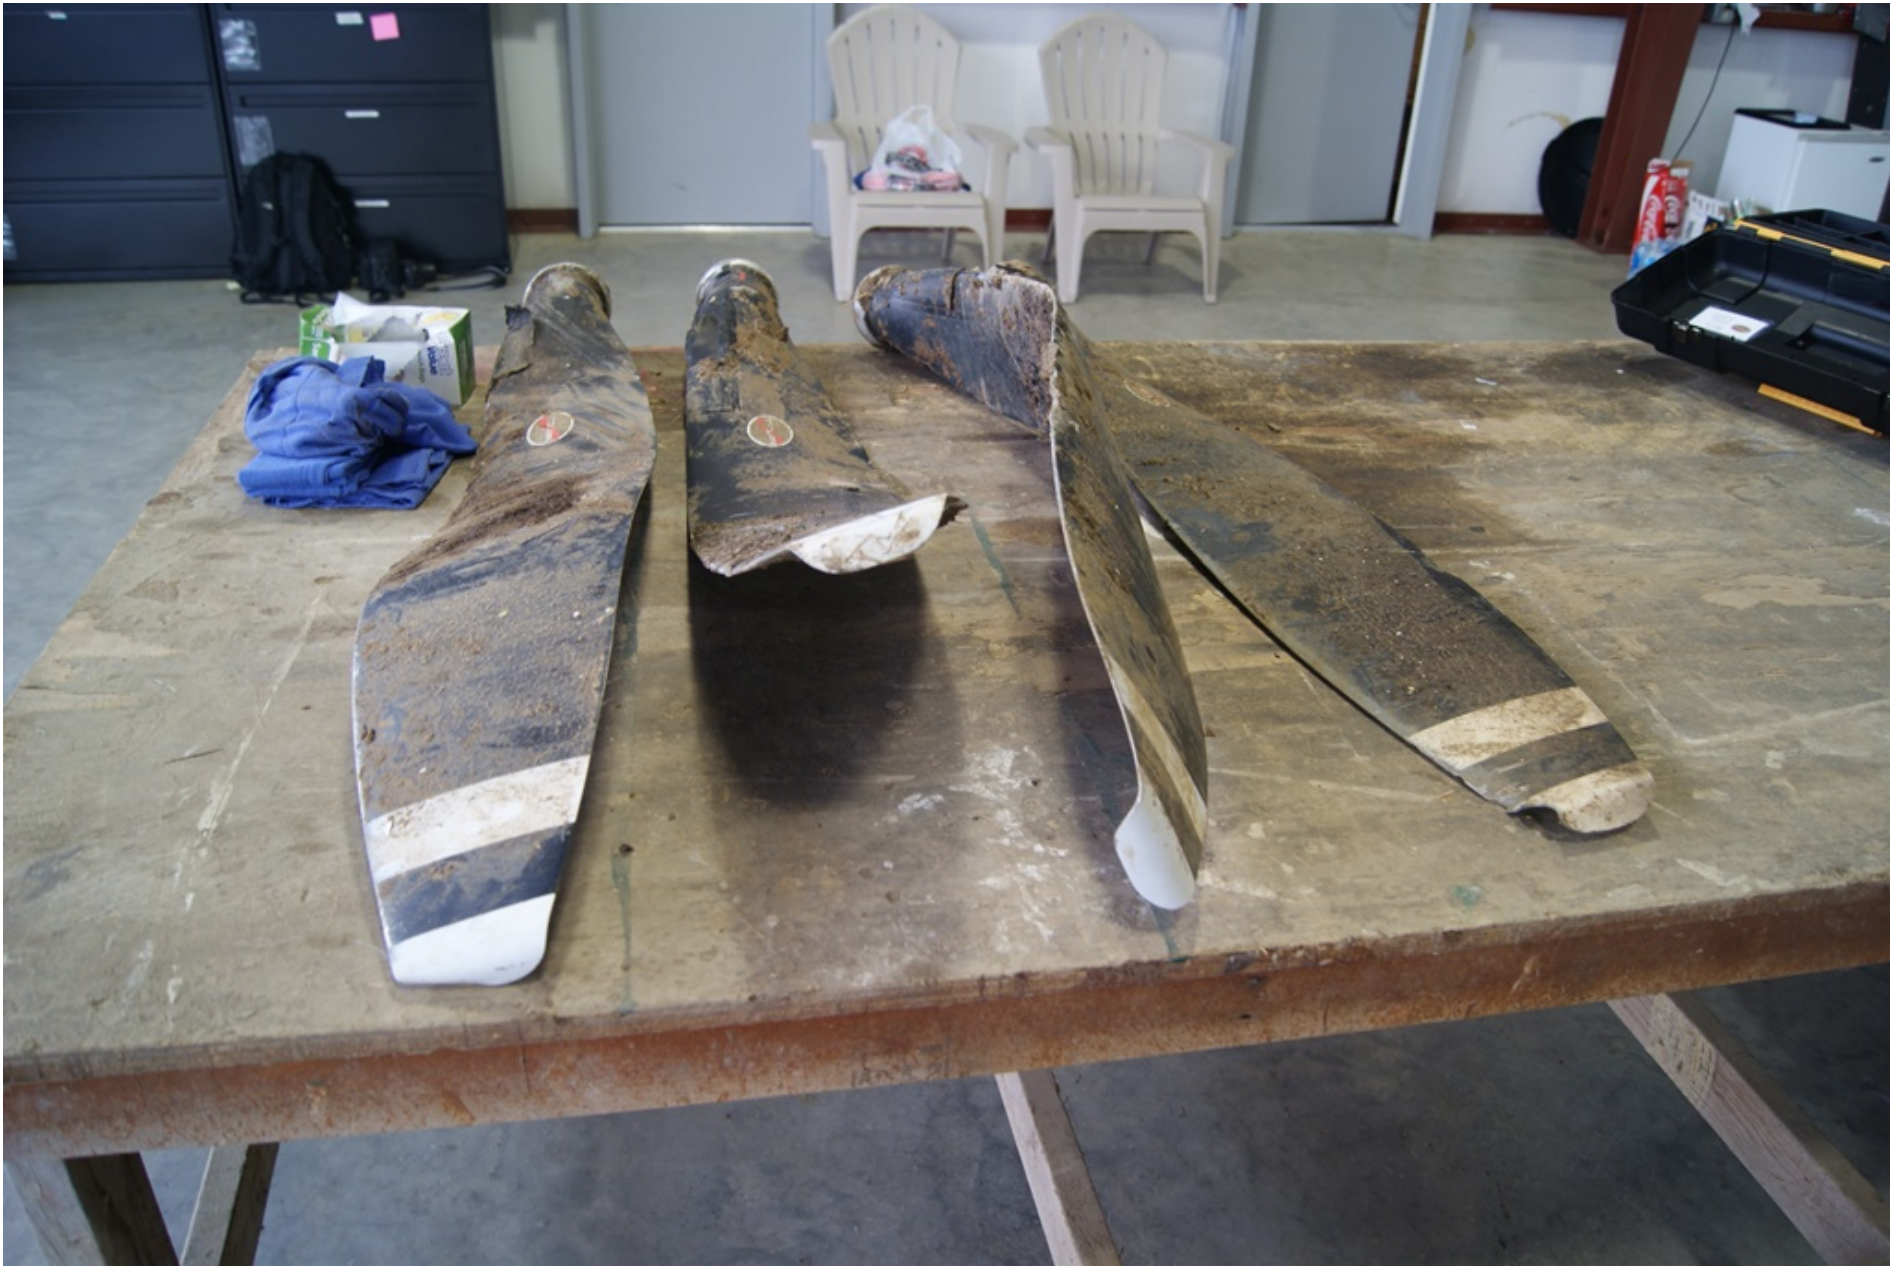
Photo 9 – Left engine propeller blades

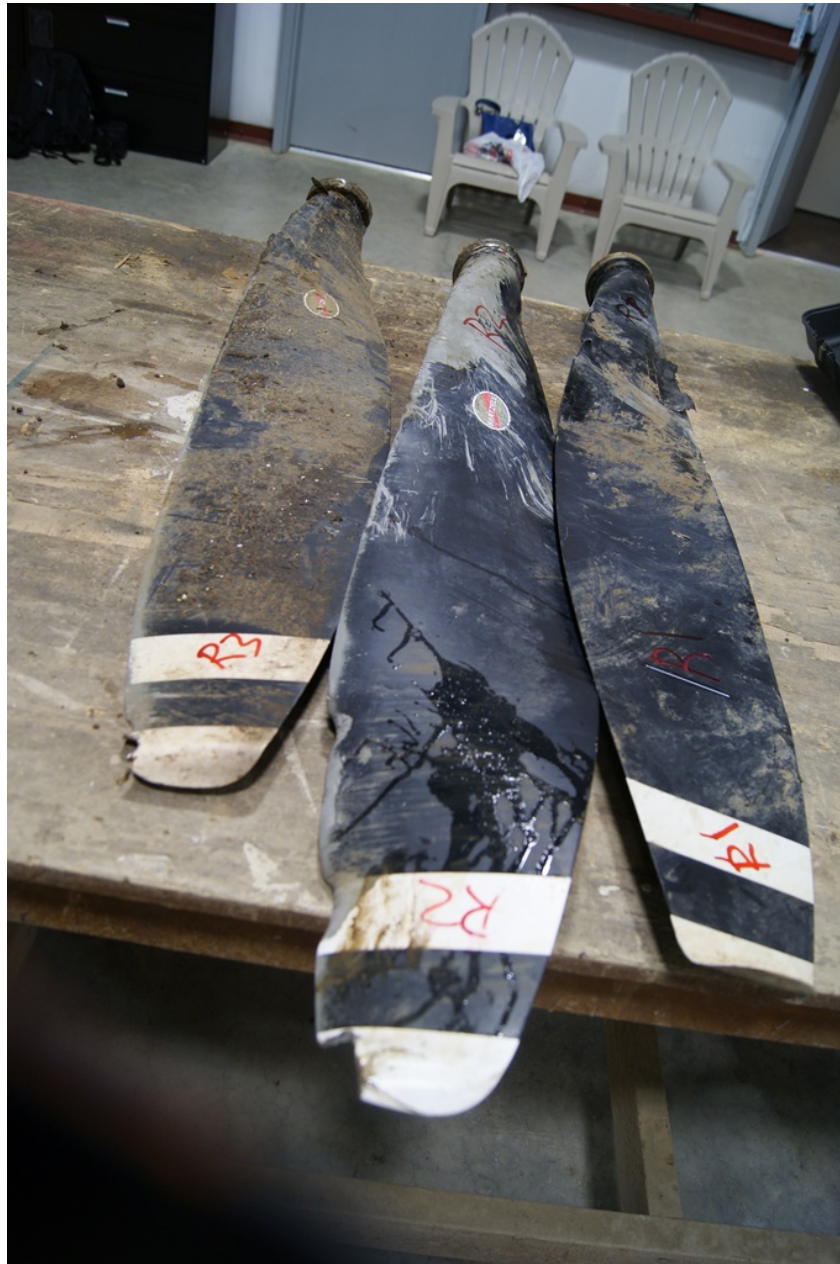
Photo 10 – Right engine propeller blades
