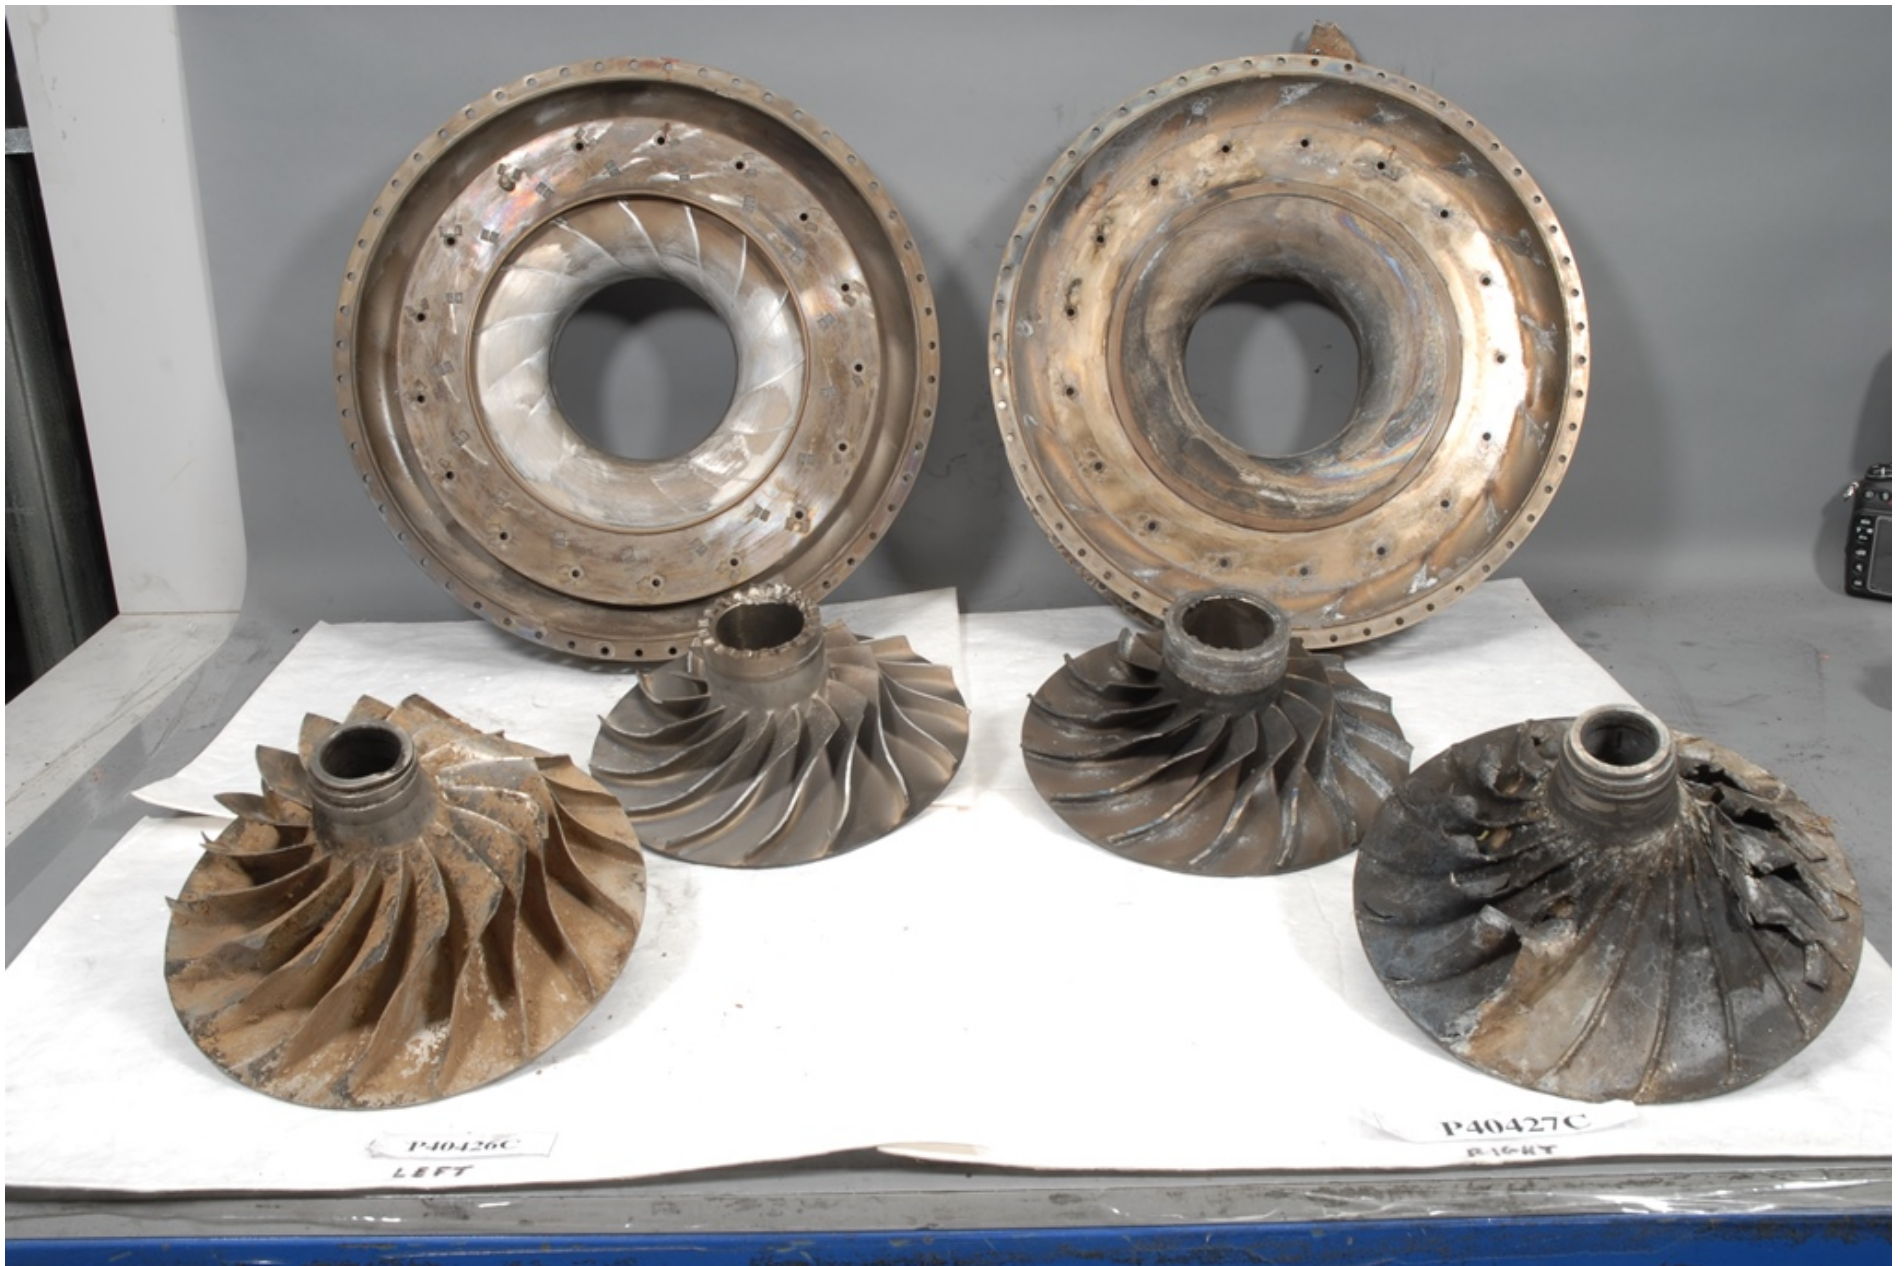
Photo 11 – Left and right engine compressor stages and compressor housings (Honeywell photograph)

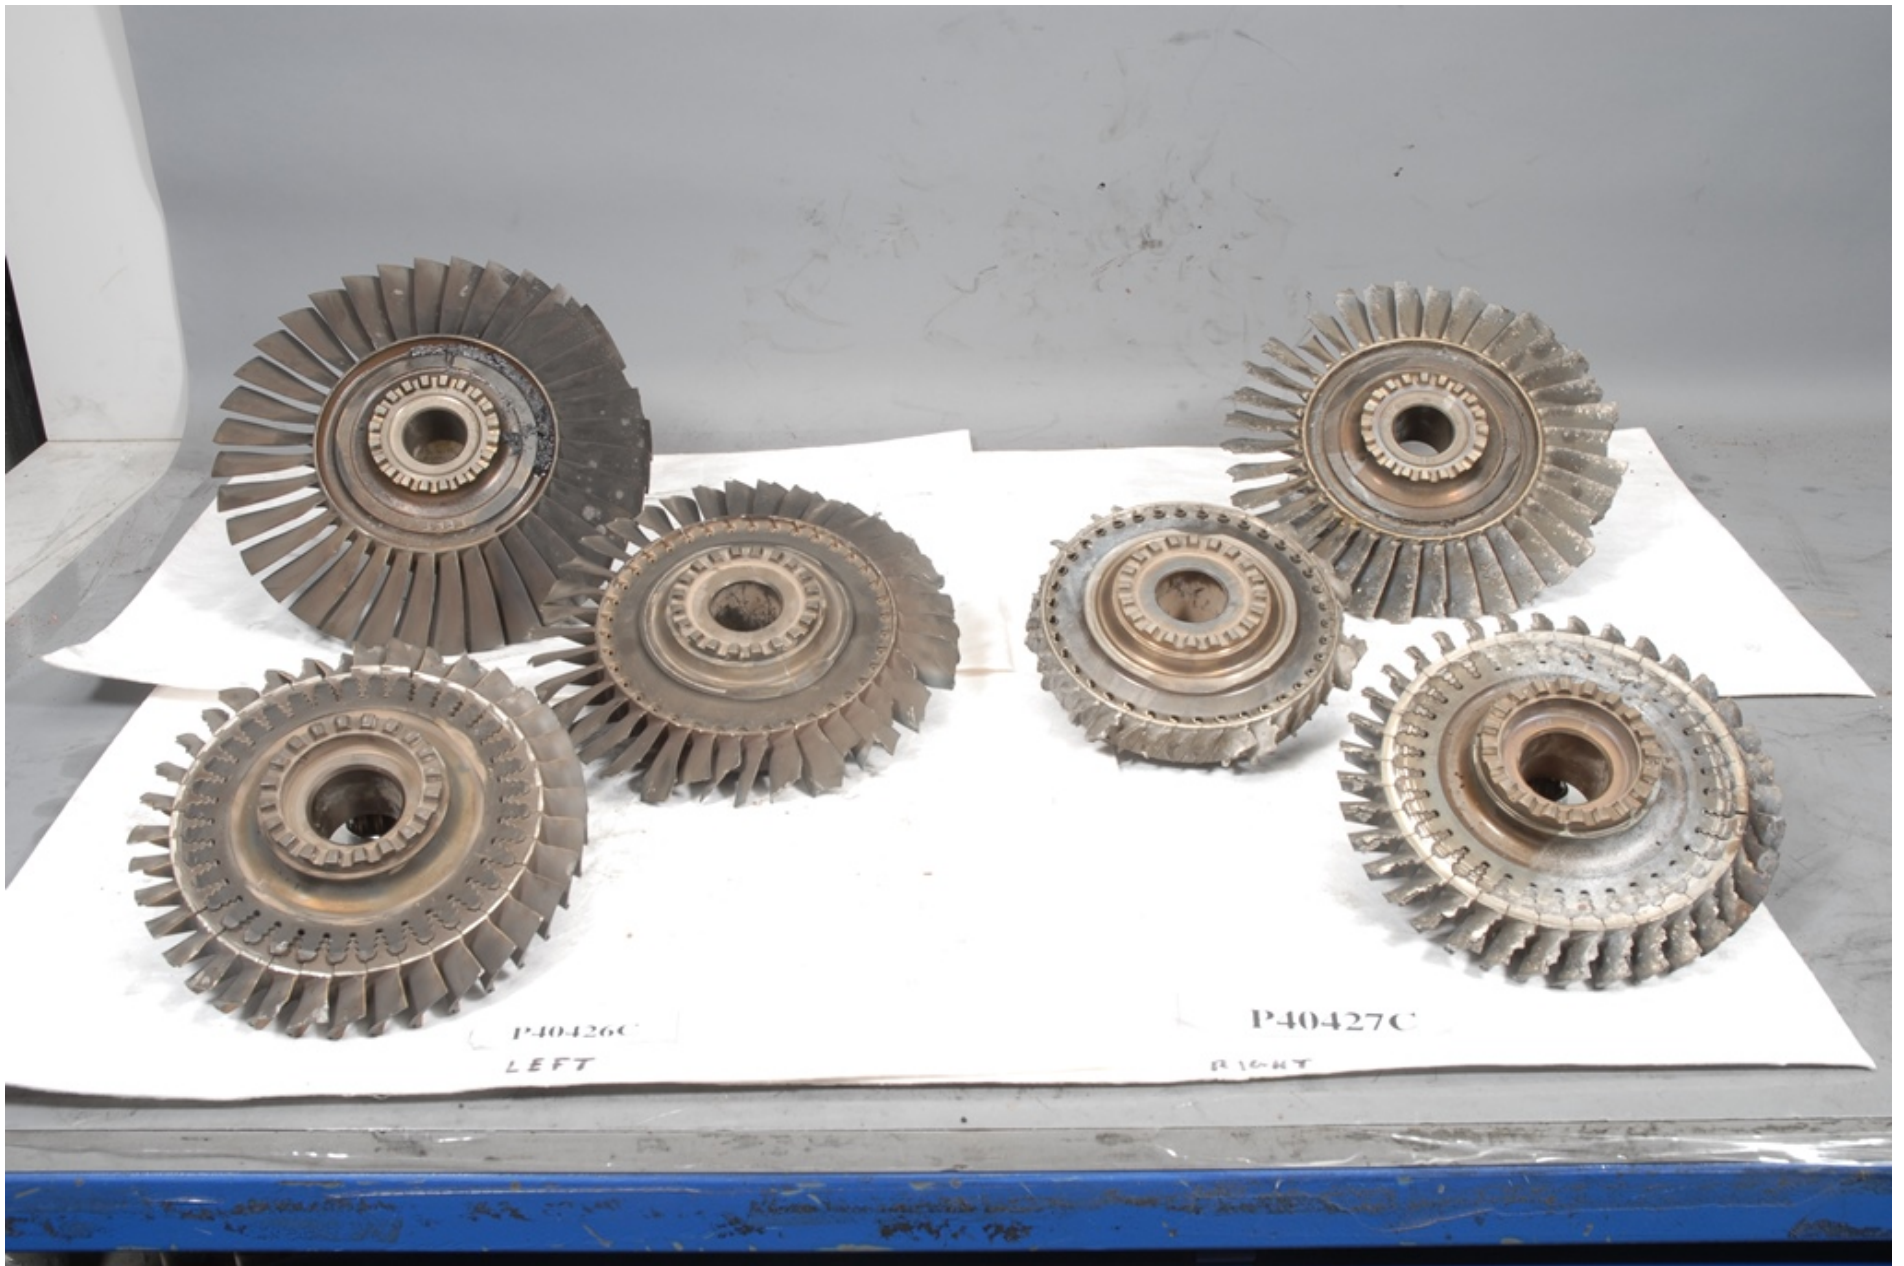
Photo 12 – Left and right engine turbine rotor stages (Honeywell Photograph)
