RE: LAX08PA259, Weaverville, CA helicopter accident

## ***Synopsis of Pertinent Facts in the Crash of N612AZ***

**LAX08PA259**

## Comparison of four sets of FCU-PRV Particle Contamination

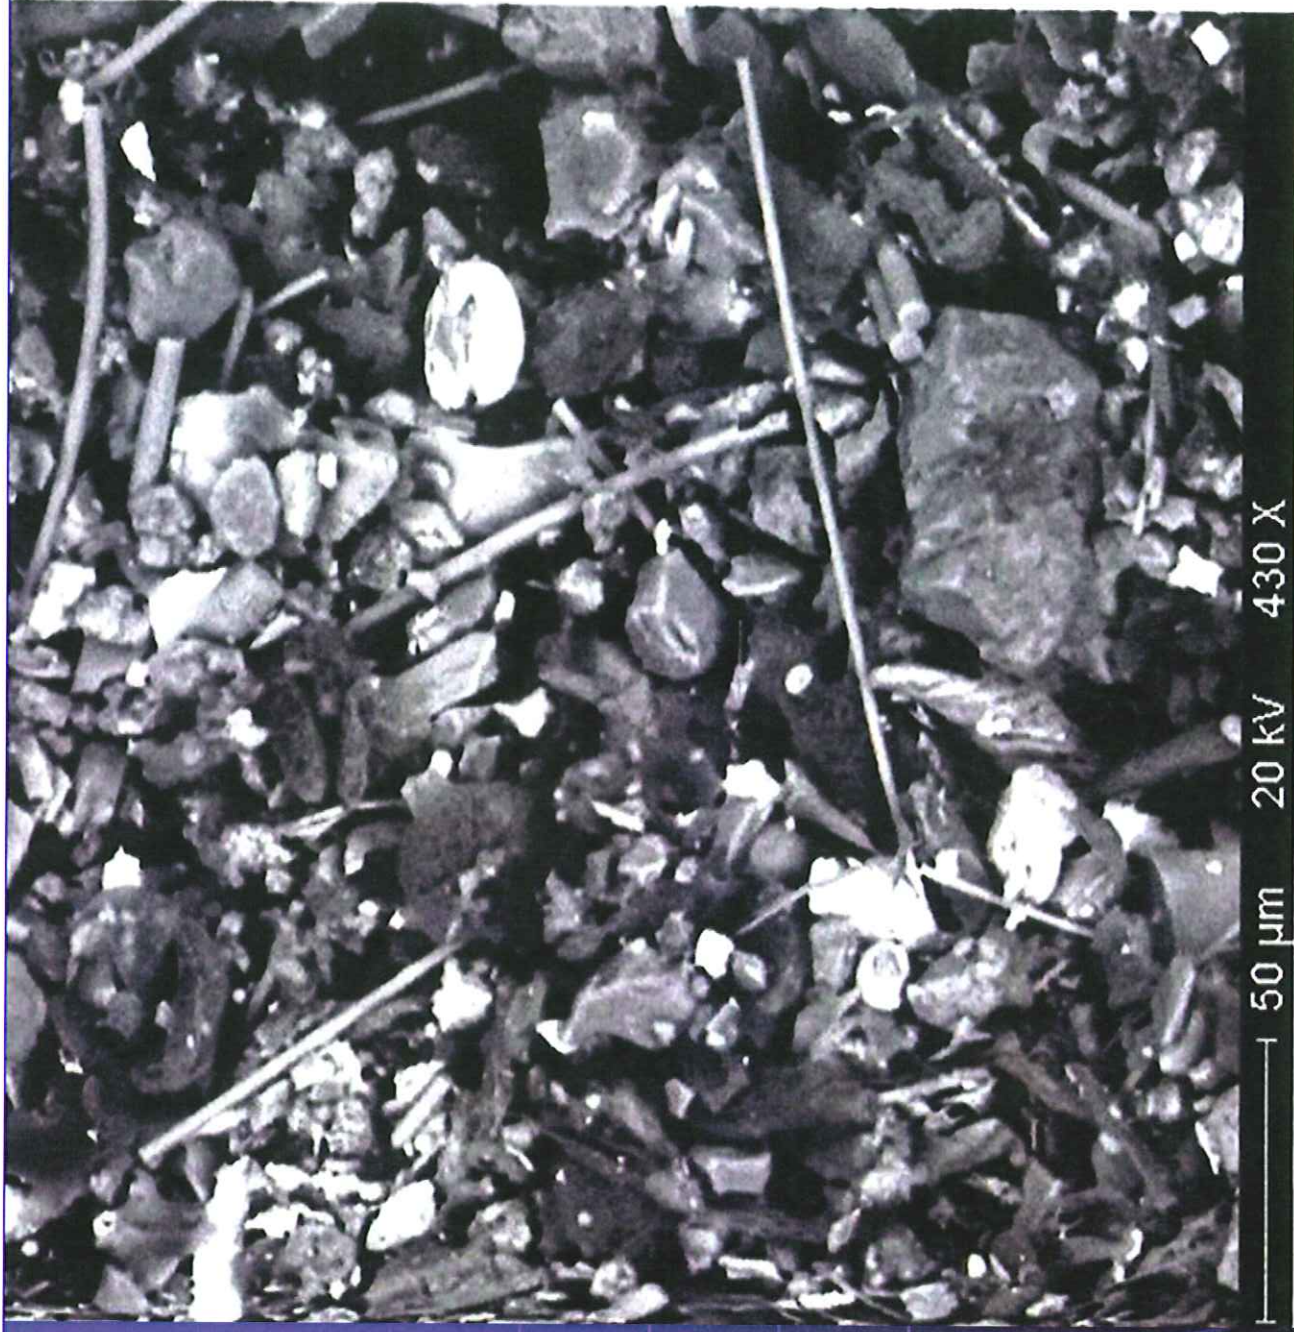
PRV- FCU  
Contaminant  
2002

Hayes Helicopter  
(Canada)

430 X

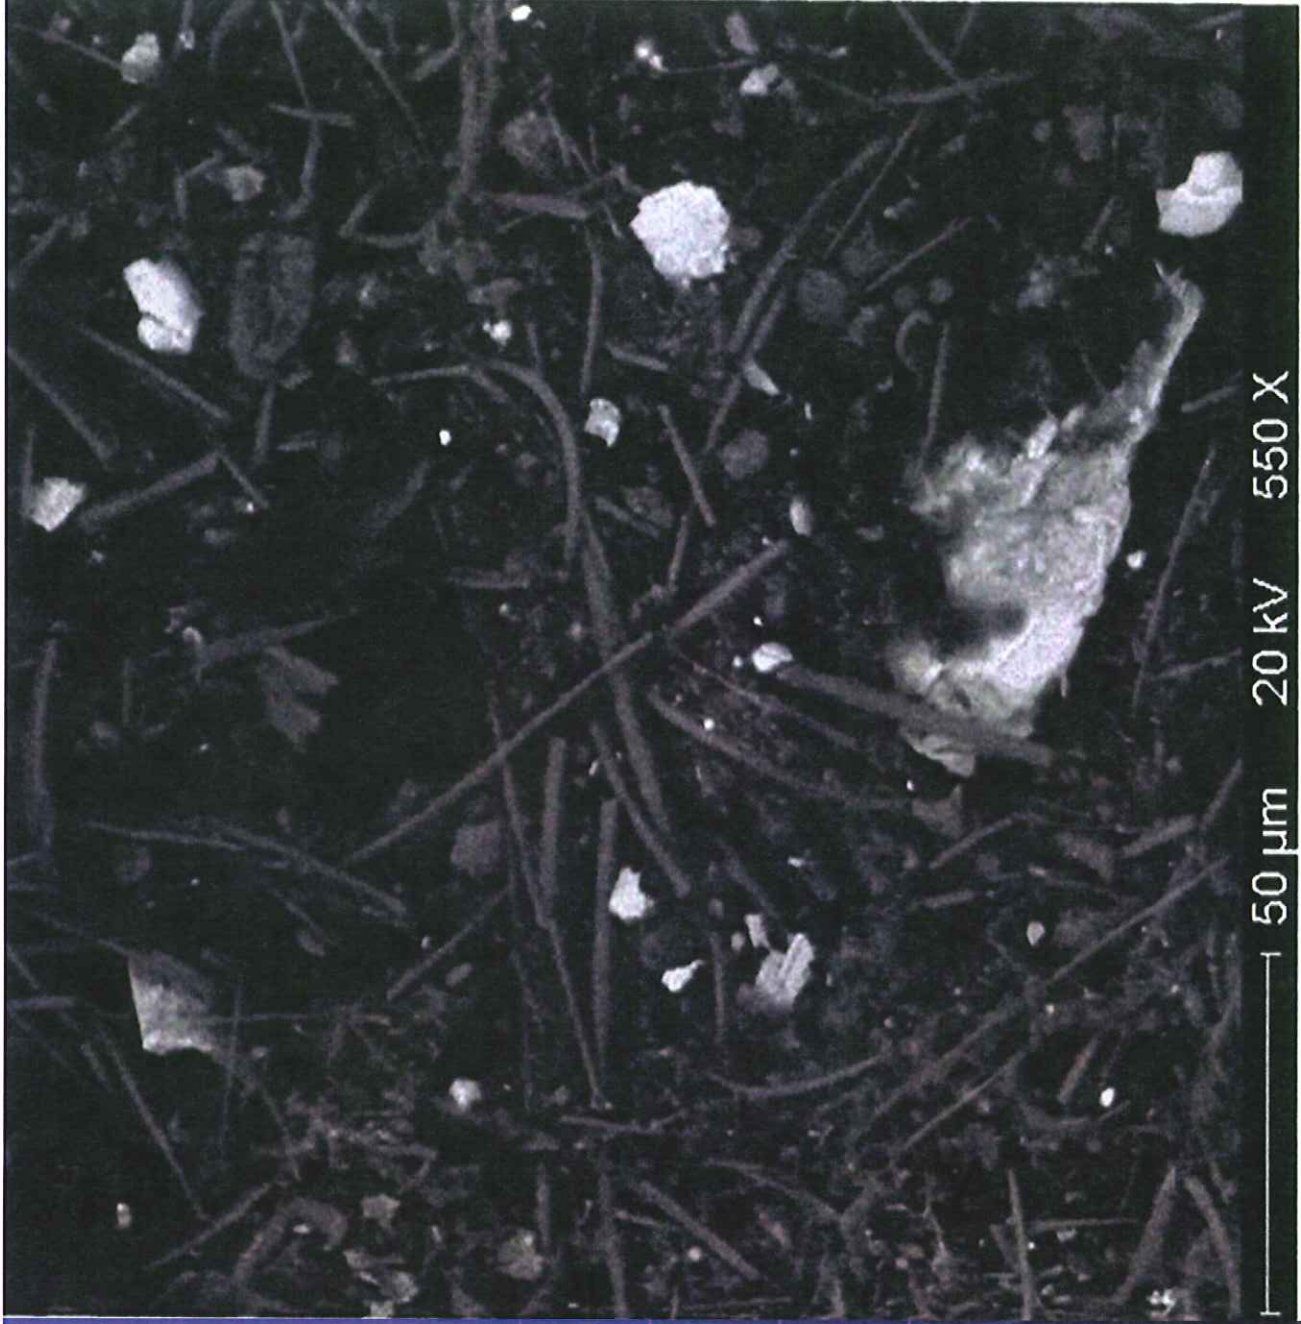
Carson  
Helicopters  
PRV-FCU  
Contaminant  
2004

550 X

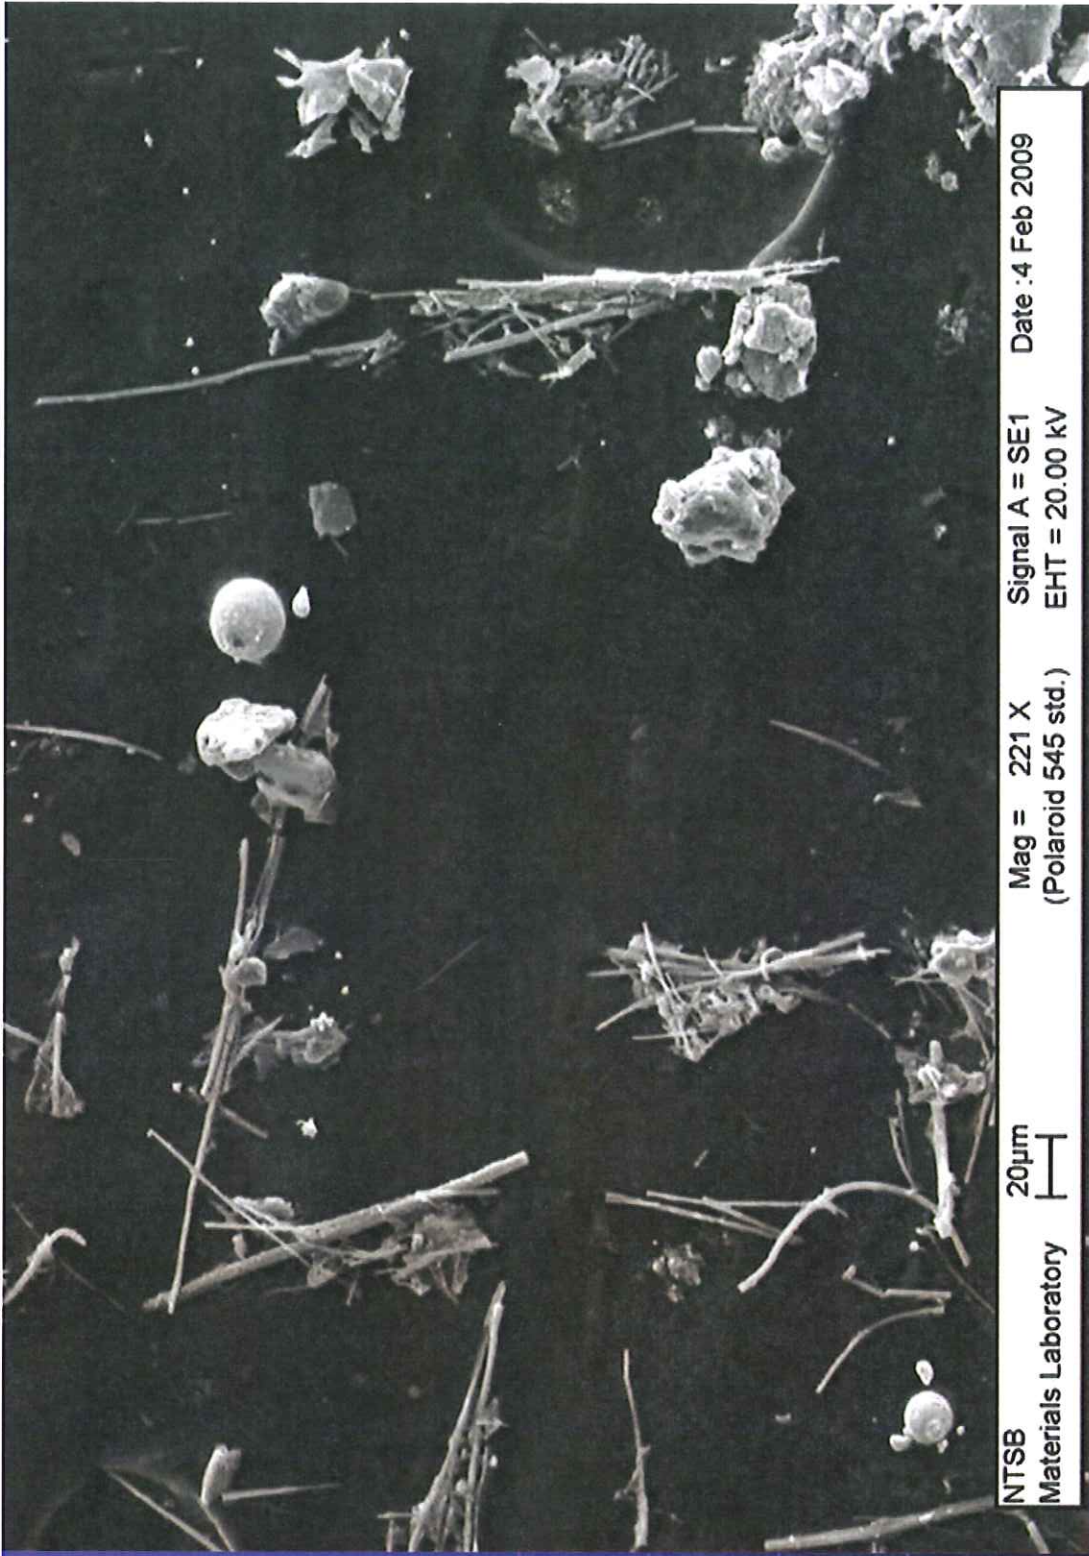
Accident Helicopter N612AZ  
from # 2 FCU Filter 221 X

-The contaminants found in the PRV of the #2 FCU were of more than sufficient quantity and size (up to 25 microns) to effectively seize the PRV. The PRV has very narrow clearance (4 microns) and acts as a trap for particles circulating in the FCU. Presence of material in the PRV can cause engine management issues and more importantly, **is indicative of particles elsewhere in the FCU that can cause multiple power problems, particularly at high power demand.** Flight testing showed a temporary power loss of even 20% in one engine would cause unrecoverable rotor RPM loss such as that experienced by N612AZ immediately prior to the crash.

- Carson has strongly urged the NTSB staff to track and compare contaminants. They have chosen not to do this. Carson commissioned an independent laboratory to compare micron photographs of other problem FCUs with contamination to the contamination in N612AZ. **The long strand silica and graphite particles are an identical match in all micron photos from several malfunctioning FCUs.**

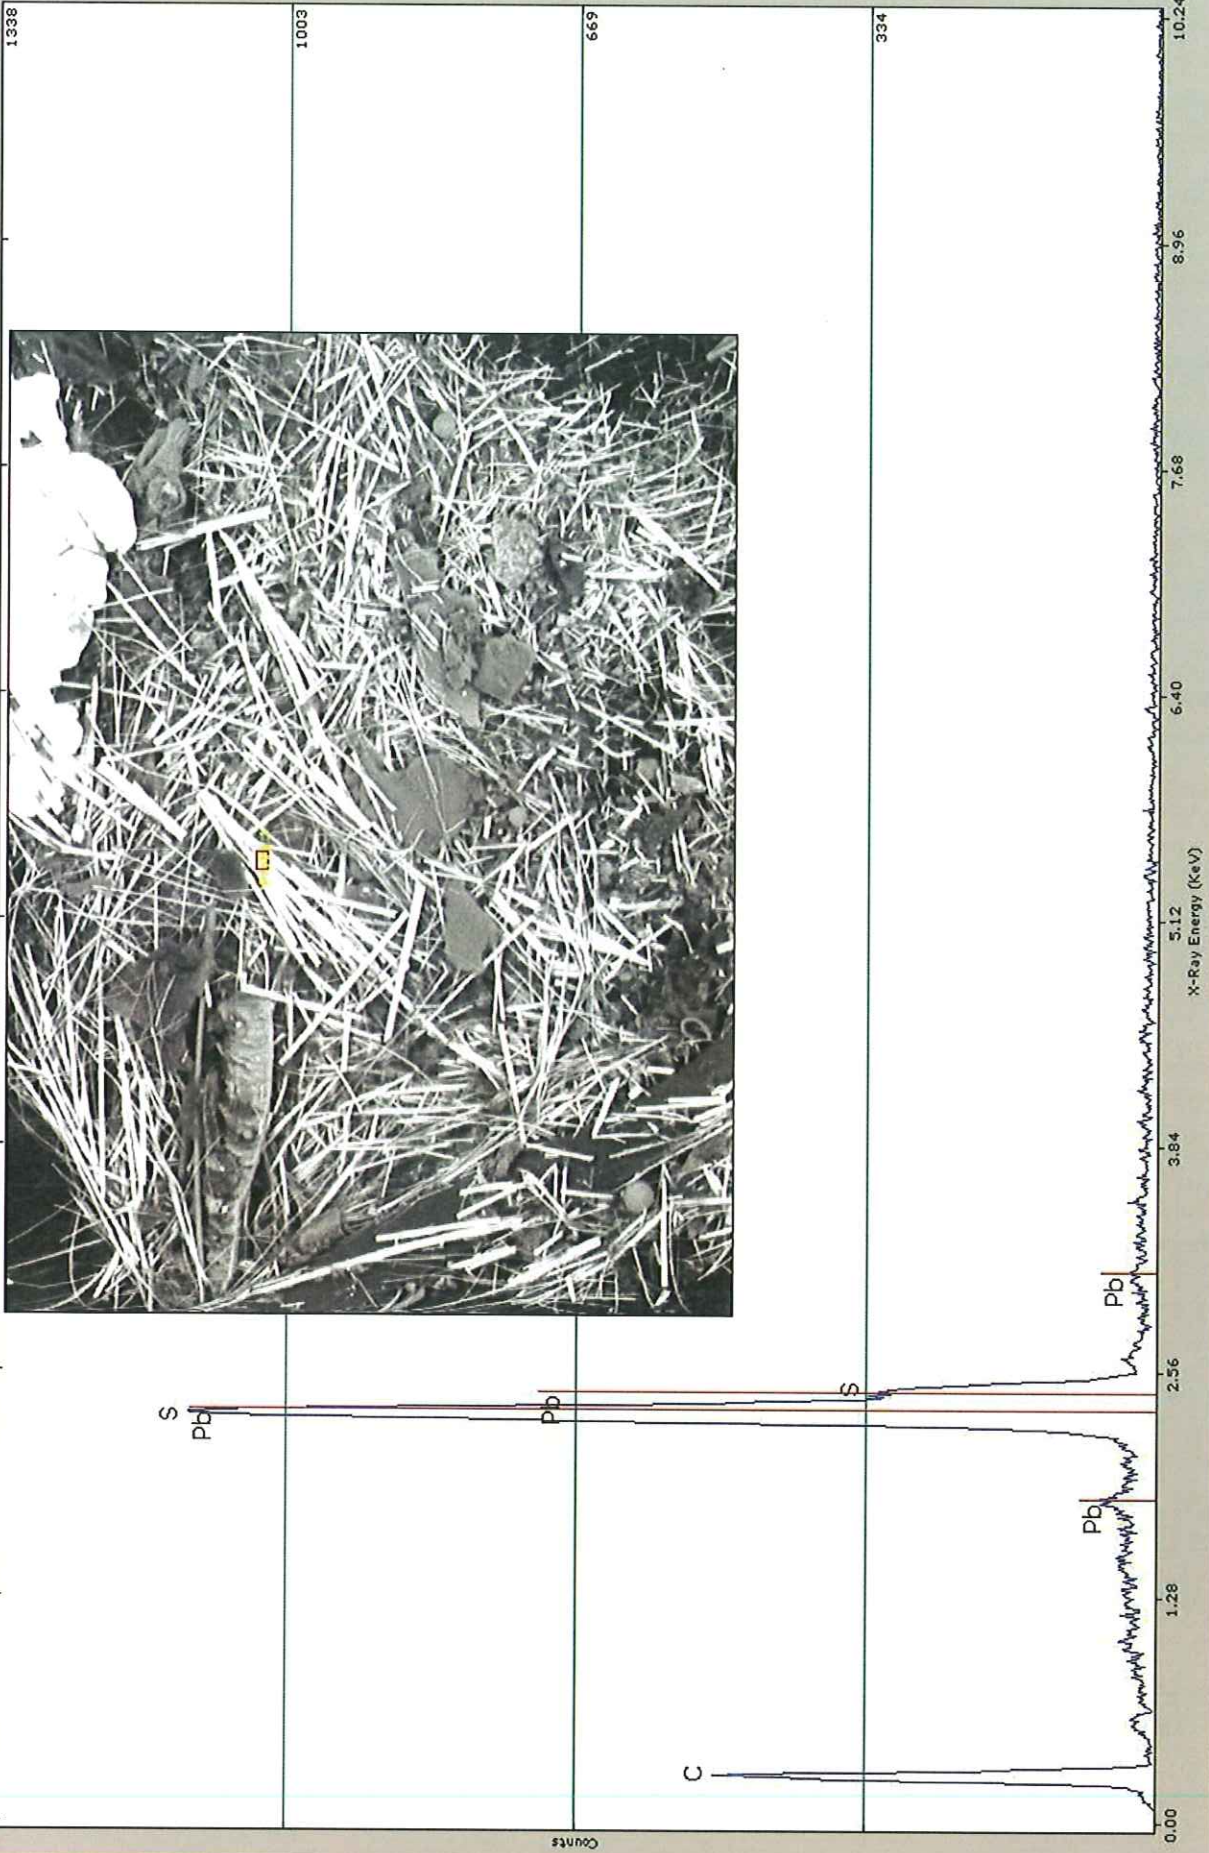
# N103WF Filter and PRV

S/N 39989 Cartridge - Probe 1 - 1000X

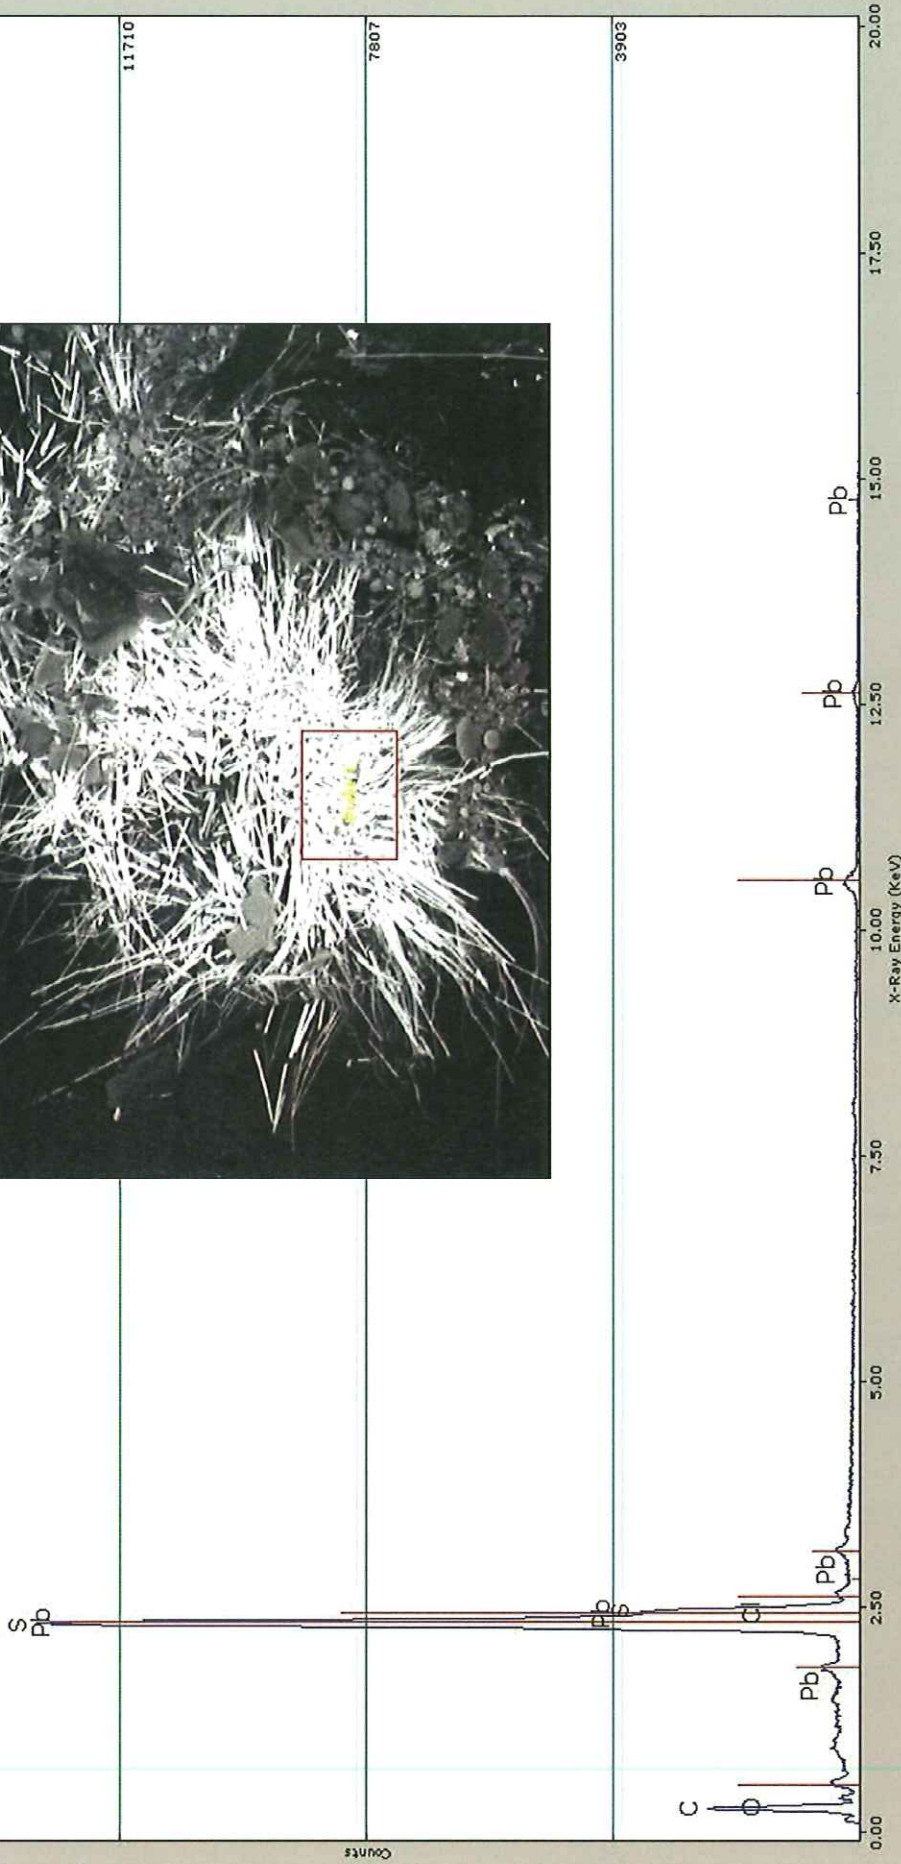
Quantitative Results for S/N 39989 Cartridge - Lead  
Analysis: Bulk Method: Standardless  
Acquired 28-Jul-2009, 20:0 KeV @ 10 eV/channel

Element	Weight %	Atomic %
C	33.67	72.02
S	29.16	23.37
Pb	37.17	4.61
Total	100.00
