# National Transportation Safety Board

## Railroad Accident Brief

### South Florida Regional Transportation Authority Highway-Rail Grade Crossing Collision

#### West Palm Beach, Florida

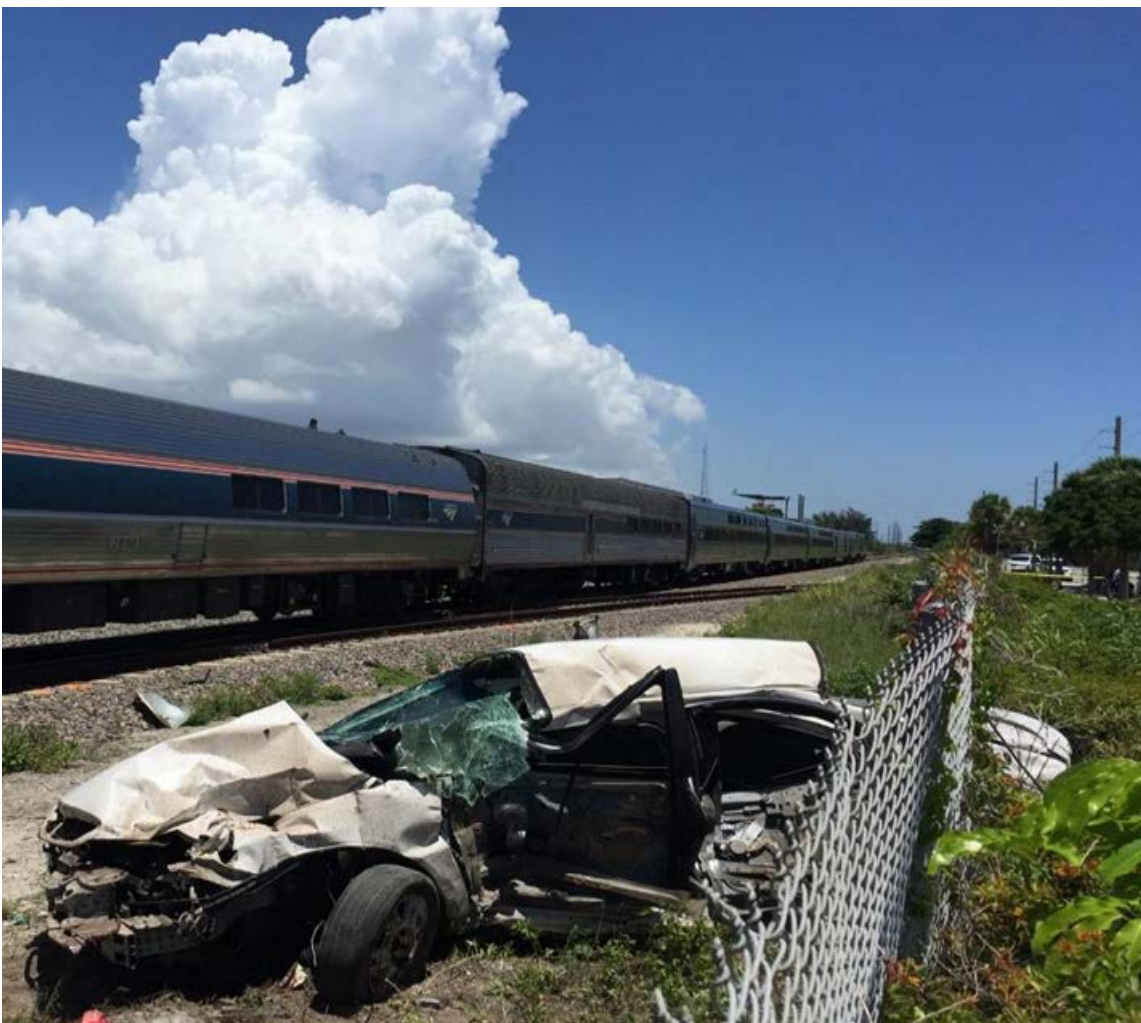
The train was en route from Miami, Florida, to New York, New York. The train did not derail. The train crewmembers and passengers were not injured. The damages to the train were estimated at \$16,300; the automobile was a total loss. At the time of the accident, the sky was clear, the visibility was 10 miles, and the temperature was 88°F.

**Figure 1.** The struck vehicle. (Photo courtesy of television station, WPBF Channel 25, West Palm Beach, Florida)

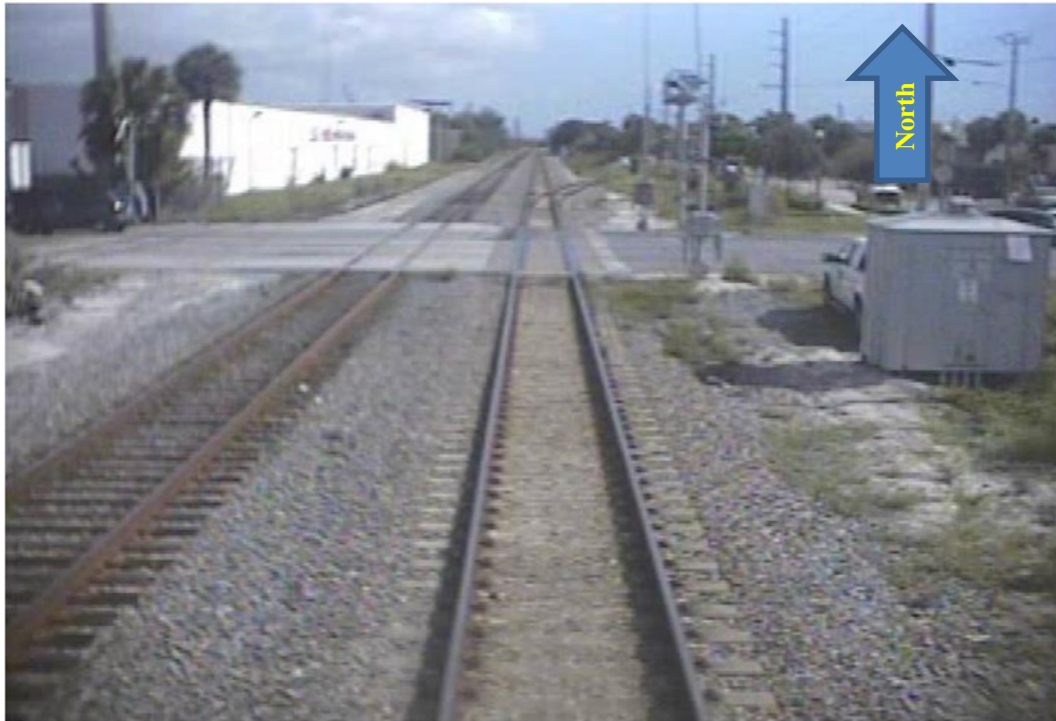
None of the crossing gates were down. (See figure 2.) At 9:59:37 a.m., a dark vehicle stopped prior to the tracks, while a white 2004 Mercury Sable continued across the grade crossing. At 9:59:38 a.m., the Amtrak train struck the Mercury while traveling 48 mph.

**Figure 2.** Photo from the locomotive video showing the grade crossing with gates in the upright position.

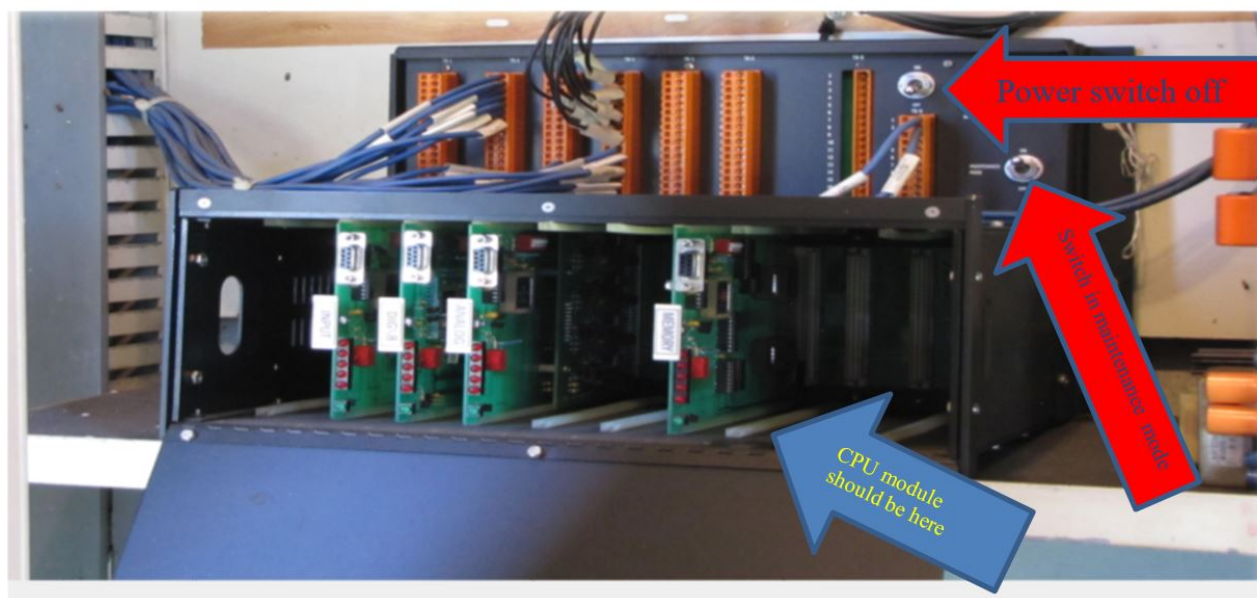
**Figure 4.** The external NAS event recorder and position of switches and missing CPU module.
