# National Transportation Safety Board

## Pipeline Accident Brief

### Gasoline Transmission Pipeline Explosion/Fire

Helena, Alabama

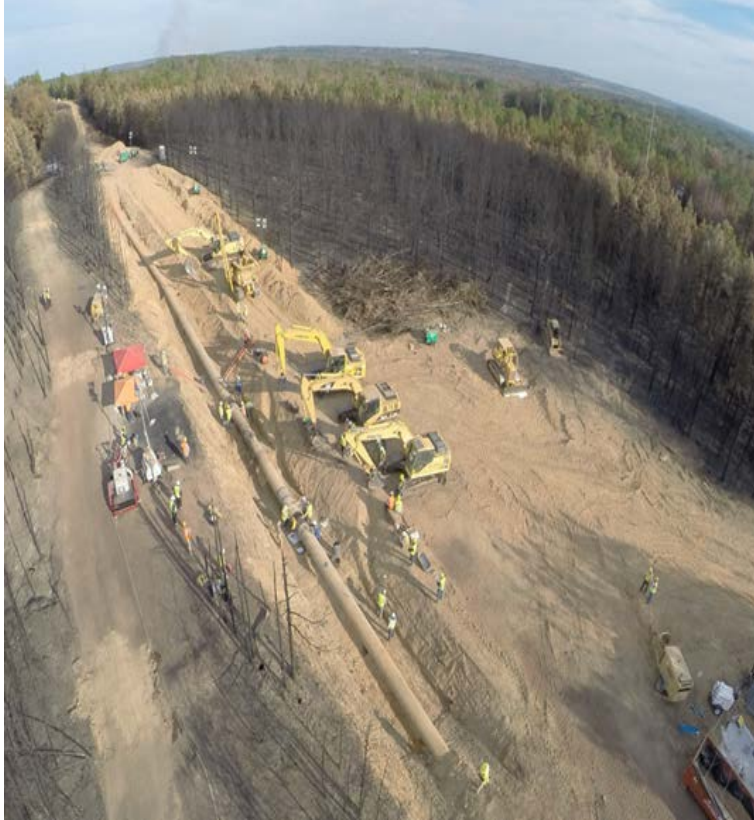
**Figure 2.** Aerial view of environmental damage. (Source: ESI, a Colonial technical contractor.)

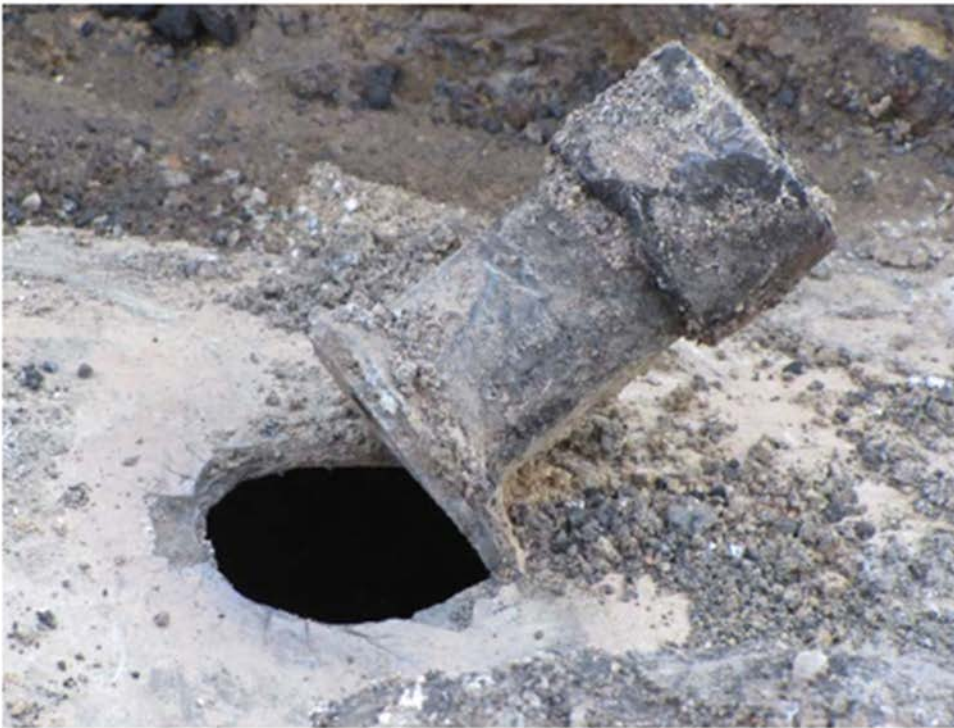
During the investigation of this accident, an area of the accident site was excavated by hand, which exposed a segment of the pipeline and the four TOR fittings that were attached to the top surface of the pipe. The examination revealed that one of the TOR fittings had been damaged

in the accident. Figure 4 shows a close-up view of the base of the damaged TOR fitting and the breach in the pipe at the point of the TOR attachment to the pipe surface.

**Figure 4.** Close-up photo of base of damaged TOR fitting and breach in pipe at point of TOR attachment to pipe. (Source: Colonial.)

The National Transportation Safety Board determines that the probable cause of the explosion was the excavation crew's inadequate planning, coordination, and communication during the excavation and failure to adhere to company policy requiring hand excavation if closer than 2 feet from the top or bottom of the pipeline until the pipeline has been exposed, which allowed the track-hoe to damage the pipeline.
