National Transportation Safety Board

Railroad Accident Brief

New Jersey Transit Train Strikes Wall in Hoboken Terminal

Hoboken, New Jersey

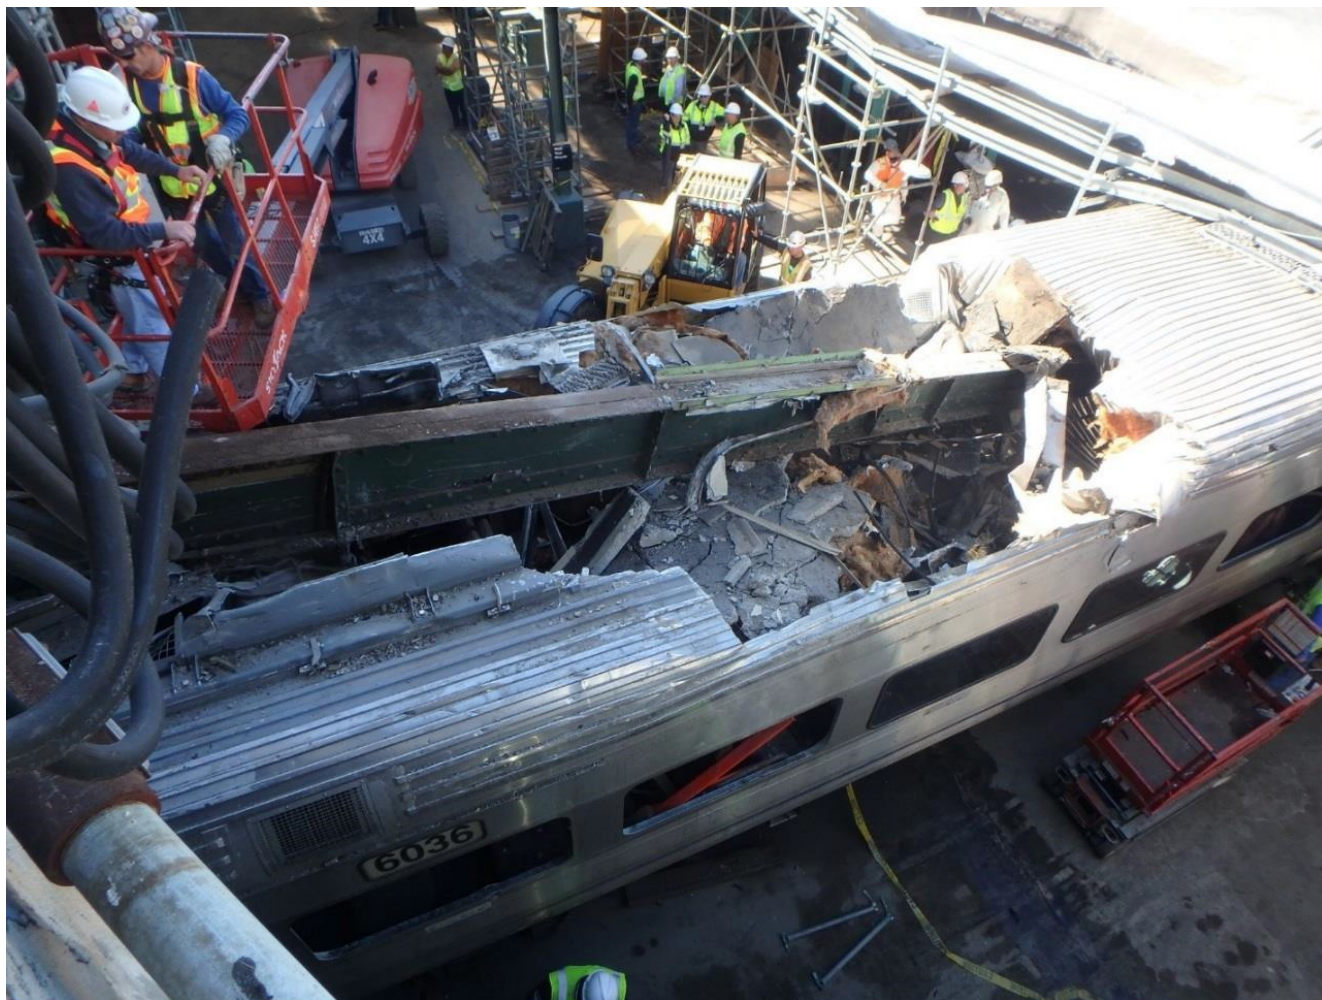
On September 29, 2016, about 8:38 a.m. eastern daylight time, New Jersey Transit (NJT) train 1614 failed to stop, overrode a bumping post at the end of track 5, and struck a wall of the Hoboken Terminal in Hoboken, New Jersey.¹ Train 1614 consisted of one controlling passenger car (cab car), three passenger cars, and one locomotive at the rear of the train. The train was traveling about 21 mph at the time of the accident.

Figure. Damaged controlling cab car.

The National Transportation Safety Board determined that the probable cause of the Hoboken, New Jersey, accident was the failure of New Jersey Transit train 1614's engineer to stop the train after entering Hoboken Terminal due to the engineer's fatigue resulting from his undiagnosed severe obstructive sleep apnea. Contributing to the accident was New Jersey Transit's failure to follow its internal obstructive sleep apnea screening guidance and refer at-risk safety-sensitive personnel for definitive obstructive sleep apnea testing and treatment. Further contributing to the accident was the Federal Railroad Administration's failure to require railroads to medically screen employees in safety-sensitive positions for obstructive sleep apnea and other sleep disorders. Also contributing to the accident was the lack of either a device or safety system that could have intervened to stop the train before the collision.
