# National Transportation Safety Board

## Railroad Accident Brief

### Dallas, Garland & Northeastern Railroad Employee Fatality

August 13, 2018

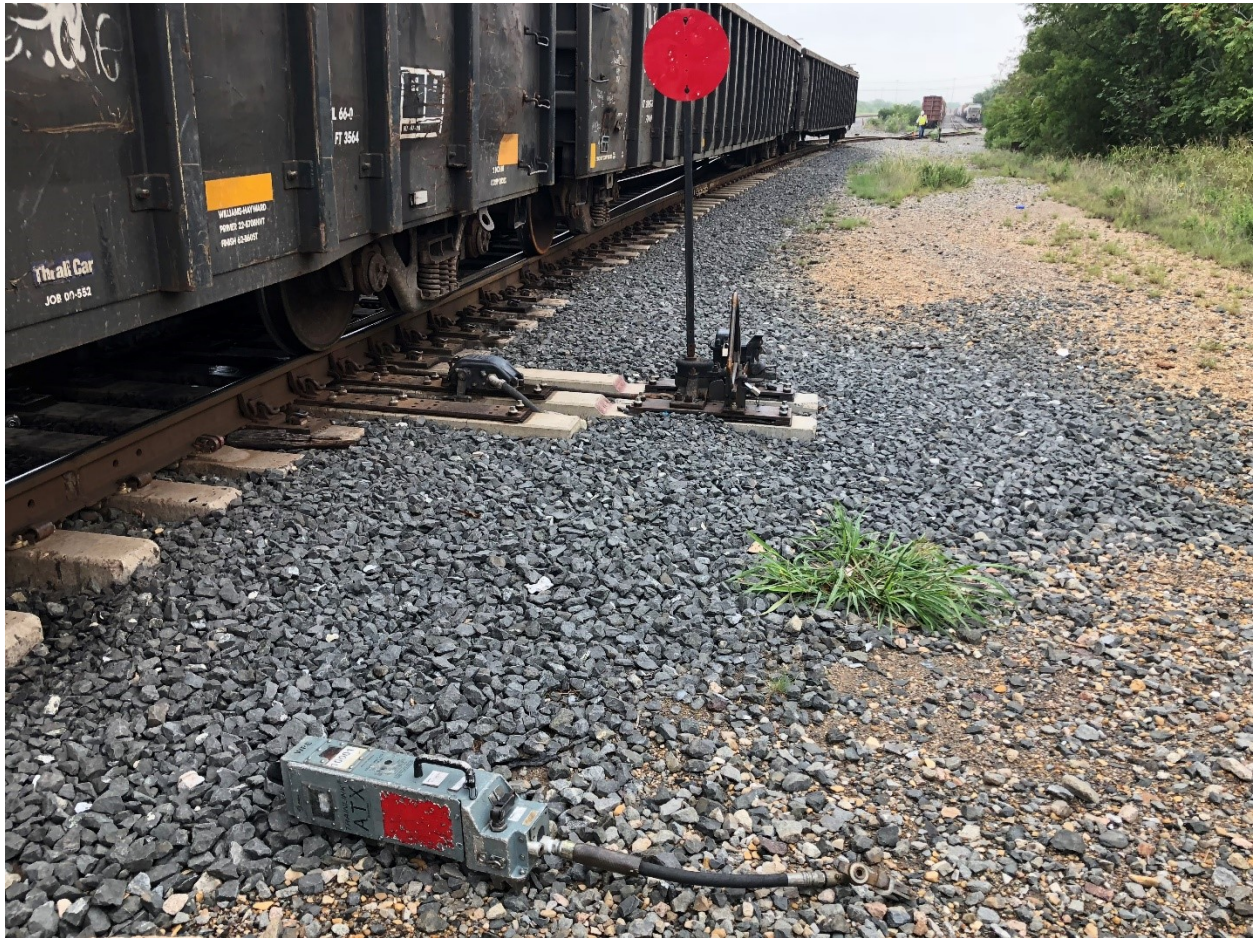
**Figure 2.** The accident train at the misaligned switch.

When the crew arrived at Cadiz Yard, the intended route to be taken was already lined for track 401. Because the switch was found lined for track 400, it is likely that the conductor inadvertently lined the switch to track 400, where the conductor was standing. The conductor likely proceeded to track 400 to operate the derail, believing that the track would be routed to track 401. He was likely directing his attention to the derail, rather than protecting the shoving movement, when he was struck.

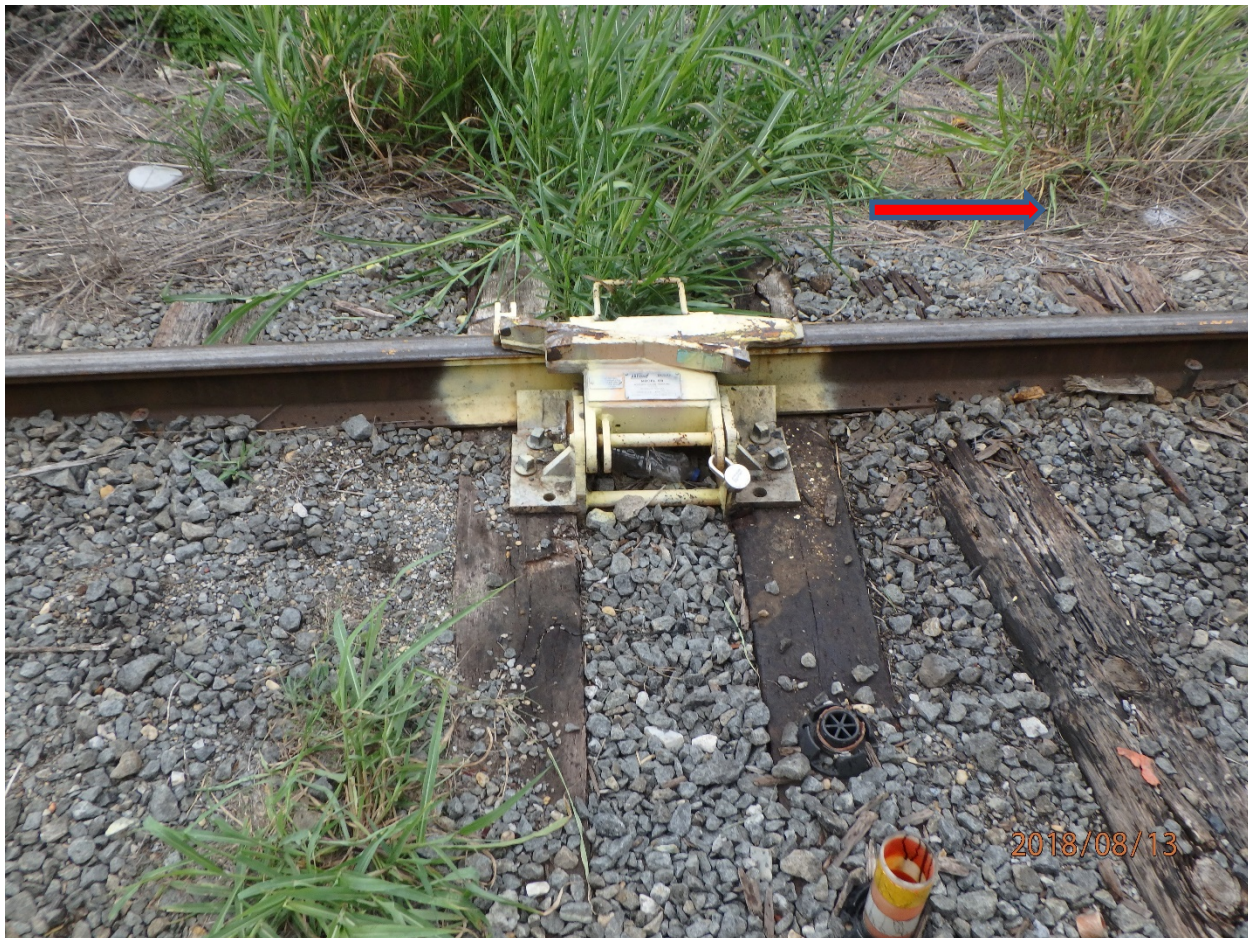
The DGNO general manager was dispatched to the accident site and found the conductor's switch keys and cap near the derail on track 400. (See figure 3.) The DGNO general manager found that the derail on track 400 was still lined and locked for the derailing position.

**Figure 3.** Photo of derail on track 400 and location of conductor's switch keys.

G&W initiated a campaign across all owned or leased railroads titled "Moving Equipment Can Kill." The campaign emphasizes the importance of situational awareness and rule compliance when crossing tracks and moving between equipment.
