Rupture of a DOT-105 Rail Tank Car and Subsequent
Chlorine Release at Axiall Corporation
New Martinsville, West Virginia
August 27, 2016

NTSB/HZM-19/01
PB2019-100294

Hazardous Materials Accident Report

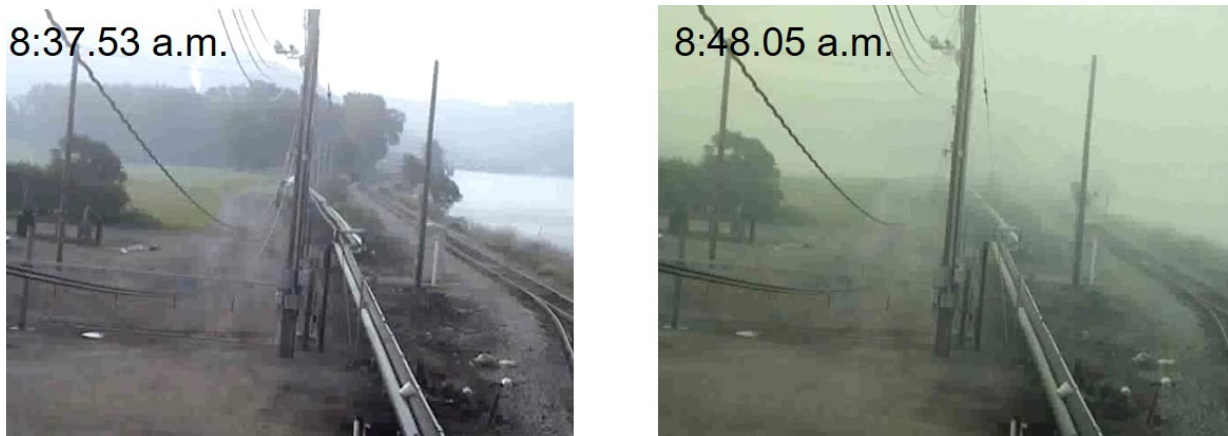
Chlorine gas sensors positioned at several locations within the plant first detected the release and alarmed about 8:28 a.m.⁵ Between about 8:29 a.m. and 11:07 a.m., several in-plant gas sensors near the point of release and downwind of the release (south), near the plant's southern perimeter, recorded chlorine concentrations above the level the National Institute for Occupational Safety and Health (NIOSH) has identified as immediately dangerous to life and health (IDLH) concentration. The perimeter gas sensors also measured chlorine concentrations that exceeded the US Environmental Protection Agency Acute Exposure Guideline Level 3; thus, chlorine concentrations at the plant perimeter were above that at which it is predicted the general population could experience life-threatening health effects or death (NRC 2004). The entire 178,400-pound load of chlorine was released from the tank car and migrated south toward the town of New Martinsville, along the Ohio River valley. Figure 3 shows the visual evidence of the chlorine release beyond Axiall's property line.⁶ The photographs show the view near the Axiall south perimeter fence looking south toward a wooded area before and after the arrival of the chlorine vapor cloud. The wooded area is about 6,100 feet southeast of the incident site. The Ohio River is on the right side of the photographs.

Figure 3. Axiall security camera views, August 27, 2016. (Photographs courtesy of Axiall.)

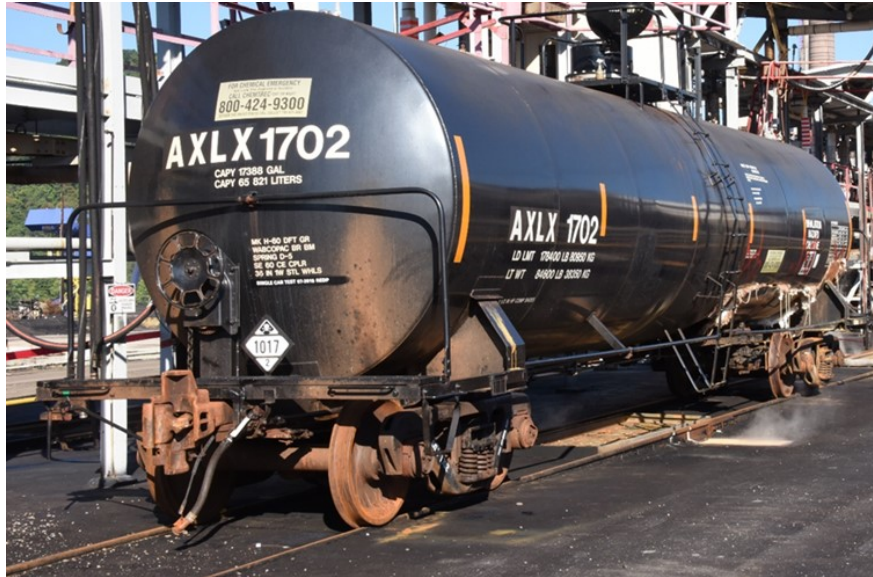
Figure 4. Tank Car AXLX1702, postincident. (Photograph courtesy of Axiial.)

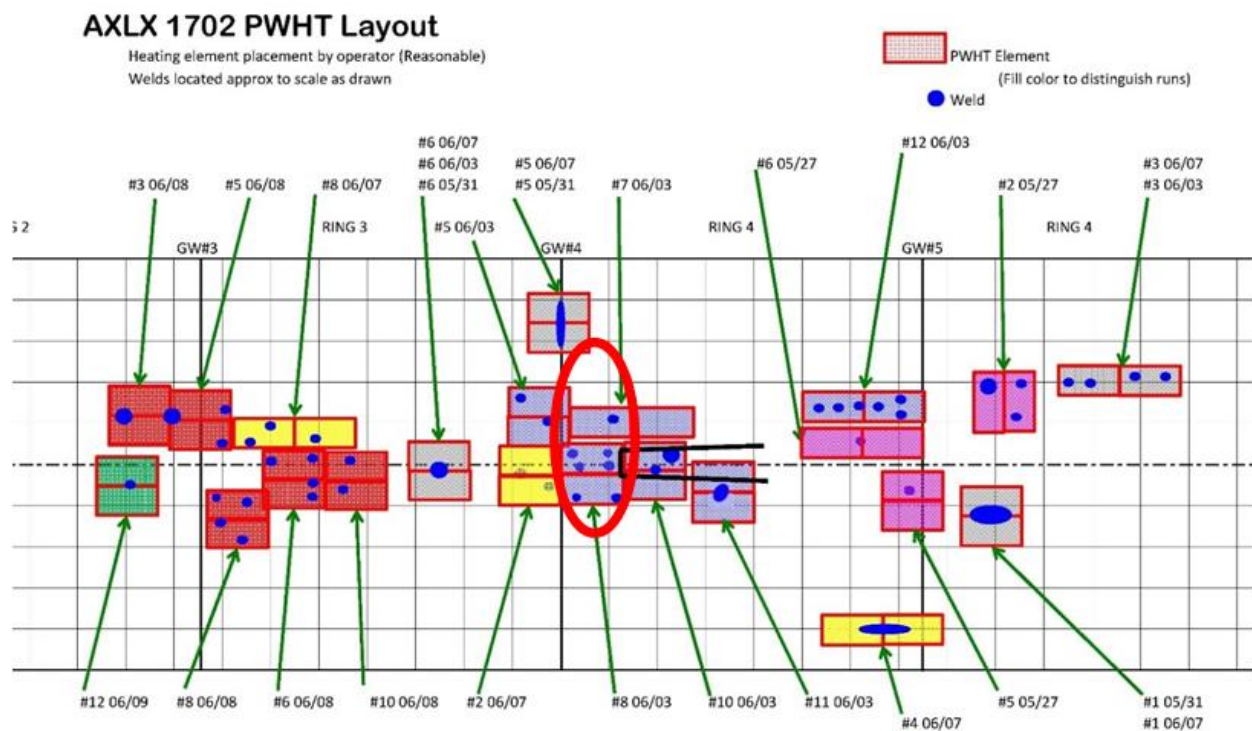
Rescar subcontracted Superheat FGH Services Inc. (Superheat) of Aston Mills, Pennsylvania, to provide internet-based remote LPWHT operations and monitoring. Superheat supplied Rescar with a general layout plan indicating the locations for placing the matrix of 26 ceramic heating-pad circuits, along with the thermocouple attachment points. The heating pads and thermocouple leads were attached to heater control units that allowed Superheat to remotely regulate the rate, intensity, and duration of the heating process. Superheat also provided Rescar technicians with a map of the locations for exterior insulation to control work-piece temperature. The heat treatment occurred on six different dates between May 27, 2016, and June 7, 2016, because equipment problems led to several of the heat treatment cycles being aborted and rerun. Figure 7 depicts the shell repair locations and the chronological order of the successful LPWHT runs. The area where the shell crack developed is circled in red near heating elements 7 and 8.

Figure 7. AXLX1702 LPWHT layout. (Courtesy of Rescar Companies.)

Superheat records indicated that the area of the tank car where the shell crack occurred received LPWHT as part of a six-circuit run on May 31, 2016, but the run was aborted. Superheat records indicate that LPWHT was successfully completed on this same area of the tank on June 3, 2016.

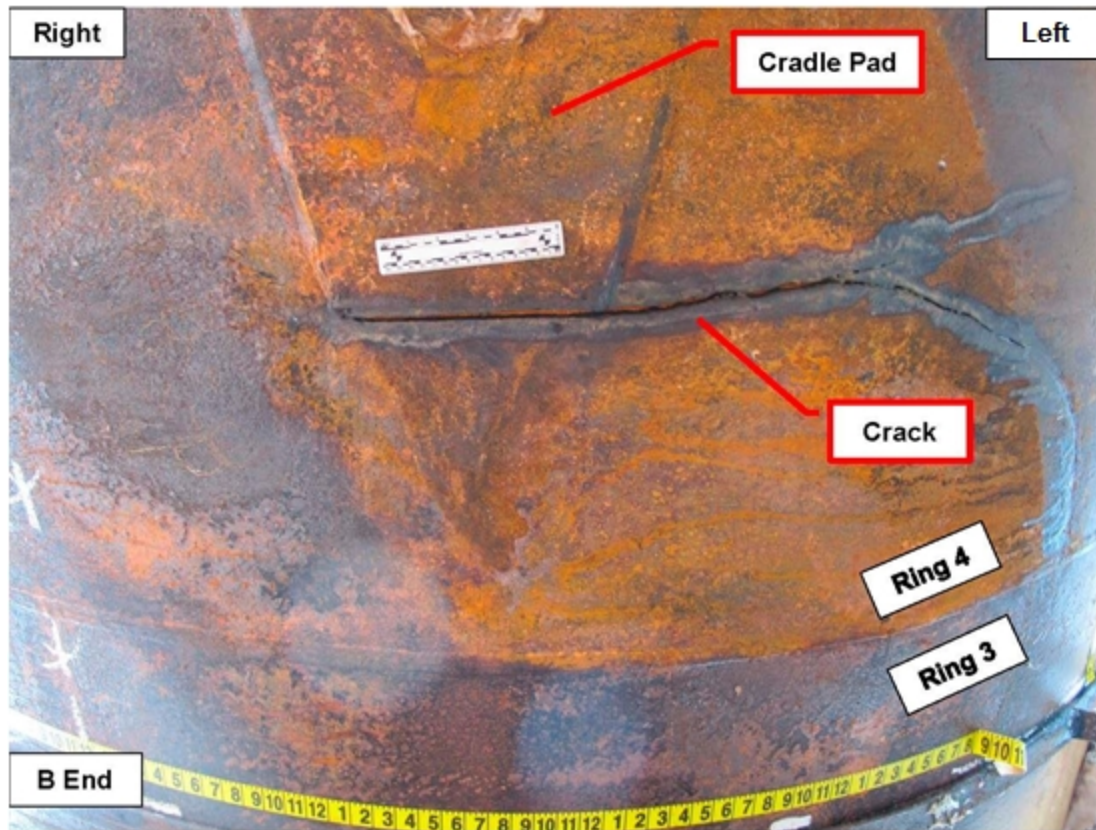
Figure 8. Exterior surface of tank car bottom showing circumferential crack inboard of cradle pad.

Differences in the welds were apparent at the inboard terminations of both right and left cradle pad-to-tank fillet welds. The different welds were consistent with manually applied repair welds, as documented in the Rescar 2010 weld crack repairs. The cradle pad repair weld was about 2.5 inches long on the right side and about 2 inches long on the left side.

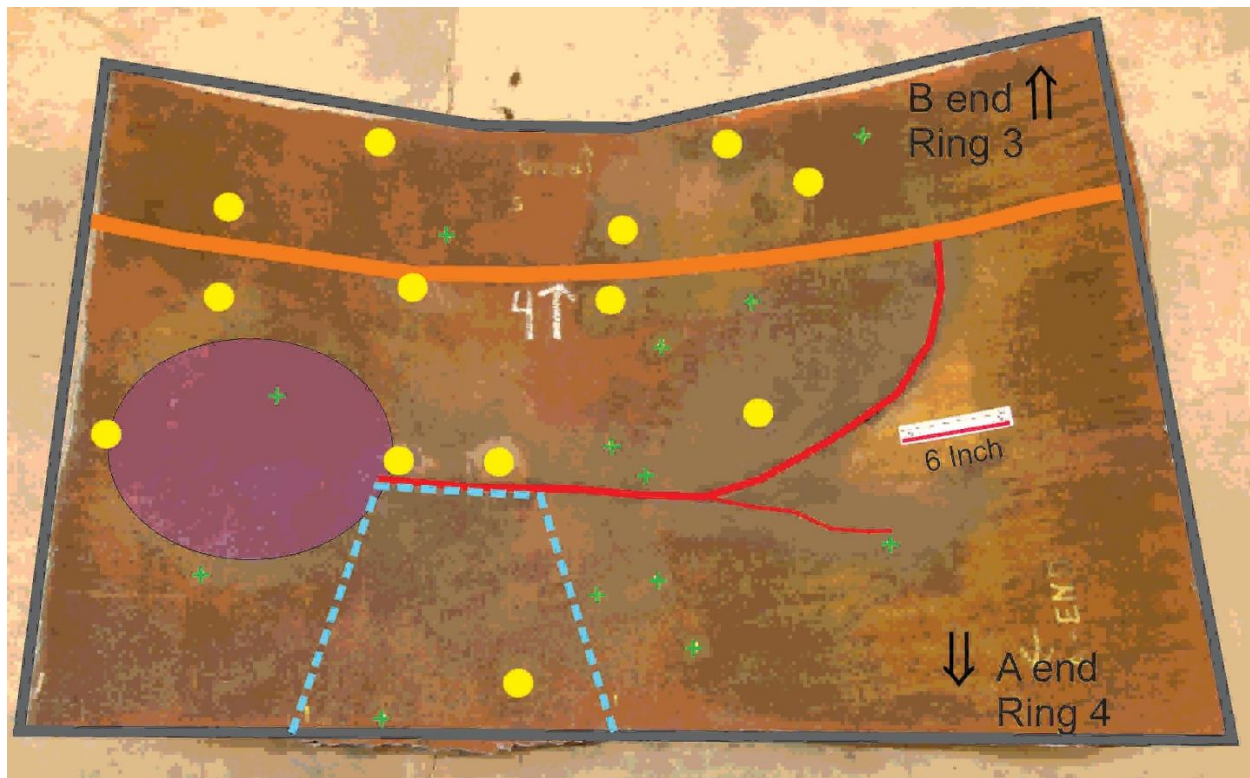
surface (dashed blue line), and girth weld between tank ring 3 and tank ring 4 (orange line).³⁴ The purple oval on the left of the cradle pad indicates the area with visible interior surface scaling. Ground spots are identified with a green + mark.

The shell material in tank ring 4 buckled between the crack at the cradle pad plate and the tank ring 3 to 4 girth weld joint. Over this 11-inch distance, the interior surface was deformed downward about 1/2 inch. The circumferential extent of the deformation could not be measured because of the size of the sample.

Figure 9. Annotated view of the interior side of the tank shell coupon.

An area of surface oxidization (scale) that measured 0.03-inch thick was found on the interior tank surface near the right corner of the cradle pad. The scaling boundaries were indistinct, but the area was estimated to be at least 12 inches in diameter and included the right-side termination of the crack. Shell thickness measurements within the scaled area with the scale removed were below the minimum allowed.³⁵ A metallographic section from the scaled area also showed decarburization 0.006-inch deep and scaling on both the interior and exterior surfaces. The scaled area material surface hardness measured somewhat softer than the

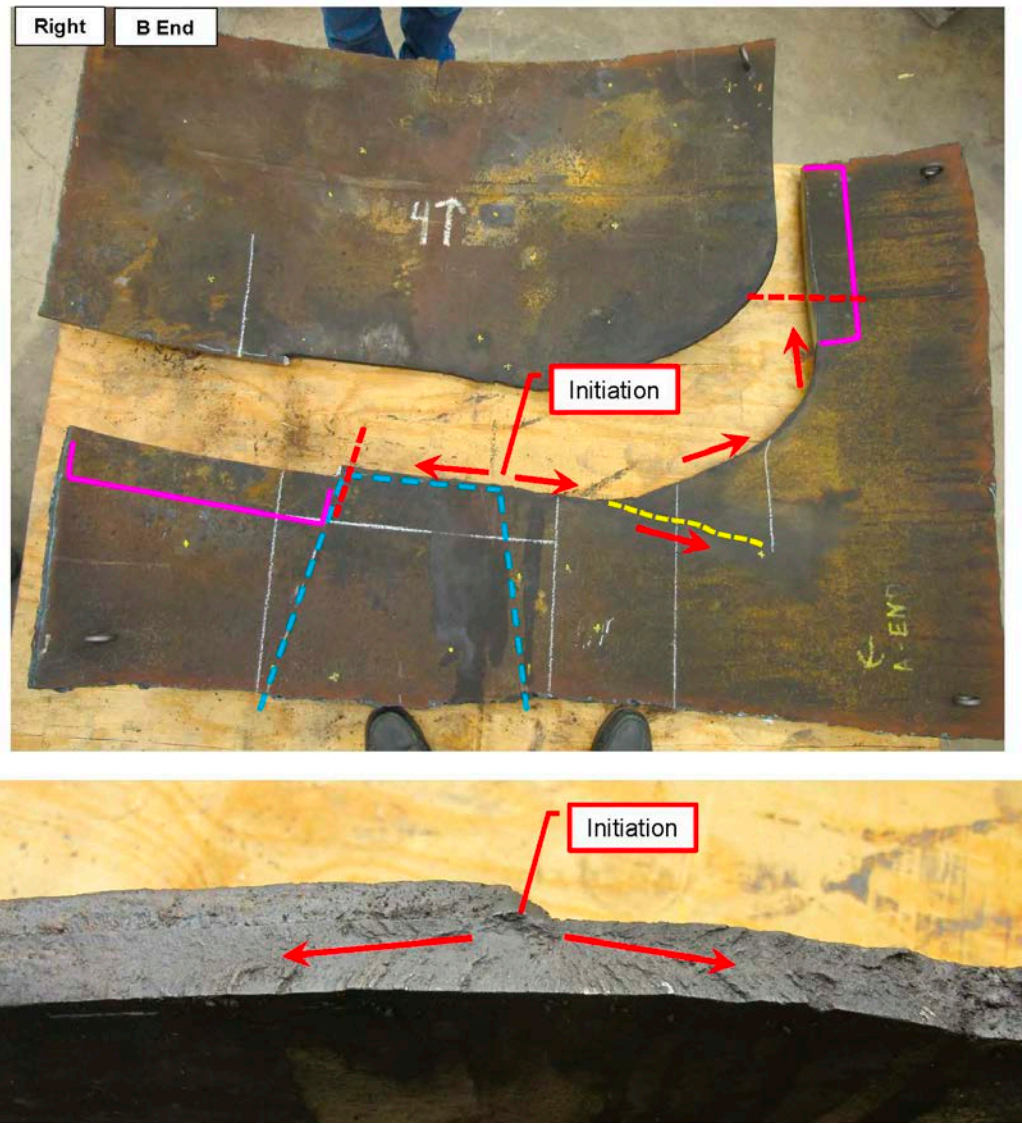
Figure 10. Interior view of the tank shell coupon.

A darker-colored elliptically shaped region at the repair weld toe that appeared consistent with an oxide layer identified the crack initiation area. NTSB investigators estimated the dark region to be about 0.7-inch wide by about 0.2-inch deep. The crack initiation region roughly followed the curved shape of the repair weld toe, which projected past the inboard end of the cradle pad by almost 0.3 inch. Three additional cracks found under the repair weld bead measured 0.037 inch, 0.094 inch, and 0.109 inch.³⁸

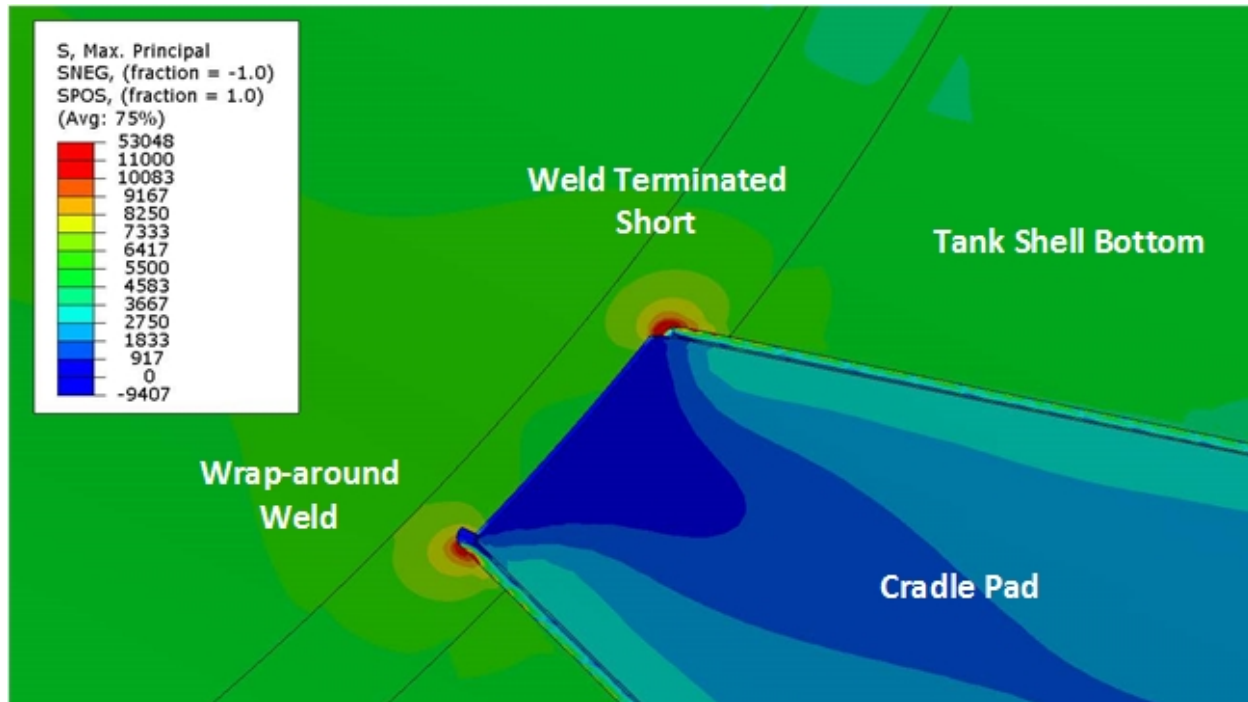
terminations in various configurations, including symmetrical and asymmetrical cases of wraparound welding (transverse and longitudinal weld terminations), and the models revealed stress concentrations in the same general tank location at the inboard edge of the cradle pad. However, the different weld termination geometries, including the actual asymmetrical case, resulted in local stresses of similar magnitudes and locations. (See figure 11.) Therefore, the asymmetrical weld geometry and wraparound welding were not likely significant factors in the tank shell failure. Nevertheless, the finite element modeling showed a stress concentration at the location where shell cracking initiated, which was the same location where investigators detected a preexisting crack immediately adjacent to thermal shell damage from uncontrolled LPWHT.

Figure 11. Maximum principal stress distribution at inboard end of cradle pad (asymmetric fillet weld).
