Derailment and Hazardous Materials Release of  
Union Pacific Railroad Unit Ethanol Train  
Graettinger, Iowa  
March 10, 2017

**Accident Report**

NTSB/RAR-18/02  
PB2019-100084

**National  
Transportation  
Safety Board**

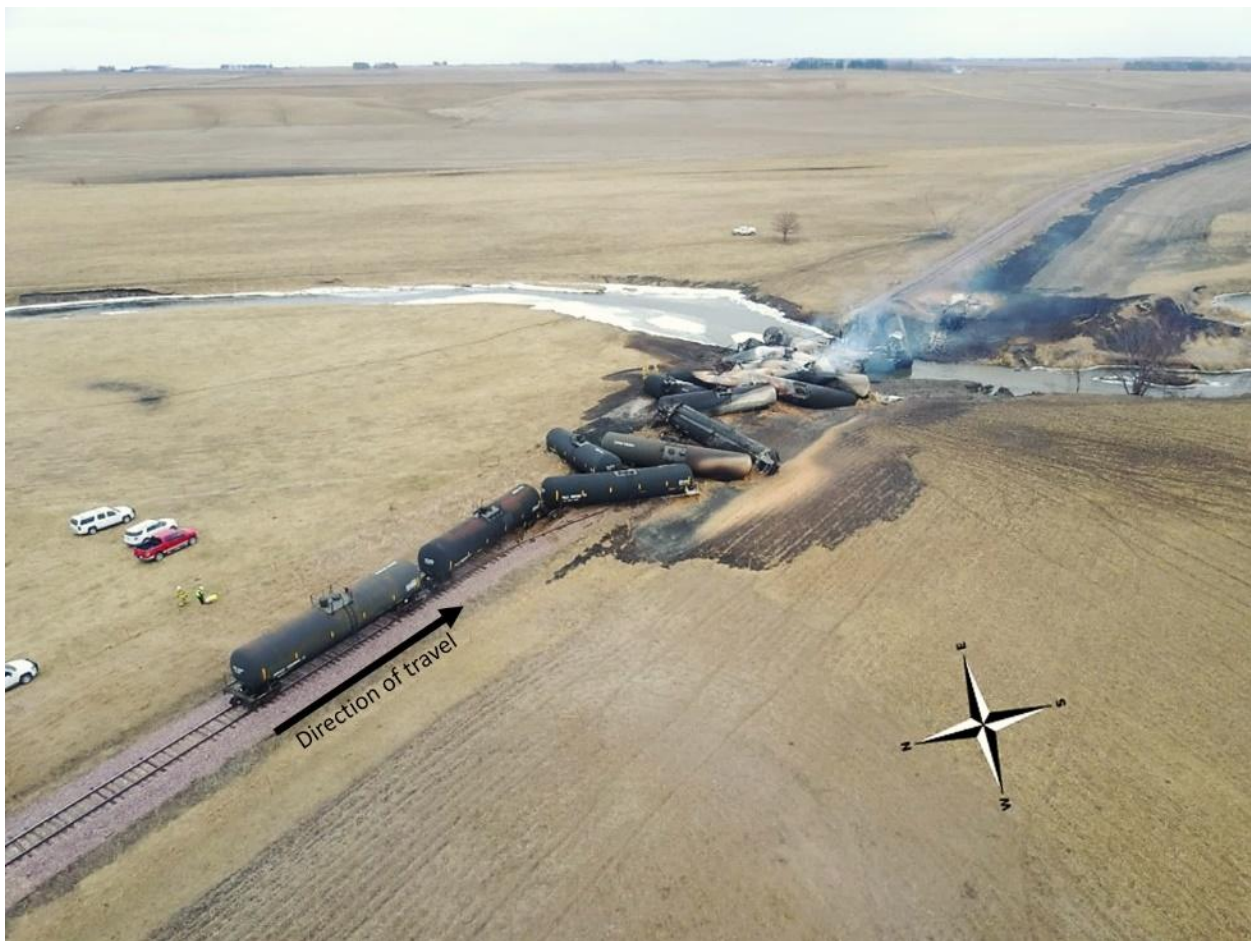
**Figure 1.** The accident site.

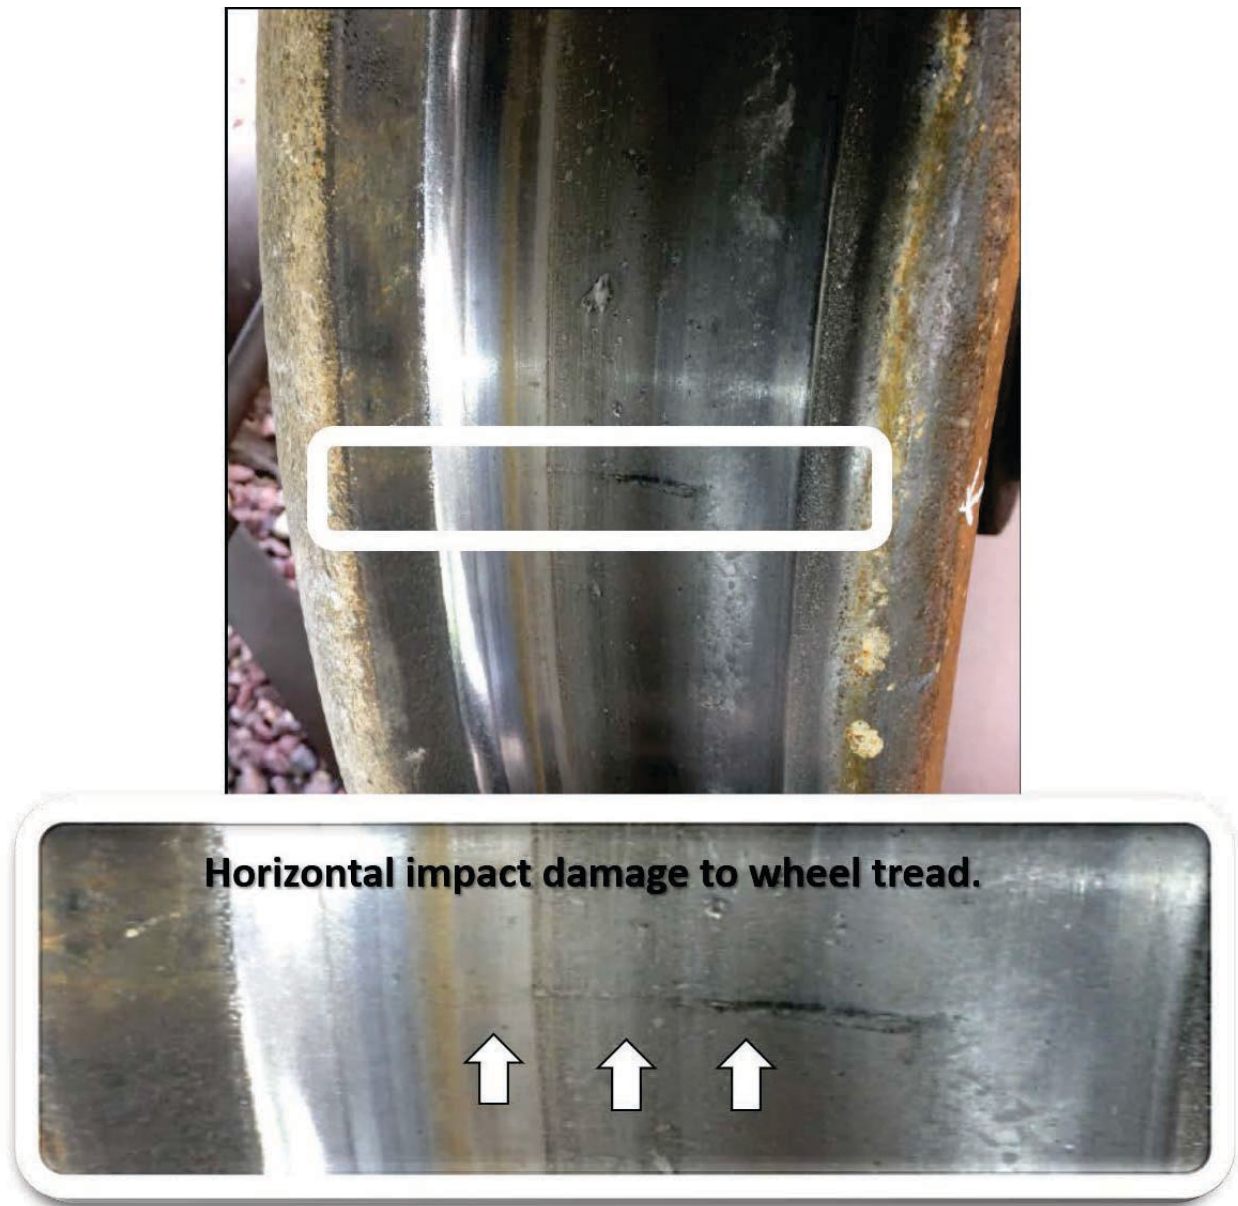
NTSB investigators inspected the nonderailed cars (1st through the 20th) that traveled over the Jack Creek Bridge. NTSB investigators observed that the wheels on the right side of several cars that rolled over the right-side rail (or south rail) exhibited fresh horizontal impact damage (impressions perpendicular to the wheel tread).<sup>10</sup> (See figure 4.) No such damage was observed on the wheels on the left side of the train. (See figure 5.)

**Figure 5.** Wheel tread impact damage on TCBX 198115.

The damage began to appear on the fourth tank car, but was not present on the fifth or sixth tank cars. On tank cars 10 through 20, the impact damage was observed on every car, becoming more pronounced toward the 20th car, which was a tank car. The 20th car, TCBX 198115, was the last car that traveled through the derailment area without derailing.<sup>11</sup>

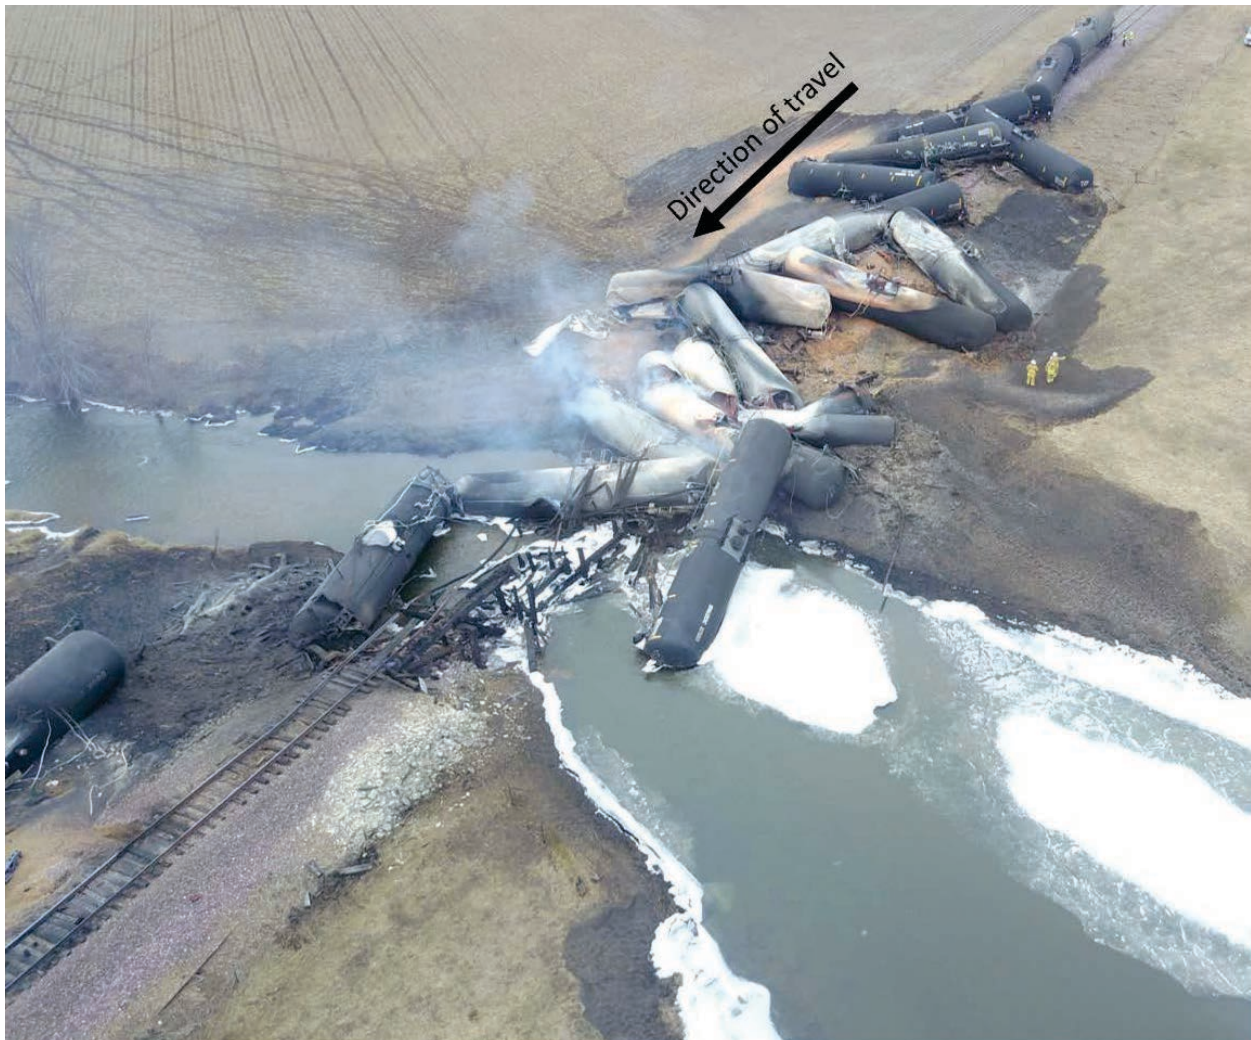
Significant track structure damage in the immediate area of the derailment prevented a comprehensive inspection of an intact track structure. The total amount of damaged and displaced rail was about 400 feet. (See figure 6.) NTSB investigators recovered, identified, and arranged about 390 feet of the damaged and displaced rail. The fractured pieces were “reassembled” based on the manufacturer, manufacture dates, and rail fracture characteristics. Each section was visually examined on scene, labeled, and inventoried. A total of 14 pieces were sent to NTSB’s Materials Laboratory in Washington, DC, for a metallurgical examination.

**Figure 6.** Aerial photograph of the derailed train and the damaged track.

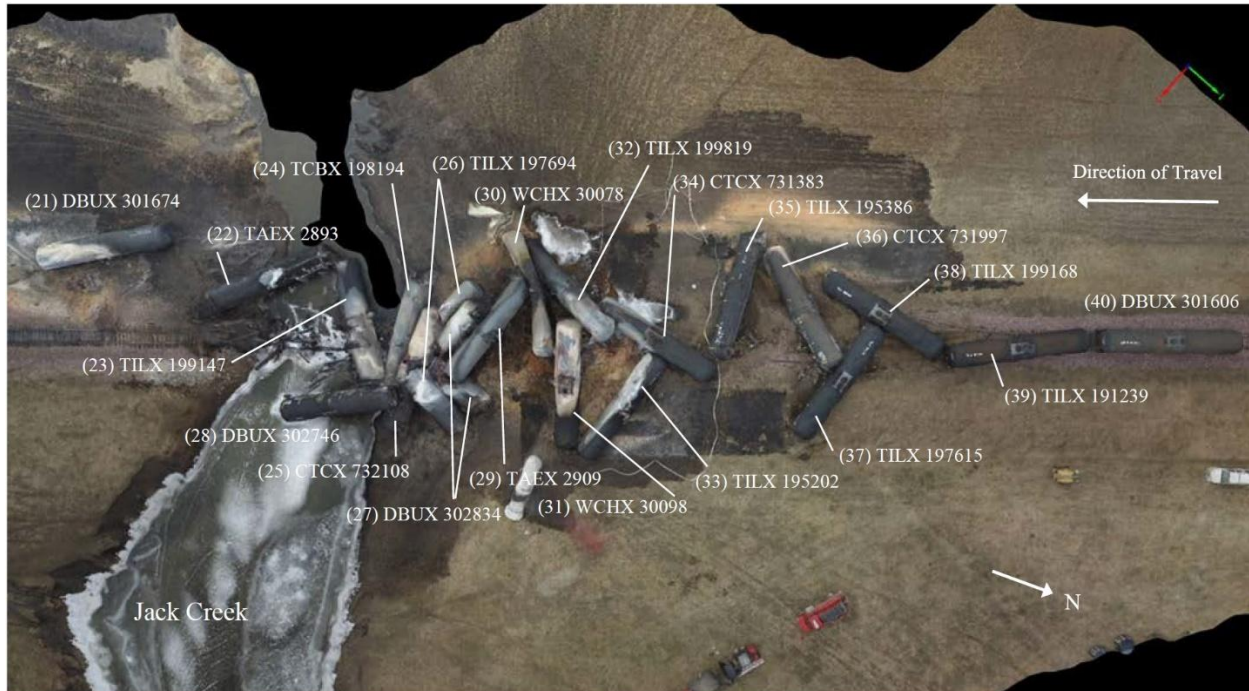
The orientation of the ethanol tank cars following the derailment is indicated in figure 7. After transloading the tank cars, crews staged them in a nearby farm field for examinations.

**Figure 7.** Derailment scene and tank car identification. The numbers in parentheses identify the location of the tank cars.

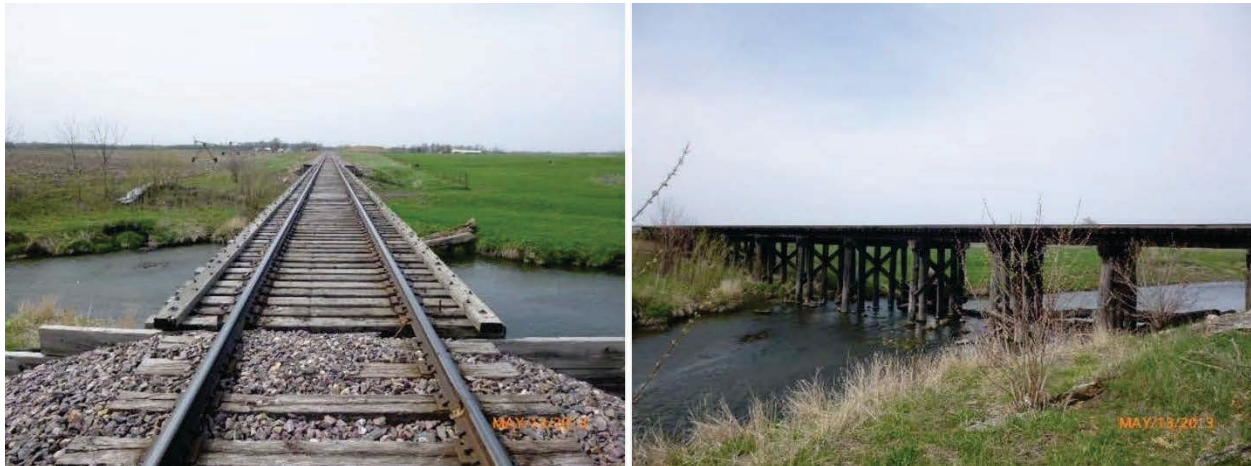
The Jack Creek Bridge was an 11-span, timber, open-deck bridge that measured 152 feet long. (See figure 8.) The bridge was destroyed by the derailment and ensuing fire.

**Figure 8.** Jack Creek Bridge in 2013. (Photographs courtesy of UP.)

According to UP documentation, this bridge was last inspected on October 11, 2016. The inspection record shows that the bridge was built in 1937 and the bridge deck ties were replaced in 1970. Although no defects or abnormalities were noted during this inspection, the UP bridge inspector mentioned in the report that there was insufficient ballast on the approach to the bridge with the comment, “high end, first tie off of bridge hanging 2 1/2 [inches].”<sup>21</sup> UP was unable to provide any documentation that this condition had been corrected prior to this derailment.

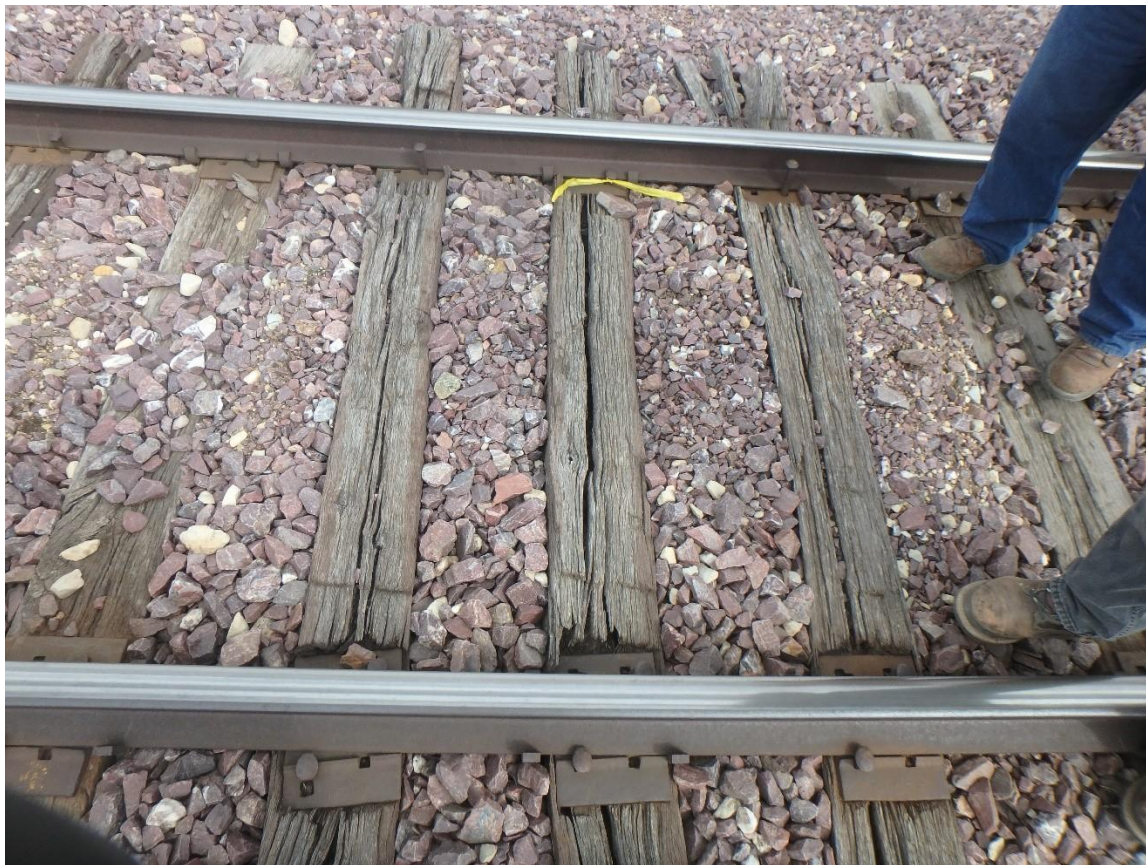
In the area of the derailment, the track structure was misaligned as a result of derailment forces. NTSB investigators took gage measurements, observed track alignment, and measured track surface leading into the disturbed track. No exceptions were taken to the track geometry in the track segment from MP 57.10 into the derailment area. NTSB investigators noted profile conditions ranging from 3/4 inch to 1-1/4 inches in the areas with defective crossties. (See figure 10.)

**Figure 10.** Split and broken crossties, that are not holding fasteners, immediately west of MP 56.9. The tie plates in the foreground have cut into the broken crossties.

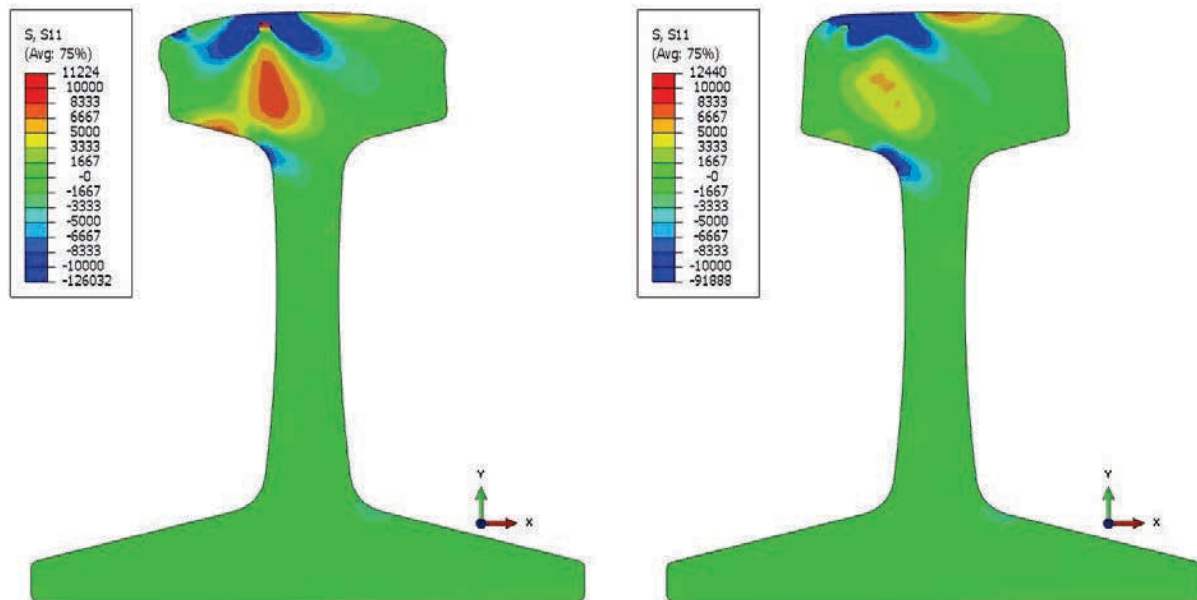
**Figure 13.** Comparison of the calculated internal transverse stresses of 90-pound rail supporting wheel loads using a worn rail profile with soft track support (left) and standard rail profile with stiff track support (right). In both illustrations, the gage side is on the left and the field side is on the right.

The model showed that the transverse stress in the rail head region was dependent on the head area of the rail cross-section and the track support conditions. A worn rail has less head area, which results in higher transverse stress in the head region. Comparing the two rail profiles

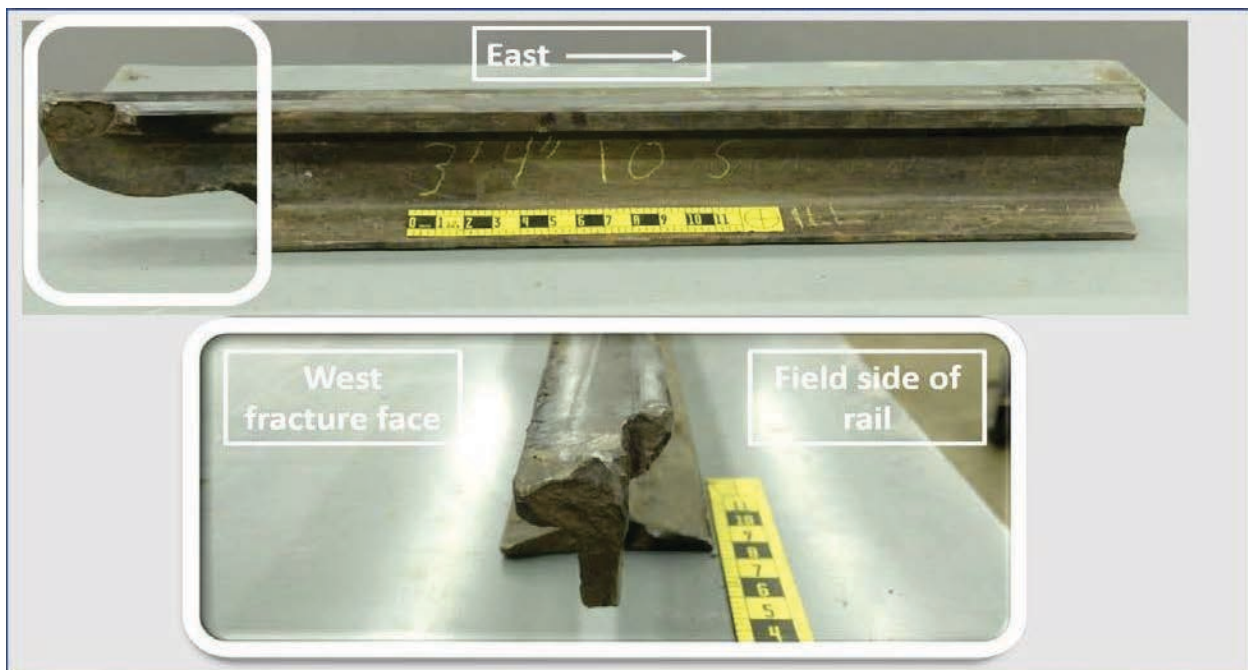
NTSB's Materials Laboratory Factual Report includes examination details on a particular section of the broken rail—a section of the south rail measuring 3 feet, 4 inches—that was located near the Jack Creek Bridge.<sup>65</sup> (See figure 14.)

**Figure 14.** Section 10S from the south rail that was recovered from the accident, showing the field side and the west fracture face.
