National Transportation Safety Board

Railroad Accident Brief

BNSF Railway Train Derailment and Subsequent Train Collision, Release of Hazardous Materials, and Fire

Casselton, North Dakota

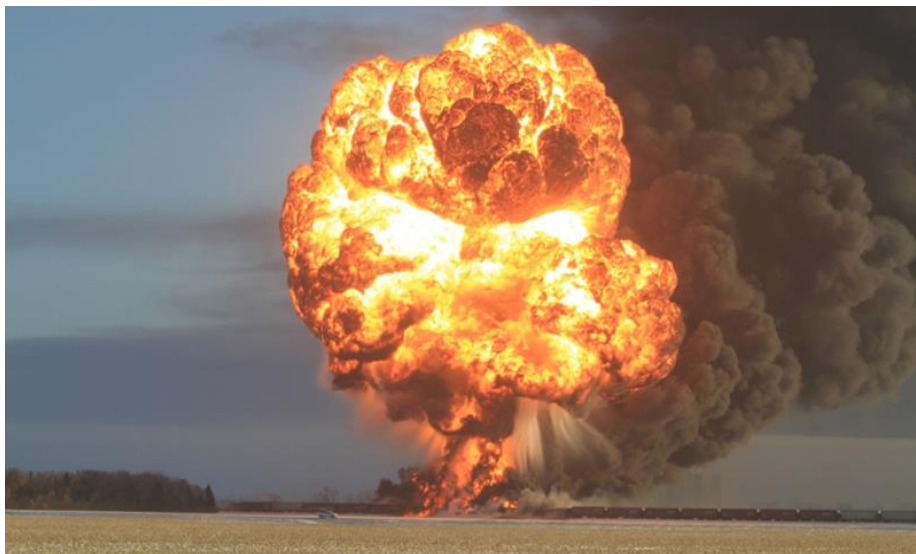
Figure 1. Burning petroleum crude oil. (Photo by Dawn Faught)

In total, about 476,000 gallons of crude oil were released from derailed tank cars that were punctured, from those with damaged bottom valves and top fittings, and from those that ruptured during the fire. The spilled crude oil created pools that caught fire. Other derailed tank cars eventually ruptured as the pool fires weakened the tank steel and increased the internal pressure. The resulting thermal tears released superheated crude oil vapor that immediately erupted into violent fireballs above the tank cars. (See figure 1.)

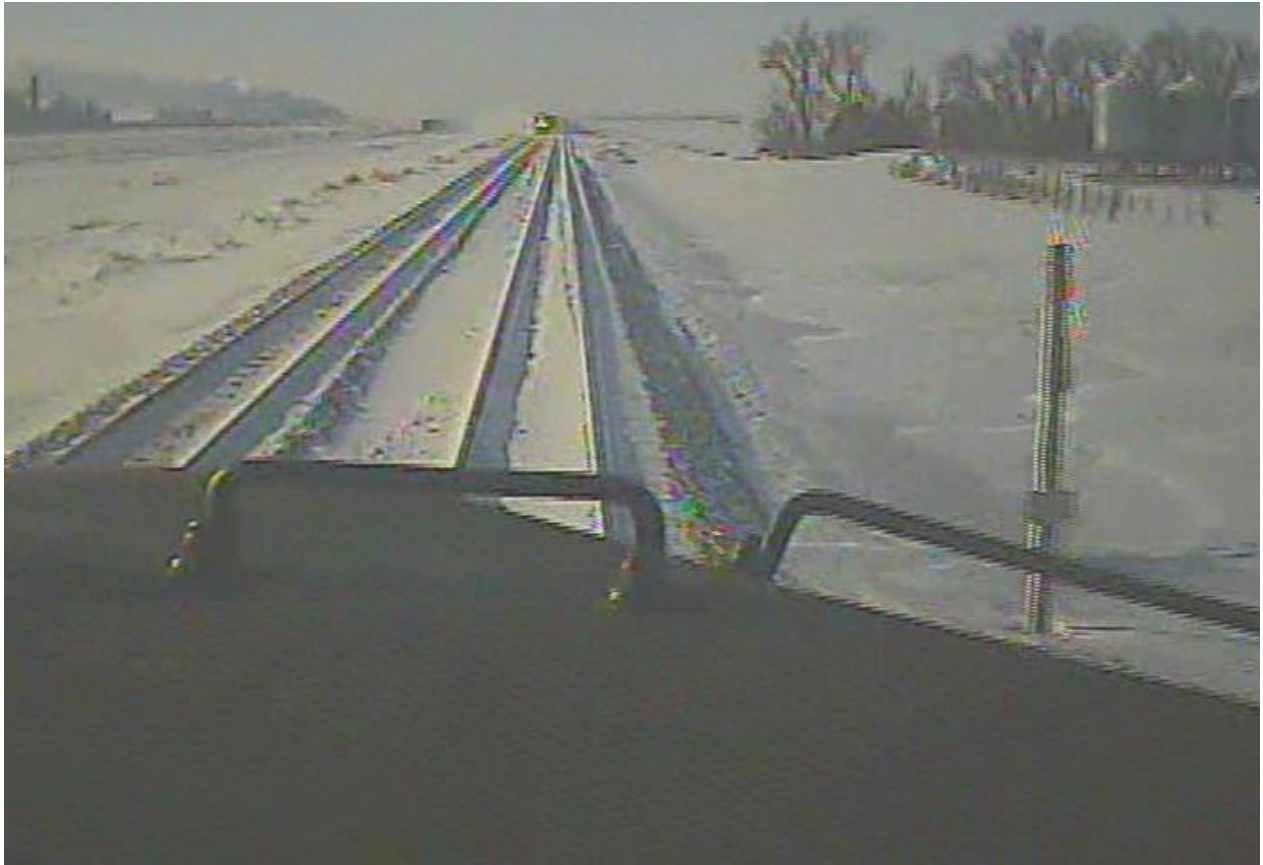
Figure 2. View from forward-facing video camera of grain train at the time the train went into emergency braking because the train had separated.

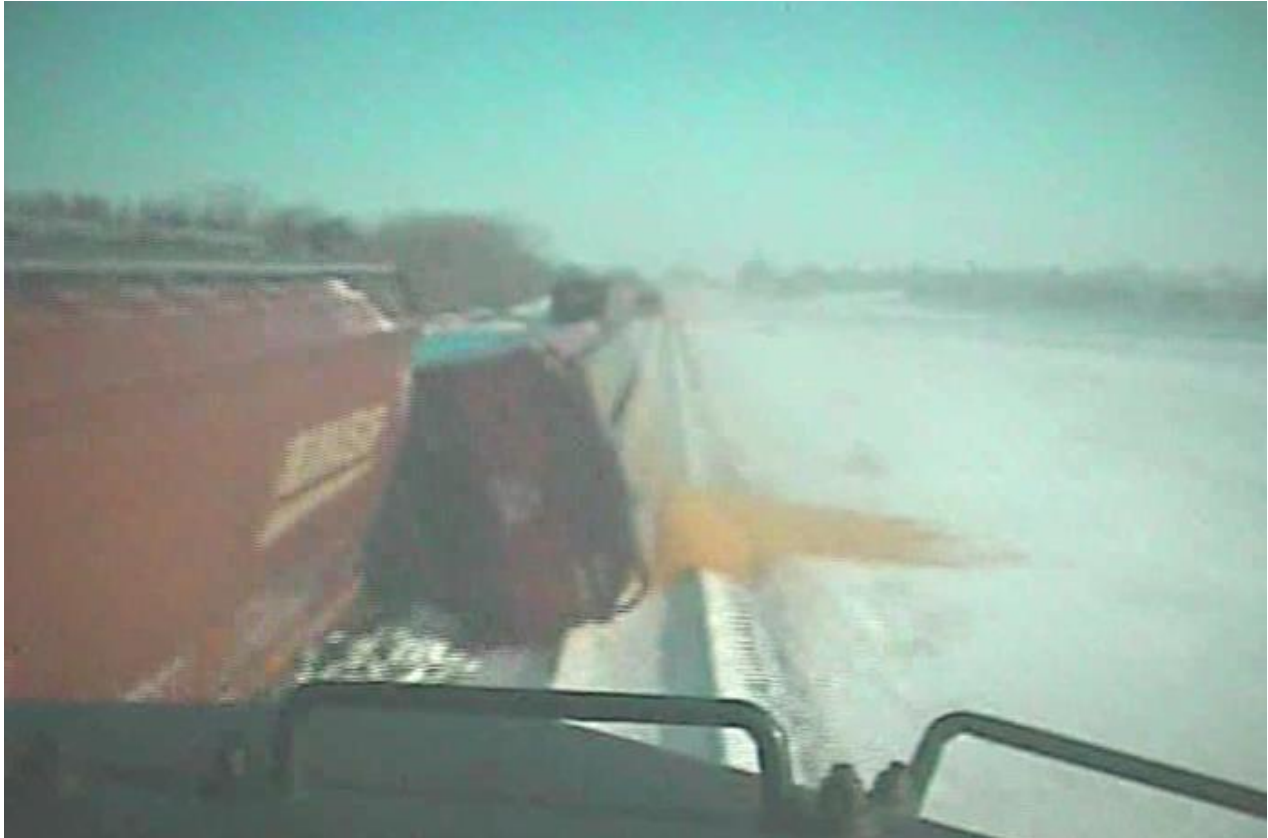
Figure 3. View from forward-facing video camera of oil train before collision.

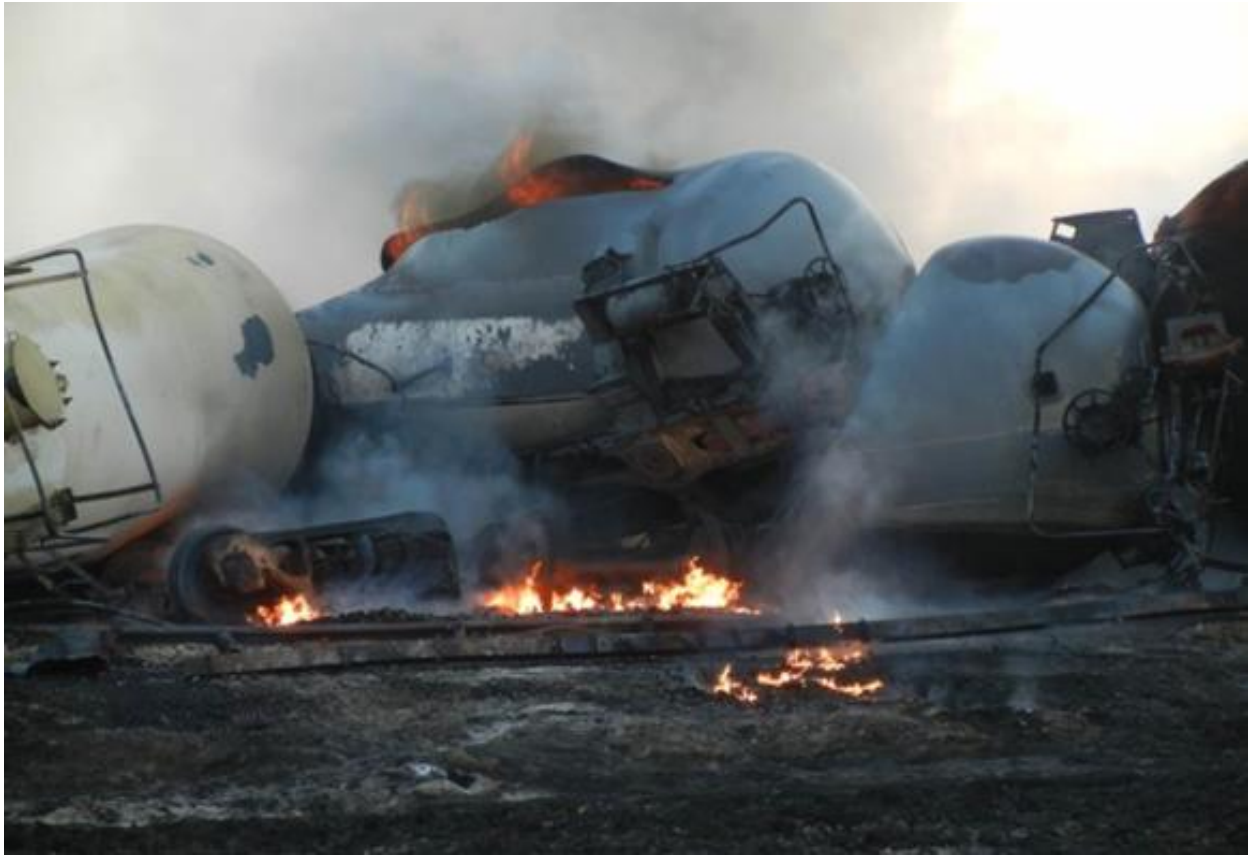
Twenty hazardous materials tank cars derailed in this accident. These tank cars were in positions 2 through 21 in the train. All of the 20 derailed tank cars were general service US Department of Transportation (DOT) specification 111 (DOT-111) tank cars that contained petroleum crude oil from the Bakken region of North Dakota.¹³ Eighteen of these tank cars were breached and released product. (See figure 4.) The damages included 13 tank cars with torn or punctured heads and shells, 3 with thermal tears, 10 with damaged valves and fittings, and 3 that released product from bottom outlet valves. Some tank cars had more than one breach of the types listed here.

Figure 4. Derailed tank car with large thermal tear.

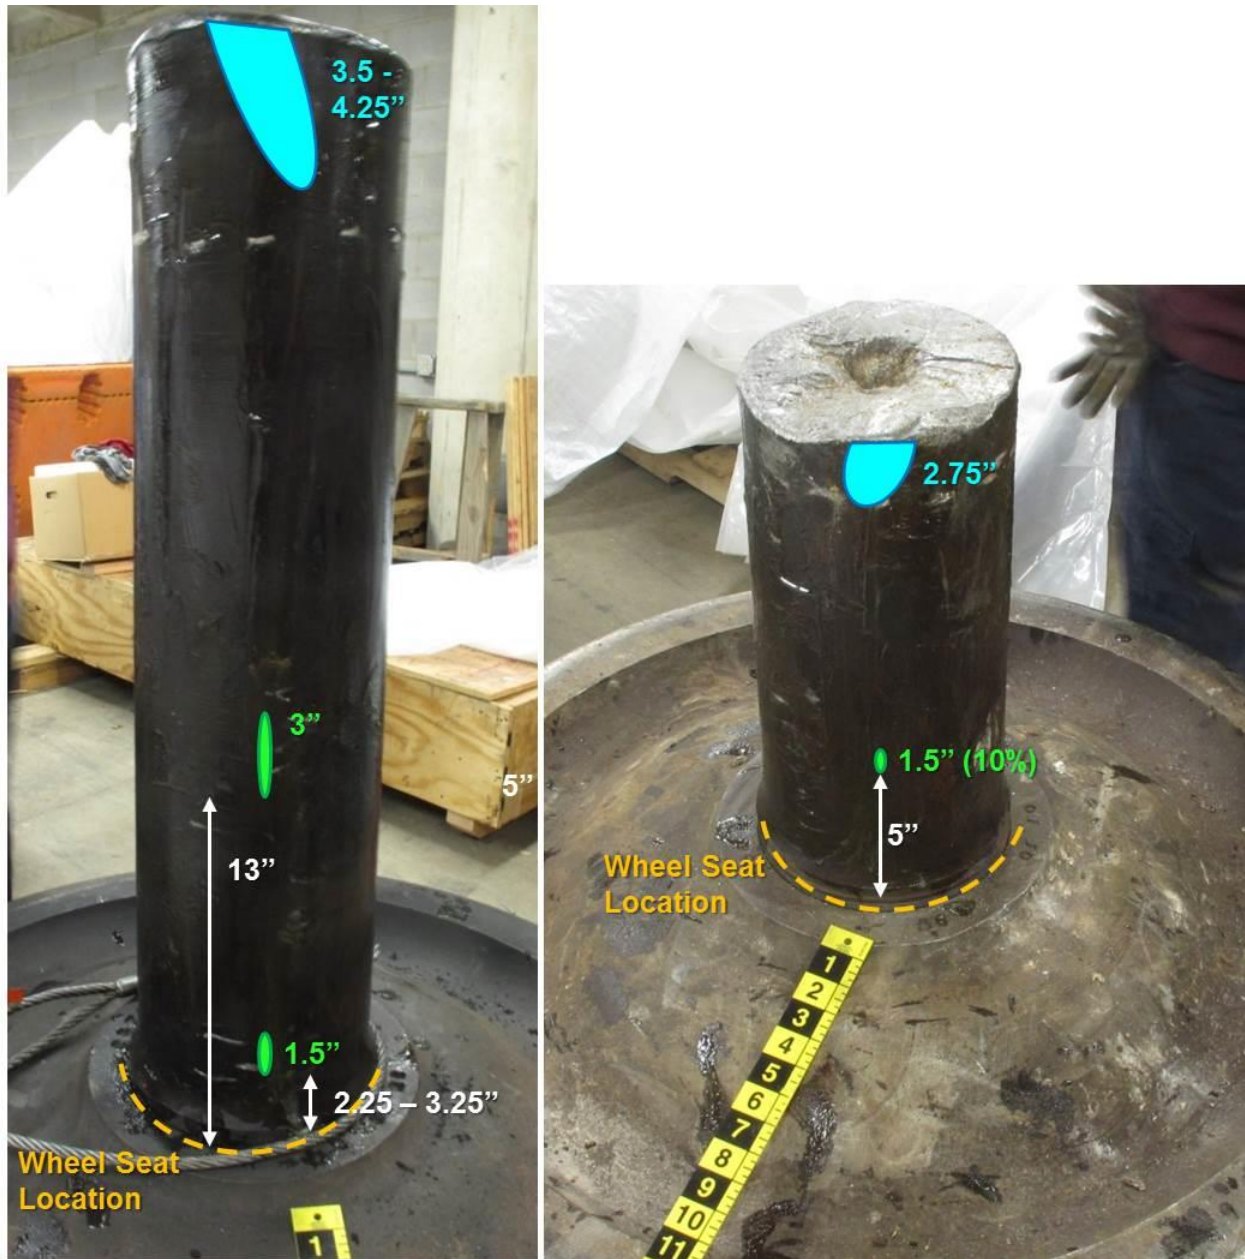
The NTSB performed an ultrasonic inspection of the axle to characterize the dimensions of the void. Figure 5 shows the two broken axle segments after testing, indicating the size and location of the exposed, confirmed void at the fractured ends of both axle segments (shown in blue). The figure also shows three other indications found by the inspection, which at the time

were potential voids, all of which were located closer to the wheel seat ends of the axle segments (shown in green).

Figure 5. Axle segments after nondestructive ultrasonic testing.

The AAR 1998 MSRP in place at the time of the 2002 axle manufacture prescribed an inspection method that was not capable of detecting the internal void. The MSRP was updated in 2009 to require both axial and radial (along the length of the axle) ultrasonic inspections to better locate internal voids. However, there was still no requirement for wheel shops to conduct this type of inspection of secondhand-use axles.²³ The NTSB concludes that had the broken axle been subjected to more thorough nondestructive testing when its bearings and wheels were remounted in 2010, the void would likely have been found, and the axle would not have been returned to service.

Require secondhand-use railroad axles to undergo nondestructive testing specifically designed to locate internal material defects in axles.

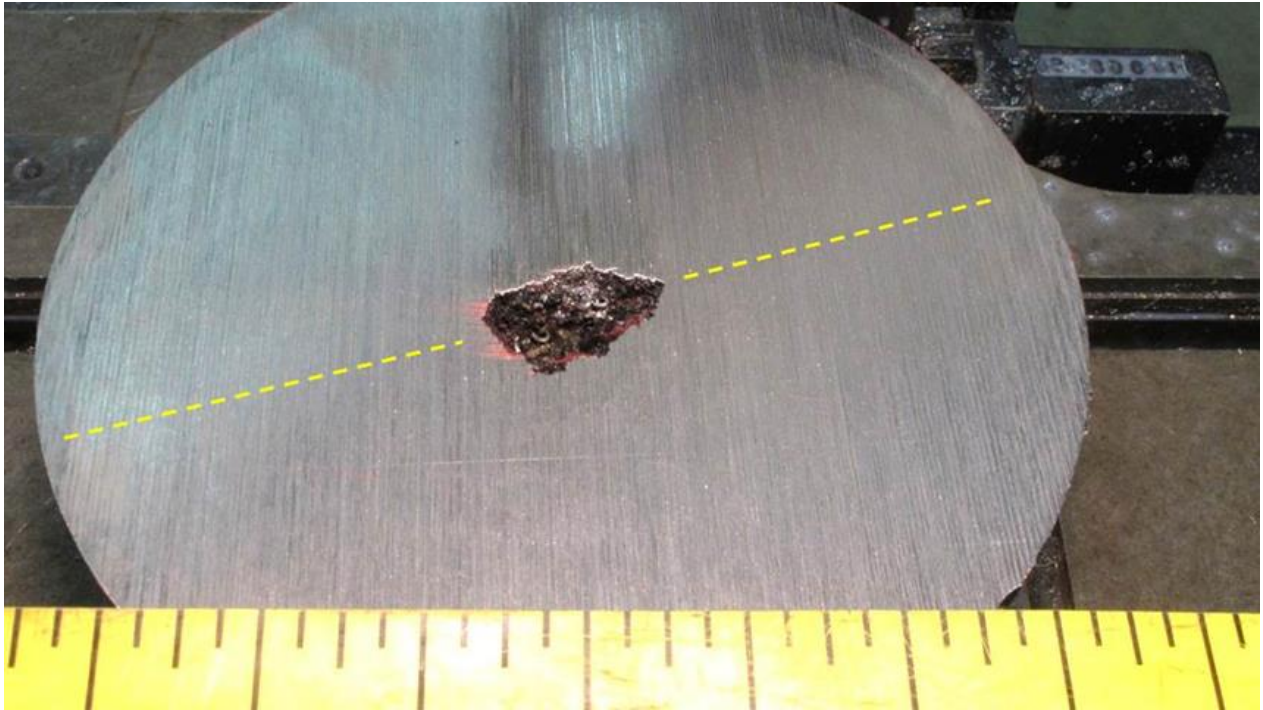
The internal centerline void on the longer axle segment, after removal of the fracture surface (about 1 inch deep), is shown in figure 6. On the cut plane, the void measured 1.25 inches by 0.75 inches. 0.

Figure 6. Centerline void on axle segment.

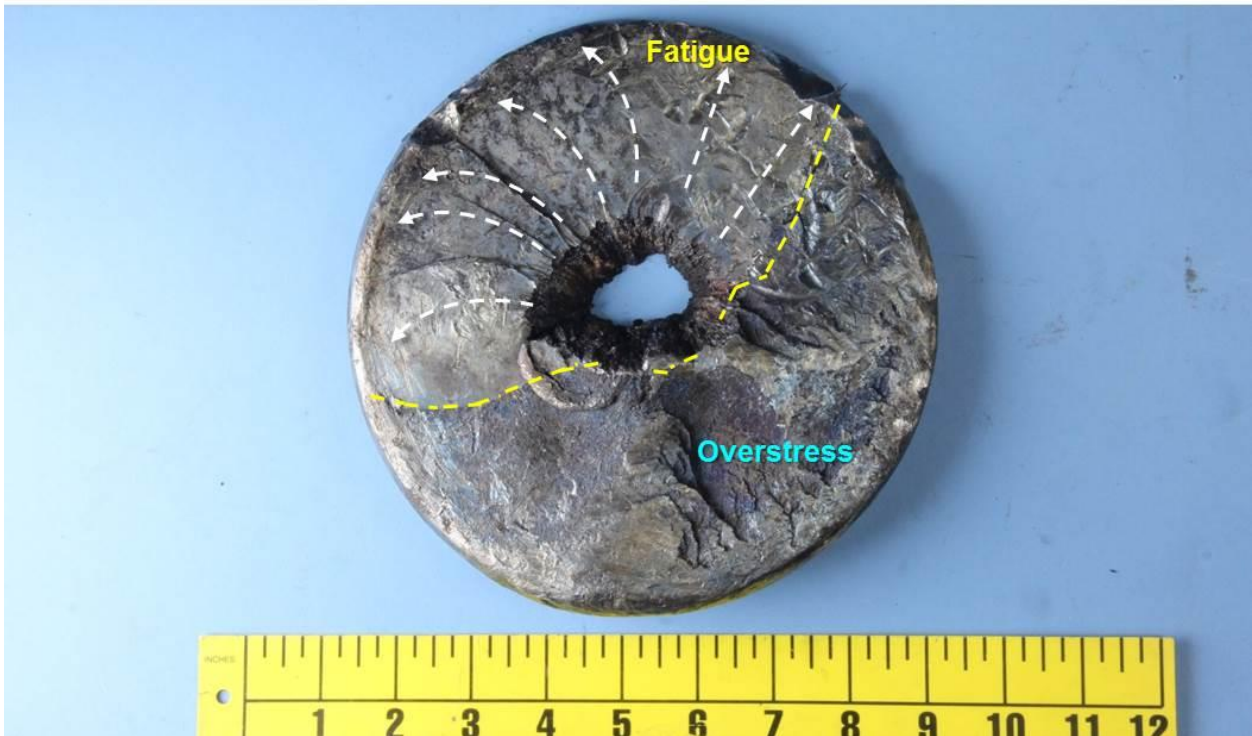
After the fracture surface was cleaned, fracture surface features indicative of fatigue and overstress were visible. (See figure 7.) Examination using a scanning electron microscope confirmed fatigue striations propagating from the internal void. The dashed line is the boundary between the fatigue and the overstress areas of the fracture.

Figure 7. Surface of axle fracture.

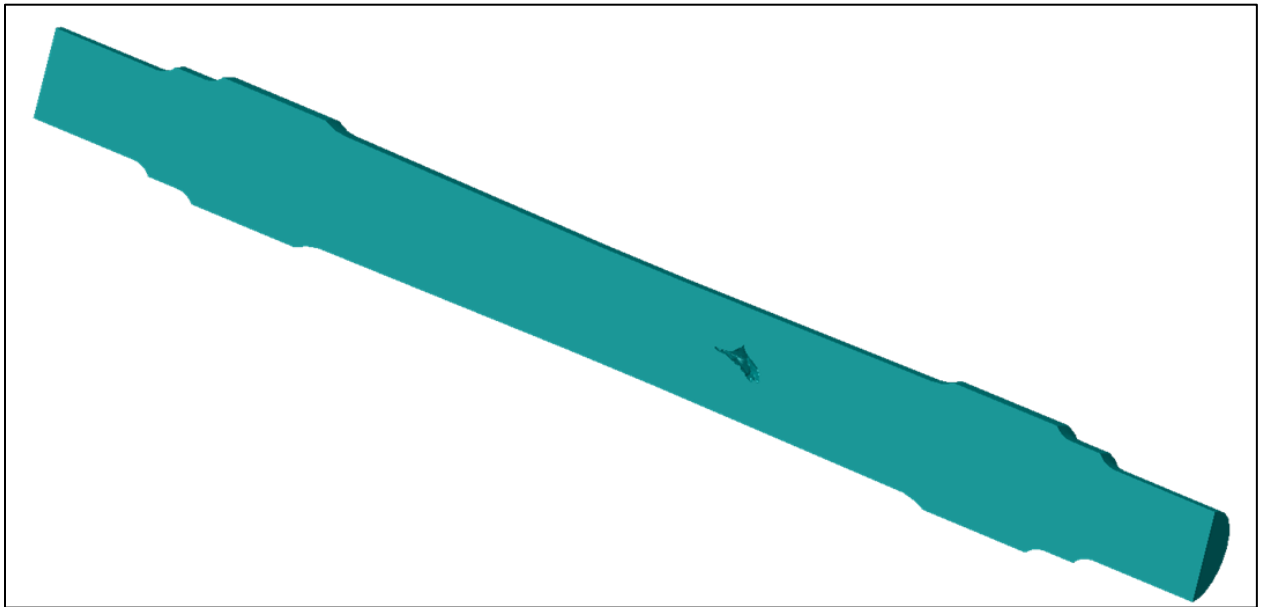
The fractured axle halves were laser scanned to develop a three-dimensional geometrical model of the axle including the void. This geometrical model and added details from specification drawings were combined to create a model of the axle and wheel assembly; and the model was analyzed using finite element modeling to evaluate the stress distribution in the axle. The geometry of the void in the axle is shown in figure 8. The model of the axle/wheel assembly was subjected to loads that result in a bending deformation as shown in figure 9. Under a bending deformation like this, the maximum tensile stress in the axle is expected to be at the top surface of the axle, but the sharp corner in the void created a stress concentration so that the maximum tensile stress would occur at the edge of the void, as shown in figure 10. The modeling showed that the internal void caused a concentration of stress substantially higher than the expected bending stress in the axle and that this stress was high enough to initiate fatigue cracking. The location of this calculated stress concentration was consistent with the region at the edge of the void where fatigue cracking initiated.

Figure 8. Geometry of the axle with the internal void defect.

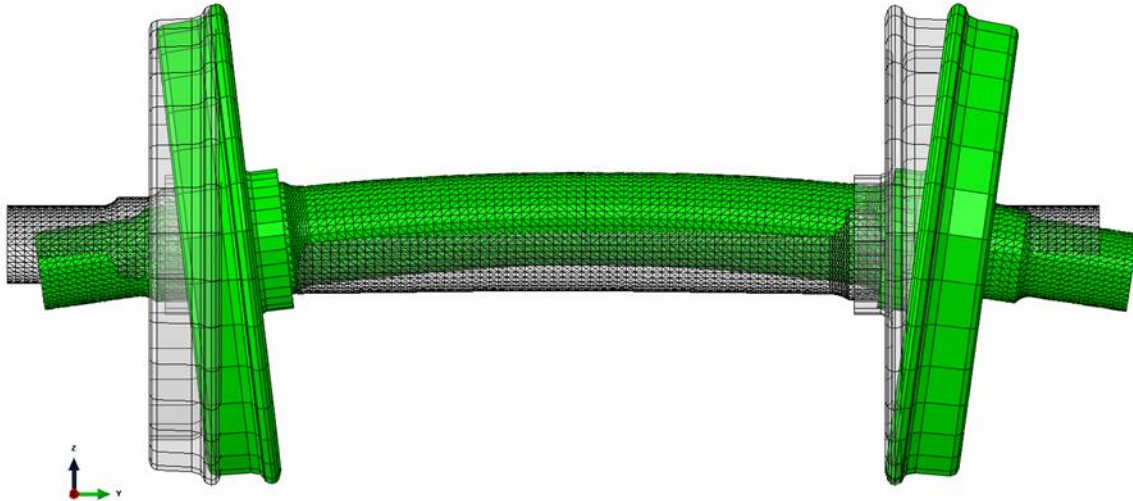
Figure 9. Computer model of deformed shape of bent wheelset. (Deformation magnified 50 times.)

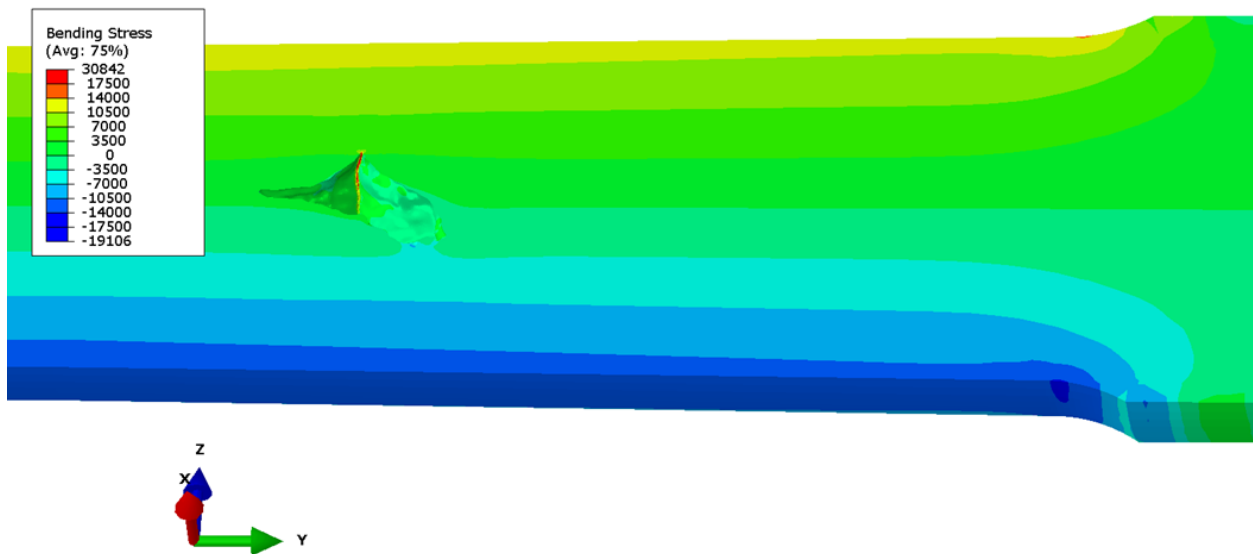
Figure 10. Cutaway view showing bending stress contours (in pounds per square inch).

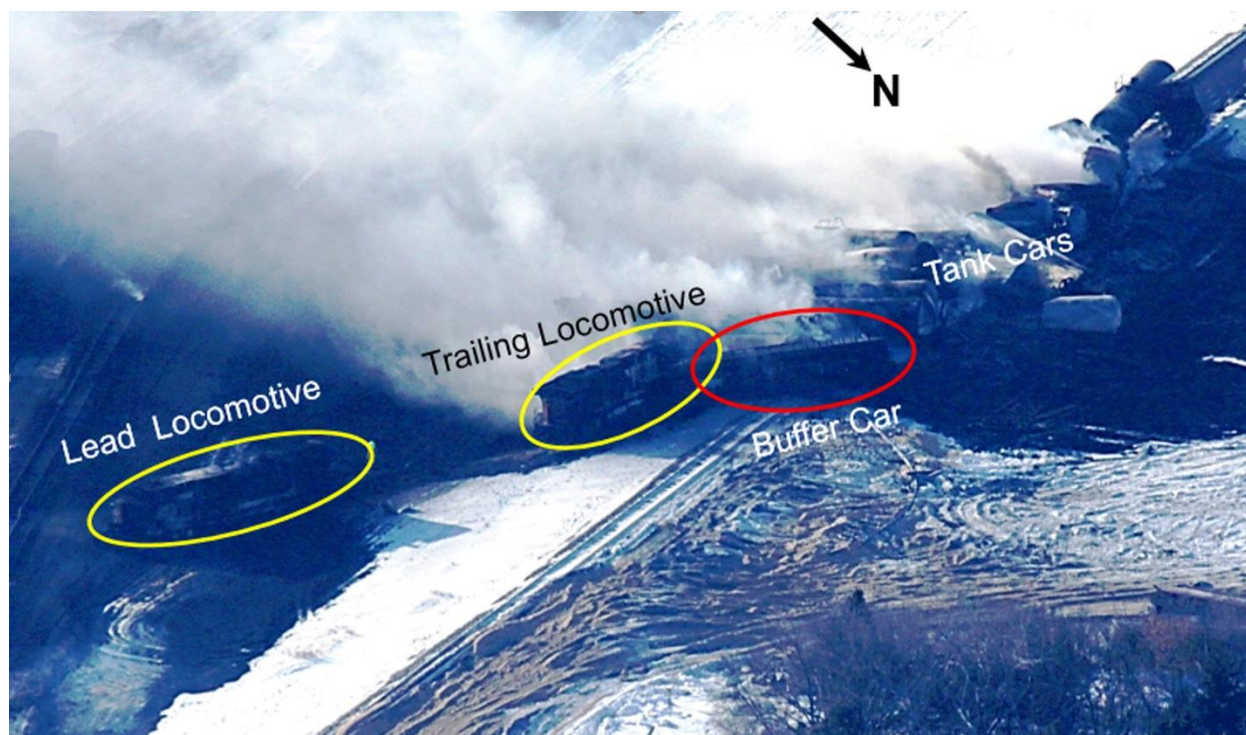
Figure 11. Aerial view of of oil train after collision. (PHMSA photo)

Postaccident examination of the derailed tank cars in this accident found that hazardous materials tank cars in positions 2 through 5 were breached and exhibited severe thermal damage. The proximity of the locomotives to the hazardous materials tank cars placed the oil train crew in peril following release of the crude oil that ignited and engulfed the locomotives in the postaccident fire within a minute or two. The NTSB concludes that had additional buffer cars, instead of flammable hazardous material tank cars, been placed in positions 2 through 5 of the train, the danger to the train crew would have been significantly reduced and would have allowed for more time for a safe egress from the locomotive. The NTSB further concludes that a one-car buffer between the locomotives and the hazardous materials exposes the train crew to unnecessary risk in accidents where cars are derailed closer to the head end of the train.

49 *CFR* 174.85 to reflect those findings. The NTSB also recommends that the FRA evaluate the risks posed to train crews by hazardous materials transported by rail, determine the adequate separation distance between hazardous materials cars and locomotives and occupied equipment that ensures the protection of train crews during both normal operations and accident conditions, and collaborate with PHMSA to revise 49 *CFR* 174.85 to reflect those findings. These new safety recommendations supersede Safety Recommendations R-08-13 and -12 to PHMSA and the FRA, respectively. Therefore Safety Recommendations R-08-12 and -13, reclassified “Closed—Unacceptable Action” in this report (under Previous NTSB Actions) are reclassified “Closed—Unacceptable Action/Superseded.” The NTSB concludes that the regulatory interpretation 06-0278 permits PHMSA, the FRA, and the railroads to ignore the plain language of 49 *CFR* 174.85 for unit trains carrying hazardous materials allowing them to operate with only a single nonplacarded car rather than five nonplacarded cars. In the interim, until the completion of Safety Recommendation R-17-01, the NTSB recommends that PHMSA withdraw regulatory interpretation 06-0278 that pertains to 49 *CFR* 174.85 for positioning placarded rail cars in a train and require that all trains have a minimum of five nonplacarded rail cars between any locomotive or occupied equipment and the nearest placarded car transporting hazardous materials, regardless of train length and consist.
