National Transportation Safety Board

Pipeline Accident Brief

Natural Gas Explosion at Educational Facility

Minneapolis, Minnesota

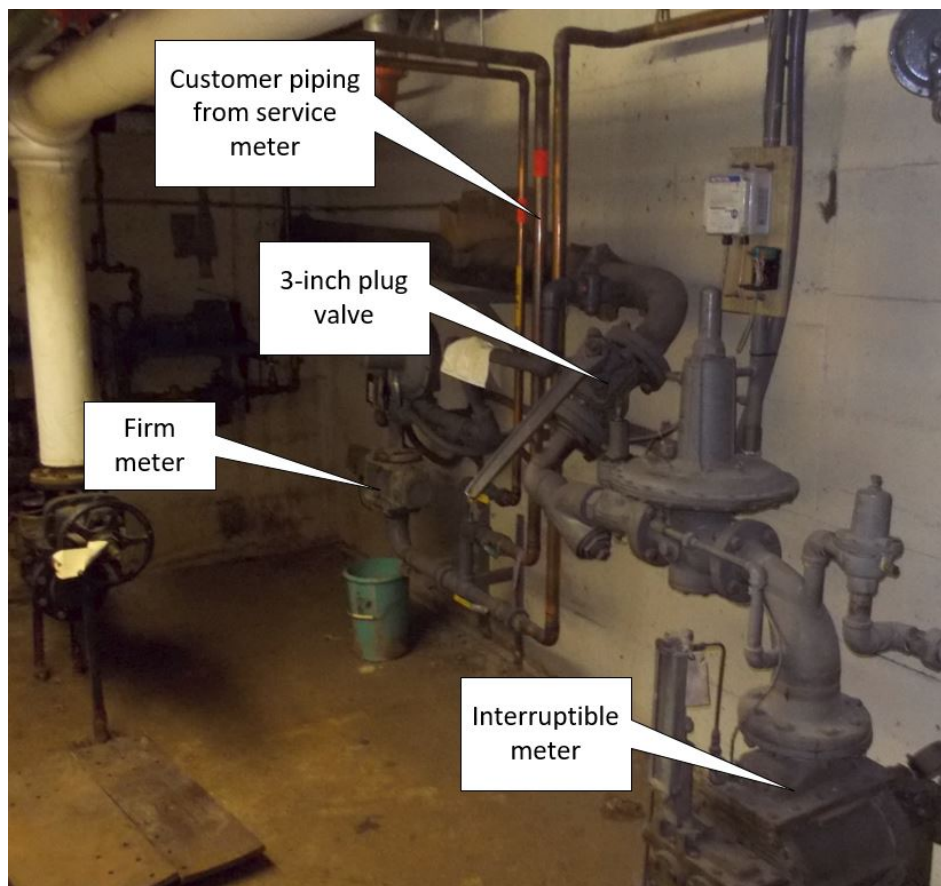
On the day of the accident, the two-person MMI pipefitting contractor crew was making modifications to piping upstream of the firm and interruptible meters, meaning the two-person crew was working on jurisdictional piping. Figure 3 is a photo taken before the accident showing the vault area of the center section of the building basement and describing the individual damaged piping elements involved in the accident. The photo depicts the location of the nonjurisdictional section of gas pipe and the jurisdictional piping that was being dismantled by the contractor work crew during the accident.

Figure 3. Photo taken before the accident of vault area of the center section of the building basement. (Source: CPEMG.)
