**NATIONAL TRANSPORTATION SAFETY BOARD**  
Office of Aviation Safety  
Washington, D.C. 20594

**UAS Aerial Imagery Factual Report**

**A.    ACCIDENT            DCA17MR007**

Location:               Graettinger, Iowa  
Date:                    March 10, 2017  
Time:                    0050 Local Time (CST)  
Event:                   Union Pacific unit train derailment

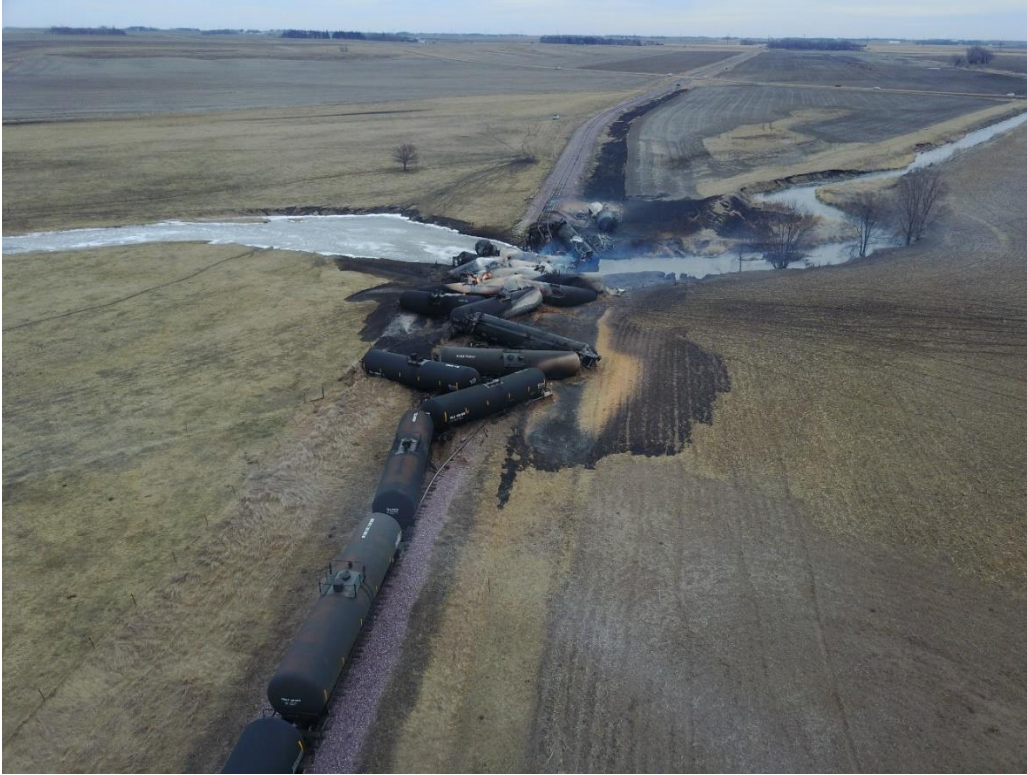
Figure 3 – Oblique Overview, looking in the direction of travel

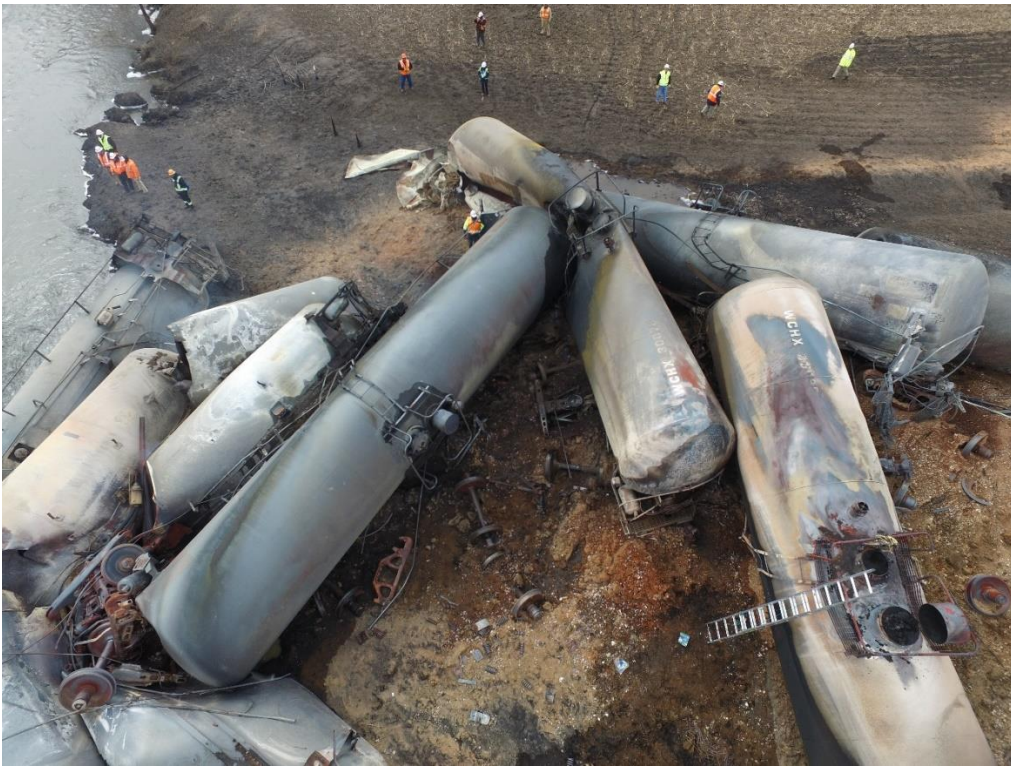
Figure 4 – Overhead of damaged cars, Jack Creek is to the left

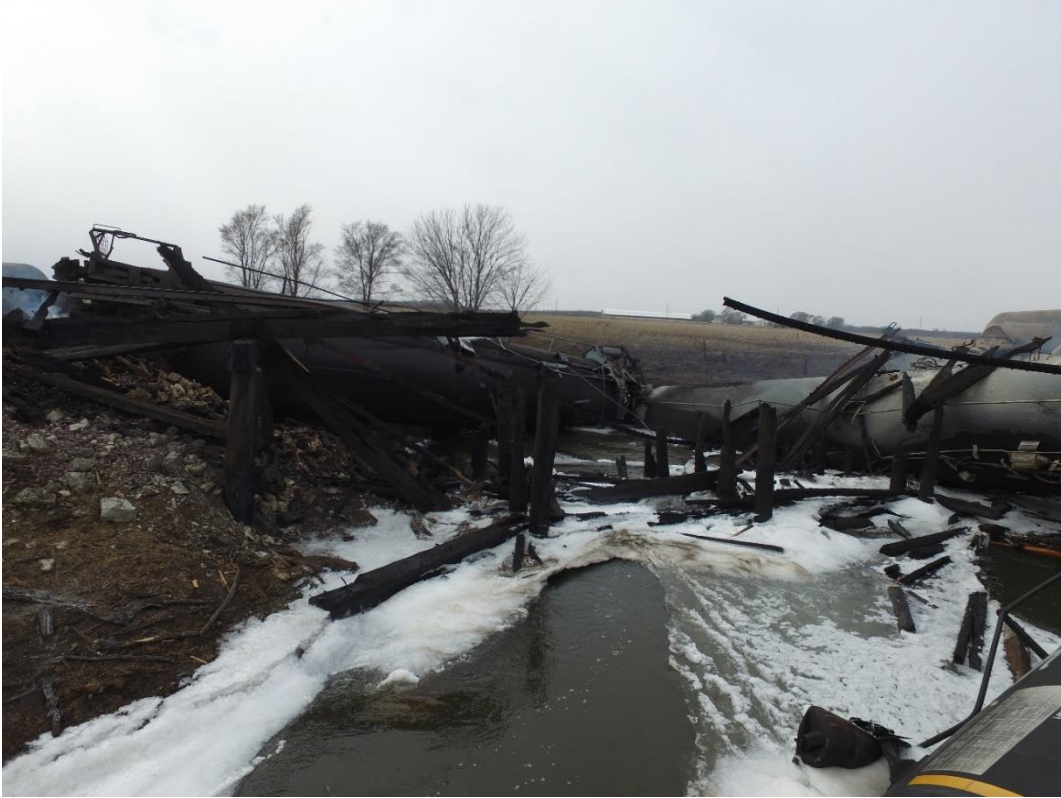
Figure 5 – Collapsed trestle looking east, viewpoint is at the original elevation of the trestle.

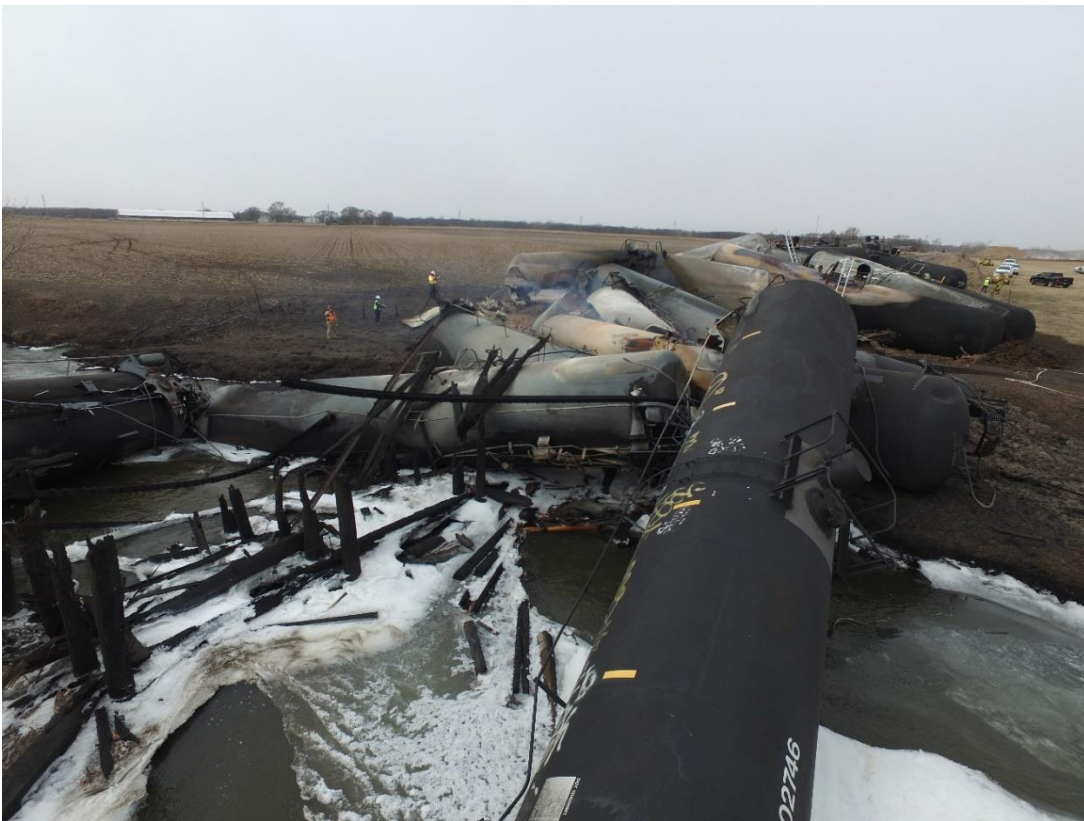
Figure 6 - Trestle from north side of creek, looking opposite the direction of travel.

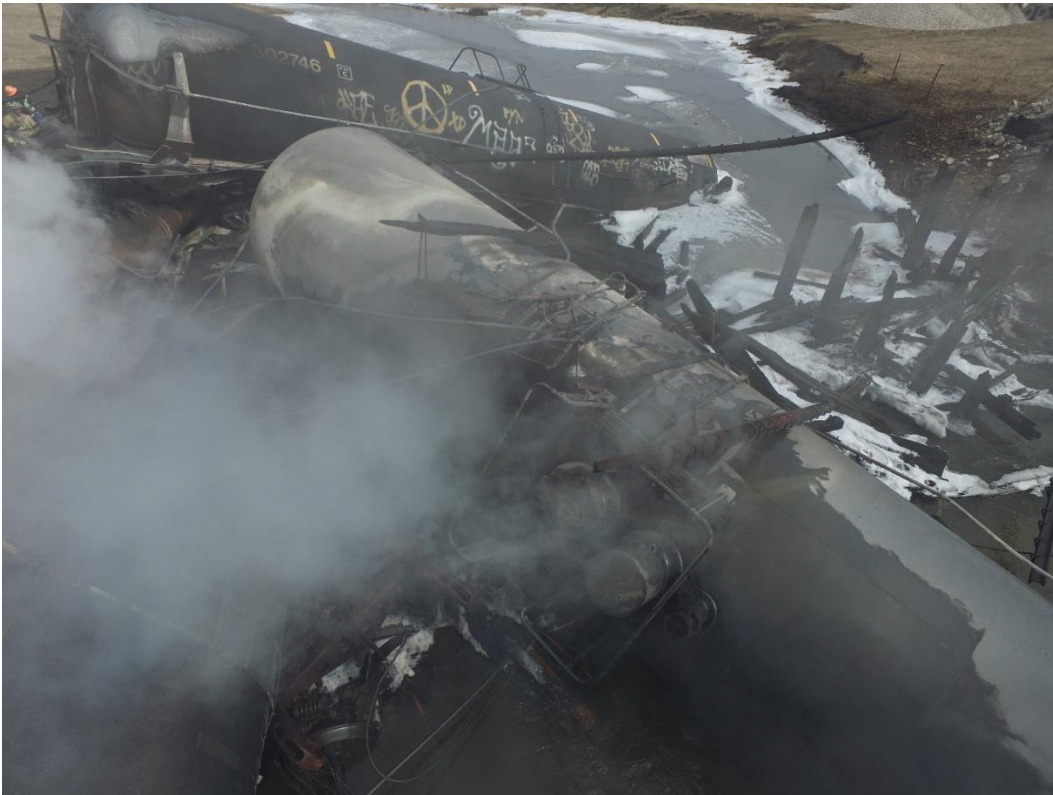
Figure 7 - Trestle and fractured track from west side
