# NATIONAL TRANSPORTATION SAFETY BOARD

## Agricultural Aerial Guidance System

Specialist's Factual Report  
by Bill Tuccio, Ph.D.

Location: Wilmot, Arkansas  
Date: August 1, 2015  
Aircraft: Air Tractor AT-602  
Registration: N6007N  
Operator: Baylee Company  
NTSB Number: CEN15FA331

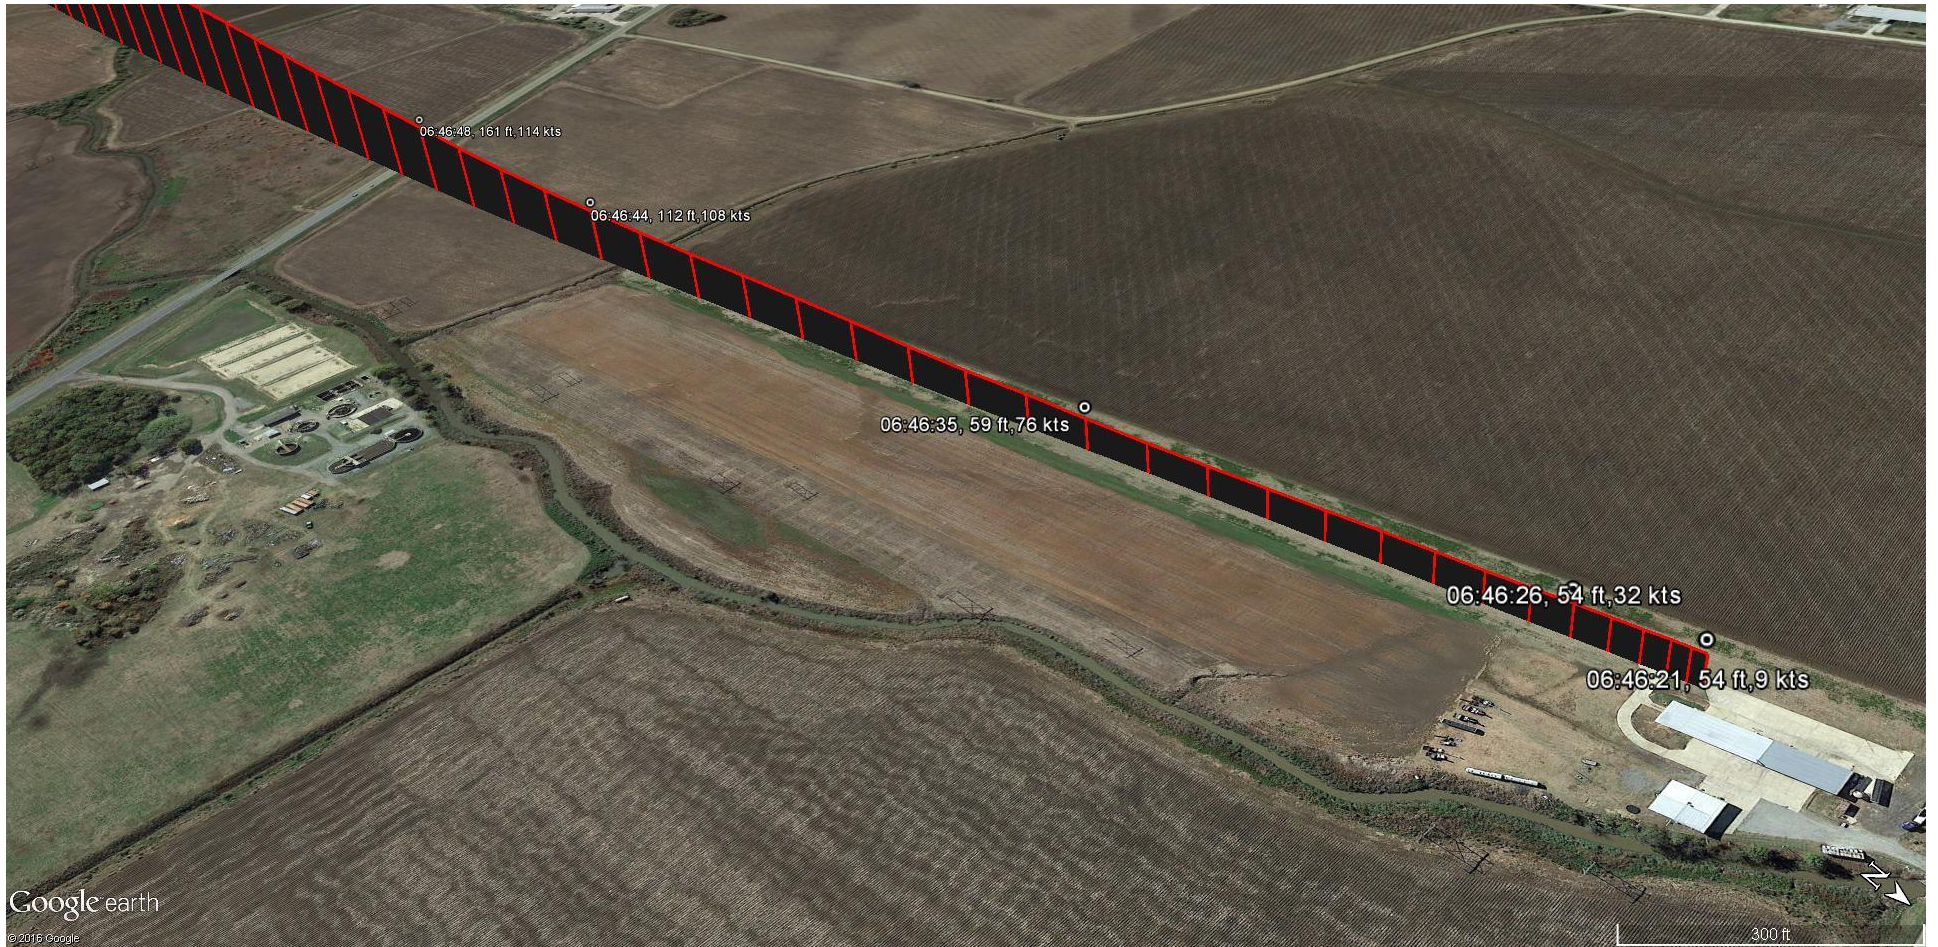
Figure 1. Start of recording.

- At about 0646 CDT, the aircraft departed the M32 airport to the south, initially climbing to about 1,000 feet MSL, and proceeding south.
- Enroute the aircraft descended to about 500 feet MSL and turned southwest about 0651 CDT.
- 
- At about 0653 CDT, the aircraft began to climb to about 1,000 feet, and begin to perform a 270 degree turn over a grouping of trees, towards the northwest. Towards the end of this turn, the altitude decreased and then began to increase again as the aircraft turned left.

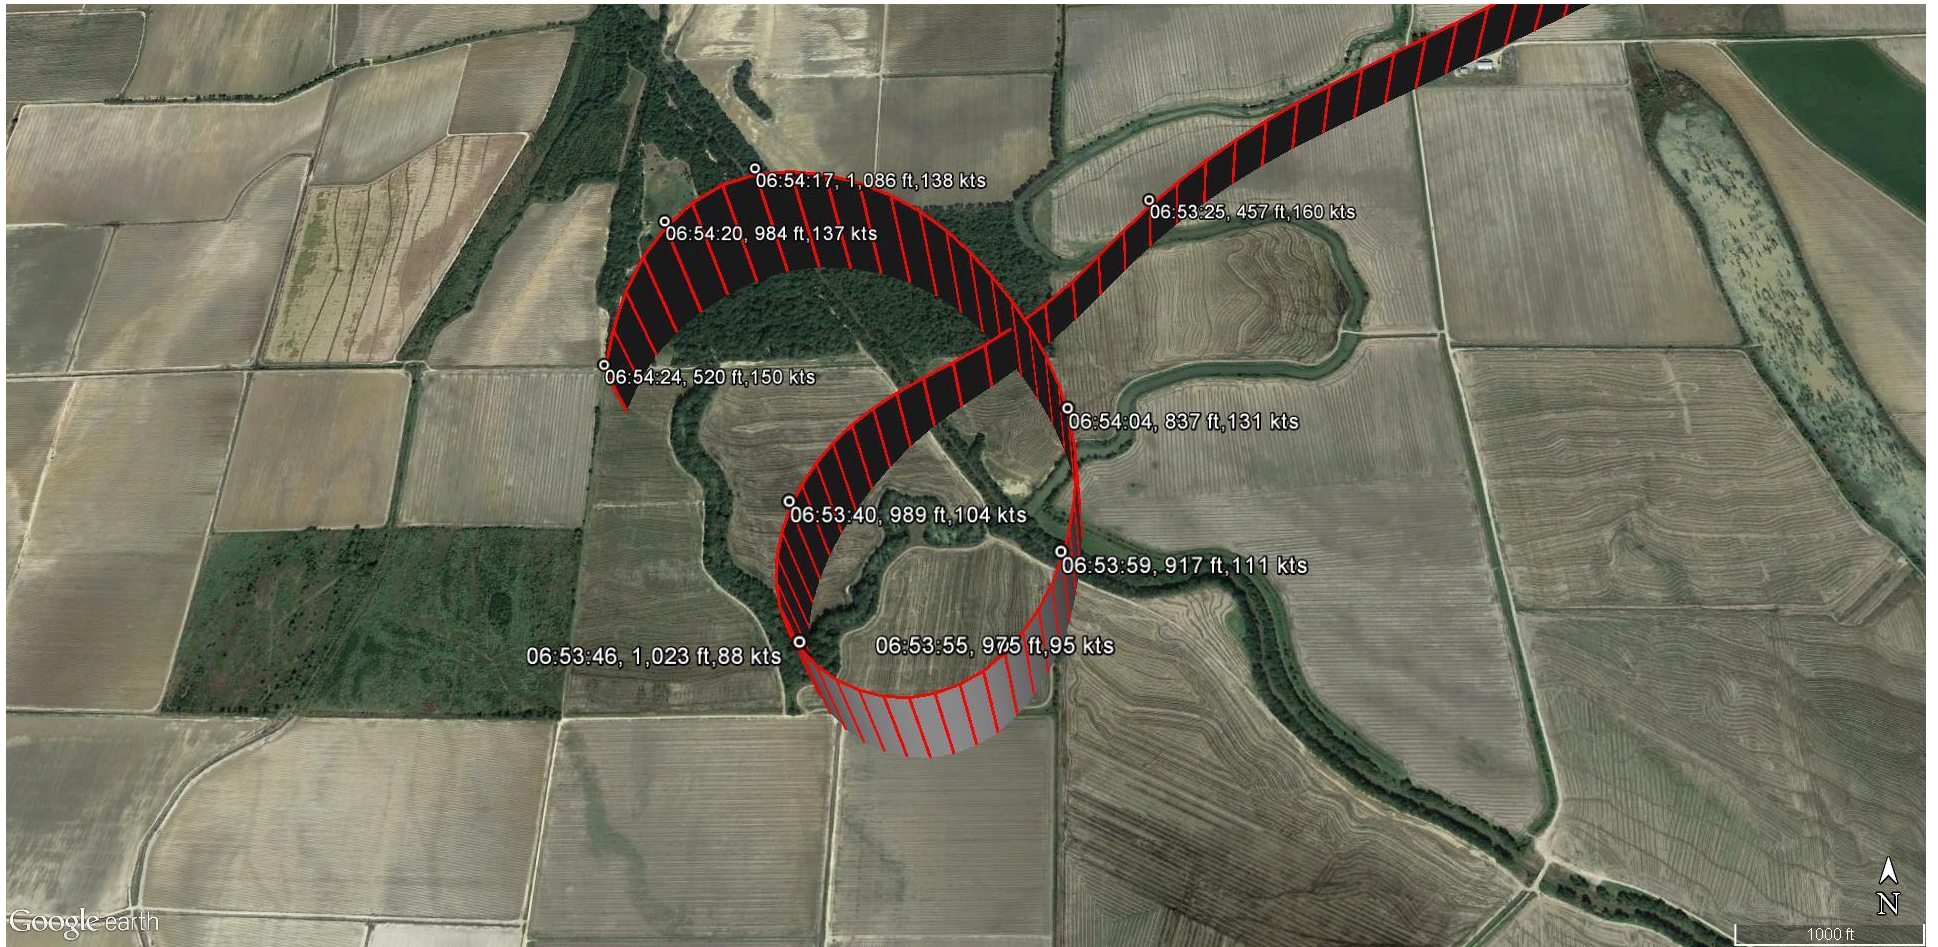
Figure 3. End of recording.

The recording ended at 0654:24 CDT. According to the recorder manufacturer, if power is removed from the recorder, up to 6-seconds of data may be lost.
