NATIONAL TRANSPORTATION SAFETY BOARD

AIRFRAME AND ENGINE EXAMINATION

WPR18FA075

Location: Concord, CA
Date: January 29, 2018
Aircraft: Cessna 152, N93316
Serial 15285465
NTSB IIC: Albert Nixon

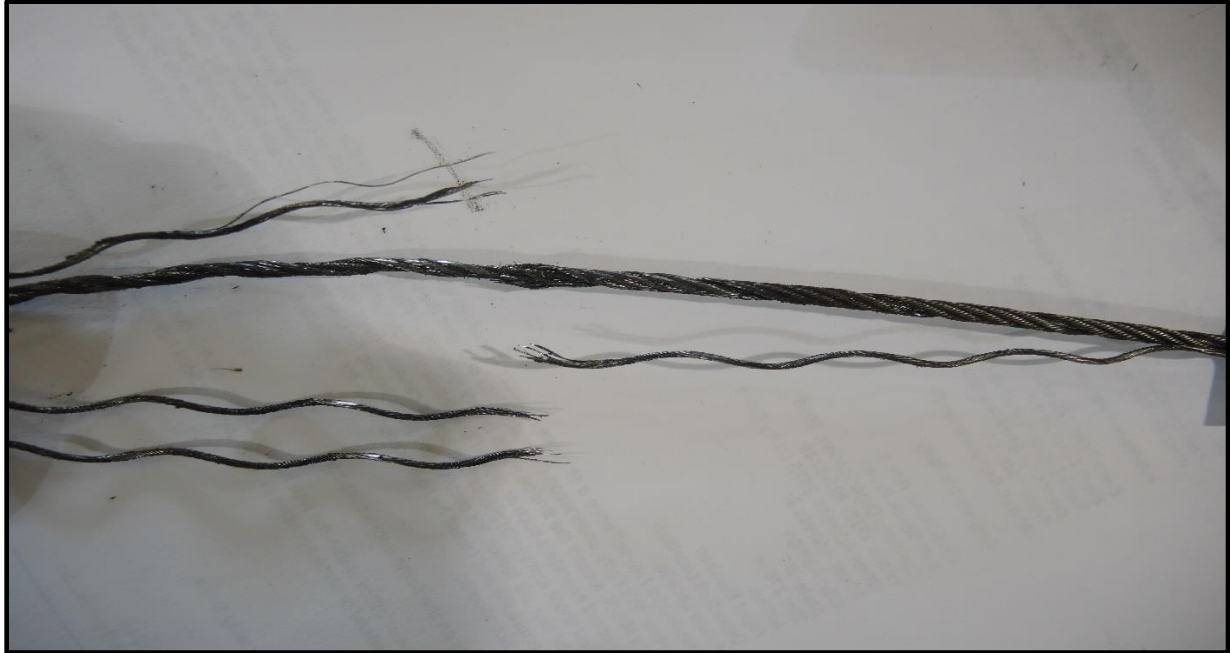
Flight control continuity was established to all flight control surfaces, with the exception of the right rudder cable, which was separated. The left rudder cable was observed to be in the process of separating, where it passed through the aft rear bulkhead in the aft tail cone. Three strands (about half of the strands) of the cable were separated. The right rudder cable was observed to be separated where it passed through the aft rear bulkhead. The aileron and elevator continuity were established from the aft portion of the cabin to the cockpit controls.

Figure 1: View of left rudder cable with some of the cable strands separated.

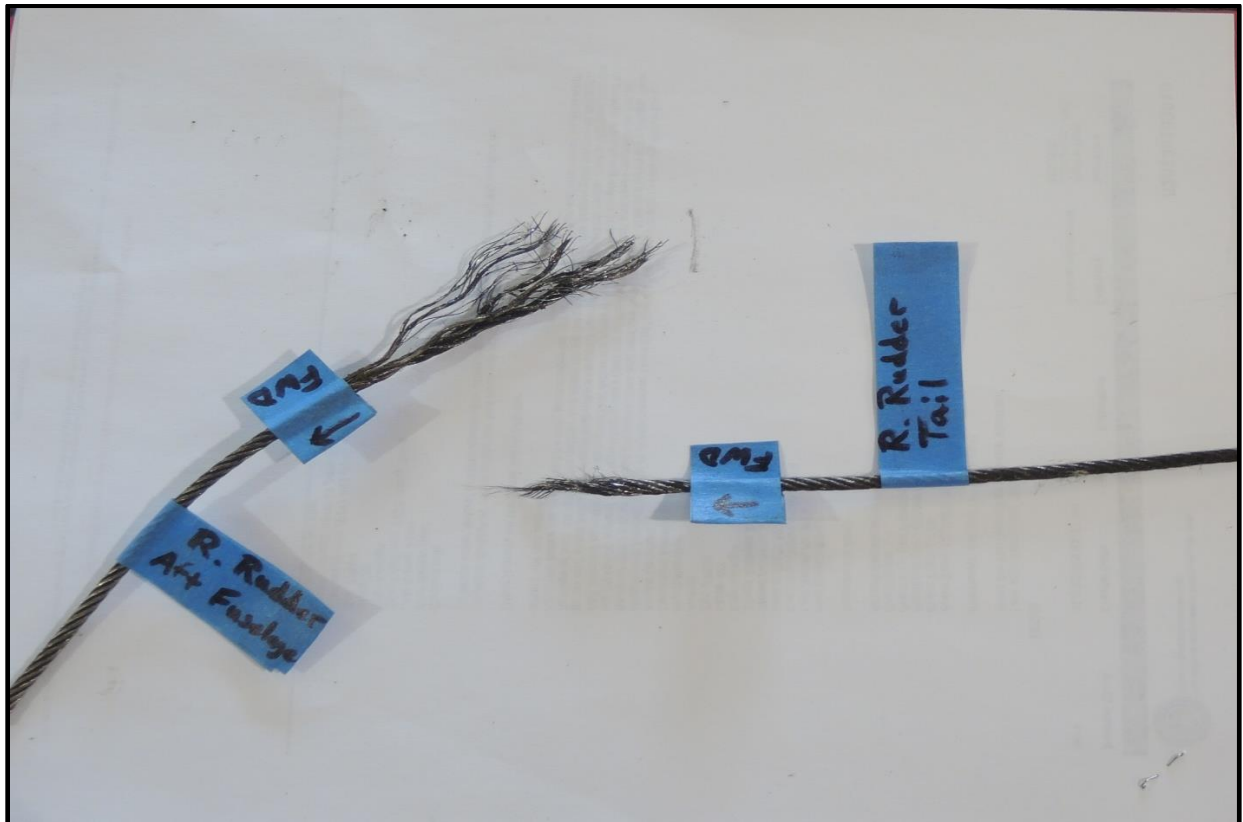
Examination of the recovered airframe was conducted on February 1, 2018, at the facilities of Plain Parts, in Pleasant Grove, California. The right cable to the rudder was found separated and the left rudder cable was partially separated. No additional evidence of preimpact mechanical malfunction was noted during the examination of the recovered airframe and engine.

Figure 2: View of the right rudder cable at separation point.
