NATIONAL TRANSPORTATION SAFETY BOARD

AILERON SYSTEM EXAMINATION

WPR15FA158

Location: Spokane, Washington
Date: May 7, 2015
Aircraft: Piper PA-46-350P, Registration Number: N962DA, Serial #: 4636031
NTSB IIC: Elliott Simpson

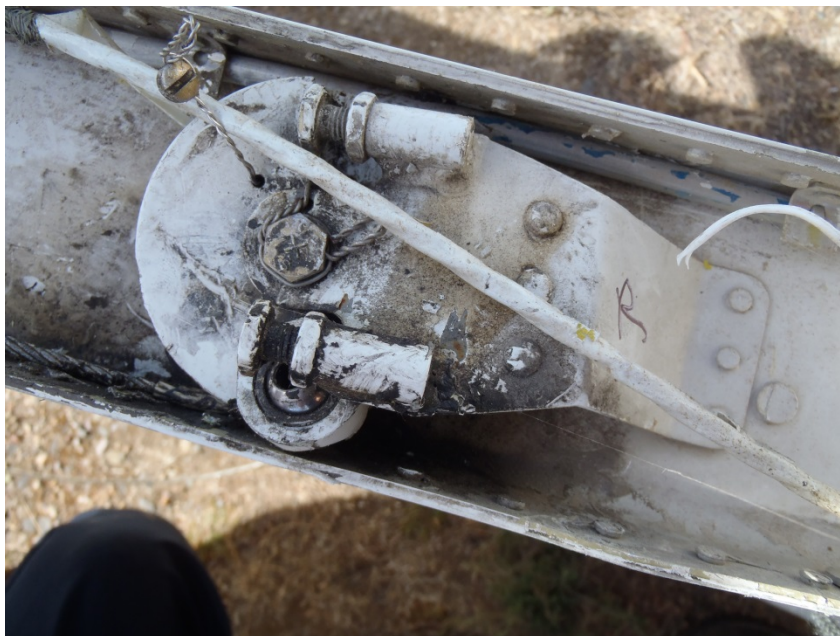
Service Letter 1131 described cleaning and lubrication procedures for the self-aligning and needle bearings of the outboard aileron sector wheel. Both bearings for the left and right wheels appeared intact and moved freely without any indication of binding (the right wheel had become impinged against its end stops during the accident sequence, and was subsequently freed during the examination (Photo 1).

Photo 1 - Right Wing Aileron Sector Wheel

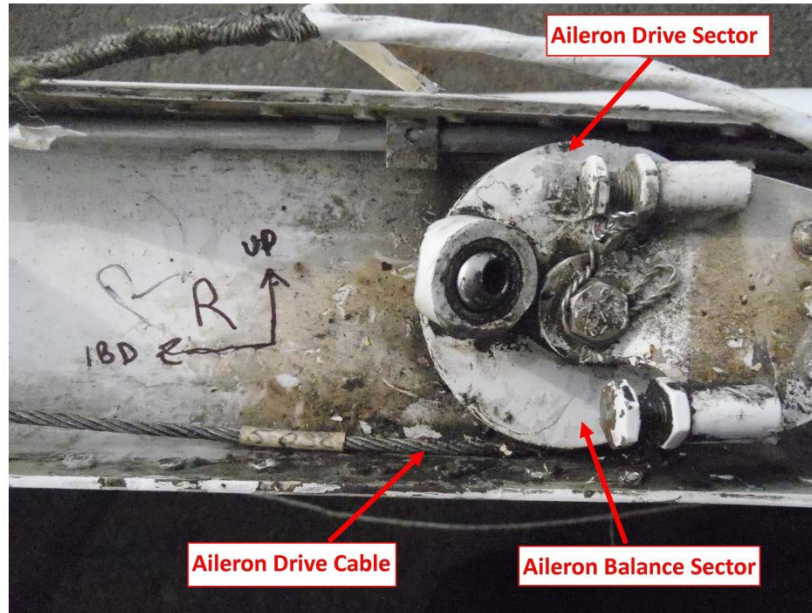
The outboard portion of the right wing had separated along with its aileron. A cable remained attached to the lower balance cable attach point of the aileron sector wheel (Photo 2), however a tag on the cable identified it as "5038", which according to Piper maintenance instructions was the aileron drive cable (Photo 3). The cable passed over the outboard balance cable pulley (Photo 6) as well as through the balance cable pass-through holes along the lower portion of the trailing edge (Photo 4,5). The cable continued, where it separated about 4 ft outboard of the root.

There was no cable attached to the upper drive section of the aileron sector control wheel (Photo 2). A cable marked with the part number "5036" exited from the upper control cable pressure vessel seal, however, according to Piper maintenance instructions, this part number corresponded to the right hand aileron balance cable (Photo 10). Inboard of the seal, the cable was connected to the turnbuckle of the left wing balance cable (Photo 11).

Photo 2 - Right Wing Aileron Sector Wheel with Drive Cable in Balance Cable Location

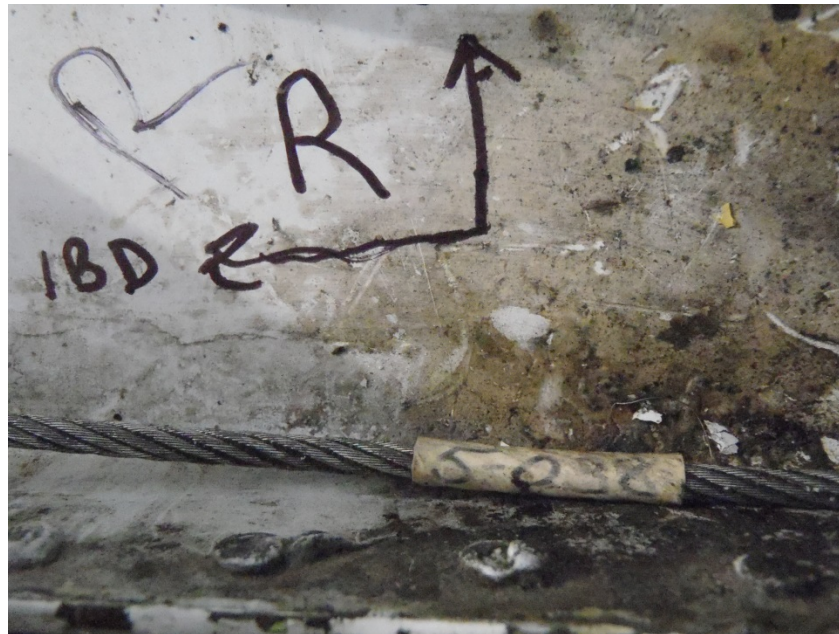
Photo 3 - Right Aileron Drive Cable in Balance Cable Location

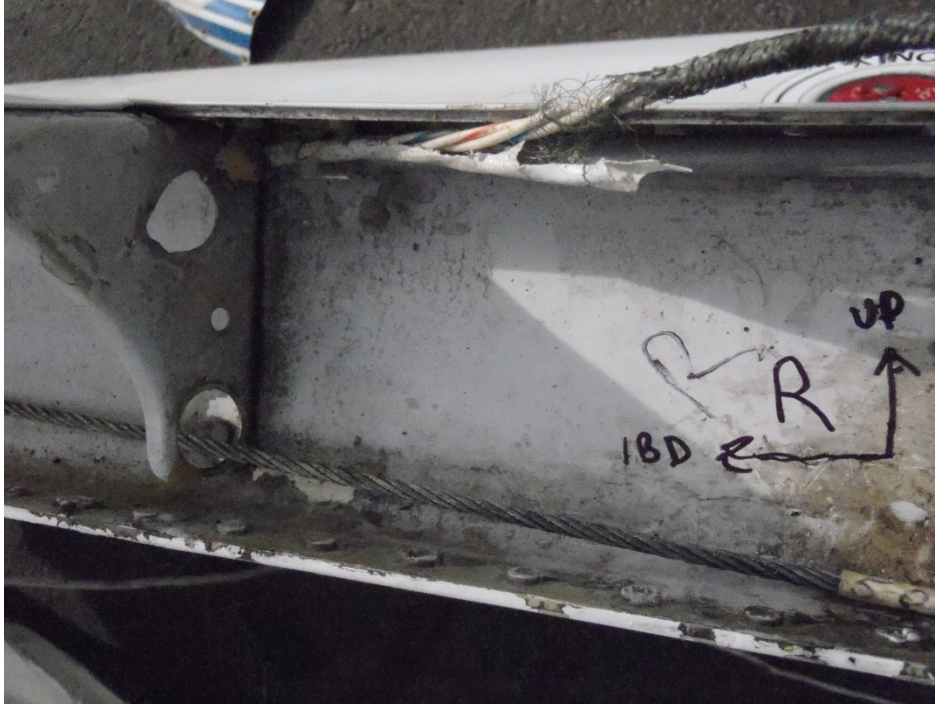
Photo 4 - Right Aileron Drive Cable at Balance Cable Pass-Through

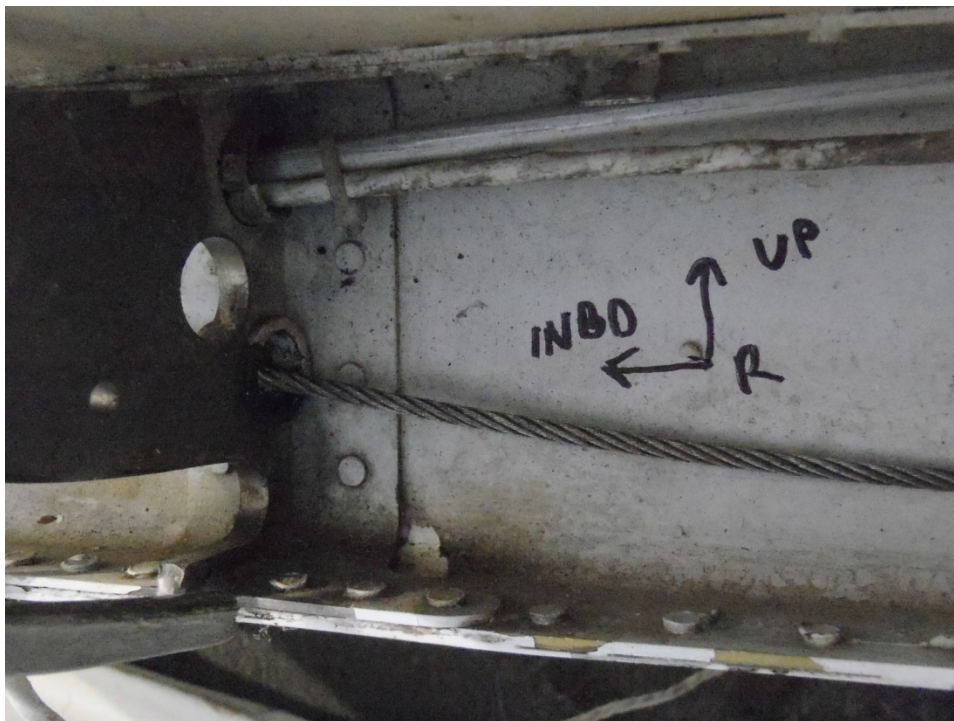
Photo 5 - Right Aileron Drive Cable at Balance Cable Pass-Through

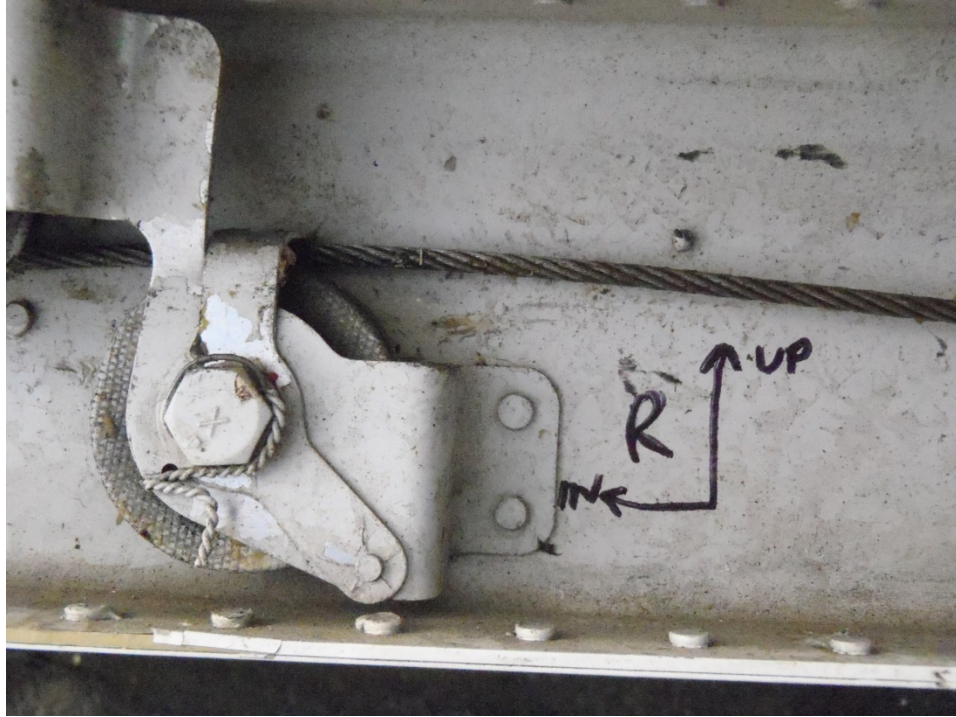
Photo 6 - Aileron Drive Cable at Outboard Balance Cable Pulley

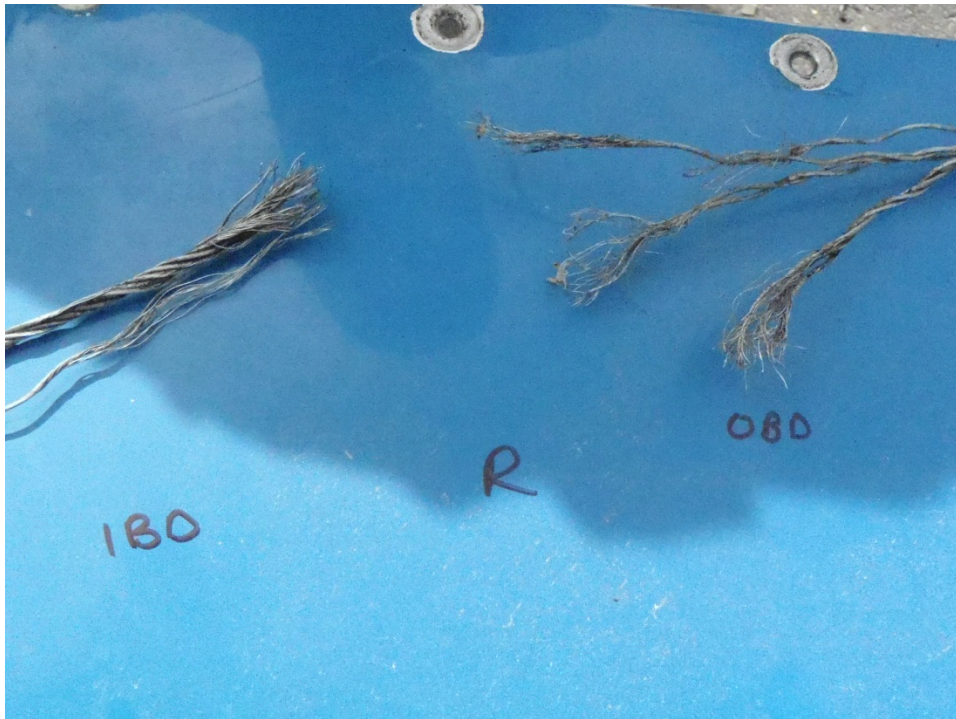
Photo 7 - Right Aileron Drive Cable

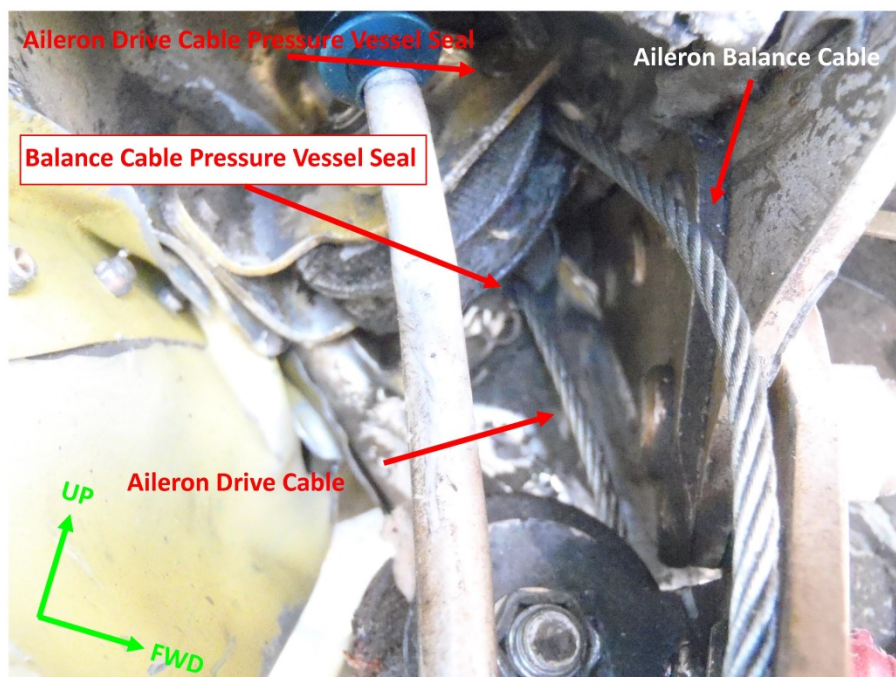
(Photo 7). The inboard section of the cable passed through the fuselage at the lower balance cable pressure vessel seal. (Photo 8). Within the fuselage a part number label "5038" was on the cable, at the termination point of a turnbuckle (Photo 9). From the turnbuckle, the cable passed around the right side drive pulley, and was continuous through to the control yoke assembly (Photo 11).

Photo 8 - Aileron Cables at Outer Side of Pressure Vessel Seals

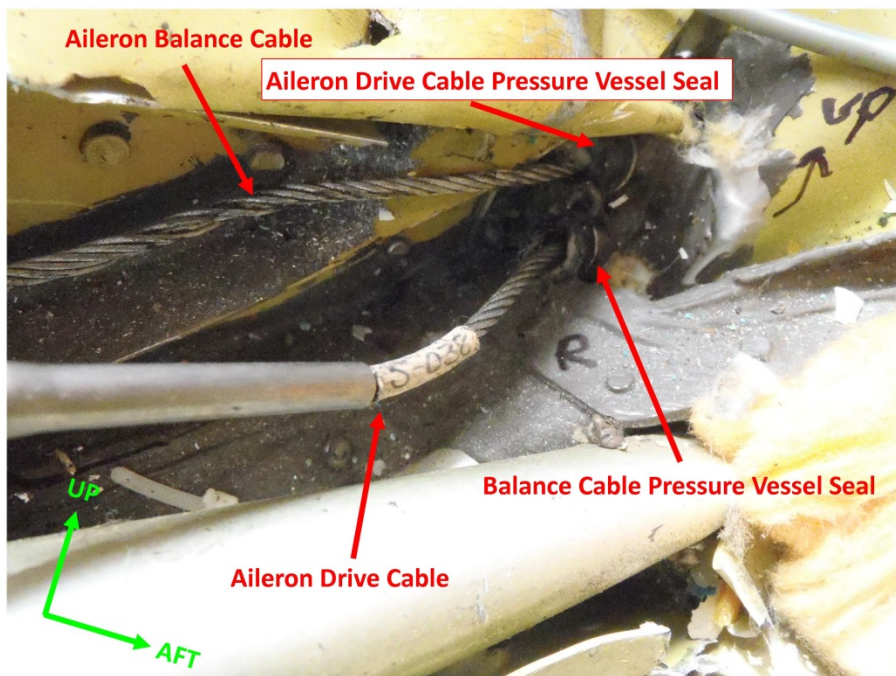
Photo 9 - Aileron Cables at Inner Side of Pressure Vessel Seals

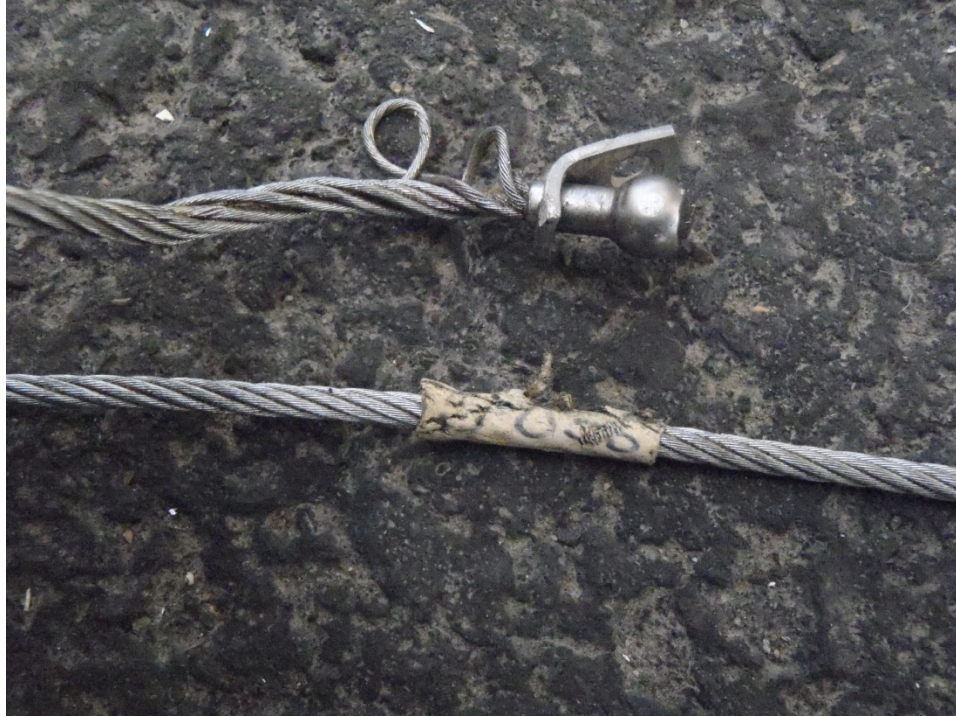
Photo 10 - Right Aileron Balance Cable

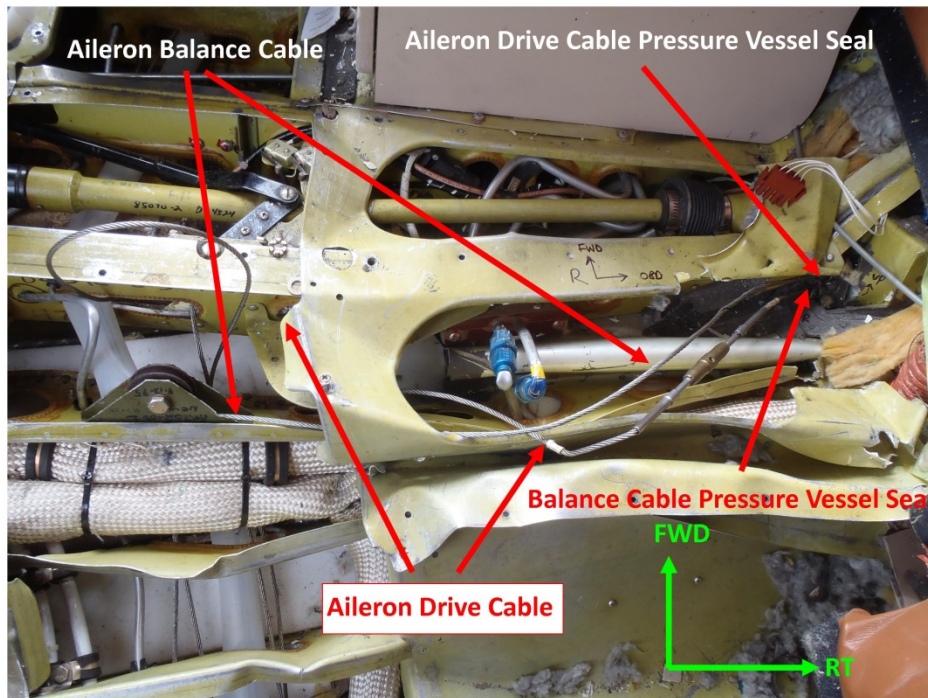
Photo 11 - Aileron Control Assembly at Wing Center Section

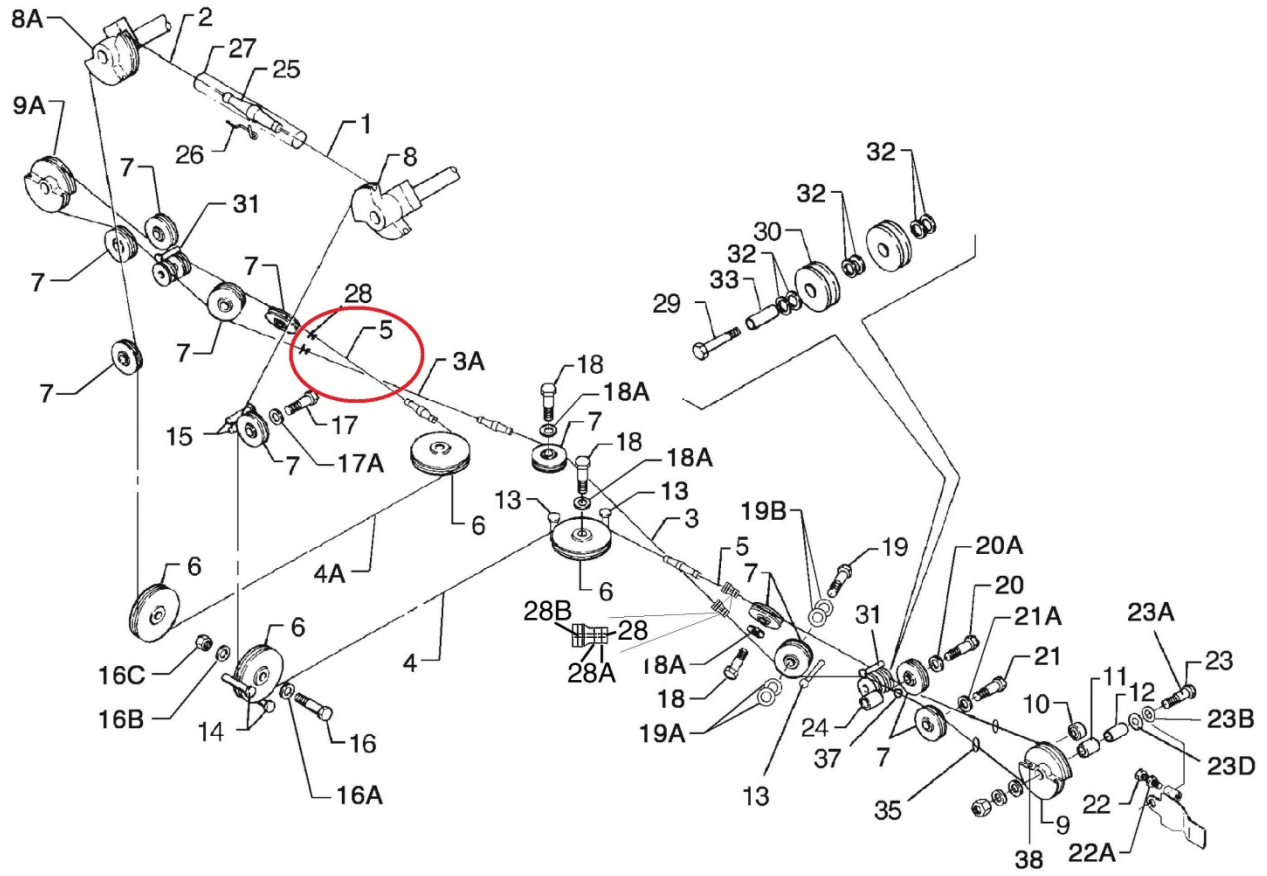
The left wing aileron control system appeared to be correctly rigged with all control cables terminating at their correct locations, and following their appropriate routing paths. Examination of the right aileron control system revealed that the aileron balance and control cable routing had been crossed over in the area of the cabin floor, between the center pulleys and wing root pressure vessel seals. As such, the balance cable continued through the wing on a route to the drive side of the aileron sector wheel, and the drive cable conversely continued on a route to the balance cable side. Under this condition, the right aileron control directions would have been reversed (Image 1).

Image 1 - Aileron Control System with Area of Cable Reversal Highlighted - Pressure Vessel Seal (28)
